# **HISTORIC RESOURCES REPORT**

**8442 Santa Ana Road**  
**(APN 060-0-220-150)**

Ventura County, California

August 14, 2020

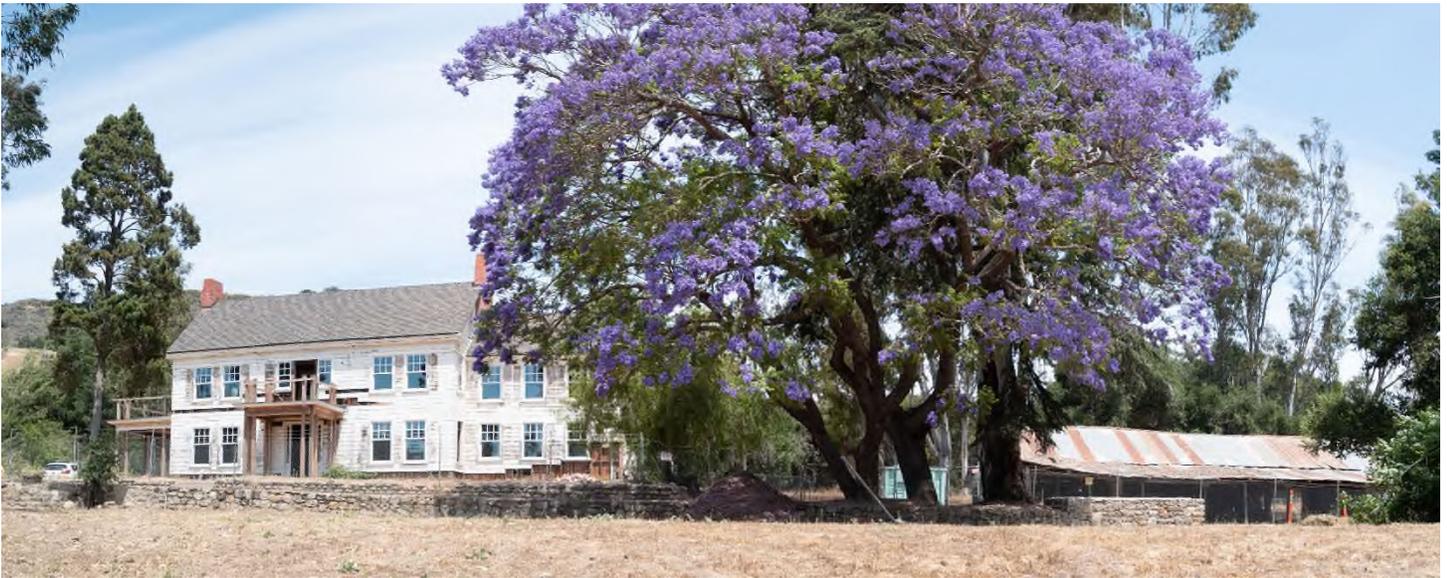
Built in 1918, the house is a two-story wood frame building with a partial basement level set on a continuous, board-formed concrete foundation partially clad in brick veneer (Figure 2). Several design features of the house including its clapboard siding, Classical-style detailing, and symmetrical façade, identify it as an example of the American Colonial Revival style, a subtype of the Period Revival movement.

**Figure 2, South Elevation with barn/garage to left, existing conditions**

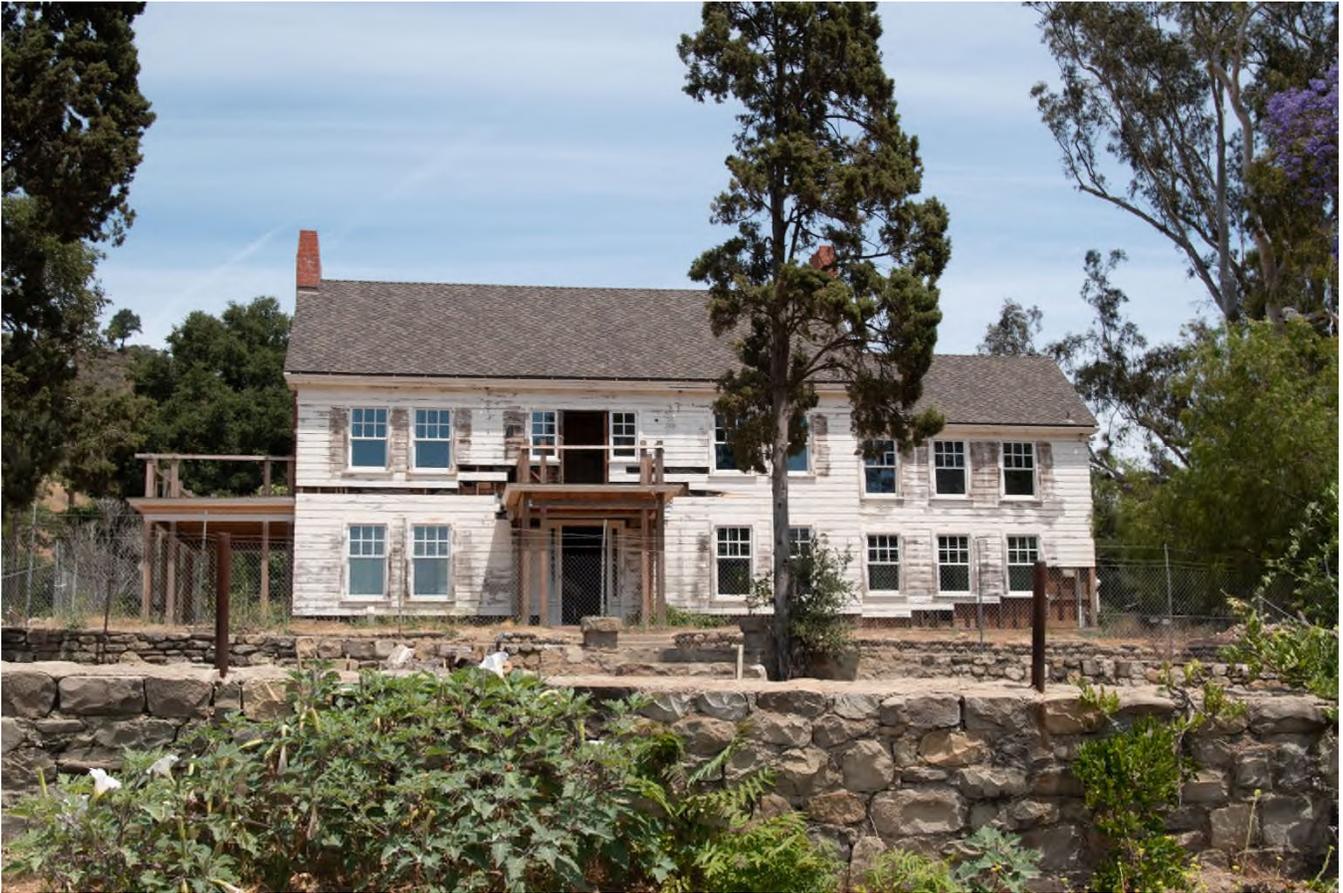
The entrance façade faces towards a two level terrace overlooks pastures that extend to the south end of the parcel (Figures 3 – 10). This elevation is composed of the main block of the house capped by a side gable roof, which is flanked on its east by a recessed wing with a lower ridge line. The main block is symmetrical in design with a centrally-placed porch sheltering an entrance door flanked by sidelights. The existing front porch is a replacement of the original porch which featured paired Classical style piers and pilasters supporting a balcony with a Classical style railing. The porch's original concrete and brick stoop survives. A symmetrical arrangement of pairs of six-over-one wood sash windows flanks either side of the porch; these windows are recent (2020) replacements of the original sash. The balcony was accessed via glazed wood panel door flanked by four-over-one sash windows set at the façade's center point. On its east side, the porch is flanked by a recessed wing whose fenestration is composed of a symmetrical arrangement of six-over-one windows. The original one-story veranda style porch capped by a balcony that extended off the west end of the elevation has been removed. The porch's existing roof structure and wood posts are replacements (2020) of the original Classical style wood piers, balustrade, and flat roof.

**Figure 3, South Elevation, existing conditions**

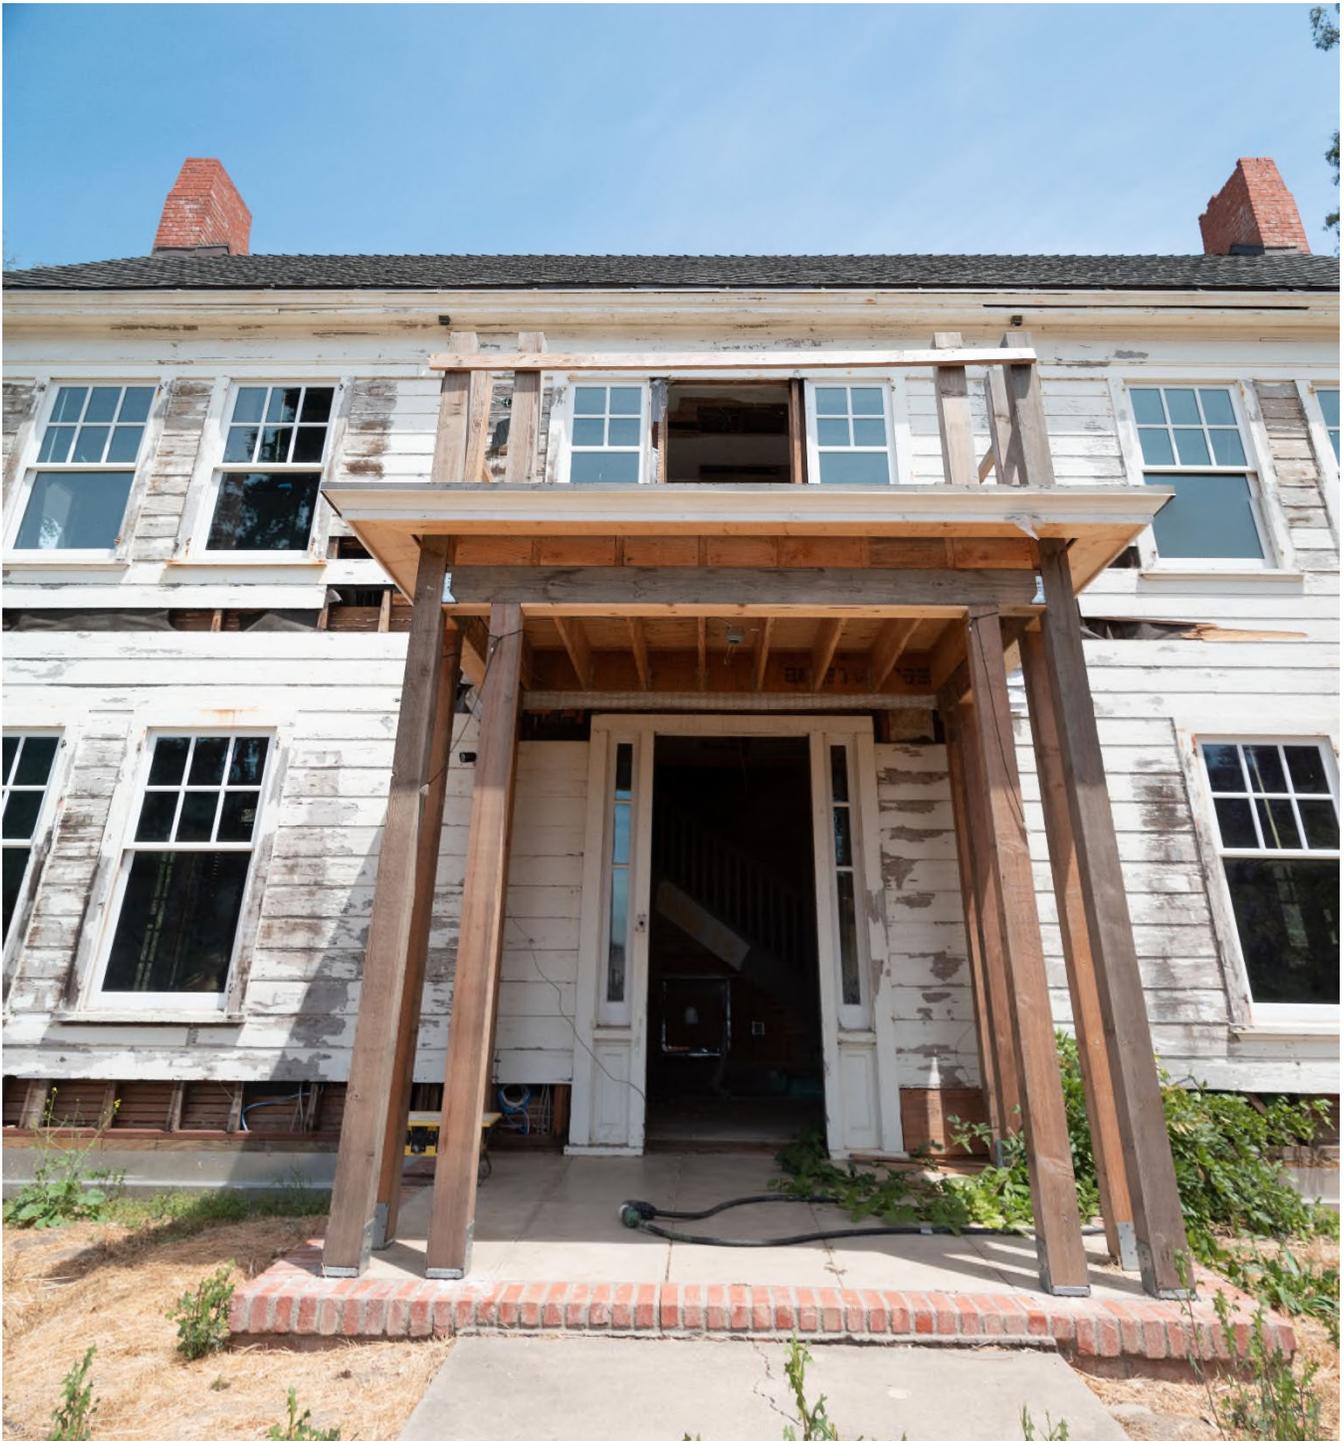
**Figure 5, South Elevation, front porch, existing conditions**

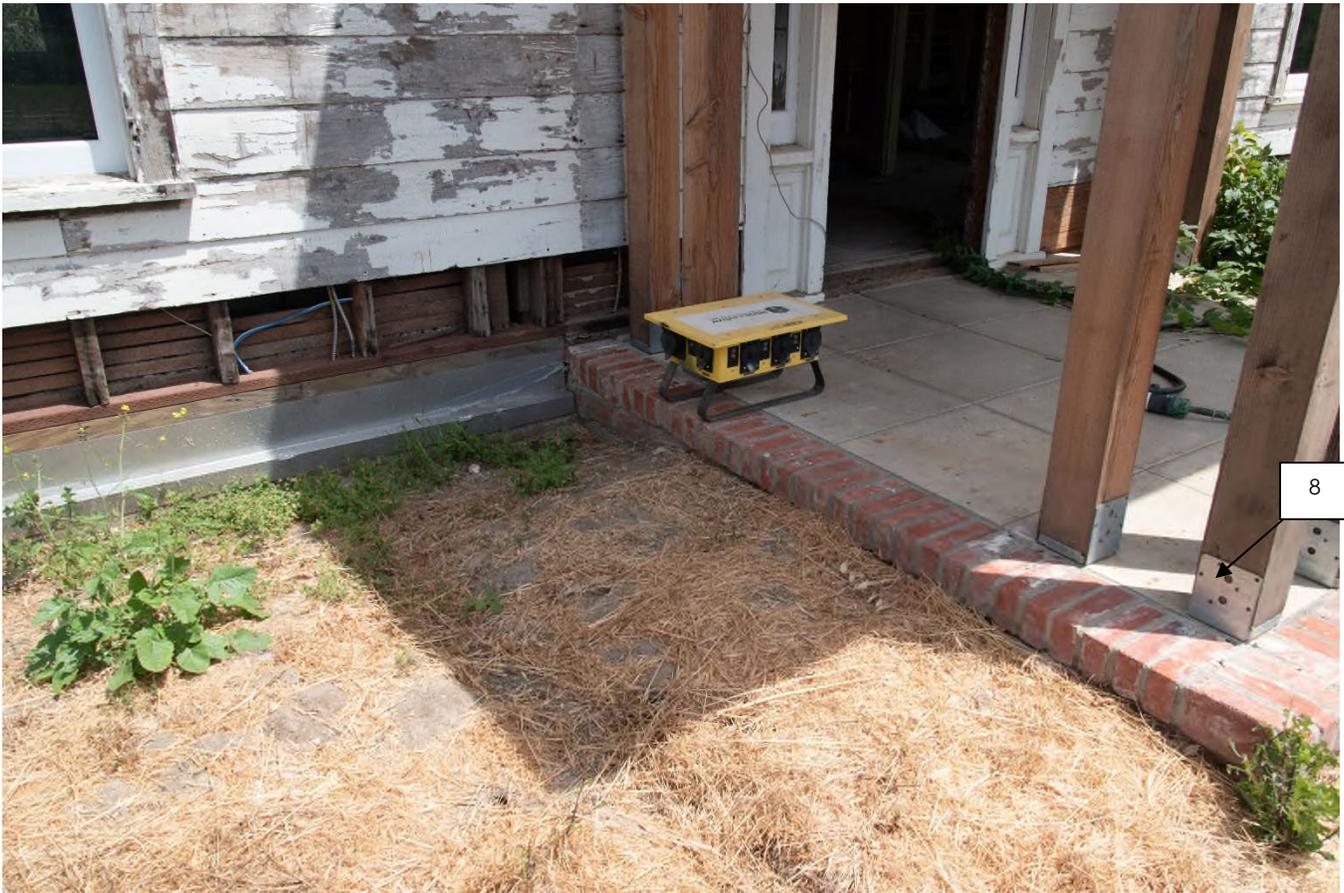
**Figure 6, South Elevation, detail of porch and foundation, existing conditions**

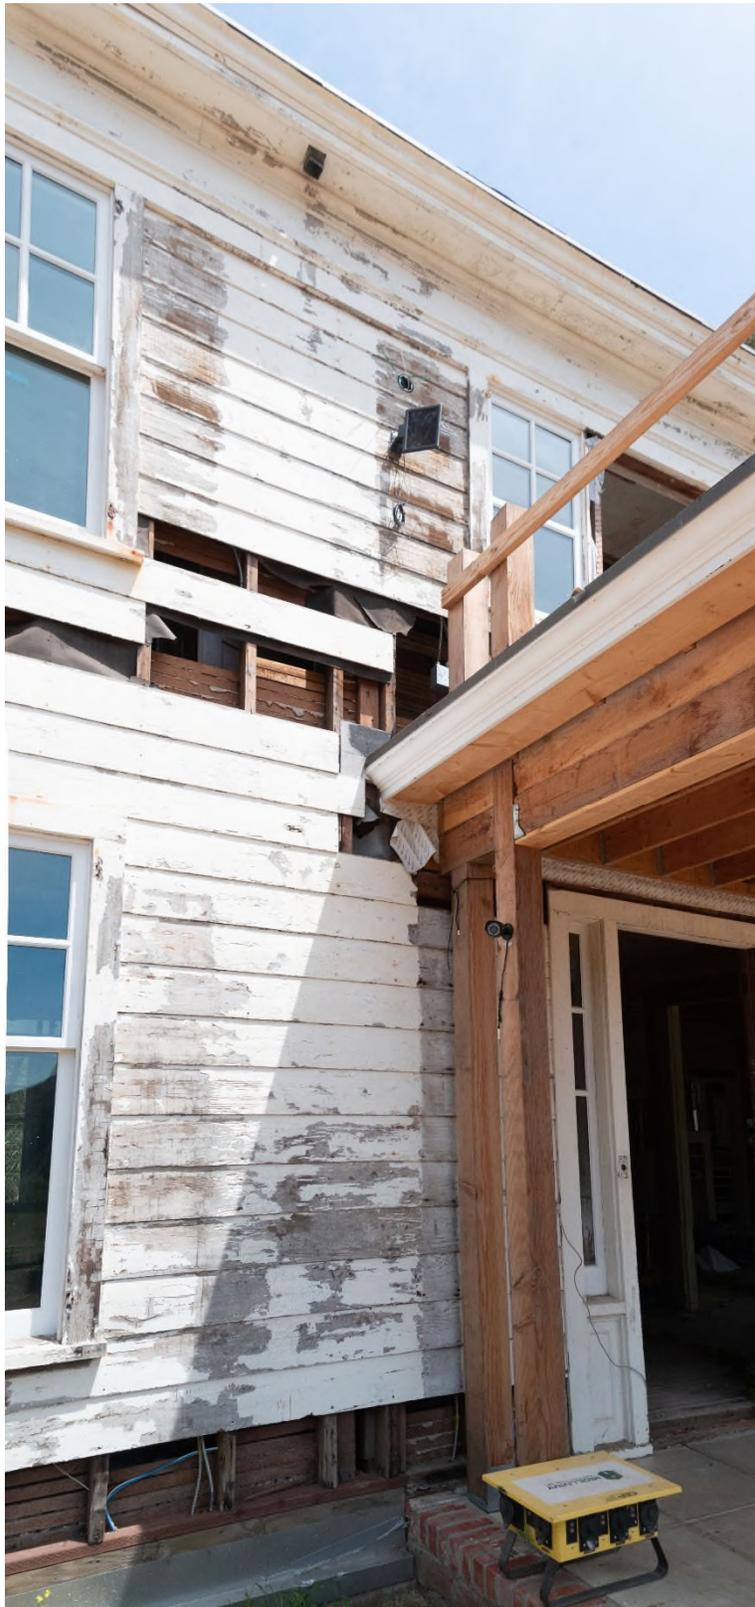
**Figure 7, South Elevation, detail of cladding, existing conditions**

- Sections of wood siding to deteriorated to repair were removed for replacement with new wood siding matching the original in material, design, dimension, and profile (Appendix A, Sheets A3.1 & A3.2, treatment plan delineated under “Finishes”). The existing siding is documented by Figures 2 -20);

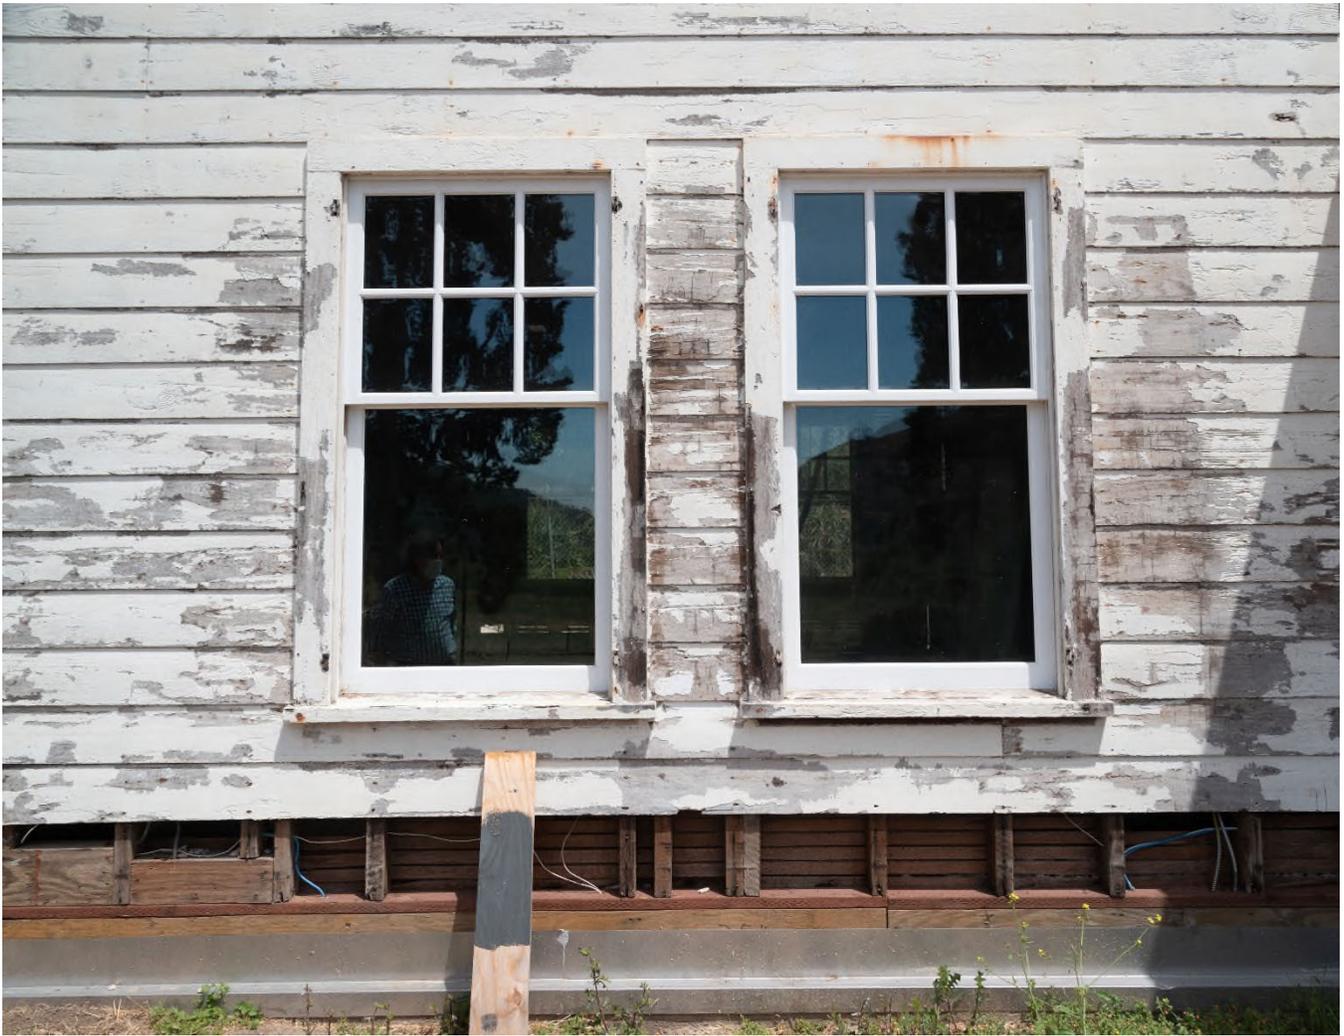
**Figure 8, South Elevation, detail of replacement fenestration, existing conditions**

- Permit as-built replacement of the damaged fenestration with new sash units matching the originals in placement, dimension, materials, and design (Sheets A3.1, A3.1, elevations depicting replacement fenestration, treatment plan delineated under “Doors and Windows” and Sheet A5.2, window and door schedule). The new windows are divided light wood units that emulate the original in the pattern of divided lights (generally six-over-one) (see Appendix A, Sheets A2.1 – A3.2 & 5.1 and see Figures 2 -20 depicting replacement fenestration). The width of window muntins was increased to 1 3/8 inches, the minimum required to maintain the structural integrity of the windows and their code-compliant glazing to maintain the structural integrity of the windows (Dovecreek 2020, Appendix B). The original windows are documented by photographs taken before the current project was initiated (These photographs were taken between the late 1980s and early to mid-2000s (see Figures 21 – 23). Window units were replaced because of decay and vandalism, which had adversely affected their structural integrity;

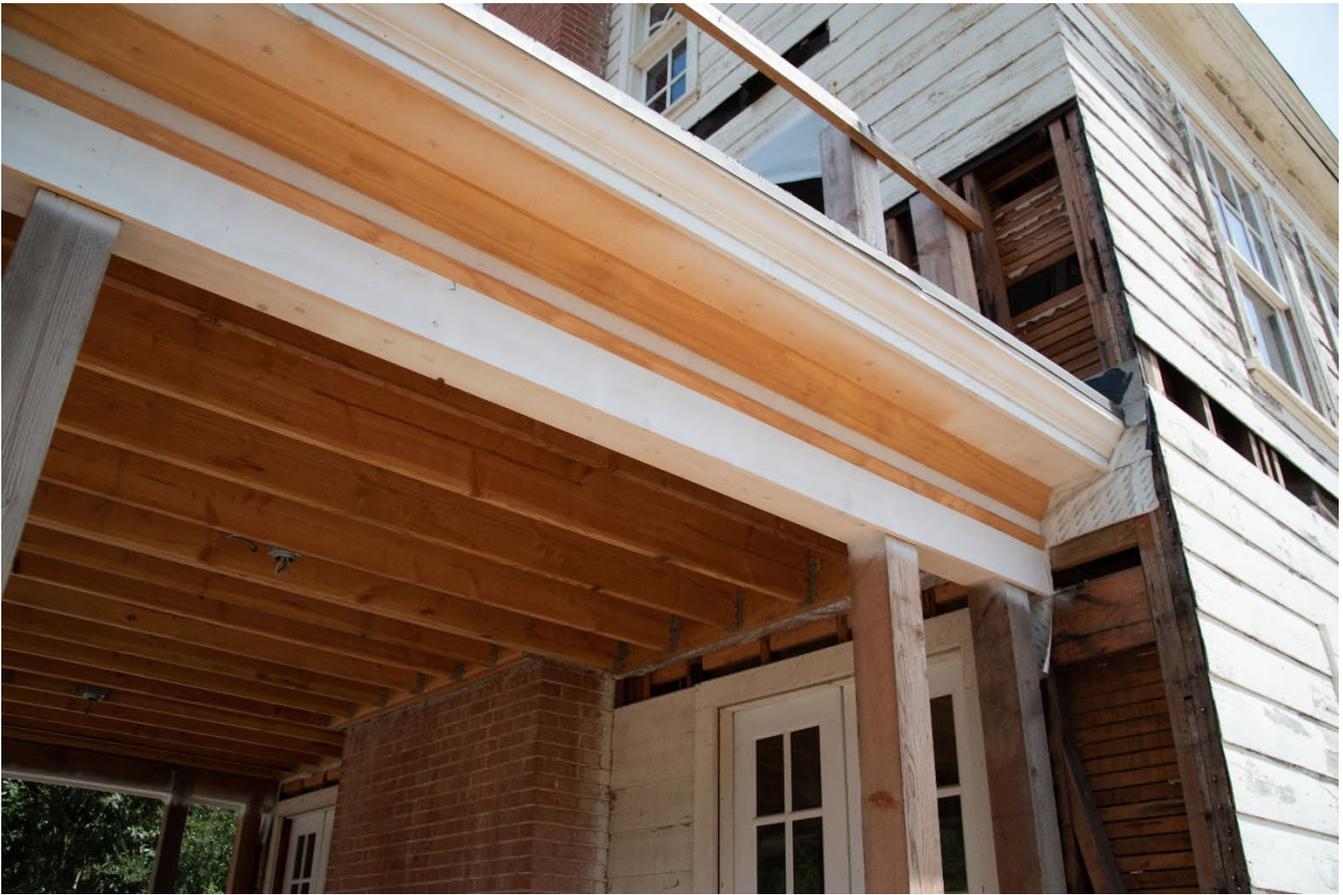
**Figure 9, South Elevation, detail of veranda roof, existing conditions**

- Replace the veranda's rooftop balcony surfacing with a DEXOTEK roof system (Sheet A2.2 & SP-1).

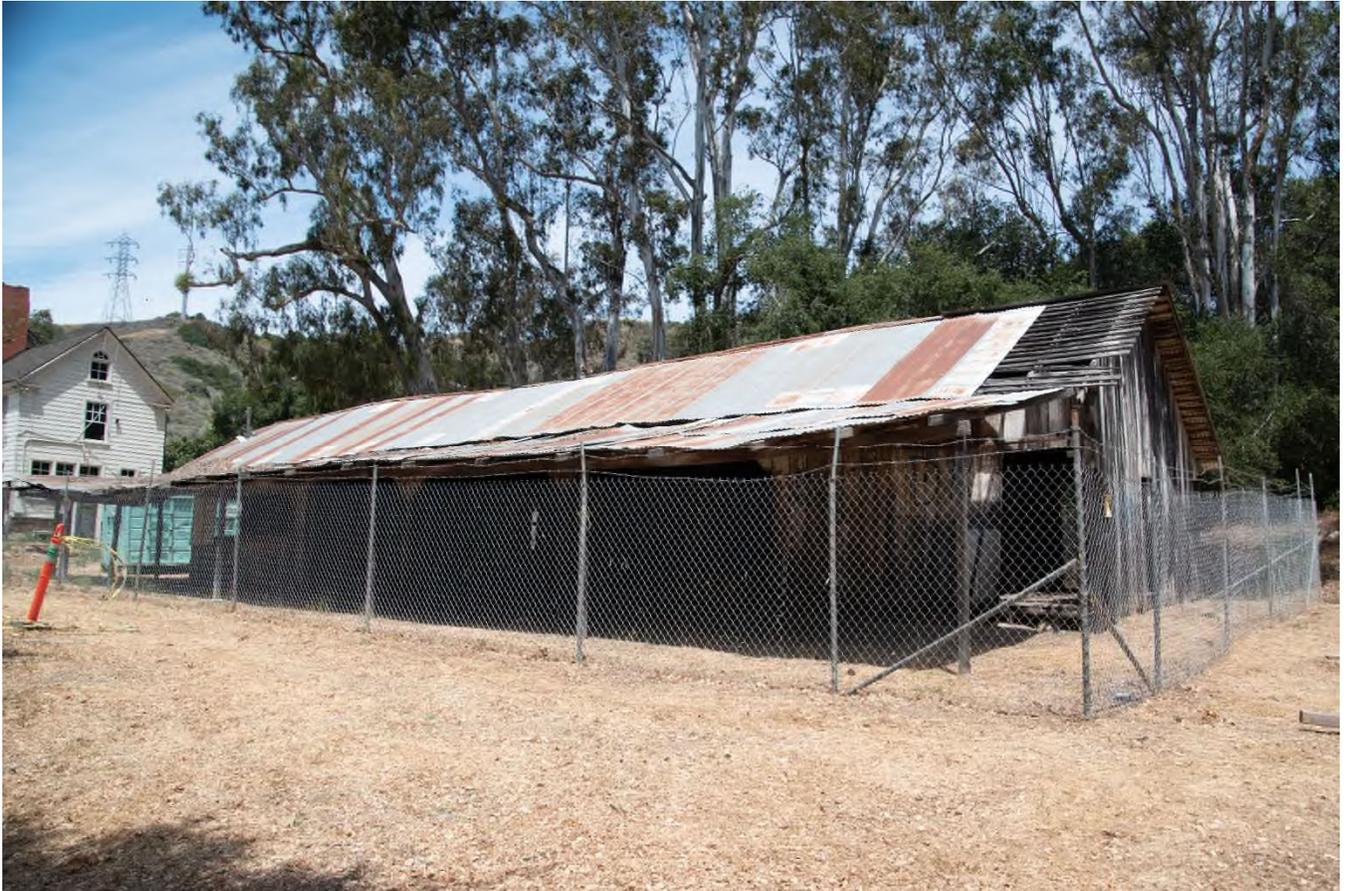
A one-story wood and metal service building housing a barn and garage, is located southwest of the house. The structure has wood framing, a broken-pitch side gable roof covered in corrugated metal and walls partially sheathed in wide wood planks (Figures 24 -

28). The garage portion of the building features a series of open bays separated by wood posts on its south elevation. Fenestration is composed of paired two, four-light wood windows on the rear elevation. The building is surrounded by security fencing and is a state of advanced deterioration, which made it unsafe to enter.

**Figure 24, Barn/Garage, South Elevation, existing conditions**

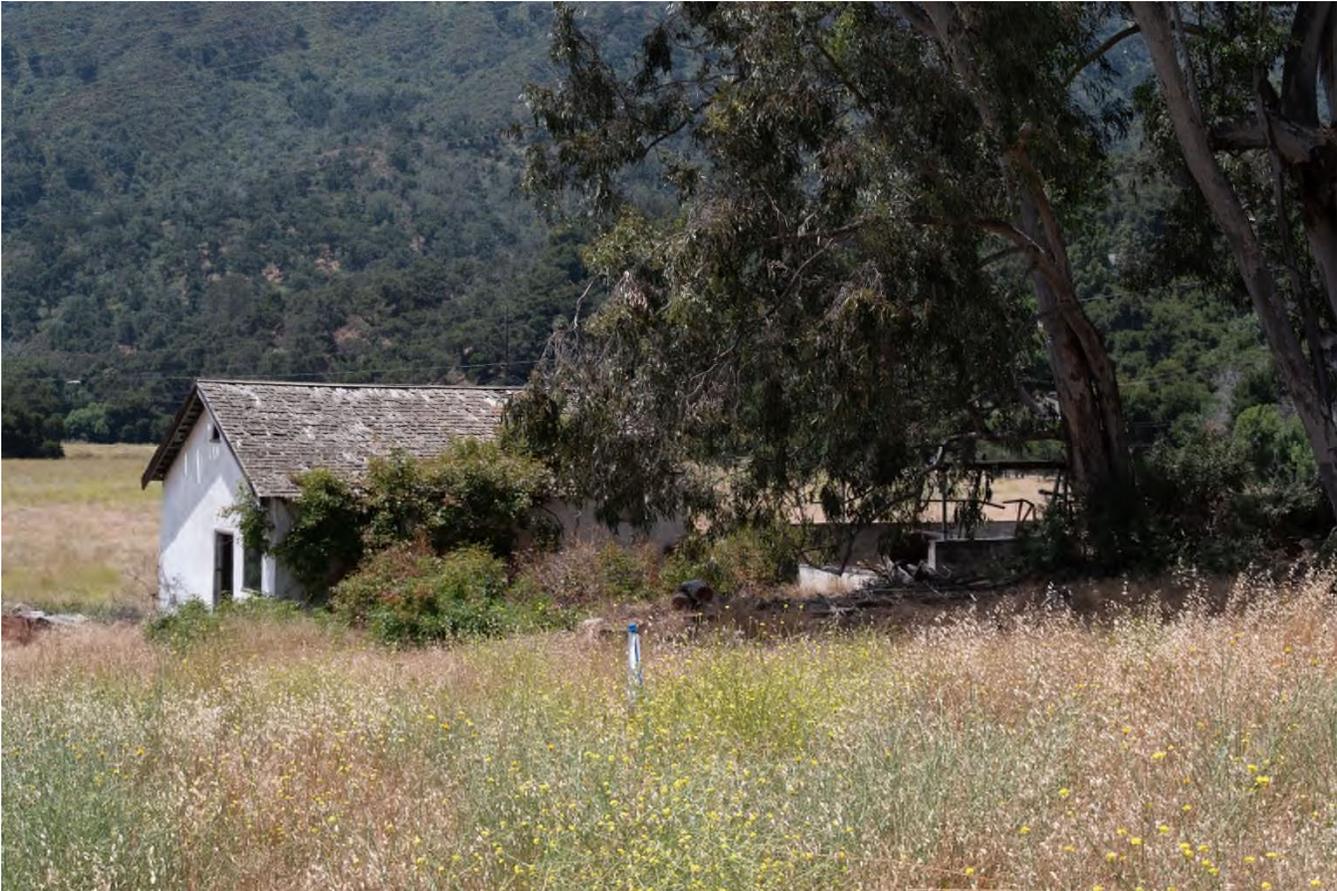
This is a stucco-clad wood frame building located north of the house (Figures 29 - 31). The building is capped by a complex cross-gable wood shingle roof with shallow eaves. The building's doors and windows have been removed or extensively damaged. A partially enclosed area surrounded by low concrete walls, located off the north end of the building, may have been associated with the possible use of the building as a dairy.

- Most of the building's doors and windows have been removed, covered by wood sheeting, or damaged by vandalism and neglect. This damage appears to have occurred since the early 2010s.

**Figure 29, "Dairy," North and East Elevations, existing conditions**
