## **Staff Report and Recommendations Agenda of October 13, 2025, Item 8a**

A request for a Certificate of Appropriateness for after-the-fact replacement of windows at a 12-unit apartment complex located at 534-542 S. F Street, Oxnard, CA 93030 (Ventura County Landmark #173: McColm Manor Apartments). (Case No. CH23-0040).

534-542 S. F Street, Oxnard, CA 93030  
Assessor's Parcel Number (APN): 202-0-121-080  
Historic Designation: Ventura County Landmark #173  
Common/Historic Name: McColm Manor Apartments

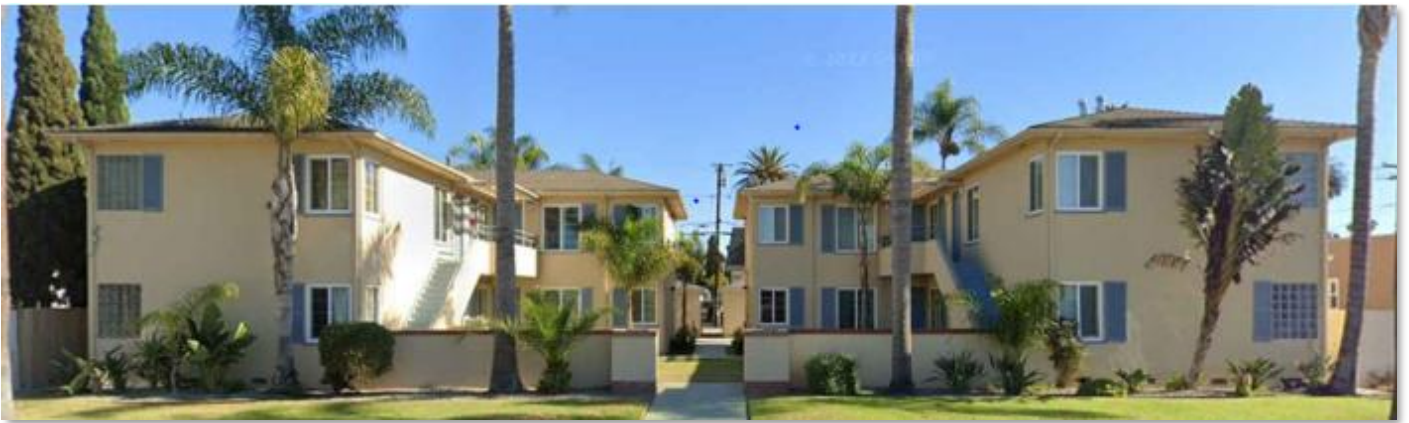
In 2022, the current property owner replaced all of the remaining original light steel casement windows with vinyl clad windows. Figure 1, below, shows the apartment complex with the new windows. This alteration removed a key character-defining

feature<sup>12</sup> and appears to have substantially reduced the historic integrity<sup>13</sup> of the property. The property owner has applied for after-the-fact authorization of this alteration. Refer to Figure 2 and Figure 3 below for views of the subject property prior to this alteration. Exhibit 4 conditions additional photos of the property's current condition.

Figure 1 – View of property in 2023 following window alteration (looking east)

- **Recommendation #1: Window Replacement.** The applicant should install new windows to match the historic windows to the extent feasible based on photographic documentation in terms of configuration, materials, details, and finish in order to be more compatible with the overall historic character of the building. Please note that projects affecting the exterior of a designated Cultural Heritage Site are subject to Cultural Heritage Board or Cultural Heritage Board staff review and approval prior to work commencing. In addition, for a Cultural Heritage Site subject to a Mills Act contract, any change affecting the interior character-defining features thereof are subject to review and approval. Work must meet all relevant Building Code and Zoning Ordinance requirements and the *Secretary of the Interior's Standards for the Treatment of Historic Properties*.

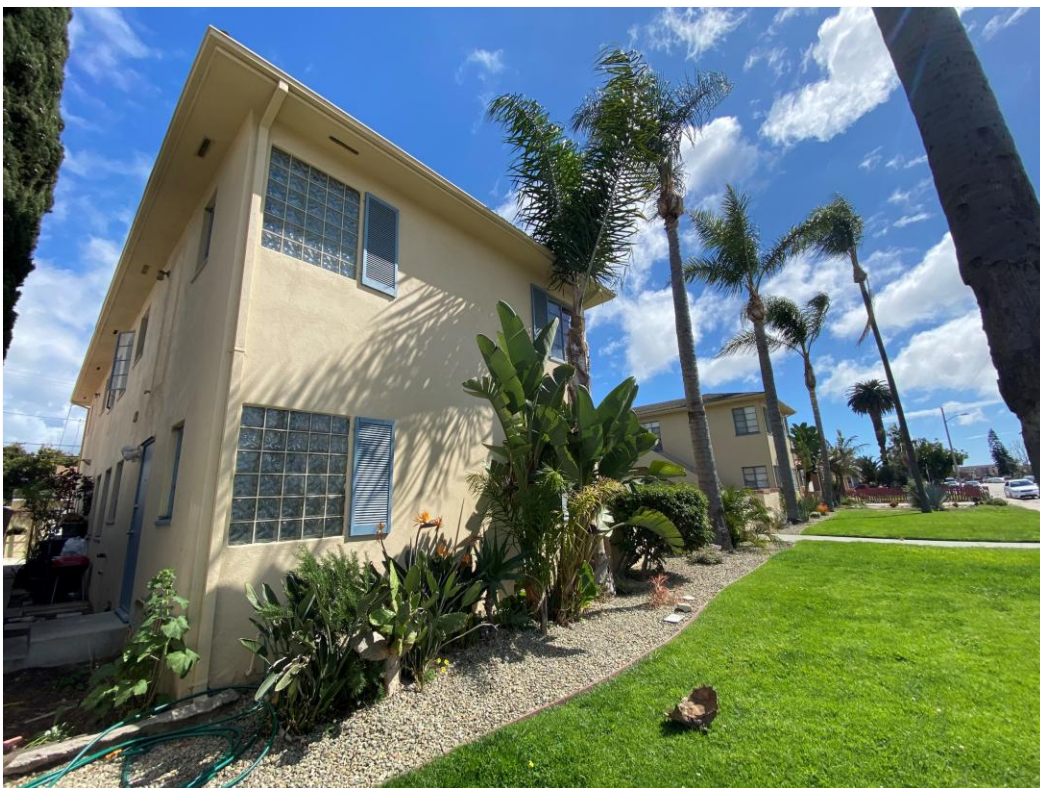
Figure 2 – View of property in 2020 prior to window alteration (looking southeast)

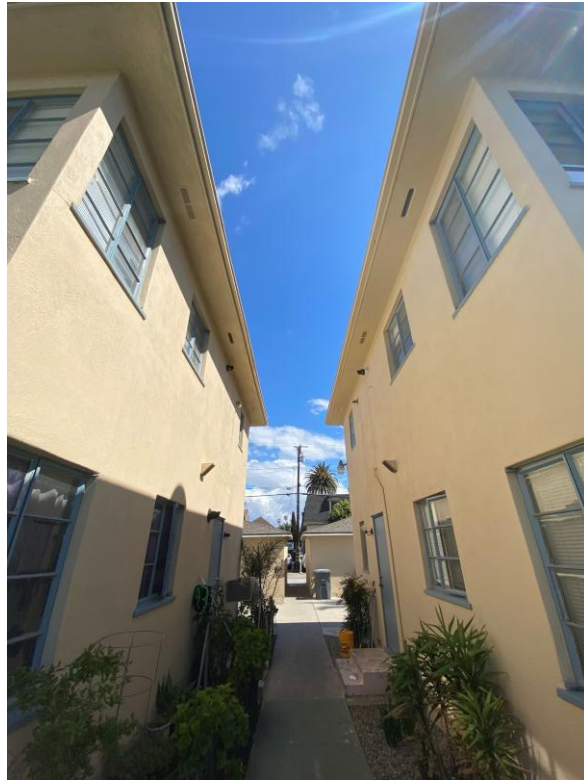
Figure 3 – View of property’s central walkway in 2020 prior to window alteration (looking east)

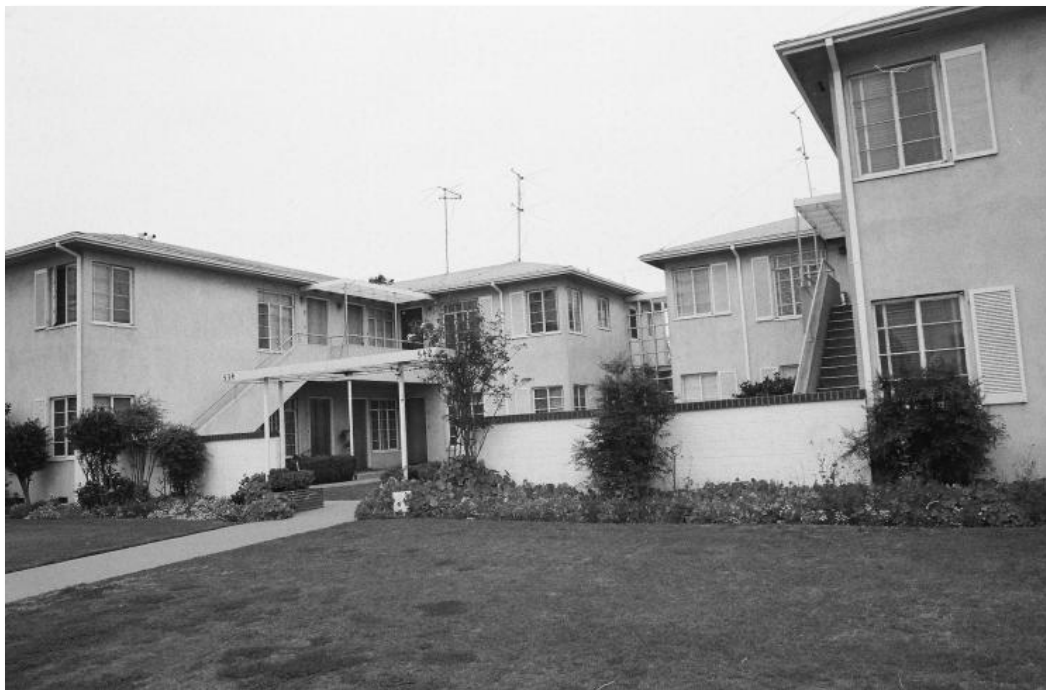
condition and re-roofing all four buildings, the apartments buildings and garages. Refer to Figure 4 for a historical photo showing the showing original wall configuration, pergola, screen, and faux window shutters.

Figure 4 – Western elevation, showing original wall configuration, pergola, and screen (1981)
