## **Staff Report and Recommendations Agenda of October 27, 2025, Item 6a**

### **County of Ventura • Resource Management Agency**

A request for a Certificate of Appropriateness for the phased installation of aluminum-clad windows over a period of five years and after-the-fact authorization of some vinyl-clad windows at a 12-unit apartment complex located at 534-542 S. F Street, Oxnard, CA 93030 (Ventura County Landmark #173: McColm Manor Apartments). The scope of work also includes the construction of a trellis at the front entrance to the property. (Case No. CH23-0040).

534-542 S. F Street, Oxnard, CA 93030  
Assessor's Parcel Number (APN): 202-0-121-080  
Historic Designation: Ventura County Landmark #173  
Common/Historic Name: McColm Manor Apartments

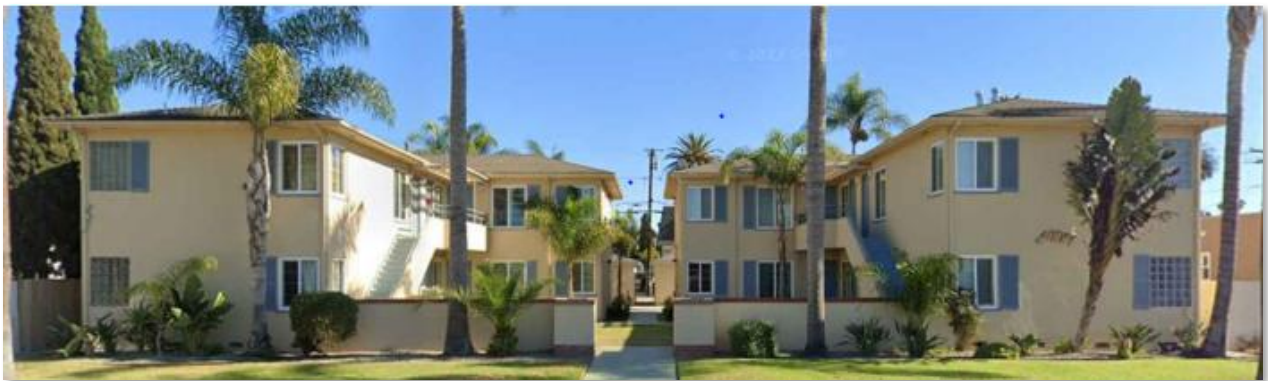
In 2022, the current property owner replaced all of the remaining original light steel casement windows with vinyl clad windows. Figure 1, below, shows the apartment complex with the new windows. This alteration removed a key character-defining feature<sup>12</sup> and appears to have substantially reduced the historic integrity of the property. The property owner has applied for the phased installation of aluminum-clad windows over a period of five years and after-the-fact authorization of some vinyl-clad windows. Refer to Figure 2 and Figure 3 below for views of the subject property prior to this alteration. Exhibit 4 conditions additional photos of the property's current condition.

Figure 1 – View of property in 2023 following window alteration (looking east)

Following the CHB hearing on October 27, 2025, the applicant now proposes replacing nearly all highly visible vinyl-clad windows on the building's primary elevations (the west elevation adjacent to F Street, and part of the north and south elevations closest to F Street) with a more appropriate aluminum-clad window product, which would more closely match the original windows in appearance and reduce the previous loss of integrity. It is the position of City of Oxnard staff that the replacement

- **Recommendation #1: Replacement Windows.** Due to their visibility from the vicinity of the property, it is recommended that all windows on the north and south elevations, along with the second-story windows on the east elevation, also be replaced. In addition, if City staff determine any existing vinyl-clad windows to remain cannot be approved retroactively due to building code issues, it is recommended that such windows also be replaced with the same aluminum-clad window product currently proposed for the rest of the property.

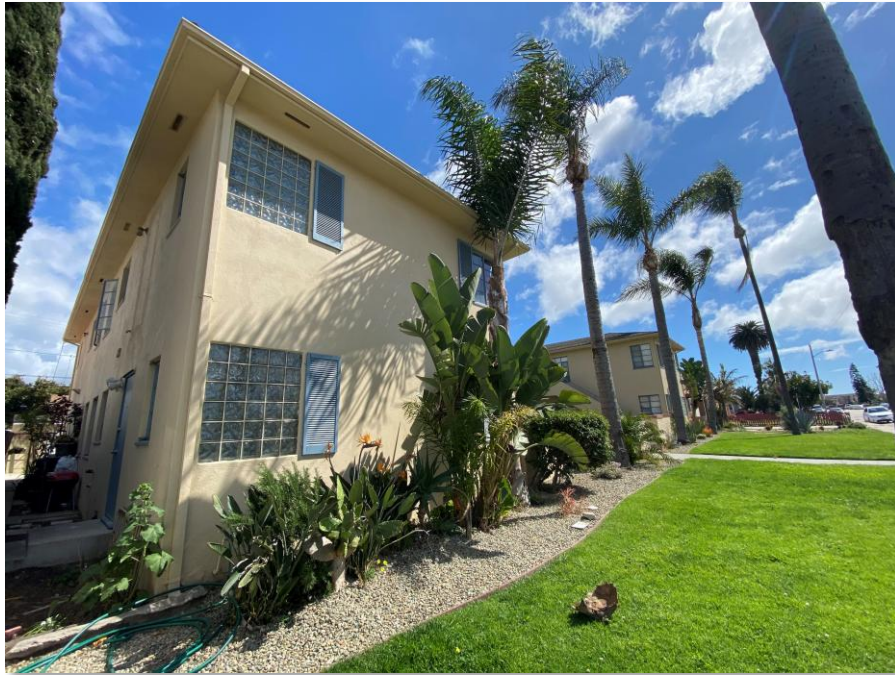
Figure 2 – View of property in 2020 prior to window alteration (looking southeast)

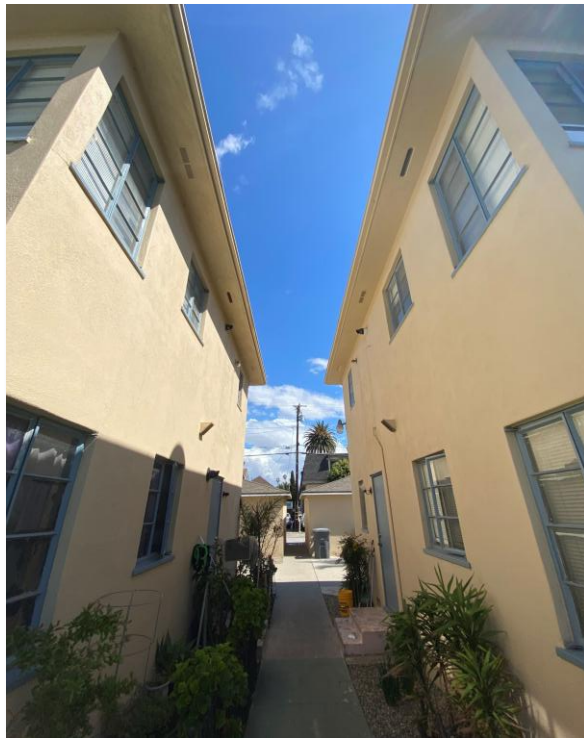
Figure 3 – View of property's central walkway in 2020 prior to window alteration (looking east)

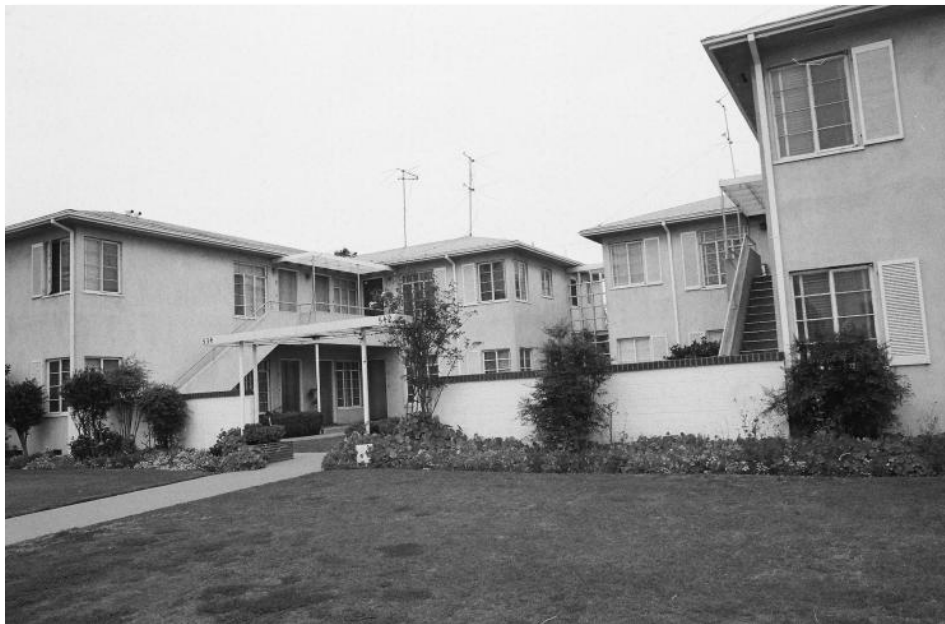
A Mills Act Historical Property Contract between the property owner and the City of Oxnard was approved for the property on December 2, 2014 (Exhibit 3). The contract is binding to the property and inherited by any subsequent owners, including the current property owner. As part of the contract, the owner agreed to preserve, restore, and rehabilitate the property in conformance with the *Secretary of the Interior's Standards for the Treatment of Historic Properties with Guidelines for Preserving, Rehabilitating, Restoring, and Reconstructing Historic Buildings* ("Secretary's Standards"), among other requirements. Based on the most recent staff inspection of the property on March 11, 2020, staff found that rehabilitation work outlined in the contract's Ten-Year Rehabilitation remained, in whole or in part, for Years 4, 7, 8, and 10 (Exhibit 3). Self-certification materials submitted in subsequent years showed that Year 7 and Year 8 items were also completed. Remaining items to be accomplished include building a pergola over the courtyard entrance to restore it to its original condition and re-roofing all four buildings, the apartments buildings and garages. Refer to Figure 4 for a historical photo showing the showing original wall configuration, pergola, screen, and faux window shutters.

Figure 4 – Western elevation, showing original wall configuration, pergola, and screen (1981)

- **Recommendation #2: Trellis.** It is recommended that the applicant revise the trellis design to more closely match the original as depicted in historical imagery and as agreed to in the adopted Mills Act contract. The original trellis featured four vertical posts, with squared horizontal beams spanning between them. The cross beams (or rafters) above were the same height as the main beams, creating a uniform profile.
