## **Staff Report and Recommendations** **Agenda of November 24, 2025, Item 6a**

### **County of Ventura • Resource Management Agency**

A request for a Certificate of Appropriateness for the installation of aluminum-clad windows on high-visibility building elevations and after-the-fact authorization of remaining vinyl windows at a 12-unit apartment complex located at 534-542 S. F Street, Oxnard, CA 93030 (Ventura County Landmark #173: McColm Manor Apartments). The scope of work also includes the construction of a pergola at the front entrance to the property. (Case No. CH23-0040).

534-542 S. F Street, Oxnard, CA 93030  
Assessor's Parcel Number (APN): 202-0-121-080  
Historic Designation: Ventura County Landmark #173  
Common/Historic Name: McColm Manor Apartments

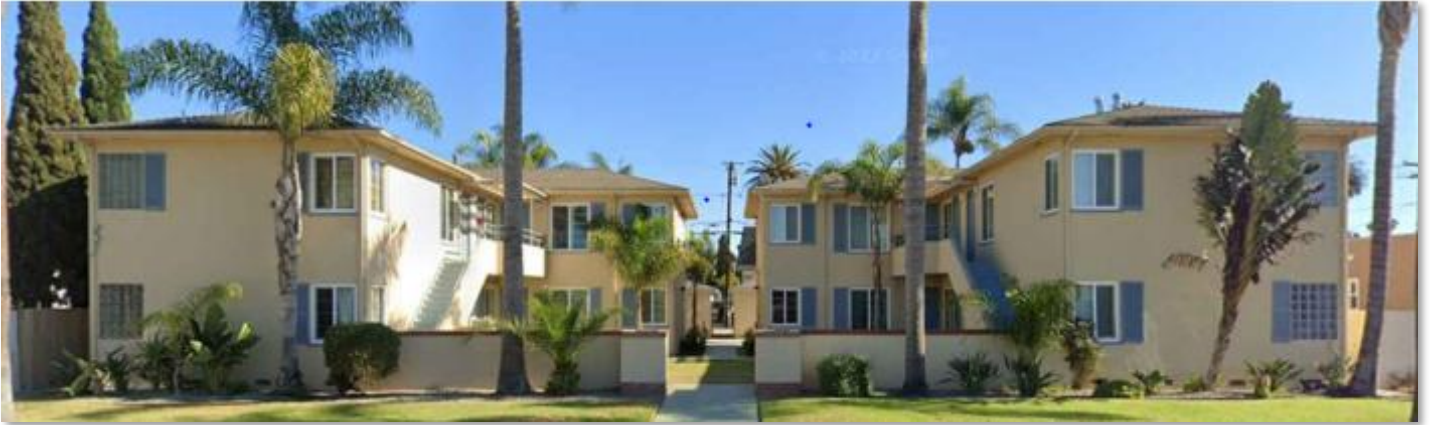
In 2022, the current property owner replaced all of the remaining original light steel casement windows with vinyl clad windows. Figure 1, below, shows the apartment complex with the new windows. This alteration removed a key character-defining feature<sup>12</sup> and appears to have substantially reduced the historic integrity of the property. The property owner has applied for the phased installation of aluminum-clad windows over a period of five years and after-the-fact authorization of some vinyl-clad windows. Refer to Figure 2 and Figure 3 below for views of the subject property prior to this alteration. Exhibit 4 conditions additional photos of the property's current condition.

Figure 1 – View of property in 2023 following window alteration (looking east)

Following the CHB hearing on October 13, 2025, the applicant now proposes replacing nearly all highly visible vinyl windows on the building's primary elevations (the west elevation adjacent to F Street, and part of the north and south elevations closest to F Street) with a more appropriate aluminum-clad window product, which would more closely match the original windows in appearance and reduce the previous loss of integrity.

- **Recommendation #1: Replacement Windows.** Due to their visibility from the vicinity of the property, it is recommended that all windows on the north and south elevations, along with the second-story windows on the east elevation, also be replaced.

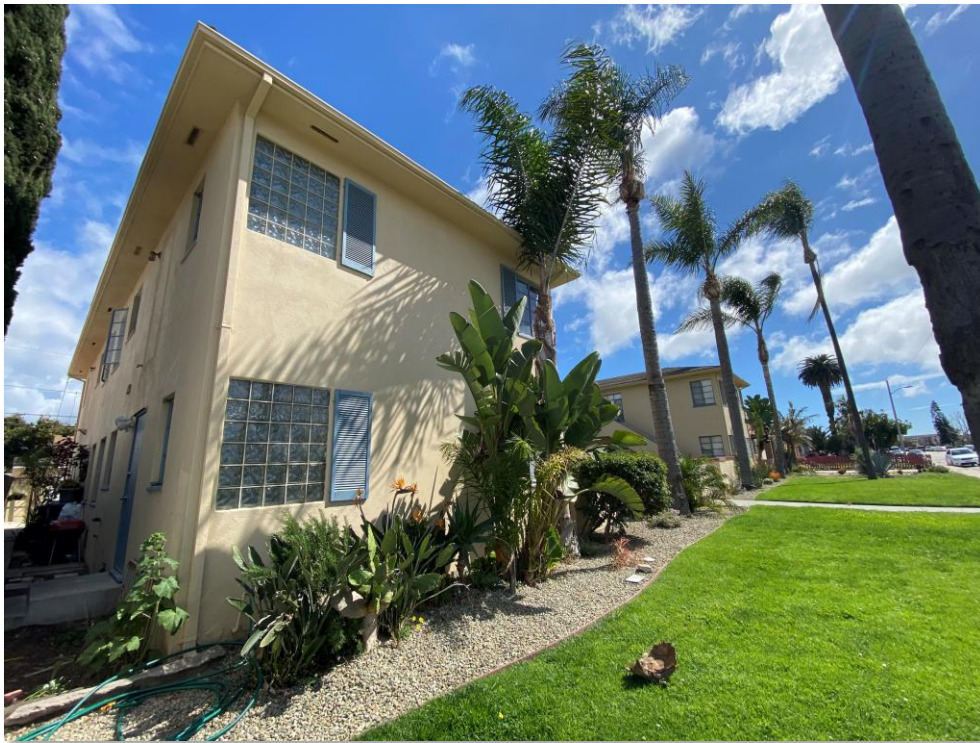
Figure 2 – View of property in 2020 prior to window alteration (looking southeast)

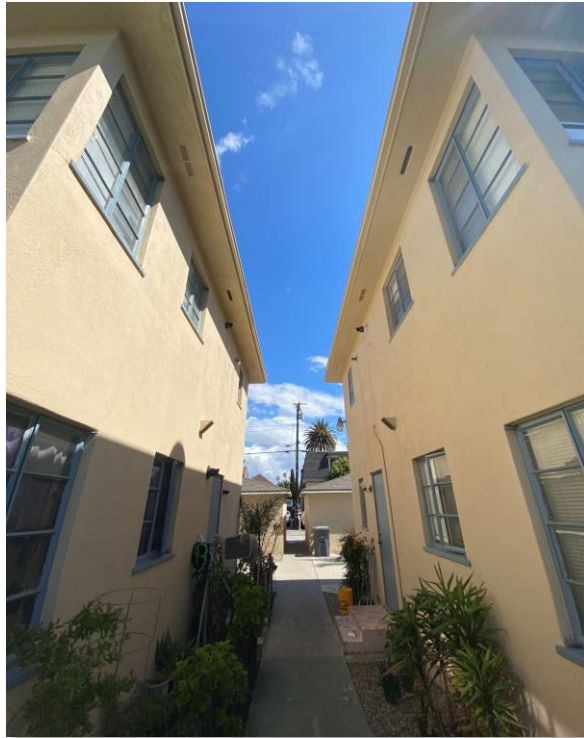
Figure 3 – View of property’s central walkway in 2020 prior to window alteration (looking east)

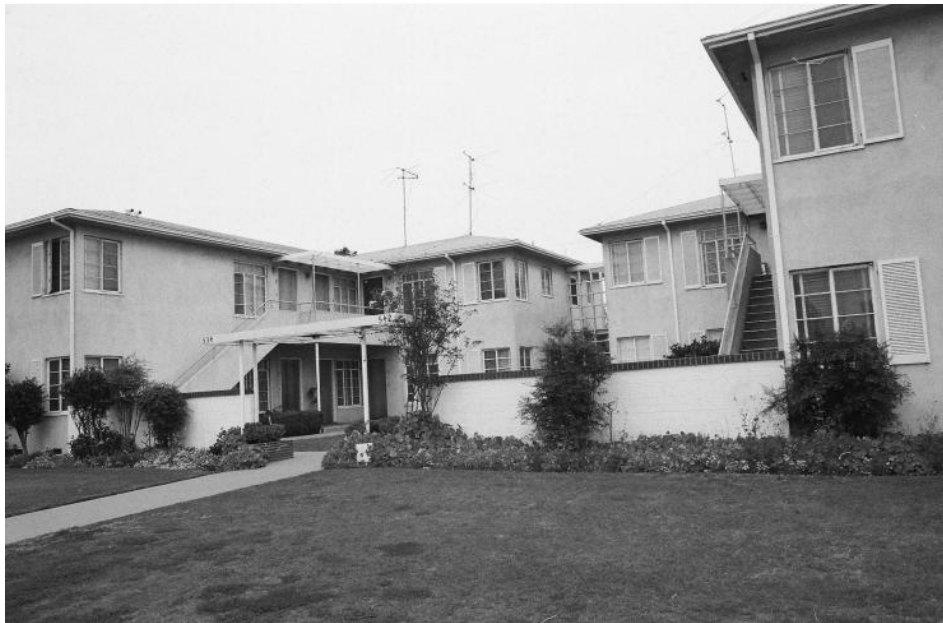
A Mills Act Historical Property Contract between the property owner and the City of Oxnard was approved for the property on December 2, 2014 (Exhibit 3). The contract is binding to the property and inherited by any subsequent owners, including the current property owner. As part of the contract, the owner agreed to preserve, restore, and rehabilitate the property in conformance with the *Secretary of the Interior's Standards for the Treatment of Historic Properties with Guidelines for Preserving, Rehabilitating, Restoring, and Reconstructing Historic Buildings* ("Secretary of the Interior's Standards"), among other requirements. Based on the most recent staff inspection of the property on March 11, 2020, staff found that rehabilitation work outlined in the contract's Ten-Year Rehabilitation remained, in whole or in part, for Years 4, 7, 8, and 10 (Exhibit 3). Self-certification materials submitted in subsequent years showed that Year 7 and Year 8 items were also completed. Remaining items to be accomplished include building a pergola over the courtyard entrance to restore it to its original condition and re-roofing all four buildings, the apartments buildings and garages. Refer to Figure 4 for a historical photo showing the original wall configuration, pergola, screen, and faux window shutters.

Figure 4 – Western elevation, showing original wall configuration, pergola, and screen (1981)

Further, the applicant proposes construction of a pergola at the property's primary entrance to satisfy a remaining Mills Act contract requirement. The proposed design of the pergola matches that which existed on the site previously and is compatible with the *Secretary of the Interior's Standards*.
