Phase II Historic Resources Report Bank of A. Levy Building, 143 W. Fifth Street Oxnard, CA

PRELIMINARY REPORT

9 April 2013

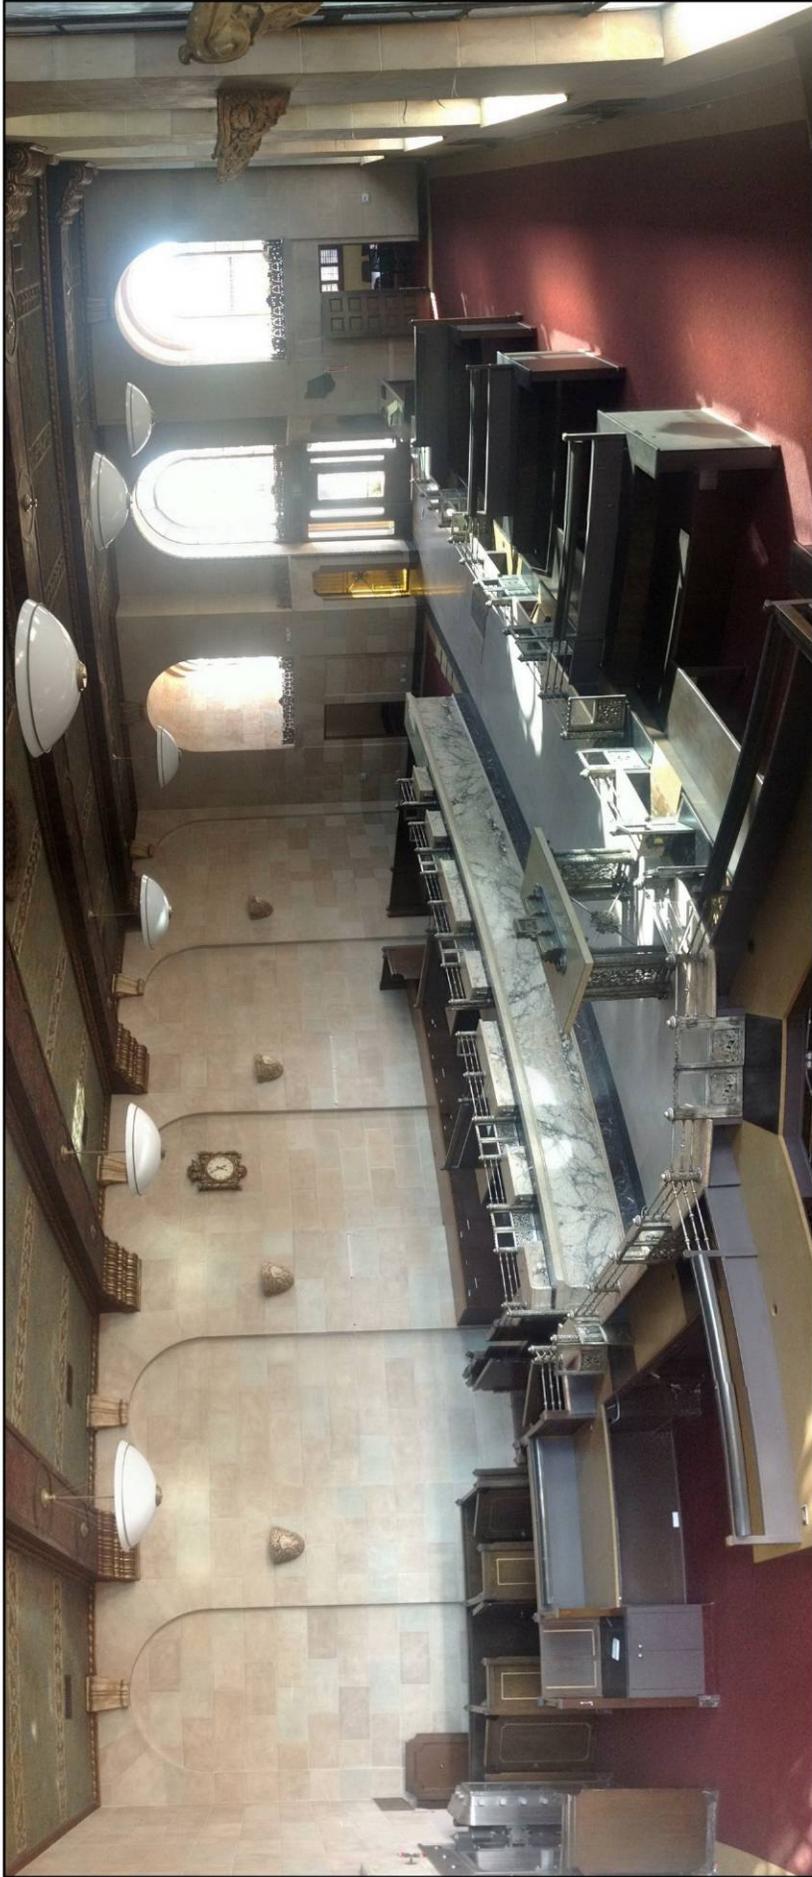
Photo 1. Panorama of banking lobby from northwestern corner. [3-4-2013]

- The pendent lighting (8 fixtures) installed in a recent re-model will be replaced with modern energy efficient fixtures that will also be designed to provide sound absorption. [Photos 1, 2]

Impact Discussion. The existing hanging light fixtures are non-historic features. Consequently, their replacement is consistent with the Secretary's Standards, provided the new fixtures are compatible with the historic architectural character of the building. (Details not provided.) See Mitigation Measure: A-1.

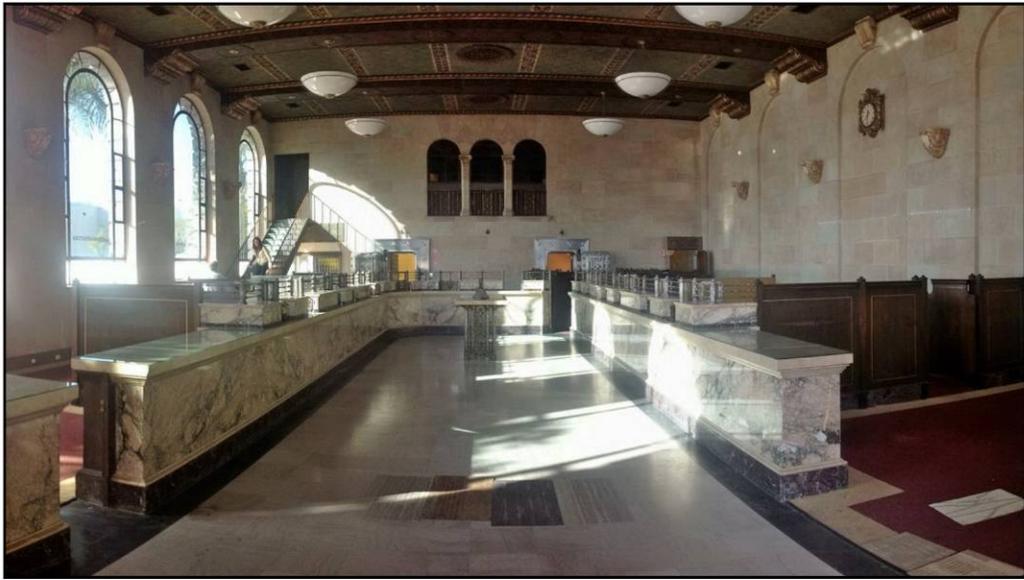
Photo 2. Banking floor, facing north. [3-4-2013]

- A steel stair added in a re-model to the banking hall will be removed. The second floor opening in the wall will be closed and the existing faux stone pattern continued. [Photos 2, 5]

Impact Discussion. The stairway is clearly a non-historic architectural feature (probably 1960s). Consequently, its removal is consistent with the Secretary's Standards. See Mitigation Measure: A-3.

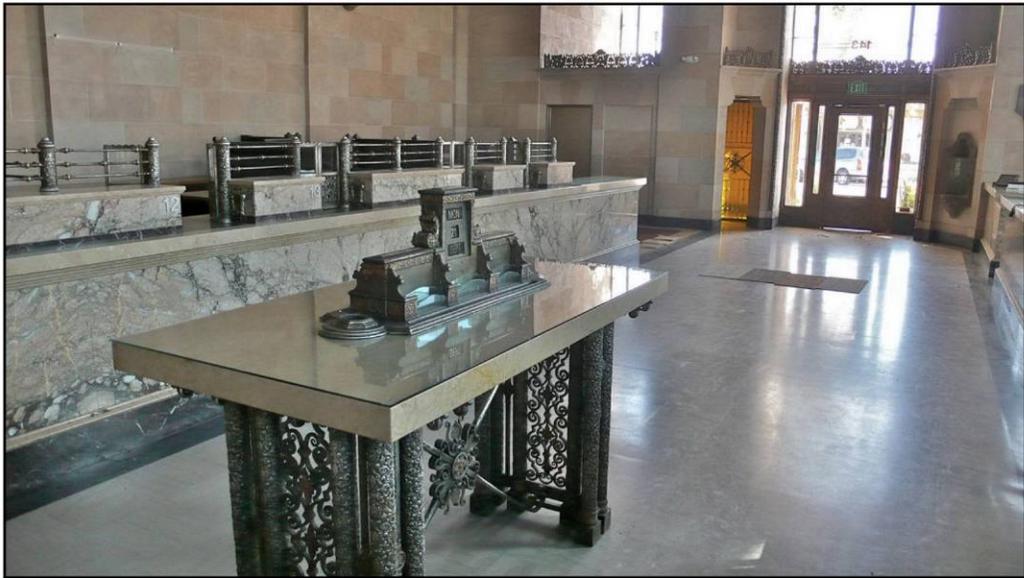
Photo 3. Banking floor, facing southeast. [3-4-2013]

- The existing customer write-up table will be retained and re-located within the banking hall. This will allow the existing public teller lobby to be re-used as a public waiting area. [Photo 3]

Impact Discussion. The table is of one of two which existed historically. It does not appear to be attached to the floor. Its relocation to elsewhere in the banking hall to accommodate the new use is consistent with the Secretary's Standards.

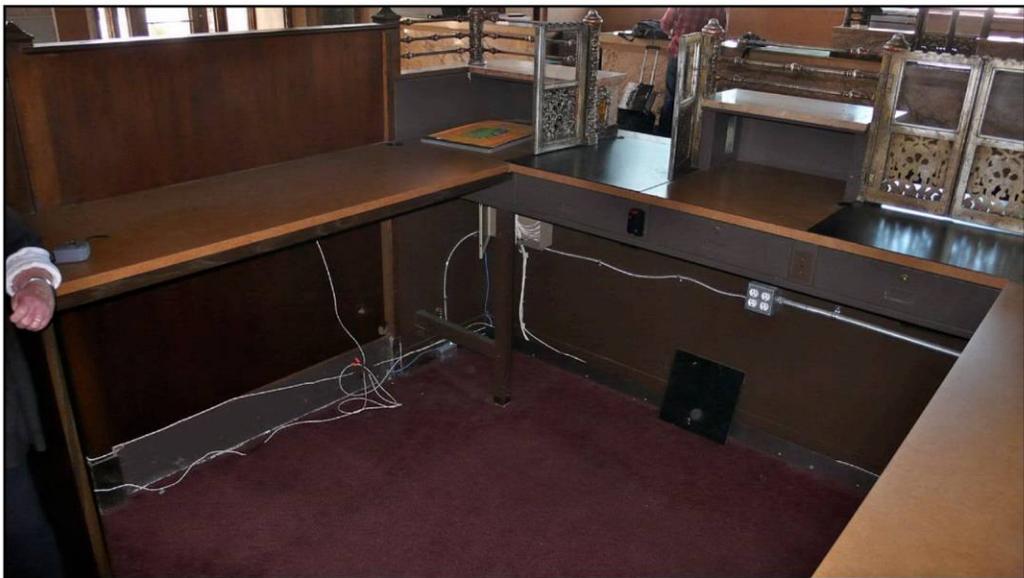
Impact Discussion. The countertop elements of the teller cages behind the marble counter areas appear to be non-historic features. Consequently, their removal is consistent with the Secretary's Standards, provided the removal of the non-historic features and the installation of new features is preformed with care to avoid damaging historic features to be retained. See Mitigation Measures: A-1, A-2.

Photo 4. Modern countertops behind teller cages. [3-4-2013]

- Remove altered back teller work surfaces and partitions. Retain the main stone faced teller line. This will allow room for modern workstations (sized to efficiently function with up to date data and electrical) to be placed against the perimeter walls. An aisle will be placed between the new workstations and the existing teller line providing a contrast between old and new. [Photos 1-9]

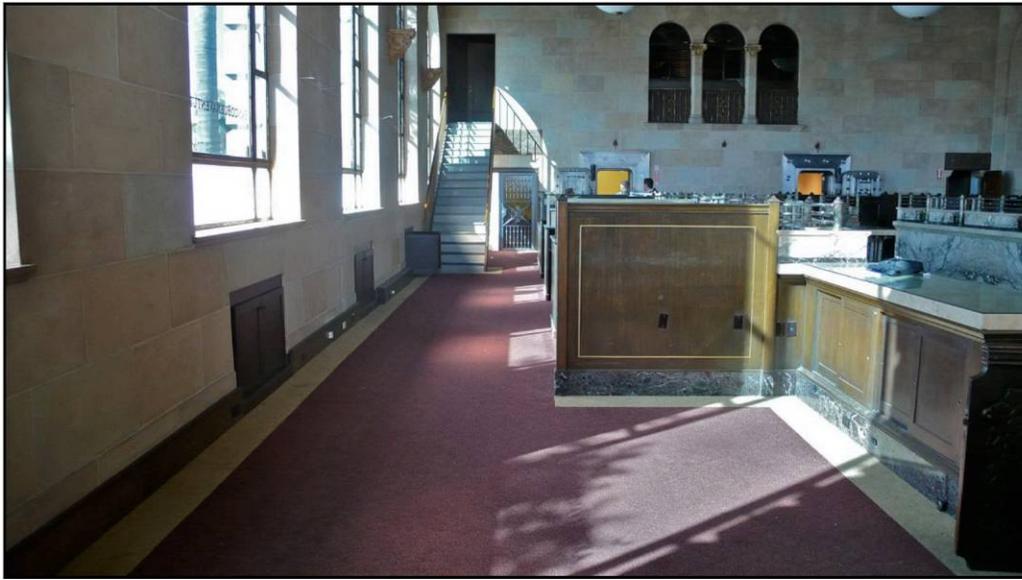
Photo 5. Behind teller cages, west side, facing north, showing wood partition to be removed. [3-4-2013]

A wood partition and swinging gate attached to the eastern wall and eastern side of the teller cage areas is proposed to be removed. A portion of a partition on the western side of the teller cage area (which presumably originally matched the eastern side but currently only exists partially) is also proposed to be removed. The removal of historic features and finishes is inconsistent with the Secretary's Standards. Ideally, the new uses of for these spaces would be accommodated within the original configuration of the spaces, and the features retained. If these features are to be removed, care should be exercised in their disassembly, they should be properly documented and stored. See Mitigation Measures: A-1, A-2, B.

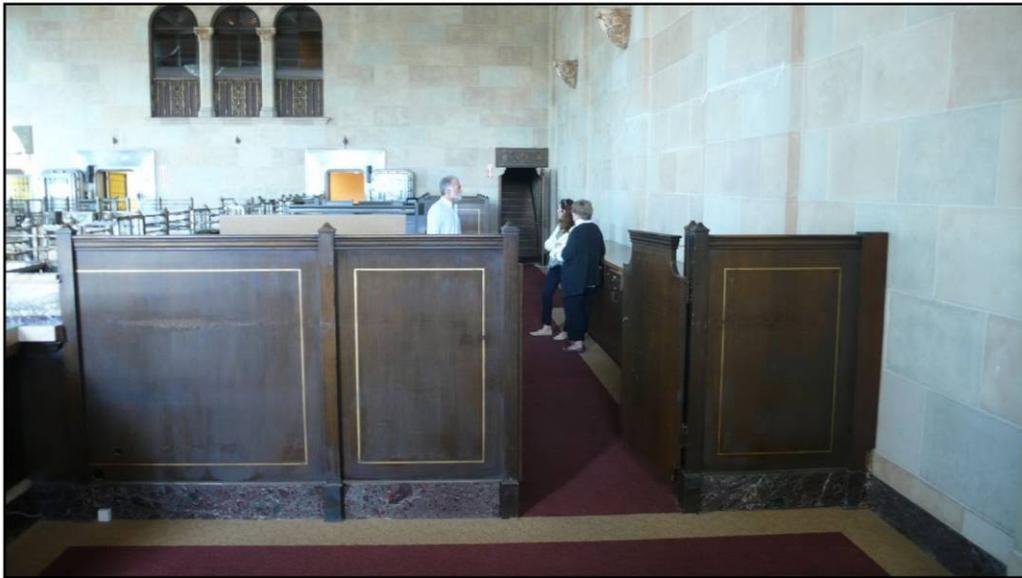
Photo 6. Behind teller cages, east side, showing partition and swinging gate to be removed. [3-4-2013]

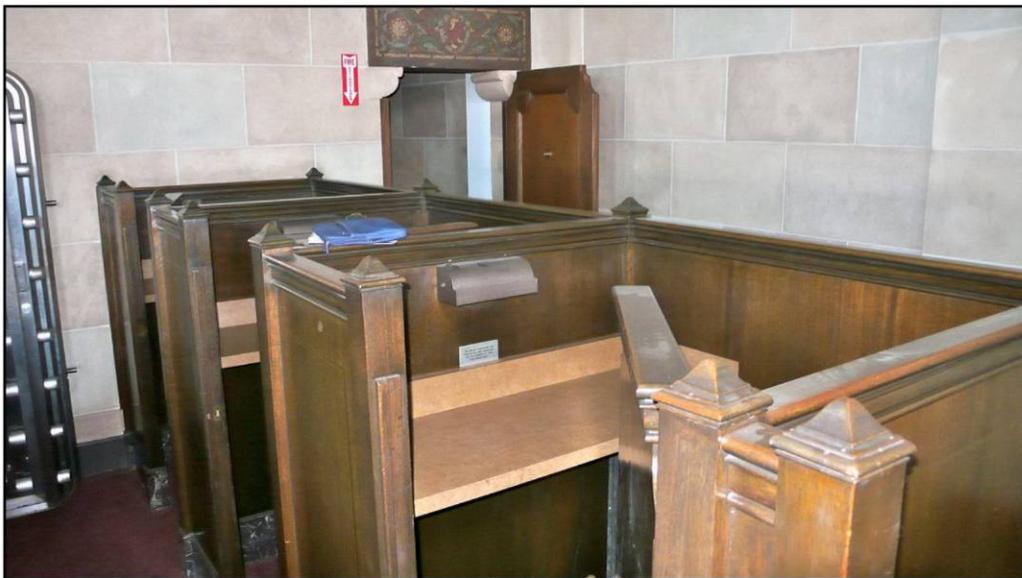
Impact Discussion. The safety deposit booths are original features of the building that contribute to defining the function and therefore the historic character of the building. The removal of these features and finishes is inconsistent with the Secretary's Standards. Ideally, new uses would be identified for these spaces and the features retained. If these features are to be removed, care should be exercised in their disassembly, they should be properly documented and stored. See Mitigation Measures: A-2, B.

Photo 7. Safety deposit box booths to be removed. [3-4-2013]

- The existing safety deposit cubicles will be disassembled and stored on-site. This will be done to allow the efficient layout of the new work stations.

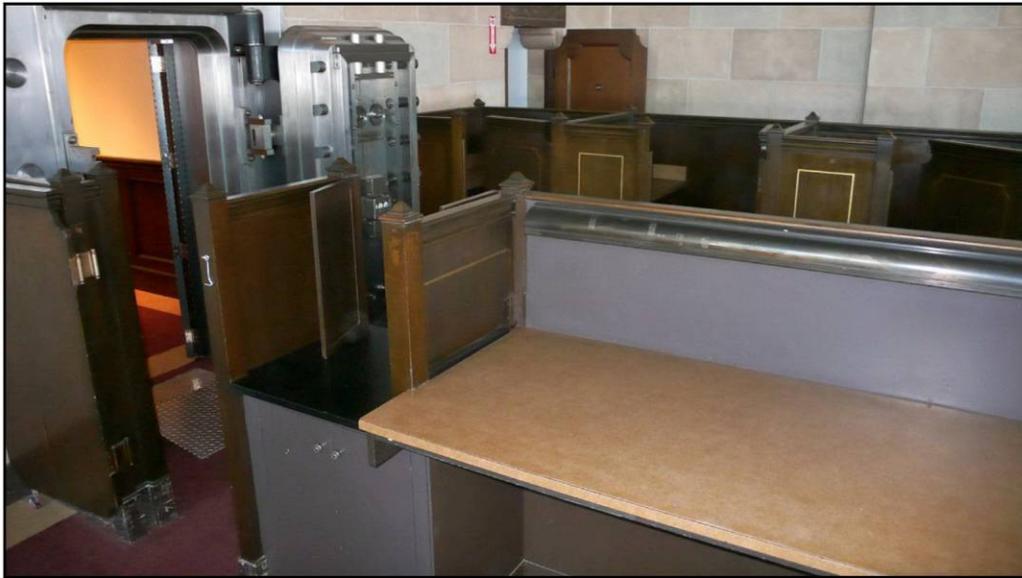
Photo 8. Partition near vault to be removed. [3-4-2013]

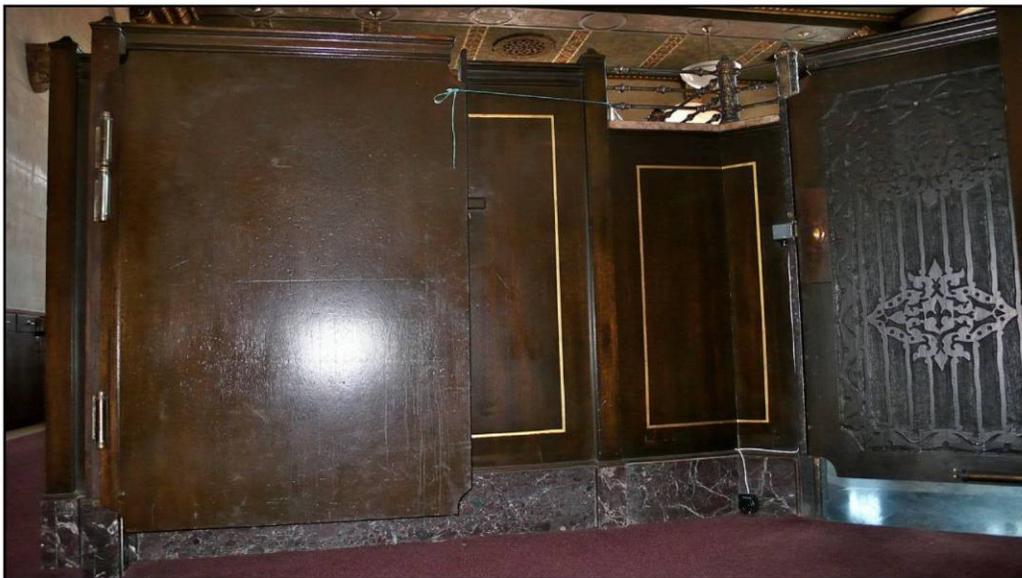
Photo 9. Partitions near safety deposit booth and vault area to be removed. [3-4-2013]

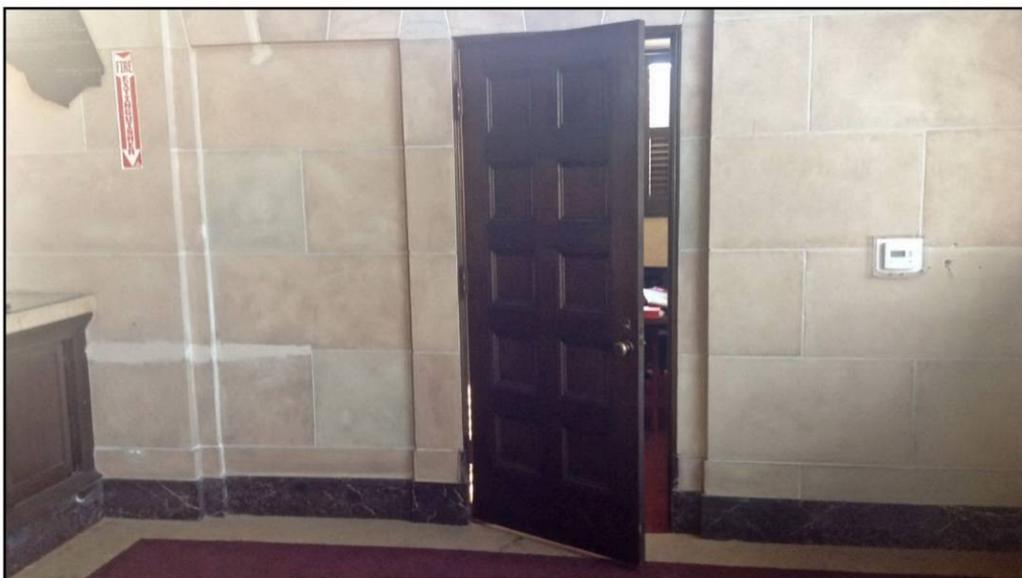
The space to the west of the entry foyer was historically configured as two office spaces with separate doorways to each office onto the banking area. The interior elevation treatment was apparently duplicated to the east side of the entry foyer to provide symmetry. One of these two doorways (eastern) has since been closed with a faux masonry treatment duplicating the finishes in the banking lobby. The existing doorway and panel door, and blind doorway, are proposed to be removed and replaced with a new door and window wall. (Complete details not provided.)

Photo 10. Office doorway, west side of entry foyer. [3-4-2013]

- The existing two offices off the banking hall have been altered in past re-models. The wall between the two has been removed, one door and frame has been removed and the door opening has been walled in to support a single room conference function. The purposed plan is to remove the door wall in-fill and the remaining existing door and frame. A new glass wall and door will be added in the enlarged opening. The function of the room will continue to be a conference room. The existing door and frame will be saved and stored on-site. [Photos 10, 11]

The removal of historic features and finishes is inconsistent with the Secretary's Standards. Ideally, the new uses of for these spaces would be accommodated within the original configuration of the spaces, and the features retained. If these features are to be removed, care should be exercised in their disassembly, they should be properly documented and stored.

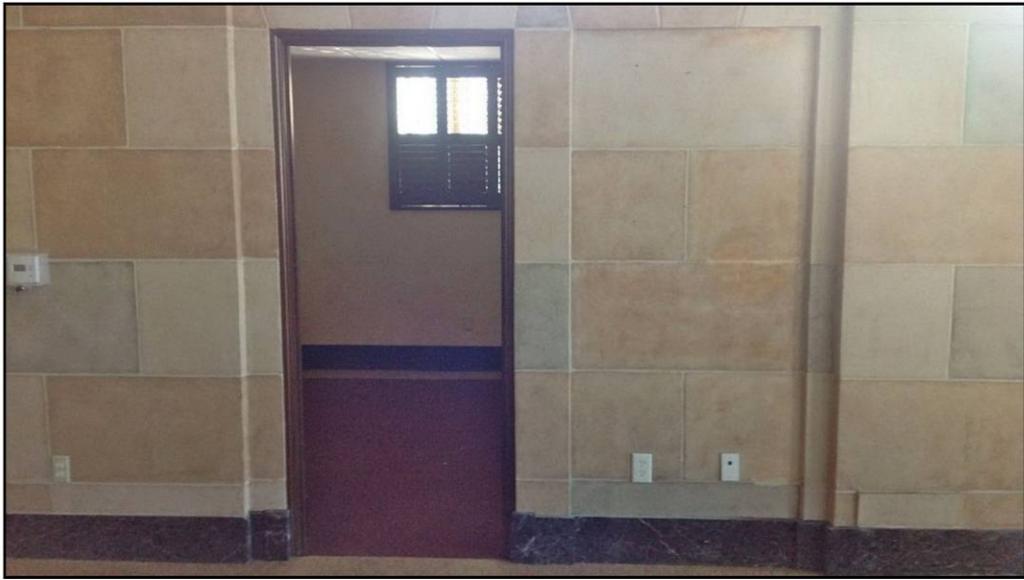
Impact Discussion. The eastern of the two spaces flanking the entry foyer originally served as the women's lounge, and historically did not communicate directly with the main banking floor as it does today. It is presently unknown when the lounge was converted to office space and the doorway opened to the banking floor. Although historical documentation is currently lacking, it appears that this interior elevation originally featured two blind doorways separated by a narrow pilaster and defined by faux masonry keystones and lintels above both. The existing doorway and blind doorway are proposed to be removed and replaced with a new door and window wall. (Complete details not provided.)

Photo 11. Office doorway, east side of entry foyer. [3-4-2013]
