CULTURAL HERITAGE SURVEY PHASE IV SANTA CLARA VALLEY

**COUNTY OF VENTURA
CULTURAL HERITAGE SURVEY
PHASE IV - SANTA CLARA VALLEY**

**Prepared by Judy Triem
San Buenaventura Research Associates**

January 1988

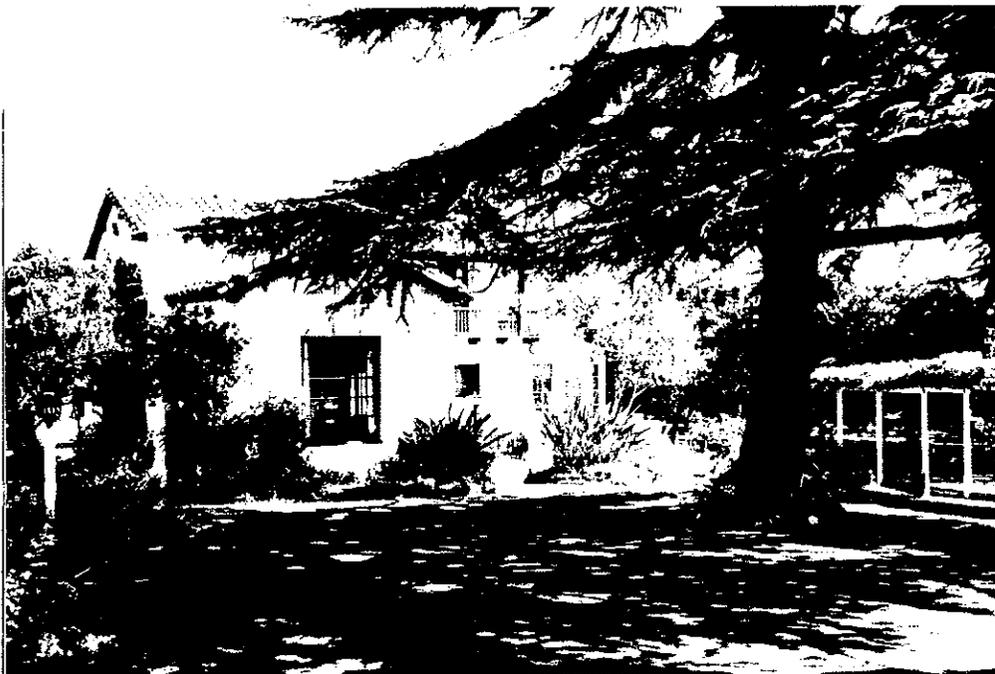
This large combination one and two-story residence is built in an L-shape with medium pitched gable roofs of tile. Under the eaves are exposed beams. The front porch is located on the inside of the L-shape and has a low stucco wall. The front door has a small Gothic window. On the front of the house is a second story balcony with wrought iron railing. The recessed windows are multi-paned with wood frames. The house is covered with stucco siding, and rests on a concrete foundation.

13. Condition: Excellent Good ___ Fair ___ Deteriorated ___ No longer in existence ___
14. Alterations: uncertain
15. Surroundings: (Check more than one if necessary) Open land ___ Scattered buildings Densely built-up ___
Residential Industrial ___ Commercial ___ Other agricultural
16. Threats to site: None known Private development ___ Zoning ___ Vandalism ___
Public Works project ___ Other: _____
17. Is the structure: On its original site? Moved? ___ Unknown? ___
18. Related features: second house; garages, mature trees - Deodar, rock wall

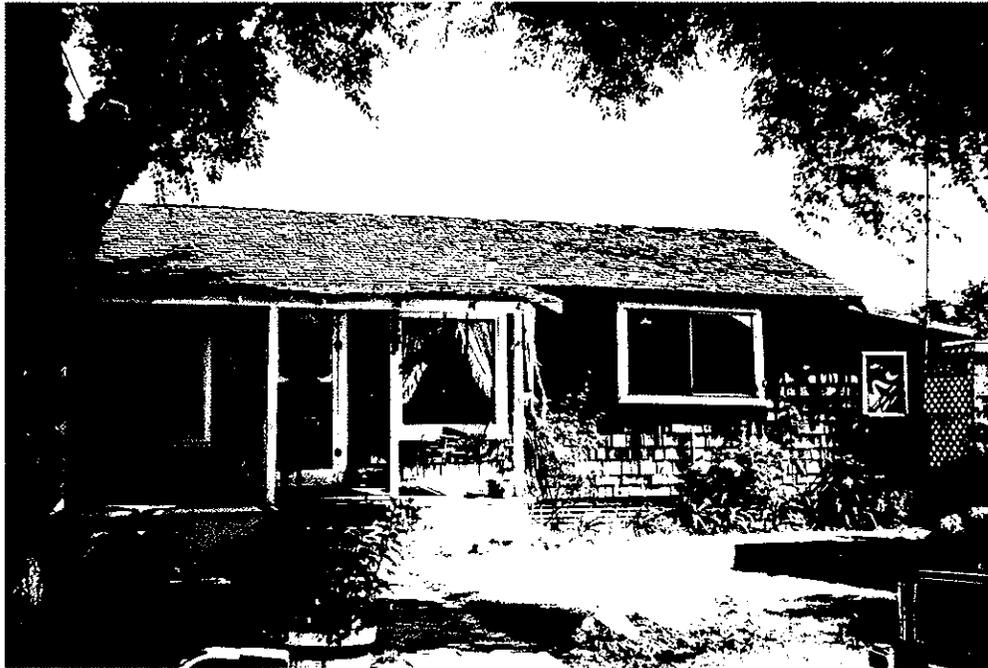
Original house

This house was the first built on the property in about 1909 and was originally located closer to Bardsdale Ave. and moved to the rear of the property when the main house was built about 1928. It has a low gable roof with a shed roof over the open porch. The porch is supported by square columns. Rafters are exposed under the eaves. Windows have been changed from wood frame to sliding aluminum in a few cases. The remaining windows have wood frames and are fixed or double hung. The house rests on a wood foundation and is covered with shingle siding.

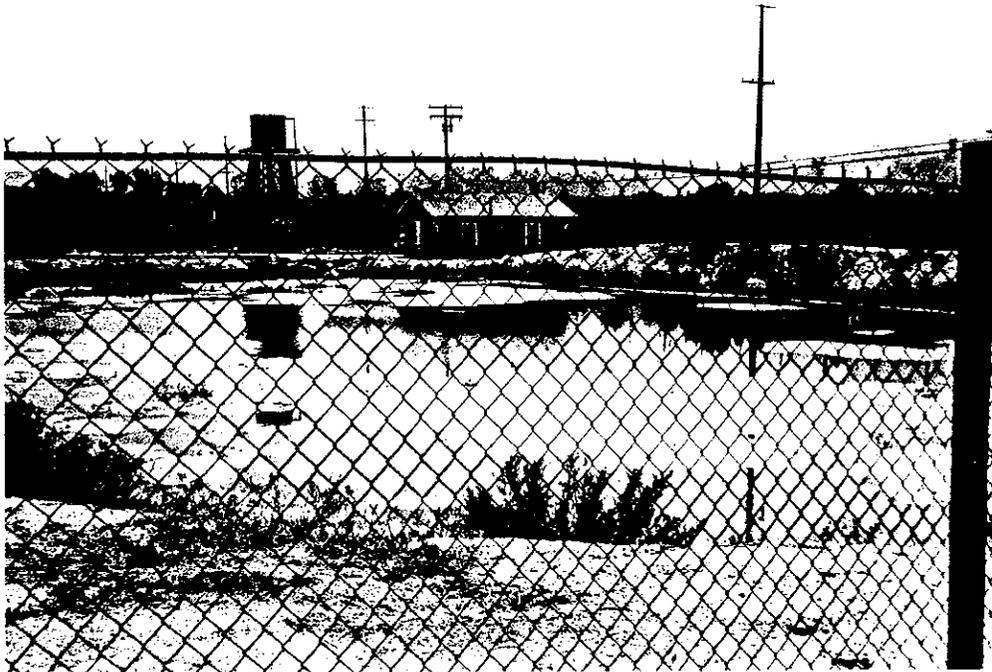
Bardsdale Reservoir

This reservoir is one of three ponds. The holding areas are of earthen construction. They are surrounded by a chain link fence.

This reservoir continues to supply water for irrigation purposes to the ranchers of Bardsdale. The reservoir was probably constructed at the time the Southside Improvement Co. was founded in 1887. Water was taken from the Santa Clara River about 5 miles to the east near the Shiells' property. The water was brought through pipes using gravity flow to the reservoir and stored here. Farmers along the way would siphon off the water for irrigation purposes. The reservoir especially helped those farmers living below it who depended directly on the water for irrigation. Originally the water ran to the farms below the reservoir along open ditches using wooden flumes. The flumes followed the general road patterns. Each farmer was responsible for getting the water from the road to the field. The early methods used wooden flumes. Later, pipes were put in underground to deliver the water. This method is still in use today. However, water now comes from wells below the Santa Clara River and additional wells in other locations to provide water for irrigation in Bardsdale. Domestic water comes from individual local wells located primarily on the rancher's property.

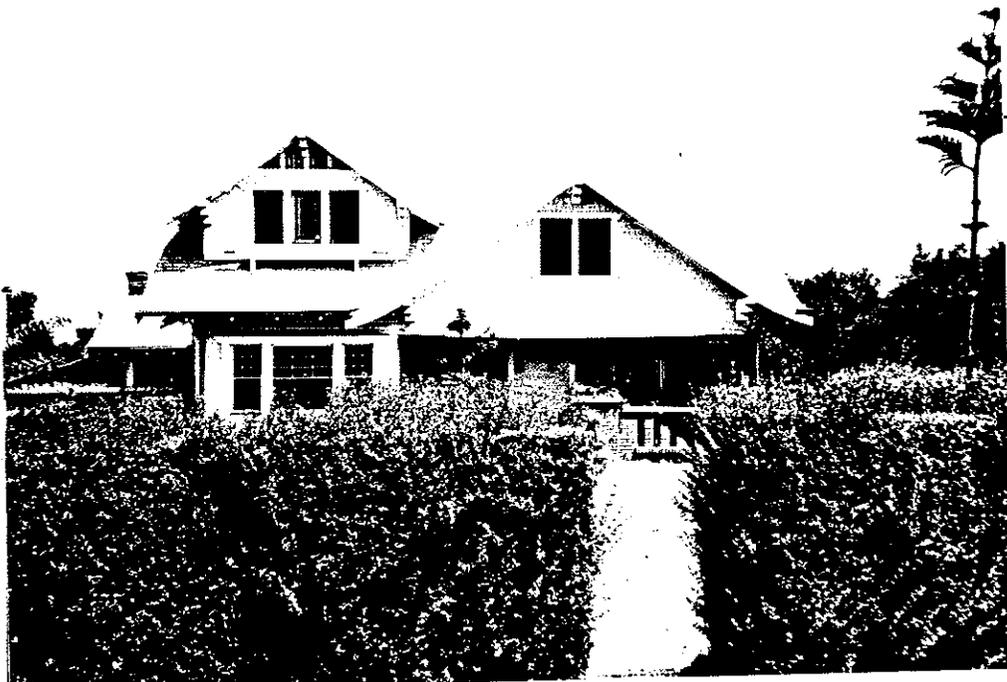
This large 1 1/2 story residence has a main side facing gable roof with offset gable over the front porch. The porch is recessed under the front gable and supported by large square brick columns with brick railing capped at the top with concrete. Rafters and decorative stepped beams are exposed under the broad sweeping eaves. Windows are a combination of fixed, double hung and casement with multi-paned wood frames and mouldings. A gabled dormer window punctuates the roofline. There is a brick chimney on the rear L-shaped portion of the house. The house rests on a concrete foundation and is covered with clapboard siding on the lower portion with square shingles under the gables.

13. Condition: Excellent ___ Good Fair ___ Deteriorated ___ No longer in existence ___
14. Alterations: none apparent
15. Surroundings: (Check more than one if necessary) Open land ___ Scattered buildings Densely built-up ___
 Residential Industrial ___ Commercial ___ Other agricultural
16. Threats to site: None known Private development ___ Zoning ___ Vandalism ___
 Public Works project ___ Other: _____
17. Is the structure: On its original site? Moved? ___ Unknown? ___
18. Related features: wood water tower, detached garage

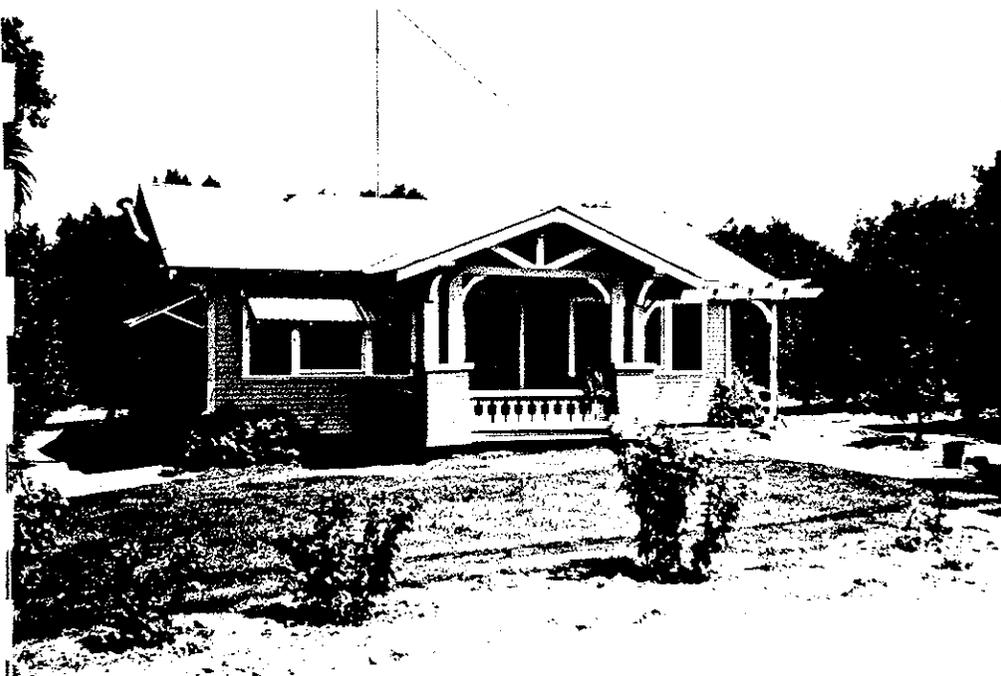
This single story rectangular residence has a medium side facing gable roof with an centered gable over the porch. Exposed rafters and knee brackets are found under the broad eaves. The porch is the main decorative source with its double columns with curved brackets and cut out porch railing. The lower porch supports are large tapered square columns with clapboard siding. Under the front gable is a three part brace and extending to the east of the porch is a pergola. Windows are casement and fixed with wood frames and mouldings. The front door has six small panes in the upper quarter. The house rests on a concrete foundation and is covered with clapboard siding.

13. Condition: Excellent Good ___ Fair ___ Deteriorated ___ No longer in existence ___
14. Alterations: addition in rear
15. Surroundings: (Check more than one if necessary) Open land ___ Scattered buildings Densely built-up ___
Residential Industrial ___ Commercial ___ Other agricultural
16. Threats to site: None known Private development ___ Zoning ___ Vandalism ___
Public Works project ___ Other: _____
17. Is the structure: On its original site? Moved? ___ Unknown? ___
18. Related features: garage

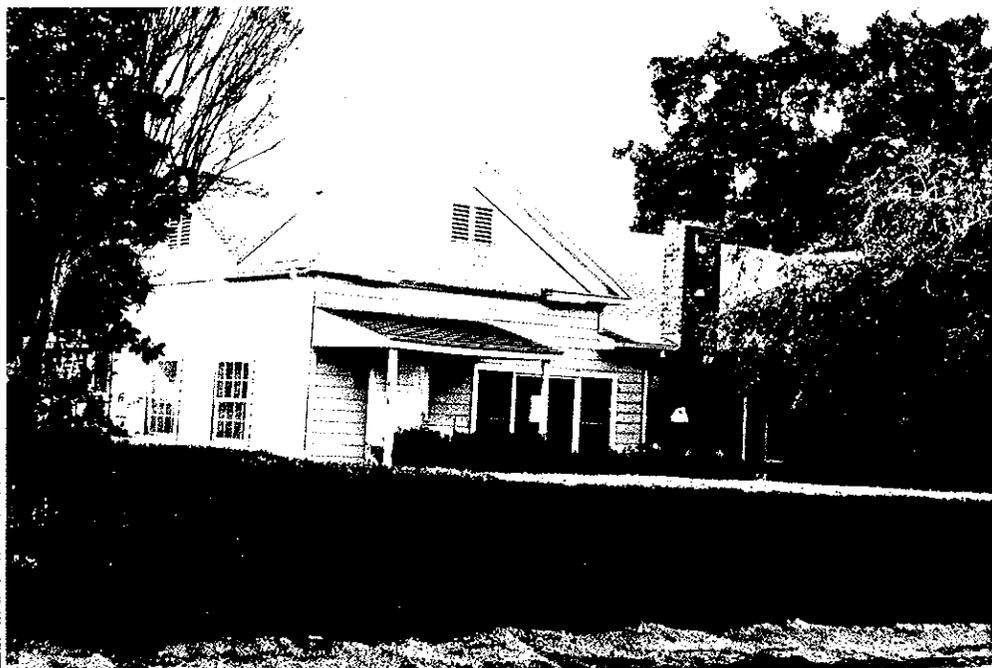
This single story residence is rectangular in shape with a sidefacing gable roof and a front facing gable at each end. The eaves are returned and boxed. Under the gable are shingles. The west portion of the house was added in 1967, and the porch was changed. The present porch has a shed roof with two square supports. Windows have been changed from the original and now are double hung with multi-panes and wood mouldings. The brick chimney was a later addition to the facade. The house has a concrete foundation and wide board siding.

13. Condition: Excellent ___ Good Fair ___ Deteriorated ___ No longer in existence ___
14. Alterations: windows, chimney, porch
15. Surroundings: (Check more than one if necessary) Open land ___ Scattered buildings Densely built-up ___
Residential Industrial ___ Commercial ___ Other agricultural
16. Threats to site: None known Private development ___ Zoning ___ Vandalism ___
Public Works project ___ Other: _____
17. Is the structure: On its original site? Moved? ___ Unknown? ___
18. Related features: garage, mature trees

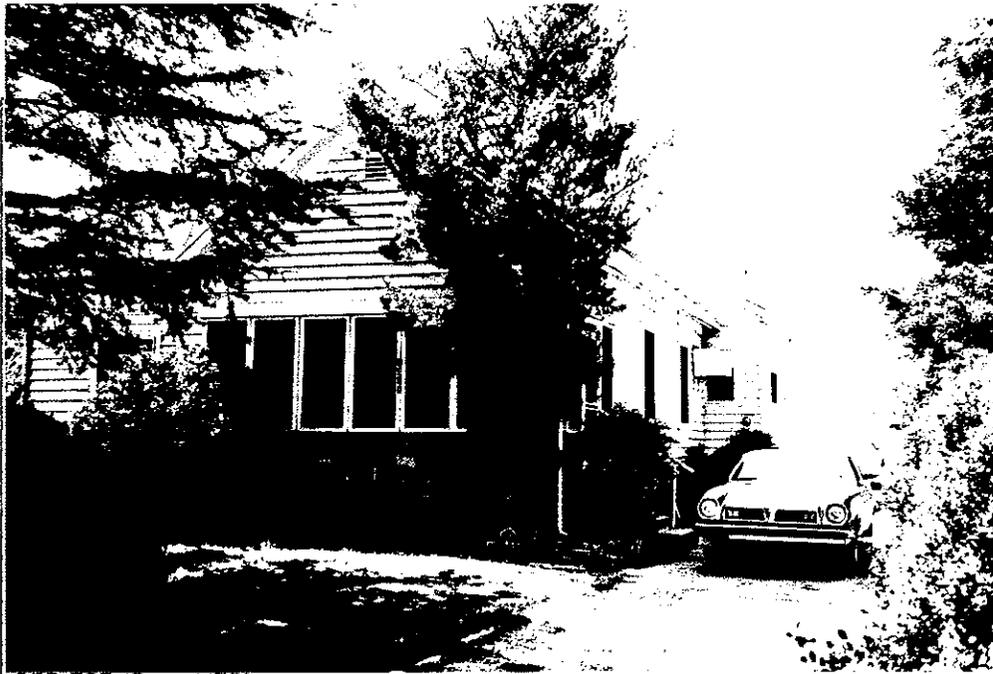
Basically rectangular in shape, this single story residence has a high gable with a sidefacing gable wing. In the rear is another higher gable addition. The eaves are boxed. The front porch is recessed under the main gable and enclosed with the lower portion of concrete block and the upper portion of screened windows. The entrance is on the side with concrete steps and iron railing. Remaining windows are double hung with raised wood mouldings. The house rests on a concrete foundation and is covered with wide board siding.

13. Condition: Excellent ____ Good Fair ____ Deteriorated ____ No longer in existence ____
14. Alterations: concrete block porch foundation, enclosed porch
15. Surroundings: (Check more than one if necessary) Open land ____ Scattered buildings Densely built-up ____
Residential Industrial ____ Commercial ____ Other agricultural
16. Threats to site: None known Private development ____ Zoning ____ Vandalism ____
Public Works project ____ Other: _____
17. Is the structure: On its original site? Moved? ____ Unknown? ____
18. Related features: detached garage in rear, mature trees

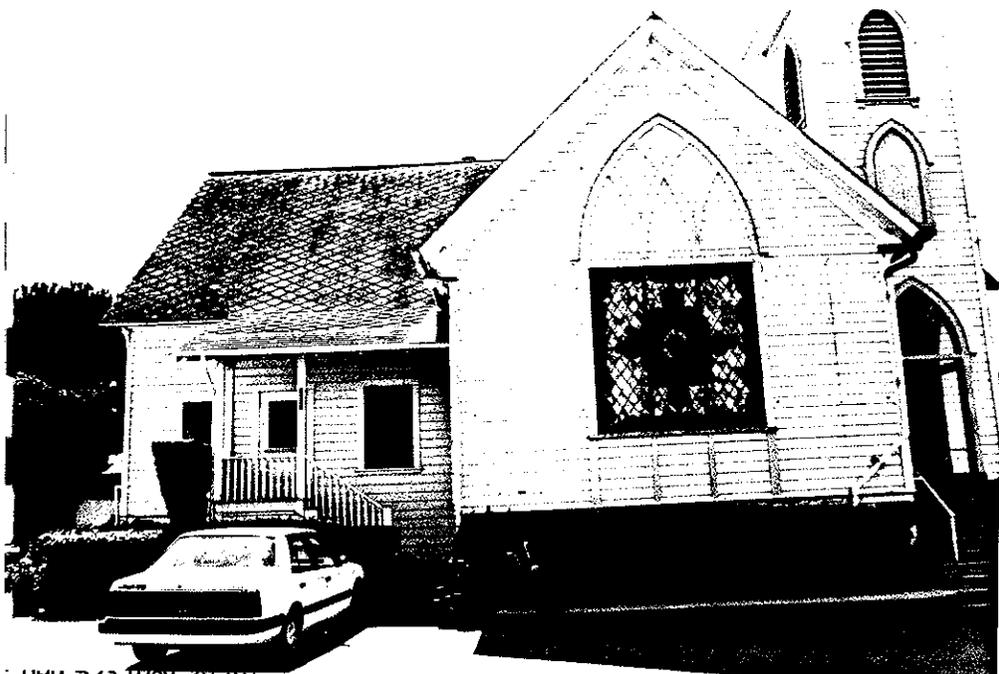
The original L-shaped portion of the church features a high pitched entrance tower in the apex with steps descending to the street. Visually prominent in its corner location, the high pitched intersecting gables, one at each corner, contain large rectangular stained glass windows topped with applied Gothic lancet shaped wooden arches. The additions to the rear and side of the building maintain the integrity of the original structure using the same materials, roof shapes and scale of the original building. The roofing is slate shingles over wood shingles. The exterior of the building is beveled drop siding and the foundation is of Sespe brownstone. The entrance tower is topped with a high pitched flared roof and finial. The vents, access openings and entryway openings are Gothic lancet shaped. In 1915 two stories and a basement were added to the east side of the building, and in 1926 a one story and basement addition were made to the south side. In 1983 the entrance was changed when the single front door was replaced with an oak door and double doors were replaced with a stained glass window.

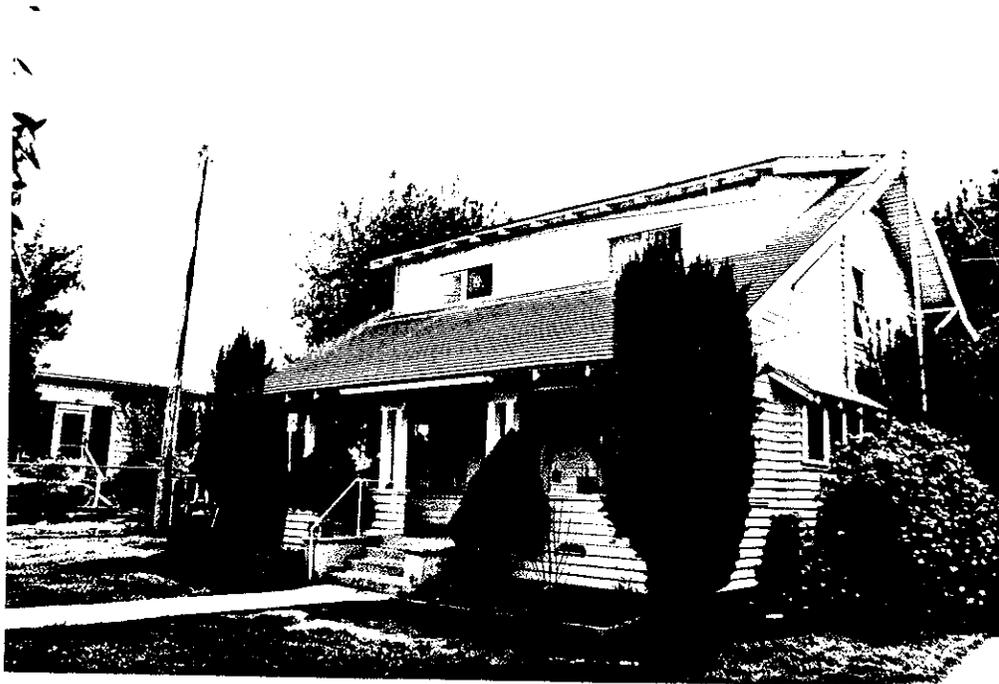
Parsonage -- 1476 Bardsdale Ave.
Parcel #: 046-214-03

The house is 1 1/2 stories tall with a high gable roof. A shed dormer extends from the roofline and has two windows. Under the broad eaves are knee brackets and exposed rafters. The front porch is located under the main gable and supported by double wood columns with a closed railing on the lower half. Windows are fixed and double hung with wood frames and mouldings. The house rests on a raised concrete foundation and is covered with wide clapboard siding.

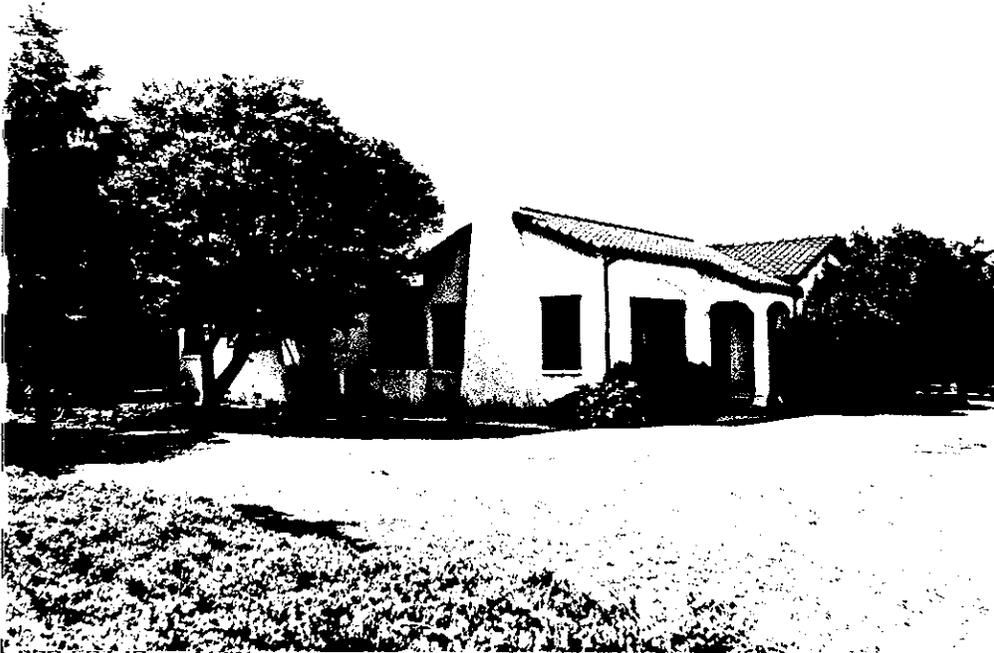
This single story residence has a sidefacing tile gable roof with offset front gable. The porch is attached with a shed roof extension from the main gable and two round arched openings. Windows are both fixed and double hung with wood frames and wood mouldings flush with stucco siding. Above the large front window is a recessed arch in the stucco siding. On the east side of the house is a tapered stucco chimney. The house rests on a concrete foundation and is covered with stucco siding.

13. Condition: Excellent Good ___ Fair ___ Deteriorated ___ No longer in existence ___
14. Alterations: none apparent
15. Surroundings: (Check more than one if necessary) Open land ___ Scattered buildings Densely built-up ___
 Residential Industrial ___ Commercial ___ Other agricultural/church
16. Threats to site: None known Private development ___ Zoning ___ Vandalism ___
 Public Works project ___ Other: _____
17. Is the structure: On its original site? Moved? ___ Unknown? ___
18. Related features: detached garage in rear

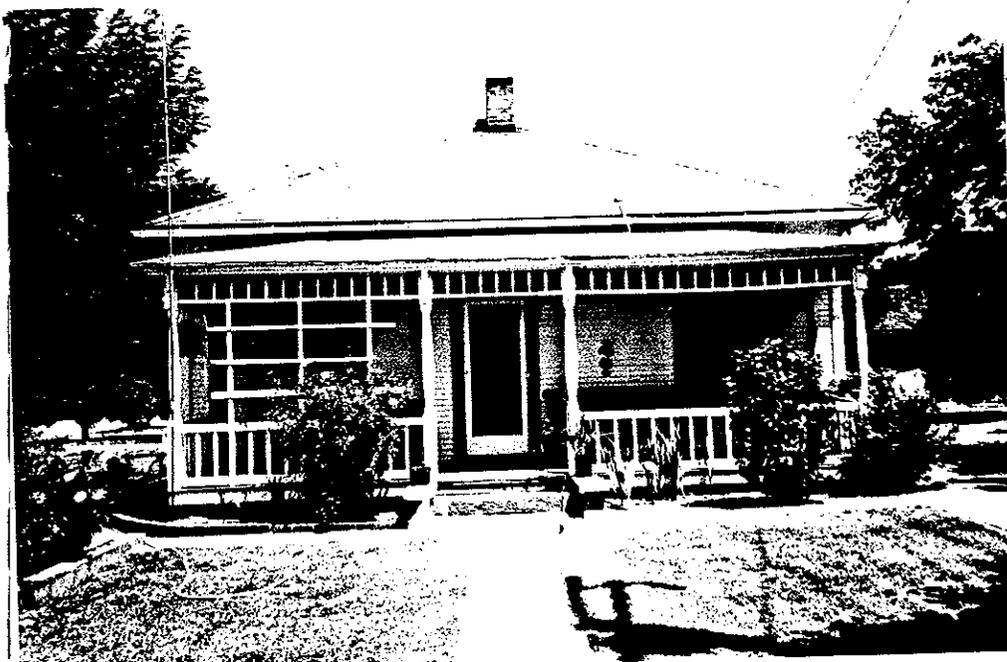
This rectangular shaped single story residence has a medium pitched hip roof with a hip roof over the front porch. The porch is supported by four turned columns with curved brackets at the top. A simple wood railing connects the posts with stickwork detail under the eaves between the columns. Windows are double hung with wood frames and wood mouldings. The house has a Sespe brownstone and concrete foundation with brownstone front steps. Siding is narrow clapboard. A brick chimney punctuates the top of the roofline.

13. Condition: Excellent ____ Good Fair ____ Deteriorated ____ No longer in existence ____
14. Alterations: none
15. Surroundings: (Check more than one if necessary) Open land ____ Scattered buildings Densely built-up ____
 Residential Industrial ____ Commercial ____ Other agricultural
16. Threats to site: None known Private development ____ Zoning ____ Vandalism ____
 Public Works project ____ Other: _____
17. Is the structure: On its original site? Moved? ____ Unknown? ____
18. Related features: Brownstone milk house; water tower, carport

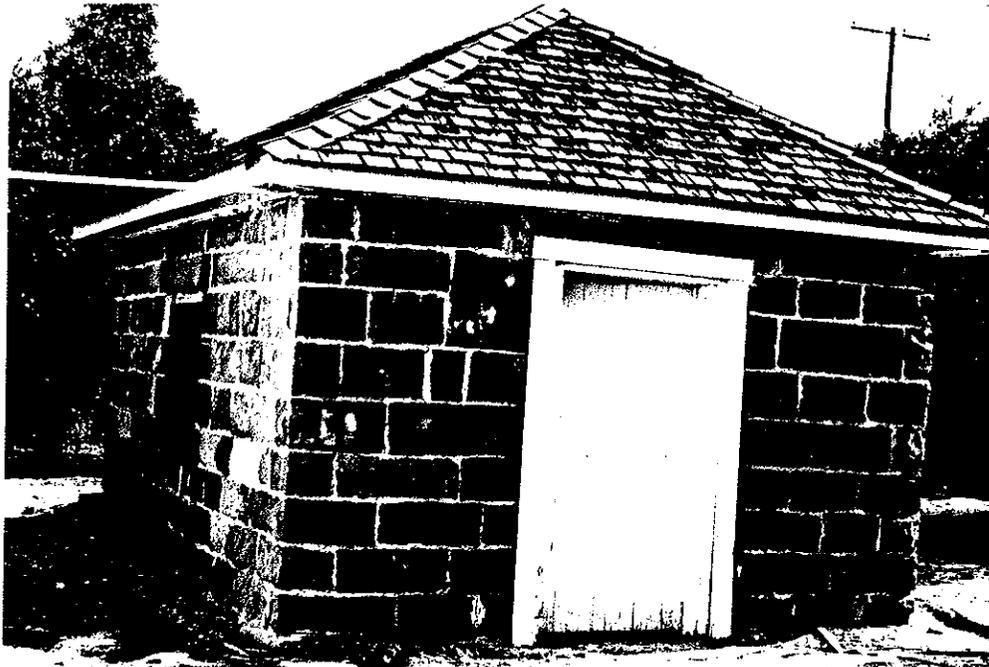
Milk House

This small square shaped structure has a hip roof with closed eaves. The building is constructed of Sespe stone. The entrance has a wood frame and wood door of vertical boards. The windows have Sespe stone lintels with wood frames.

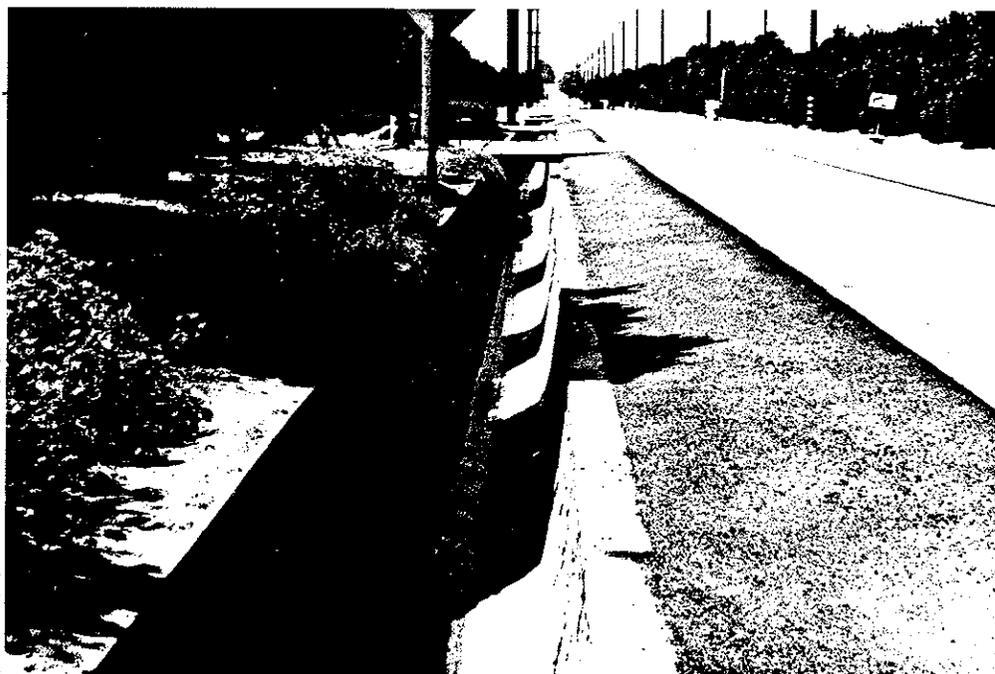
The ditches run both north and south and east and west along the major roads in Bardsdale to carry the run-off from the rains and excess irrigation water. Some of these ditches are built of stone and concrete and are about 3 to 4 feet deep and 4 to 5 feet wide.

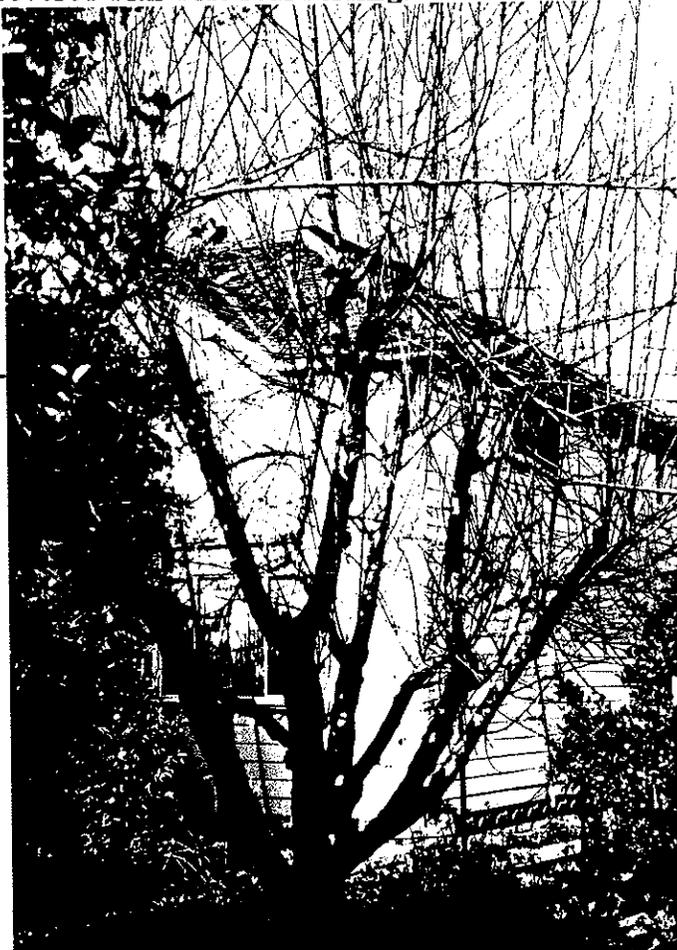
This 1 1/2 story residence has a main truncated hip roof with a front gable over the porch. The porch is supported by wood pillars. Eaves are boxed and there are fishscale shingles on upper half of the front gable. Windows are a combination casement and fixed with wood mouldings. Some of the windows are located directly below the eaves on the side of the house. The house rests on a concrete and brownstone and is covered with wide board siding.

13. Condition: Excellent ___ Good Fair ___ Deteriorated ___ No longer in existence ___
14. Alterations: _____
15. Surroundings: (Check more than one if necessary) Open land ___ Scattered buildings Densely built-up ___
 Residential Industrial ___ Commercial ___ Other agricultural
16. Threats to site: None known Private development ___ Zoning ___ Vandalism ___
 Public Works project ___ Other: _____
17. Is the structure: On its original site? Moved? ___ Unknown? ___
18. Related features: garage (two); small shed

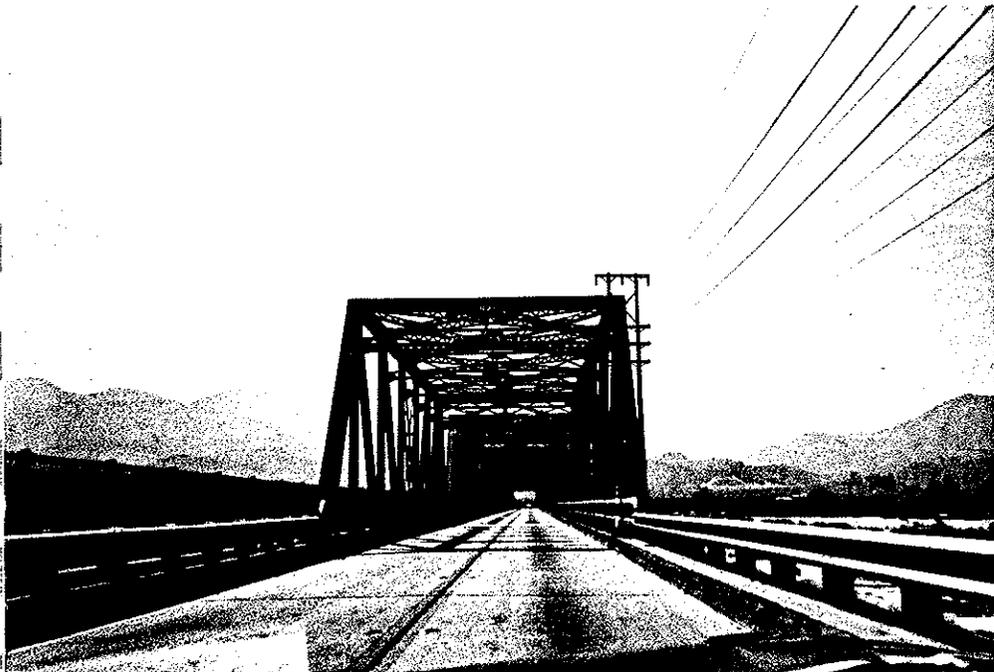
The bridge has an 8 riveted steel Pratt through truss main spans, with reinforced concrete T-girder approach spans and semi-detached precast/prestressed reinforced concrete T-girder sidewalk, all on reinforced concrete piers and abutments on pile foundations. The truss spans are each 129.5' long, and overall the bridge spans 1,645'. Its 20.7' width carries a 2-lane roadway between steel railings, crossing the stream essentially at a right angle (no skew).

13. Condition: Excellent ____ Good Fair ____ Deteriorated ____ No longer in existence ____
14. Alterations: widened in 1972; lengthened in 1939
15. Surroundings: (Check more than one if necessary) Open land ____ Scattered buildings ____ Densely built-up ____
 Residential ____ Industrial ____ Commercial ____ Other ____
16. Threats to site: None known Private development ____ Zoning ____ Vandalism ____
 Public Works project ____ Other: _____
17. Is the structure: On its original site? Moved? ____ Unknown? ____
18. Related features: N/A

The original bridge was designed by Ventura County in 1908-9. Like the present bridge, it had 8 steel truss main spans (probably pin-connected), but with earth filled approaches. The approaches washed out in 1914 and the County replaced them with timber approach spans on concrete pile bents, and in 1916 constructed revetments upstream to provide flood protection.

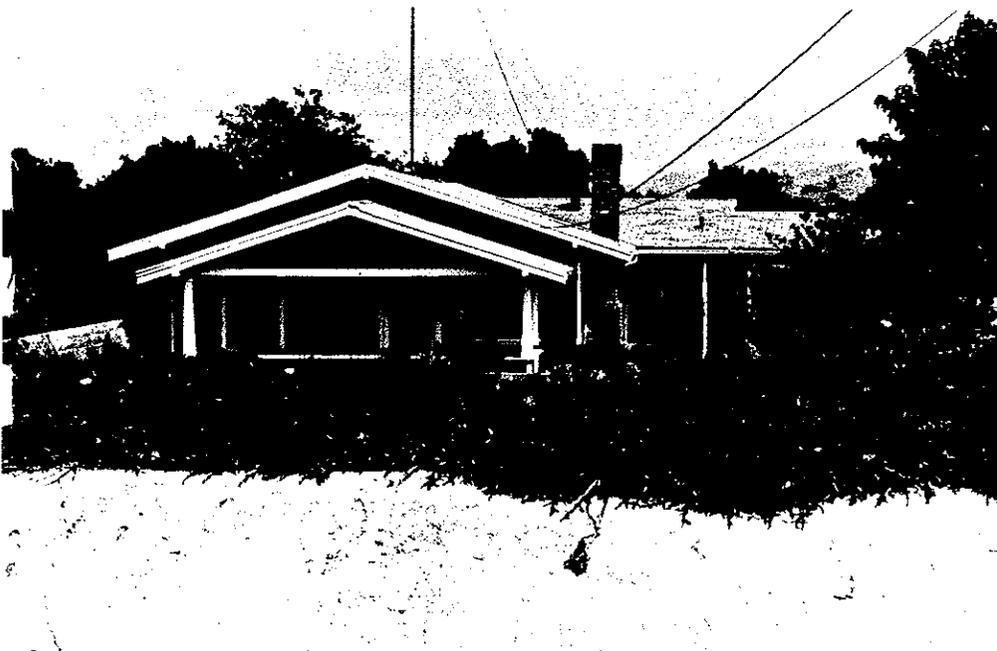
This single story residence has a low pitched gable roof with a separate gable over the front porch. The porch is supported by tapered wood columns capped at the top and a solid wood railing of narrow clapboards. Rafters and beams are exposed under the broad eaves. There is an exterior brick chimney on the south side of the house. Windows are double hung with wood frames or sliding aluminum with flat wood mouldings. The house is covered with narrow clapboards except for the south addition which is covered with wide clapboard siding. Under the gables are vertical slats that act as decorative vents.

13. Condition: Excellent ___ Good Fair ___ Deteriorated ___ No longer in existence ___
14. Alterations: addition on south side
15. Surroundings: (Check more than one if necessary) Open land ___ Scattered buildings Densely built-up ___
Residential Industrial ___ Commercial ___ Other agricultural
16. Threats to site: None known Private development ___ Zoning ___ Vandalism ___
Public Works project ___ Other: _____
17. Is the structure: On its original site? Moved? ___ Unknown? ___
18. Related features: barn, sheds

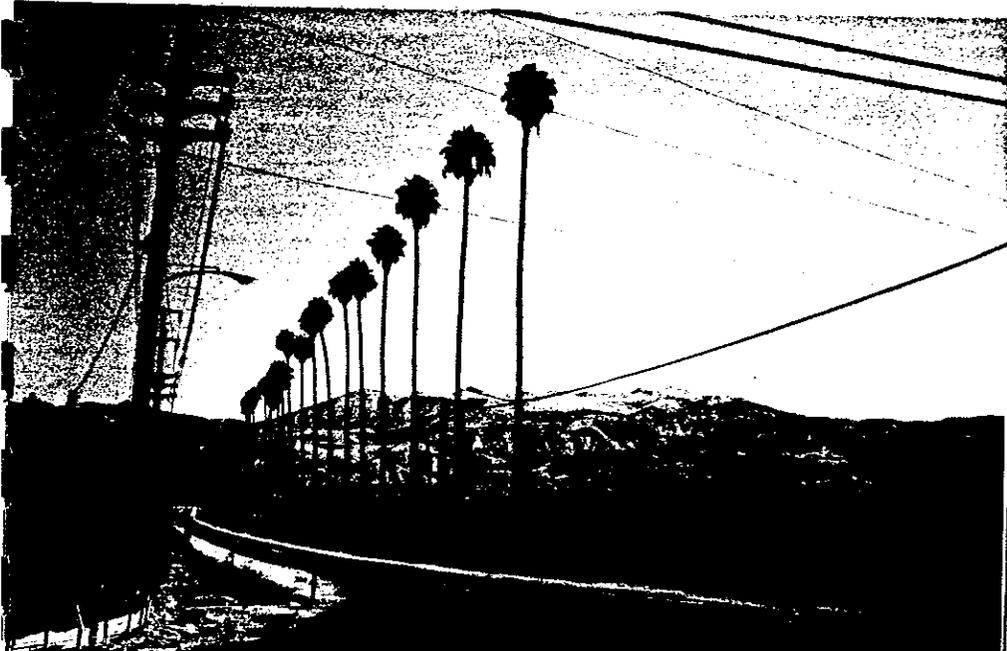
This row of approximately 38 palm trees runs along the east side of Chambersburg Rd. from Guiberson Rd. south to where the road turns and heads west. The approximate 100 foot height of these trees makes them a visual landmark in Bardsdale and the surrounding area. There are approximately 30 trees near the road right-of-way. The trees are Washingtonia Robusta, a Mexican fan palm. The Washingtonia Robusta grows taller than the California fan palm (Washingtonia filifera), which grows to 60 feet.

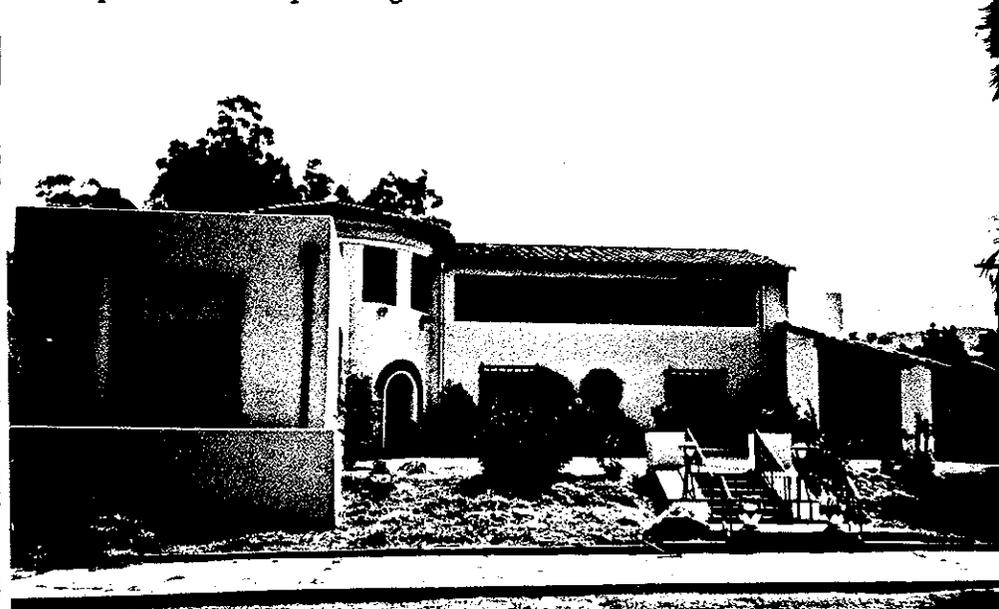
A two-story plaster house. The west front has three large paned picture windows. There is also an octagonal ship porthole window. Spanish iron grill works cover windows and some have a prominent "K" on them. The north front juts out from the front side wall (a flower planter is attached to this wall as part of the structure). A chimney is on the north end of this north front. This north front forms a t-shape to the house. On the west, main front, a brick walkway leads up through a wall-enclosed lawn to the wood paneled front door with a circular window. The door is set into the rounded turret. The arch doorway is rimmed by orange Italian tile. The roof is of Spanish red tile. The door opens into the turret foyer which opens to the top of the two-story turret rafters. The inside roof supports are wooden. A red tile open spiral staircase rims the inside wall of the turret opposite the front door opening. Iron grill railings are attached to the stairs and supports are attached to the railings and attached to the top of the turret at the second story.

All the rooms in the house radiate from the turret rotunda. The living room leads off from the foyer. This room has hardwood floors, painted stencil open rafters, and a fireplace. The paned, roll-out windows overlook vast circular green garden area and circular driveway on the west with the garden pond and lush plantings.

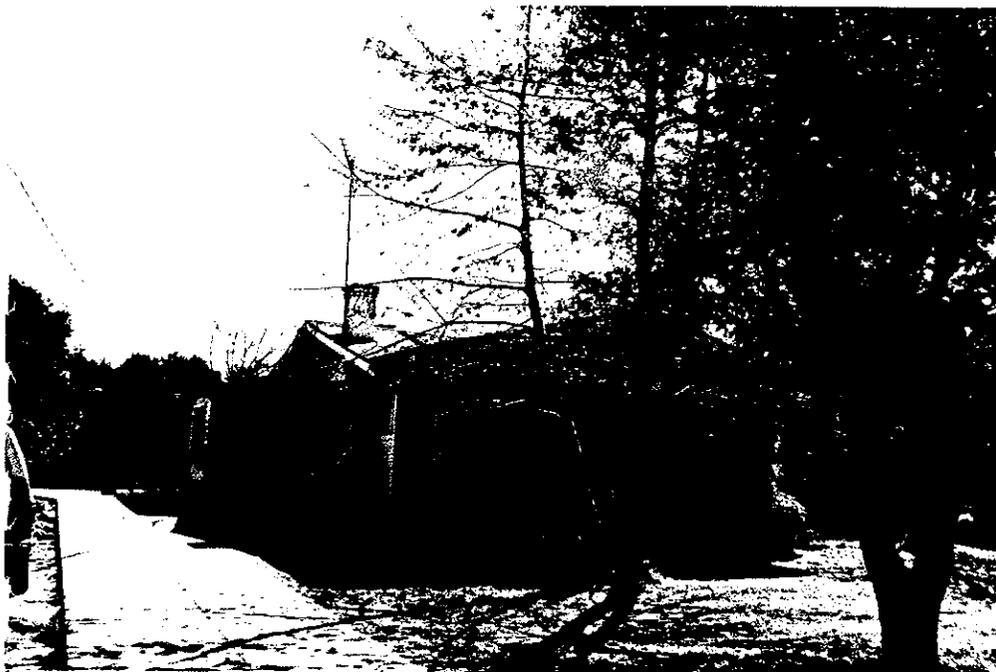
This single story rectangular shaped bungalow has a low side facing gable roof with a front facing gable over the porch. Exposed beams and rafters are found under the broad eaves. The attached porch is supported by large square brick columns. Windows are a combination of fixed, casement and double hung with wood frames and mouldings. The house has a brick chimney on the north side. Covered with clapboard siding, the house rests on a slightly raised foundation. Concrete steps lead up to the porch.

13. Condition: Excellent _____ Good Fair _____ Deteriorated _____ No longer in existence _____
14. Alterations: none apparent
15. Surroundings: (Check more than one if necessary) Open land Scattered buildings _____ Densely built-up _____
 Residential _____ Industrial _____ Commercial _____ Other agricultural
16. Threats to site: None known Private development _____ Zoning _____ Vandalism _____
 Public Works project _____ Other: _____
17. Is the structure: On its original site? Moved? _____ Unknown? _____
18. Related features: carport

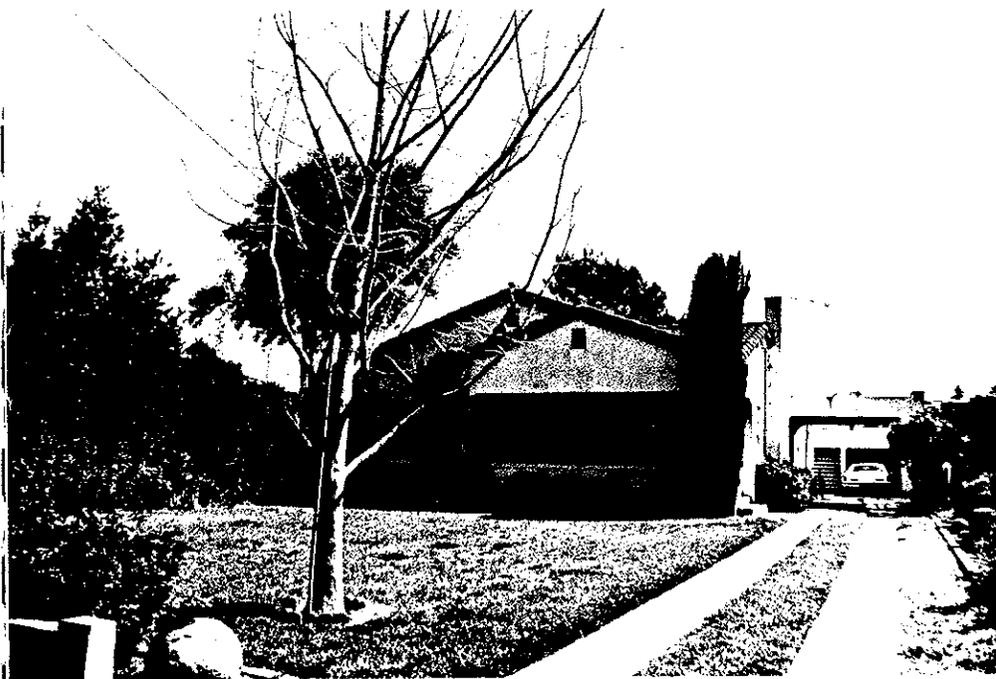
This single story bungalow style residence has a gabled tile roof and is covered with stucco siding. There is an offset gable over the front porch. The stucco porch columns are arched at the corners and the porch railing is covered with stucco. There is an exterior chimney on the south side. Also attached to the south side is a porte cochere with a flat roof and raised parapet at the corners. Windows are a combination of fixed, casement and double hung with wood frames and multi-panes. The house rests on a concrete foundation.

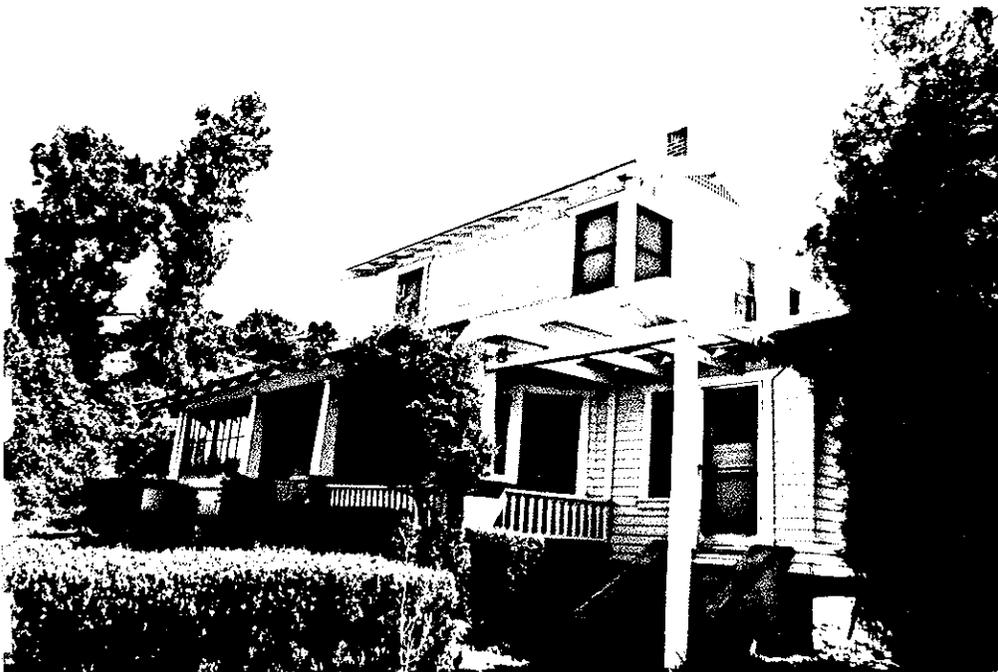
This large two-story bungalow style residence has a one-story gabled roof portion over the front porch and west side. Rafters and beams are exposed under the broad eaves. The Craftsman influence is seen in the stone foundation and porch stair railing and columns. The upper portion of the porch columns are of tapered square wood capped at the top. A portion of the porch has been enclosed with glass windows and vertical board siding underneath. There is a wood porch railing on the west side of the porch. The long porch extends to the west corner of the house where there is a second entrance with pergola. Windows are double hung with wood frames and angled mouldings at the top corners. On the front porch is a slanted bay window. Siding is wide clapboard. A brick chimney punctuates the roofline.

13. Condition: Excellent ___ Good Fair ___ Deteriorated ___ No longer in existence ___
14. Alterations: none apparent
15. Surroundings: (Check more than one if necessary) Open land ___ Scattered buildings Densely built-up ___
 Residential Industrial ___ Commercial ___ Other agricultural/oil
16. Threats to site: None known Private development ___ Zoning ___ Vandalism ___
 Public Works project ___ Other: _____
17. Is the structure: On its original site? Moved? ___ Unknown? ___
18. Related features: several buildings - barns, cottages, barbecue house, etc.

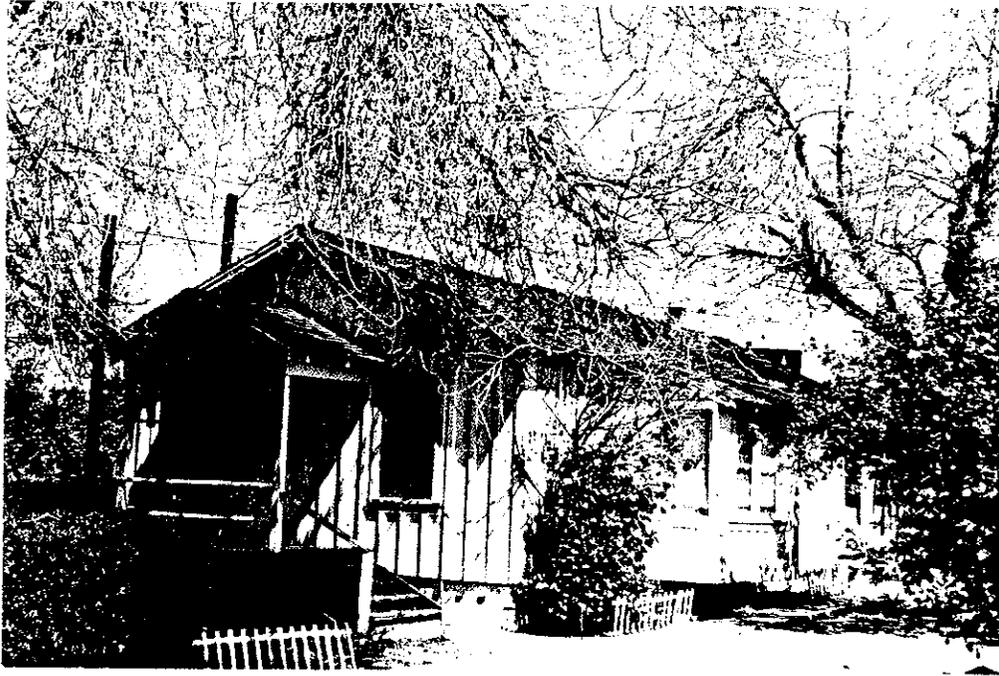
1324 Los Angeles Ave.
Parcel #: 108-080-255

This board and batten cottage was originally part of the Robertson Ranch and served as a ranch hand's residence. It was built about 1925

The house has a gable roof with an offset gable over the porch. Rafters are exposed under the eaves. On the south side is a slanted bay window. Windows are double hung with wood frames and mouldings. The house rests on a concrete foundation.

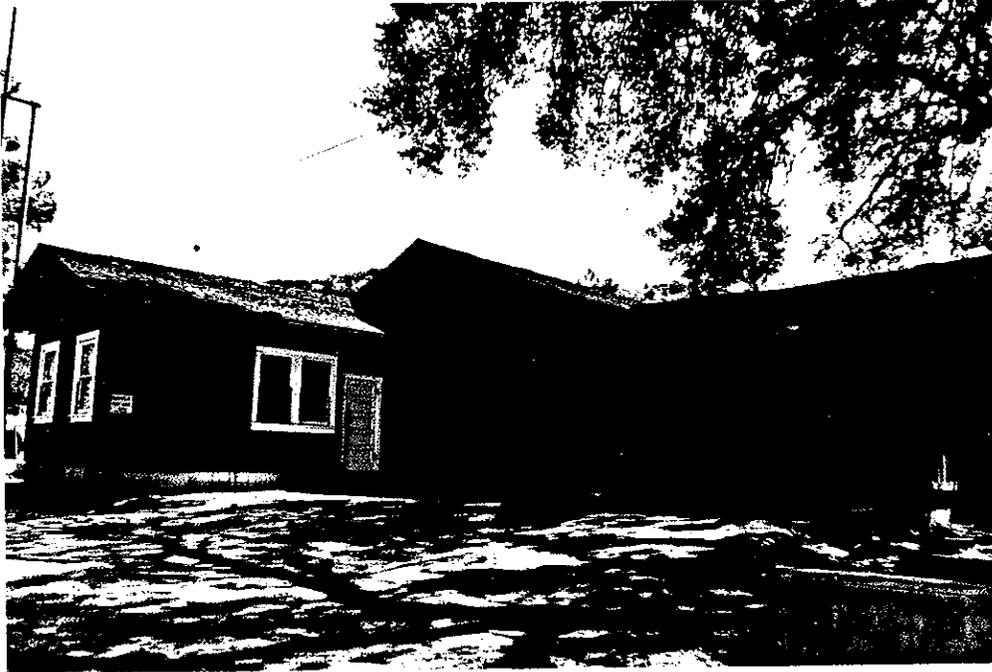
Robertson Ranch
Parcel #: 108-080-255

These outbuildings were part of the Robertson Ranch. The barn has a gable roof with two gabled wings. Siding is board and batten. The large wood doors slide on a track. One gabled wing was added later and is covered with a false brick exterior. Windows are double hung with wood frames and mouldings. This may have been used as an office or shop. Dates given by the Assessor's office are 1917 to 1925.

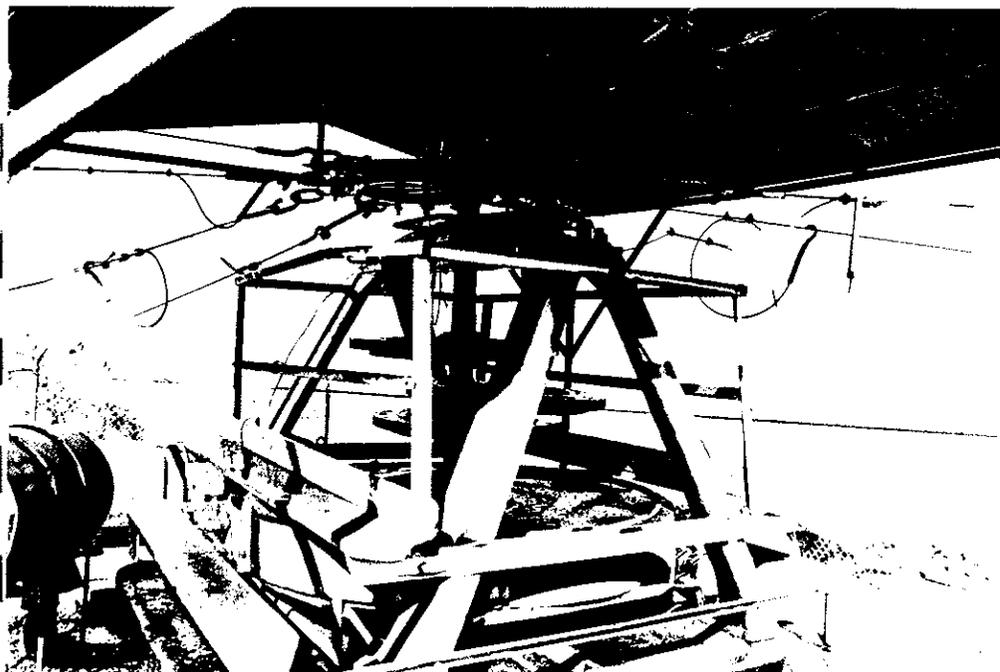
The Union Oil Co. has a large oil operation located in the hills south of Bardsdale. The area, known as the Bardsdale Field, extends roughly between Santa Paula Street on the west and slightly past Grimes Canyon Rd. on the east. Several old oil rigs are found in this area. They include several Allen patented pumping units, commonly referred to as "jackline" pumping units and jackline pumps.

The jackline pumping unit makes it possible to pump many shallow wells from one central power source. The pumping jack links each well to the central pumping unit. Presently the Bardsdale Field produces 150 barrels a day for the Union Oil Co.

The photograph below is an example of the Bardsdale Field's Allen patented pumping unit showing the revolving eccentric wheel that alternately pulls and releases cables that pump a dozen or so wells. These cables run up and down the hillsides and connect to the pumping jacks.
