CULTURAL HERITAGE SURVEY PHASE IV SANTA CLARA VALLEY

**COUNTY OF VENTURA
CULTURAL HERITAGE SURVEY
PHASE IV - SANTA CLARA VALLEY**

**Prepared by Judy Triem
San Buenaventura Research Associates**

January 1988

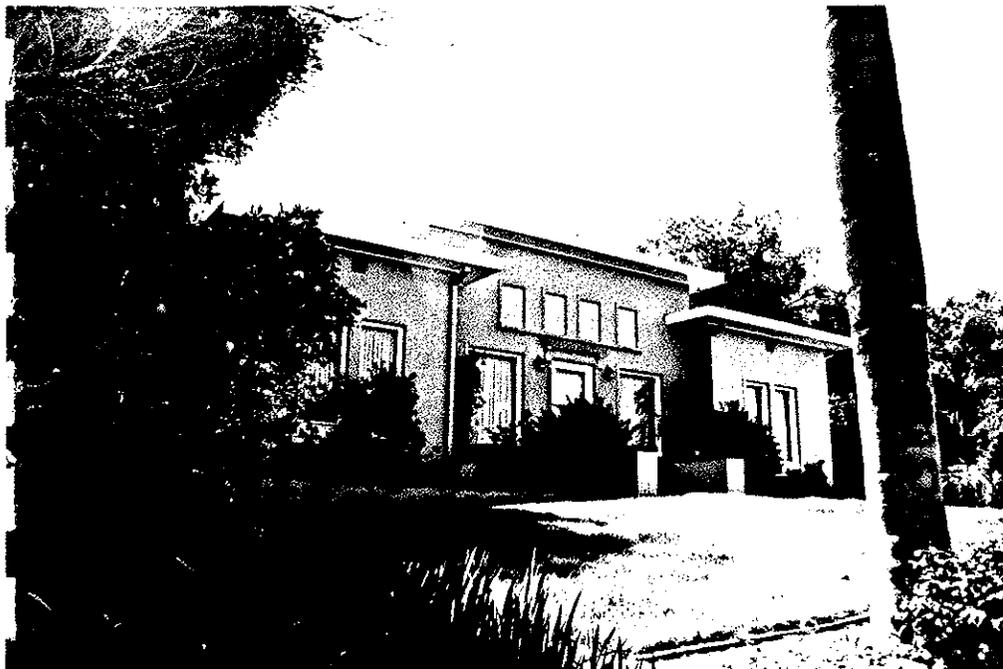
This single story residence has a flat roof with a raised center portion and two lower roofed wings. The eaves are boxed. Originally there was a wood railing across the top of the roof. The front porch is raised with capped concrete railing. The symmetrical facade has the front door flanked by two large windows. These windows were originally french doors as were the windows on each wing. The windows once had wood balconies. Windows have wood frames and are slightly recessed. Above the front entrance are four small rectangular panes with wood frames. Above the front door is a small raised stucco band that repeats itself under the row of windows. The house is covered with stucco.

13. Condition: Excellent ___ Good Fair ___ Deteriorated ___ No longer in existence ___
14. Alterations: Originally had french doors, decorative wood railing
15. Surroundings: (Check more than one if necessary) Open land ___ Scattered buildings Densely built-up ___
 Residential Industrial ___ Commercial ___ Other agricultural
16. Threats to site: None known Private development ___ Zoning ___ Vandalism ___
 Public Works project ___ Other: _____
17. Is the structure: On its original site? Moved? ___ Unknown? ___
18. Related features: garage with unit above; swimming pool, barn, shed

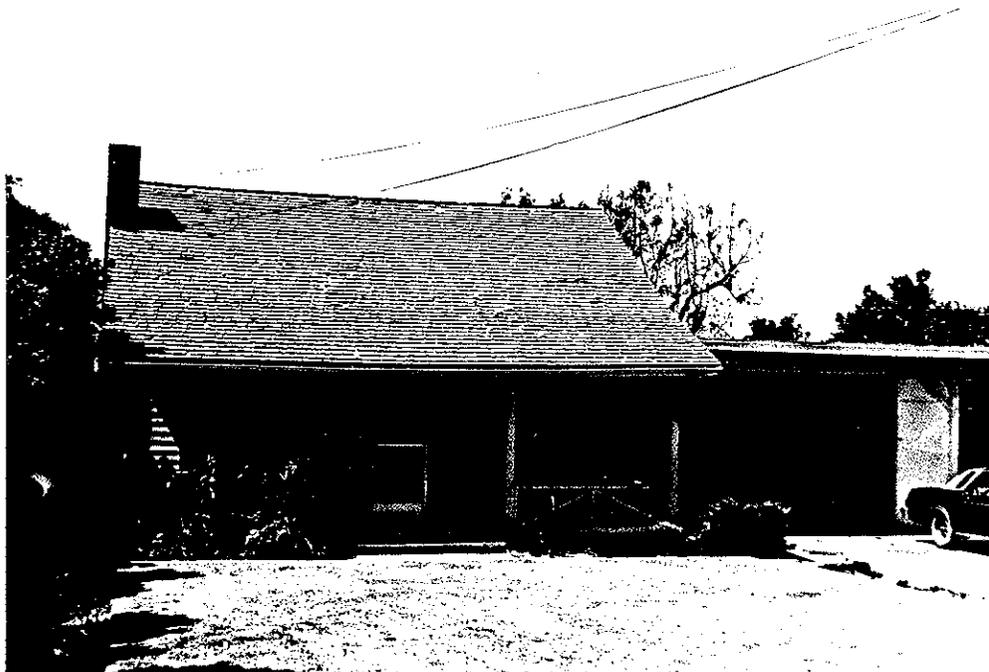
The house has a hip roof with exposed rafters under the eaves. The porch is recessed under the main roof and has a corner square post support. Windows are double hung with wood frames and mouldings. A brick chimney is located on the north side. Siding is clapboard. The house was remodeled about 1945.

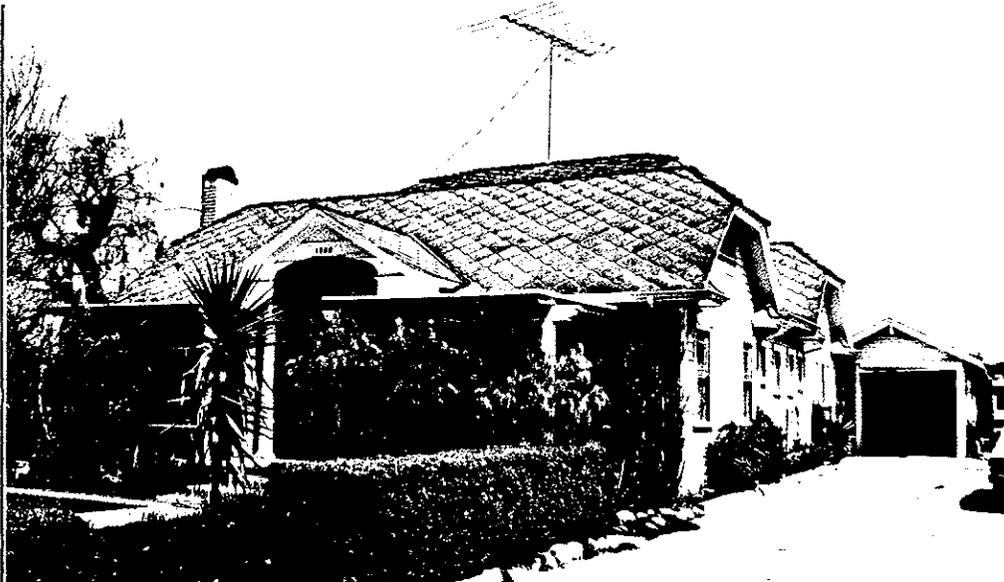
This large residence is a combination of one and two-story sections with a complex roofline of intersecting clipped gables. The eaves are boxed and returned. There is a hable roof over the front porch supported by double circular capped columns with an arch at the top. On either side of the front porch is a covered pergola with exposed beams and rafters supported by wood columns. Windows are double hung and fixed with wood frames and mouldings. The house rests on a concrete foundation and is covered with clapboard siding. The second story portion was added in 1945 and is the same style as the rest of the house.

13. Condition: Excellent ___ Good Fair ___ Deteriorated ___ No longer in existence ___
14. Alterations: none apparent
15. Surroundings: (Check more than one if necessary) Open land ___ Scattered buildings Densely built-up ___
Residential Industrial ___ Commercial ___ Other agricultural
16. Threats to site: None known Private development ___ Zoning ___ Vandalism ___
Public Works project ___ Other: _____
17. Is the structure: On its original site? Moved? ___ Unknown? ___
18. Related features: detached garage, shed

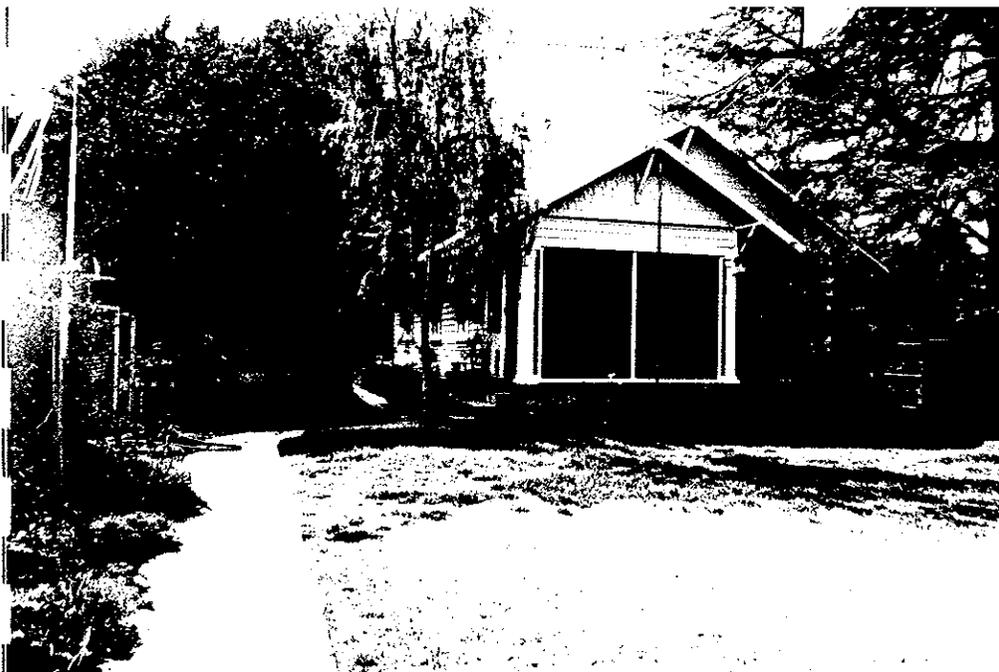
This single story bungalow has a medium gable roof with an offset gable over the porch. Under the eaves are knee brackets and exposed rafters. The house is covered with clapboard siding except for shingle siding under the gables. The porch is supported by two square posts capped at the top and enclosed with screens. Windows are double hung with wood frames and mouldings. The house is rectangular in plan and rests on a brick foundation.

13. Condition: Excellent ___ Good Fair ___ Deteriorated ___ No longer in existence ___
14. Alterations: screened- in porch
15. Surroundings: (Check more than one if necessary) Open land ___ Scattered buildings Densely built-up ___
 Residential Industrial ___ Commercial ___ Other agricultural
16. Threats to site: None known Private development ___ Zoning ___ Vandalism ___
 Public Works project ___ Other: _____
17. Is the structure: On its original site? ___ Moved? Unknown? ___
18. Related features: detached garage, wash house

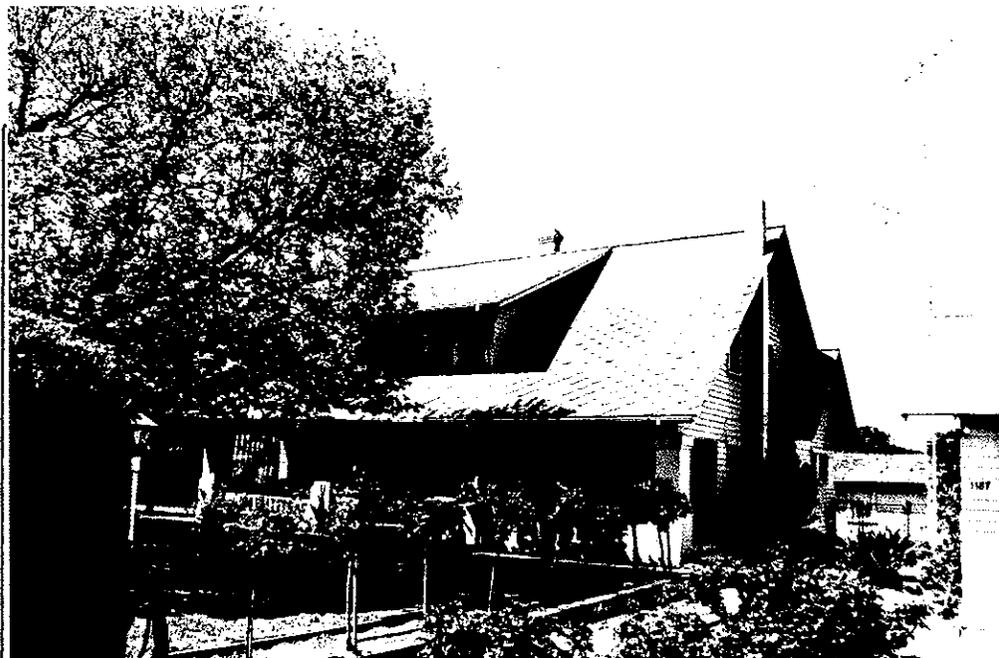
This 1 1/2 story residence has a steep pitched gable roof with shed roof dormer window. The front porch is recessed under the main gable and supported by four large square capped stucco columns and open wood railing. Windows are a combination of double-hung, casement and fixed with wood frames and mouldings. There are two brick chimneys. The house is covered with clapboard siding and rest on a concrete foundation. Some alterations include the addition of front doors and the moving of the original front door to accomodate an office space.

13. Condition: Excellent Good ___ Fair ___ Deteriorated ___ No longer in existence ___
14. Alterations: some door and window changes
15. Surroundings: (Check more than one if necessary) Open land ___ Scattered buildings Densely built-up ___
 Residential Industrial ___ Commercial ___ Other agricultural
16. Threats to site: None known Private development ___ Zoning ___ Vandalism ___
 Public Works project ___ Other: _____
17. Is the structure: On its original site? Moved? ___ Unknown? ___
18. Related features: detached two-car garage, small outbuilding in rear

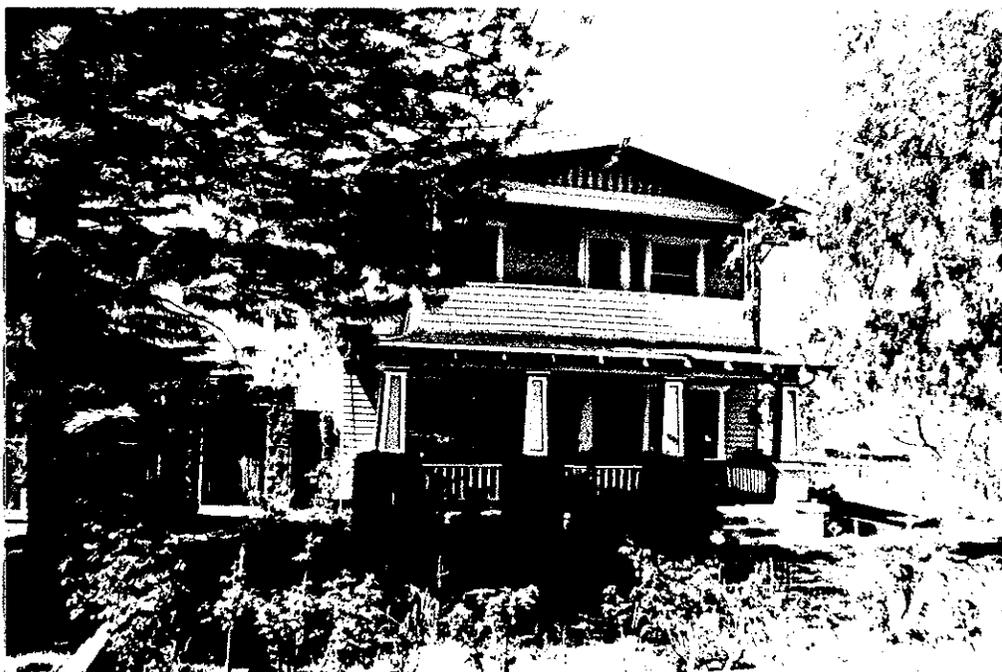
This rare two-story California Bungalow has a low pitched gable roof with decorative vent, exposed beams and rafters under the broad eaves. The second floor has a recessed balcony across the facade supported by tapered and capped square columns with recessed panels and a solid wood railing covered with shingles. The first floor porch extends across the length of the facade and has a bell-cast hip roof supported by tapered wood columns and open wood railing. The house is covered with clapboard siding on the first floor and shingle siding on the second floor. Windows are both fixed and double hung with wood frames and flat wood mouldings angled at the upper corners and tapered on the sides. On the side of the house is a slanted bay window. The house rests on a raised concrete and wood foundation.

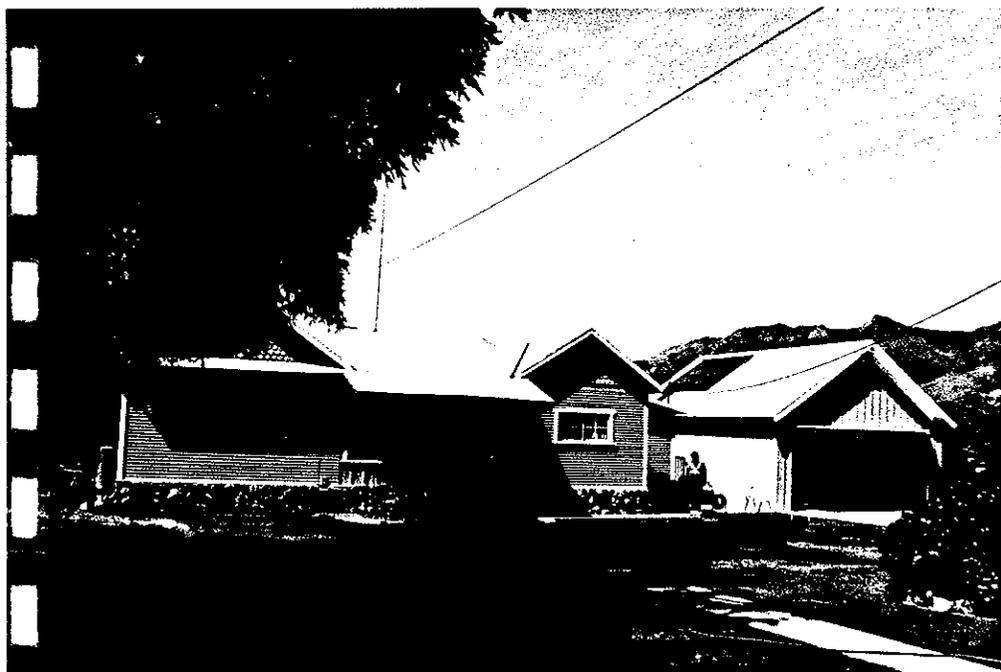
This single story house originally was only half the size it is today. Presently it has a medium sidfacing gable roof with a gable at each end. The porch was recessed creating a U-shape, but has now been enclosed and a shed roof added over the entrance. Also added are concrete steps and metal railing. The original windows were also changed to shorter sliding wood frame windows. Under the two front gables are the original fishscale shingles and boxed eaves. Siding is narrow clapboard, but originally was wide board siding. When the house was moved the south side and north wing were added. The house rests on a concrete and stone foundation.

A plaque hangs on the Coast Redwood in the front yard and says, "This tree planted by Fred H. Young and Marie W. Young, 1906, in memory of their love of trees and plants. It shall stand until nature lays it low."

13. Condition: Excellent Good ___ Fair ___ Deteriorated ___ No longer in existence ___
14. Alterations: porch enclosed, windows changed, siding
15. Surroundings: (Check more than one if necessary) Open land ___ Scattered buildings Densely built-up ___
 Residential Industrial ___ Commercial ___ Other agricultural
16. Threats to site: None known Private development ___ Zoning ___ Vandalism ___
 Public Works project ___ Other: _____
17. Is the structure: On its original site? ___ Moved? Unknown? ___
18. Related features: detached two-car garage

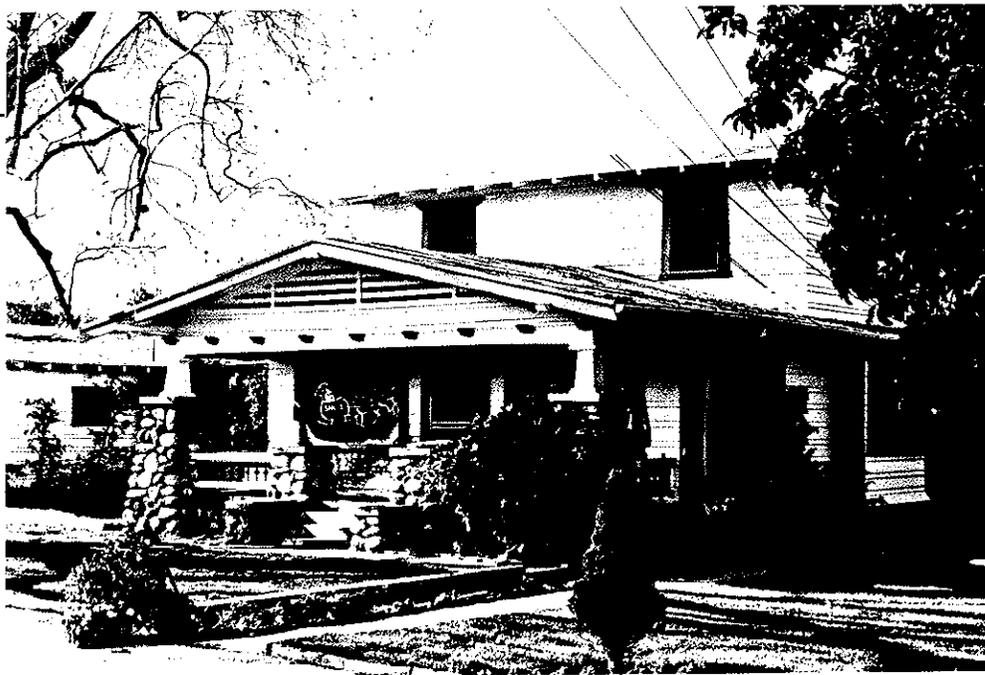
This bungalow residence is a combination of both one and two stories with low pitched gable roofs. The second story has a sidefacing gable with exposed rafters. The first story has a front facing gable with recessed porch. Purely Craftsman are the tapered stone columns and stair railing. The top of the columns have short wood capped columns that connect to the beam. The wood front door has four square beveled glass panes. Under the porch gable is a decorative vent and exposed beams and rafters. Siding is a combination of narrow and wide clapboards. Windows are double hung with wood frames and flat wood mouldings angled at the top and tapered on the sides. The house rests on a raised concrete and stone foundation.

13. Condition: Excellent ___ Good Fair ___ Deteriorated ___ No longer in existence ___
14. Alterations: _____
15. Surroundings: (Check more than one if necessary) Open land ___ Scattered buildings Densely built-up ___
 Residential Industrial ___ Commercial ___ Other agricultural
16. Threats to site: None known Private development ___ Zoning ___ Vandalism ___
 Public Works project ___ Other: _____
17. Is the structure: On its original site? Moved? ___ Unknown? ___
18. Related features: detached garage, wood shed, mature trees

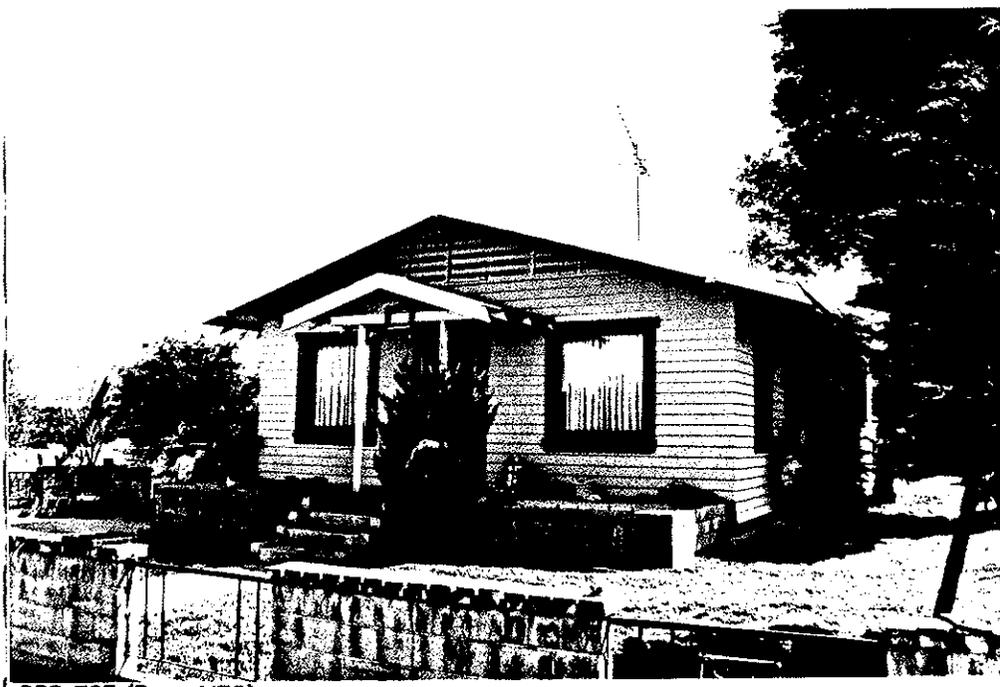
This modest bungalow is one story with a low gable roof and rectangular shape. The front porch is attached with a small gable roof supported by two square posts. Rafters and beams are exposed under the broad eaves. Windows are fixed in front and double hung on sides with wood frames and flat wood mouldings. Under the front gable is a decorative wood vent with horizontal siding. The house rests on a concrete foundation and is covered with clapboard siding.

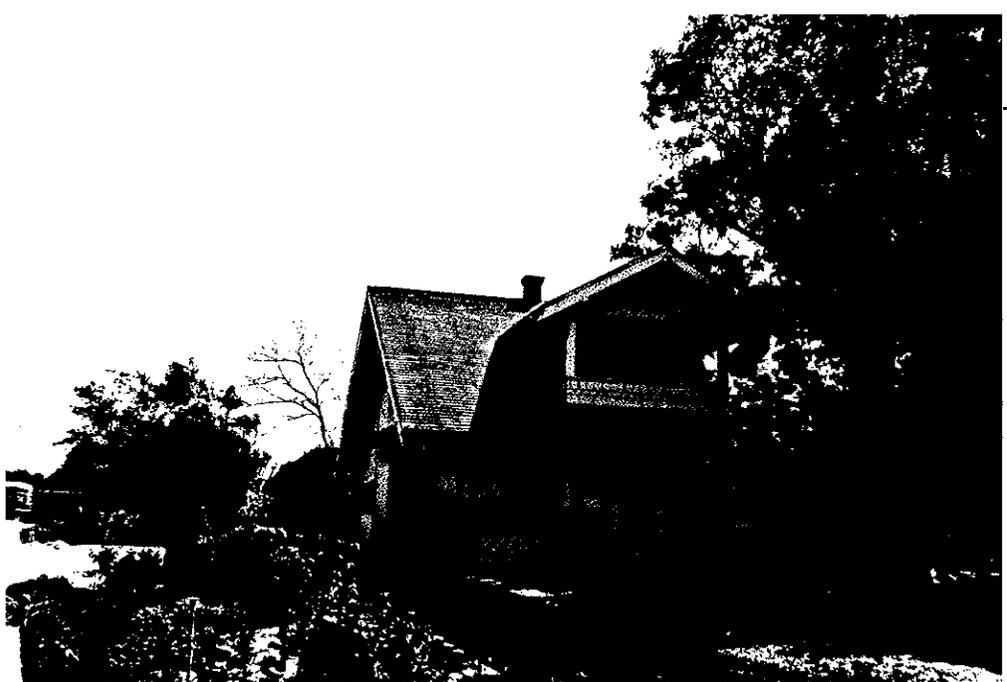
This large 1 1/2 story bungalow features a gabled dormer window with recessed porch balcony. The balcony is covered with shingled wood railing topped with square posts. Exposed rafters and beams are located under all the eaves. The upper portion of the house is covered with shingles and the lower portion with clapboards. The porch extends across the front of the house and is recessed under the gable. Massive tapered stone columns, showing the Craftsman influence, are then topped by short tapered wood columns. Windows are double hung with wood frames and flat wood mouldings. Some windows have multi-paned diamond shapes. The porch has been partially enclosed with multi-paned glass windows and doors. The house rests on a concrete and stone foundation. On the south side is an exterior brick chimney and another brick chimney punctuates the roofline.

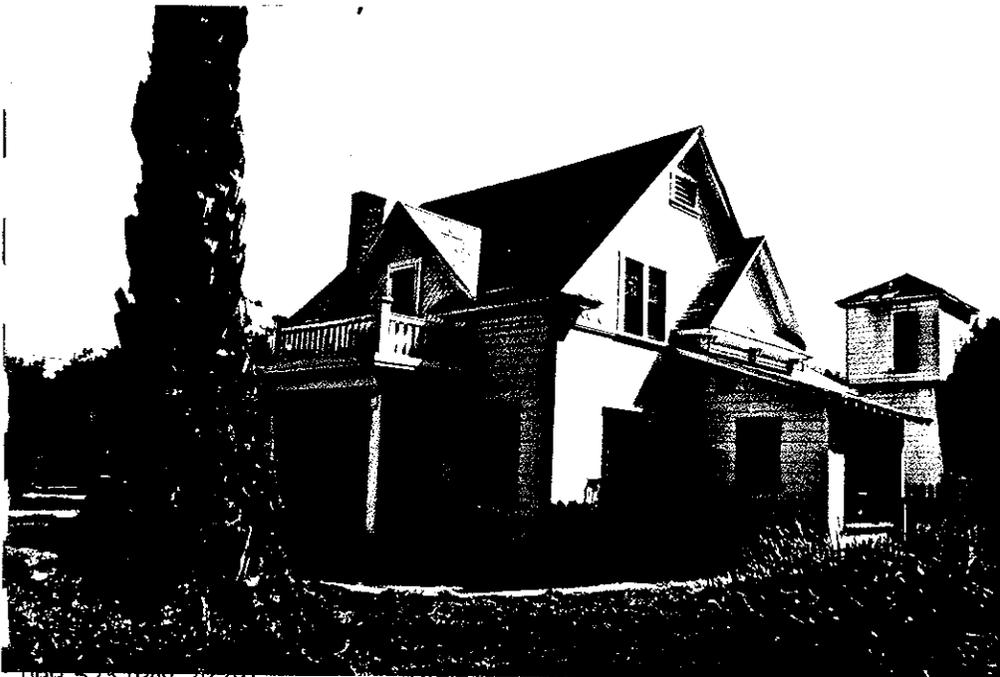
This 1-1/2 story residence has a high pitched side facing gable roof with a centered gable over the entrance. The roof eaves show the Italianate influence with their classical boxed treatment and elaborately carved brackets. The shingle siding under the gable is another Victorian era influence. However, the front porch and balcony above illustrate a later Colonial Revival style as does the multi-paned sidelights on each side of the front door. Some of the windows have been changed from the narrower windows like those on the second floor to wider, multi-paned windows. The south side has a later shed roof addition. Originally this was probably a bay window given the gabled treatment above the shed roof. The porch and house rest on a concrete foundation. On the north side is a brick chimney. The house is covered with wide shiplap siding.

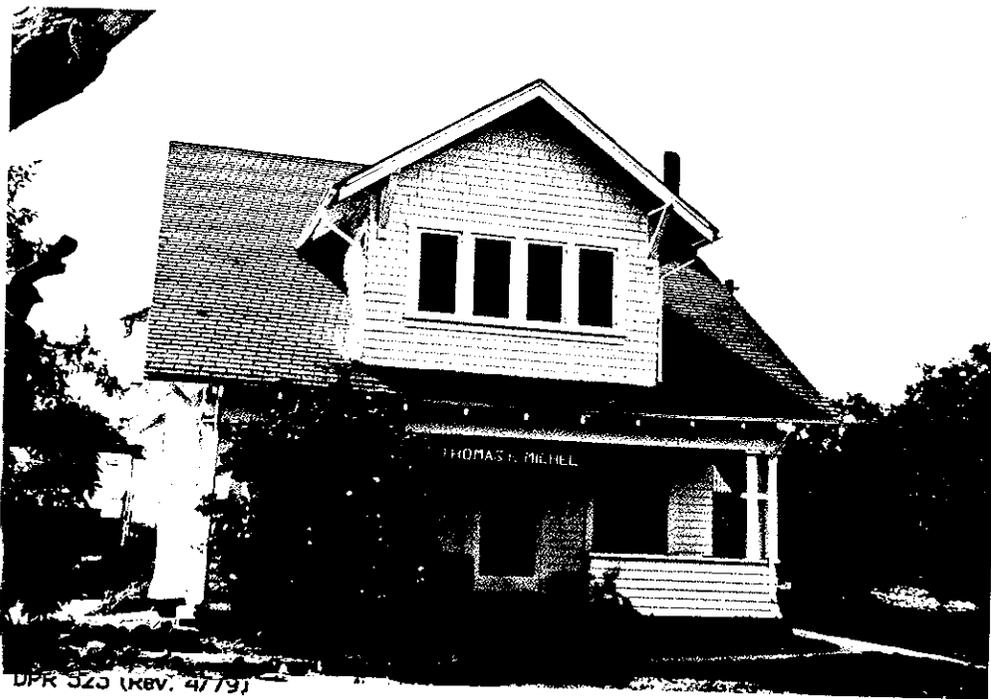
This 1-1/2 story residence has a high pitched side facing gable roof with a large centered gabled dormer. The dormer acts as a screened porch. Under the eaves are exposed rafters and knee brackets. The porch is recessed across the front of the house under the main gable. The porch is supported at the corners with double capped wood columns. The porch railing is covered with clapboard siding. Windows are double hung and casement with flat wood mouldings. The house rests on a raised concrete foundation and has a brick chimney. The lower half of the house is covered with clapboards and the upper half with shingles.

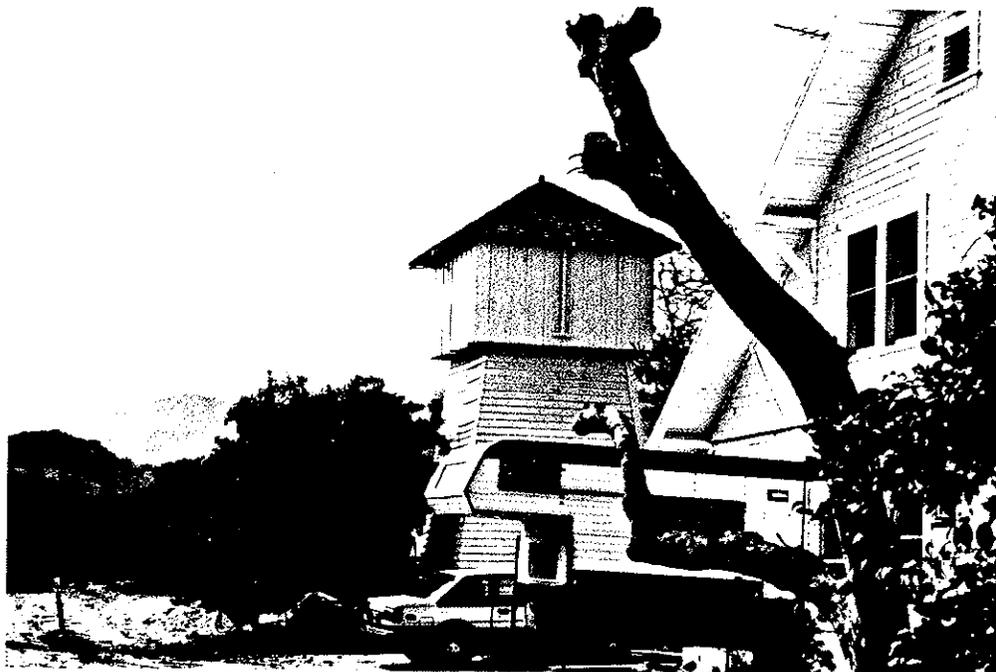
Water tower

This wood water tower is one of the few remaining water towers in Bardsdale. It has a hip roof and is covered with board and batten siding on the upper half and clapboard siding on the lower half.

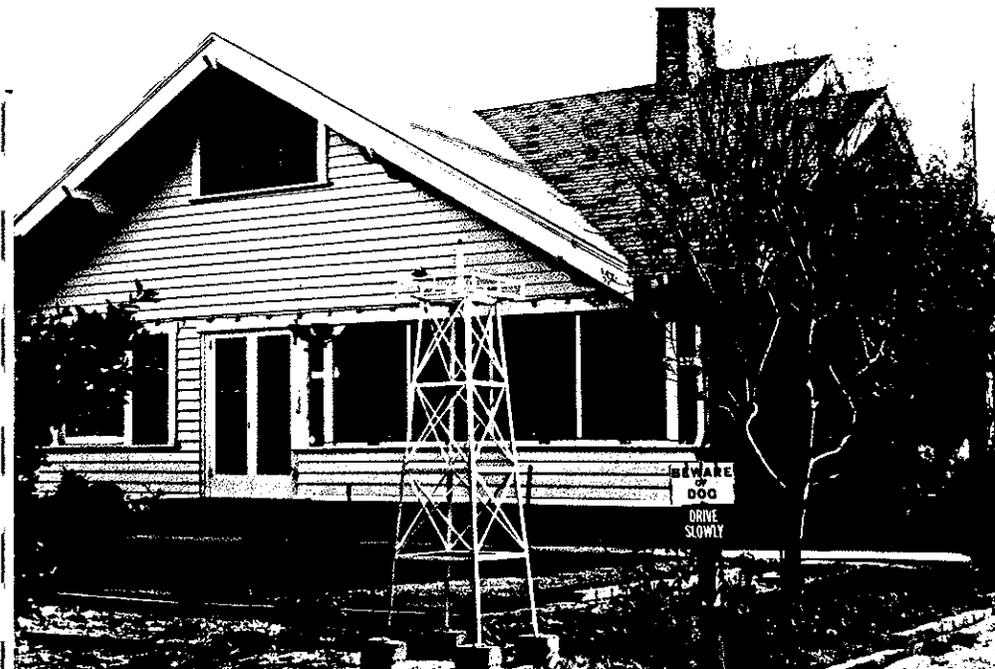
This 1 1/2 story bungalow has a medium side facing gable roof with an offset front gable. Under the eaves are exposed beams and rafters. The front porch is recessed under one side of the front gable. The porch is enclosed with screens and supported by double square wood columns and a closed wood railing covered with wide clapboards. Windows are double hung and fixed with wood frames and mouldings. The house rests on a concrete foundation and is covered with wide clapboard siding. A stuccoed chimney punctuates the roofline.

13. Condition: Excellent Good Fair Deteriorated No longer in existence
14. Alterations: none apparent
15. Surroundings: (Check more than one if necessary) Open land Scattered buildings Densely built-up
 Residential Industrial Commercial Other agricultural
16. Threats to site: None known Private development Zoning Vandalism
 Public Works project Other: _____
17. Is the structure: On its original site? Moved? Unknown?
18. Related features: pump house, barn, tool shed, bird house

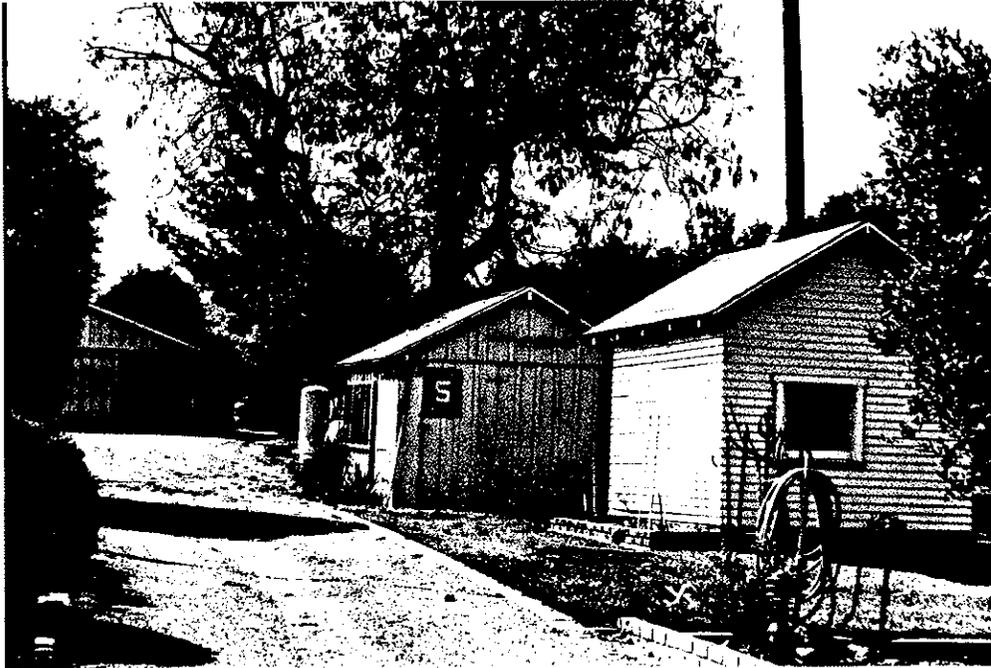
Pumphouse/storage building

The building in the foreground is the pumphouse. It has a gable roof and is square in shape with rafters exposed under the eaves. The building rests on a concrete foundation and is covered with clapboard siding. The window is fixed with wood frame and moulding.

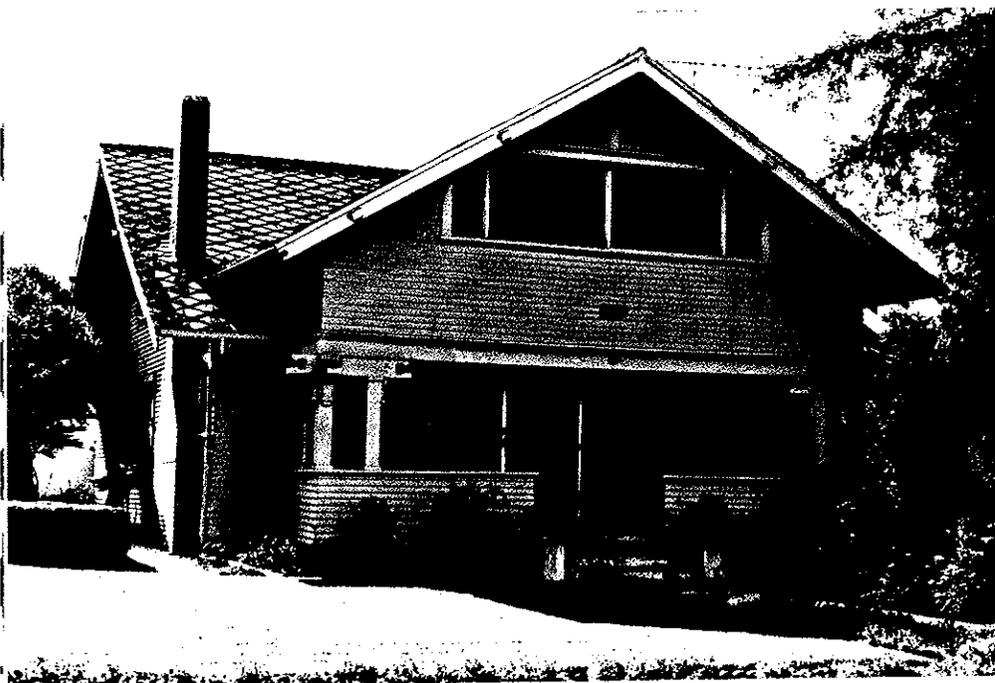
This large 1 1/2 story residence has a high side facing gable roof with a centered front gable extending out over the front porch. Under this main gable is a second floor screened porch with open porch below. The porch is supported by a grouping of three columns at each corner. The decorative columns have a short cutout beam above them and wood brackets under the beams. The porch railing is enclosed and covered with narrow clapboard siding. Under the broad eaves are exposed rafters, beams and knee brackets. On the east side of the house is an exterior brick chimney. Windows are fixed and double hung with wood frames and flat wood mouldings. On the west side is a bay window. The front door has a diamond shaped window and two iron straps. The house rests on a concrete foundation and is covered with narrow clapboard siding.

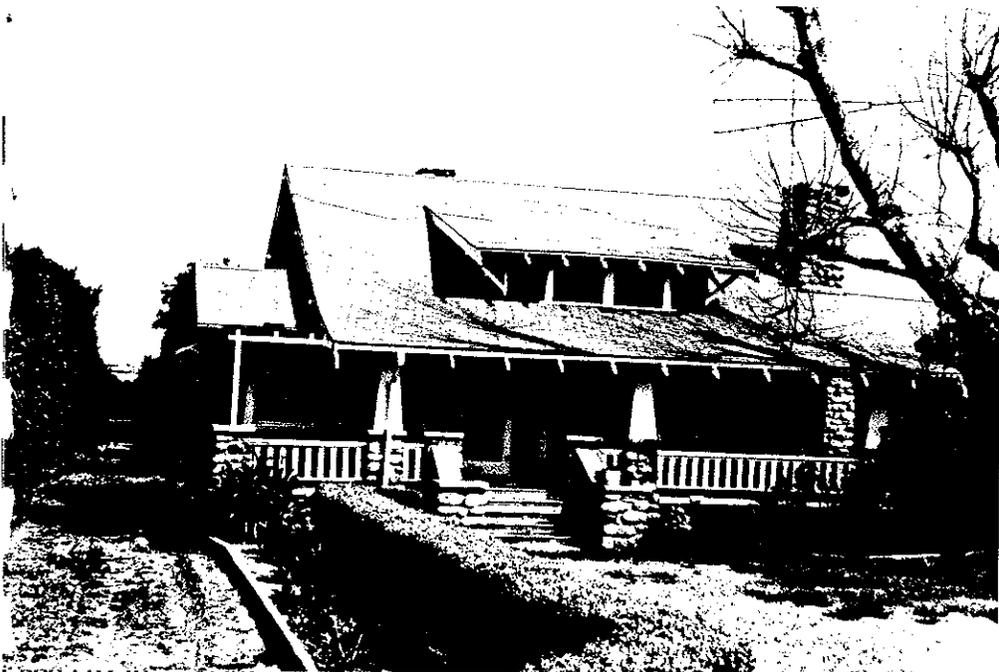
This rectangular shaped bungalow has a medium pitched gable roof that is slightly bellcast at the ends. The 1-1/2 story side facing gable roof has a shed roof dormer window. The eaves have sharply pointed rafters and knee brackets. The porch is recessed under the gable and supported by tapered wood columns on the upper half and square stone columns on the lower half. A wooden porch railing connects the columns. The porch is open at the west end with a wood pergola extending from the eaves. Windows are multi-paned fixed or double hung with flat mouldings tapered at the sides. On each side of the front door are sidelights made up of glass blocks. Craftsman features include the stone foundation, chimneys and porch railing and the shingled wood siding.

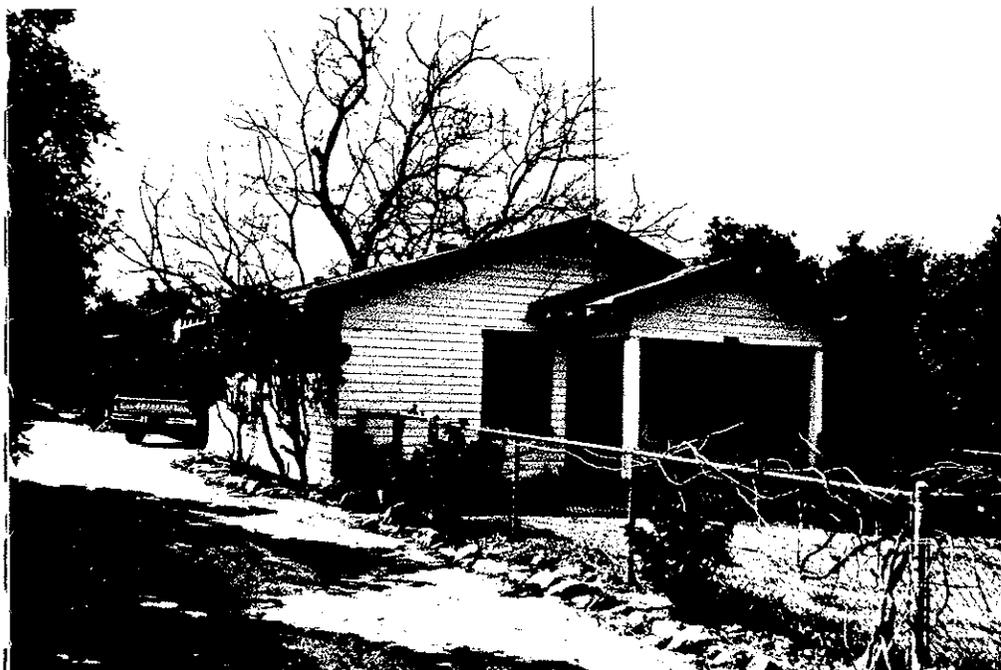
This modest single story bungalow is rectangular in shape with a low gable roof. An offset gable covers the porch and is supported by square posts. Rafters and beams are exposed under the eaves. Under the main gable is a decorative vertical board vent. Windows are double hung with wood frames and flat wood mouldings. The house rests on a concrete foundation and is covered with clapboard siding. The front door has six panes in the upper portion.

13. Condition: Excellent ___ Good ___ Fair Deteriorated ___ No longer in existence ___
14. Alterations: none apparent
15. Surroundings: (Check more than one if necessary) Open land ___ Scattered buildings Densely built-up ___
 Residential Industrial ___ Commercial ___ Other agricultural
16. Threats to site: None known Private development ___ Zoning ___ Vandalism ___
 Public Works project ___ Other: _____
17. Is the structure: On its original site? Moved? ___ Unknown? ___
18. Related features: shed

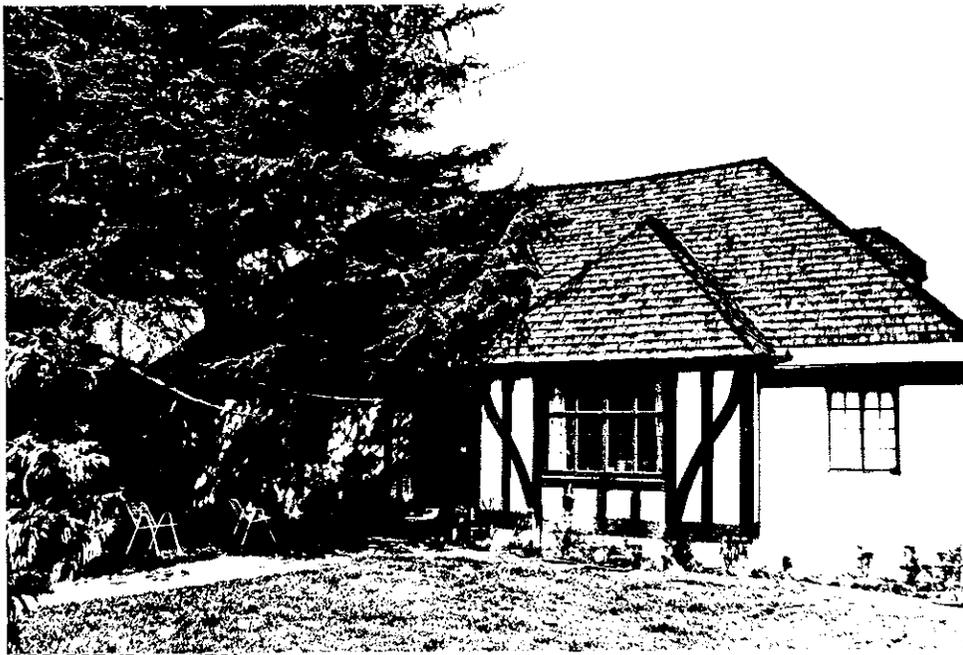
This 1- 1/2 story English Cottage style residence has a high hip roof covered with wood shingles. The low sloping roof extends downward partially covering the stucco and half-timbering. Windows are slightly recessed and are wood casement with multi-panes. A smaller hip roof projects with a half-timbered bay window next to the front entrance. Hipped dormer windows break up the broad roofline. On the north side is a tall chimney. Interior features include hand hammered metal light fixtures and fireplace gates.

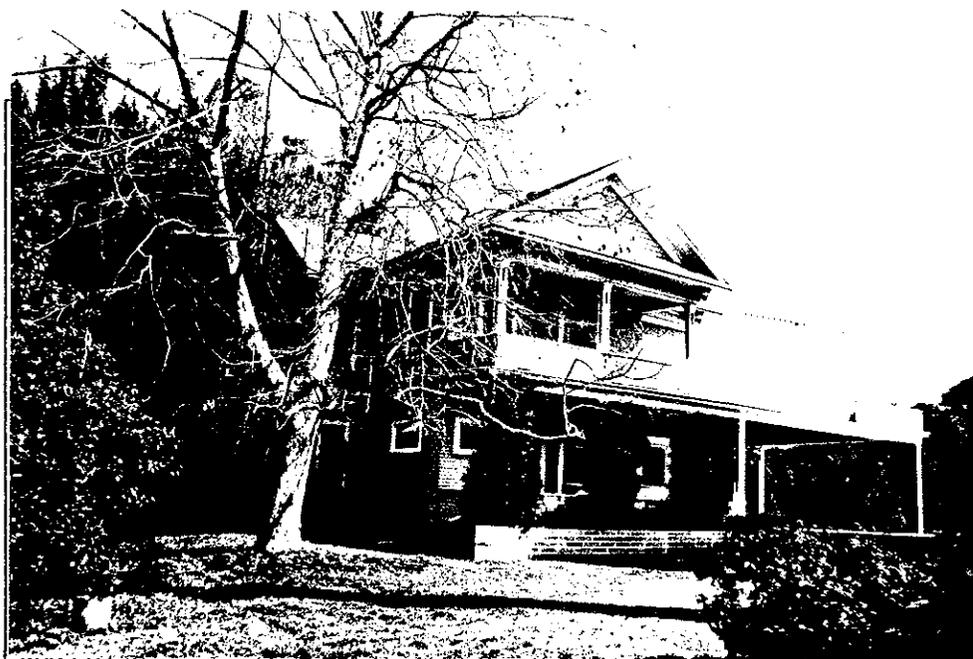
The main feature of this large two-story residence is the L-shaped porch and balcony with its square capped columns with recessed panels. The porch balcony has a wood railing covered with narrow clapboards to match the rest of the house. The medium high pitched intersecting gables have boxed eaves with flat paired brackets underneath. The gables have shingled siding. On the west side of the house is a two-story slanted bay window. Windows are double hung with wood frames and curved mouldings. The house rests on a stone foundation and is covered with narrow clapboard siding. A modern brick planter has been added in front of the porch.

13. Condition: Excellent ____ Good X Fair ____ Deteriorated ____ No longer in existence ____
14. Alterations: none apparent
15. Surroundings: (Check more than one if necessary) Open land ____ Scattered buildings X Densely built-up ____
Residential X Industrial ____ Commercial ____ Other agricultural
16. Threats to site: None known X Private development ____ Zoning ____ Vandalism ____
Public Works project ____ Other: _____
17. Is the structure: On its original site? X Moved? ____ Unknown? ____
18. Related features: carport

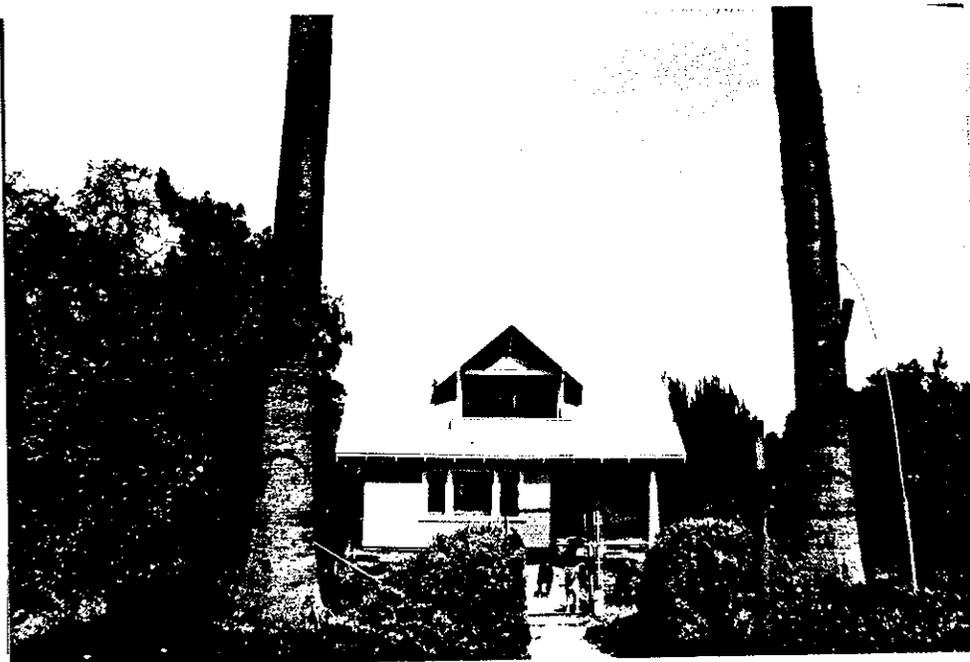
This rectangular shaped 1 1/2 story residence has a high pitched gable roof punctuated by a gabled dormer window with balcony. Under the eaves are exposed rafters and knee brackets. The porch is recessed under the east side of the main front gable and supported by a tapered wood column. The windows are a combination of fixed, casement and double hung with wood frames and mouldings tapered on the sides. Siding is narrow clapboard. The balcony siding is vertical board and was probably not original. The house rests on a concrete foundation.

13. Condition: Excellent ___ Good Fair ___ Deteriorated ___ No longer in existence ___
14. Alterations: none apparent
15. Surroundings: (Check more than one if necessary) Open land ___ Scattered buildings Densely built-up ___
 Residential Industrial ___ Commercial ___ Other agricultural
16. Threats to site: None known Private development ___ Zoning ___ Vandalism ___
 Public Works project ___ Other: _____
17. Is the structure: On its original site? Moved? ___ Unknown? ___
18. Related features: garage

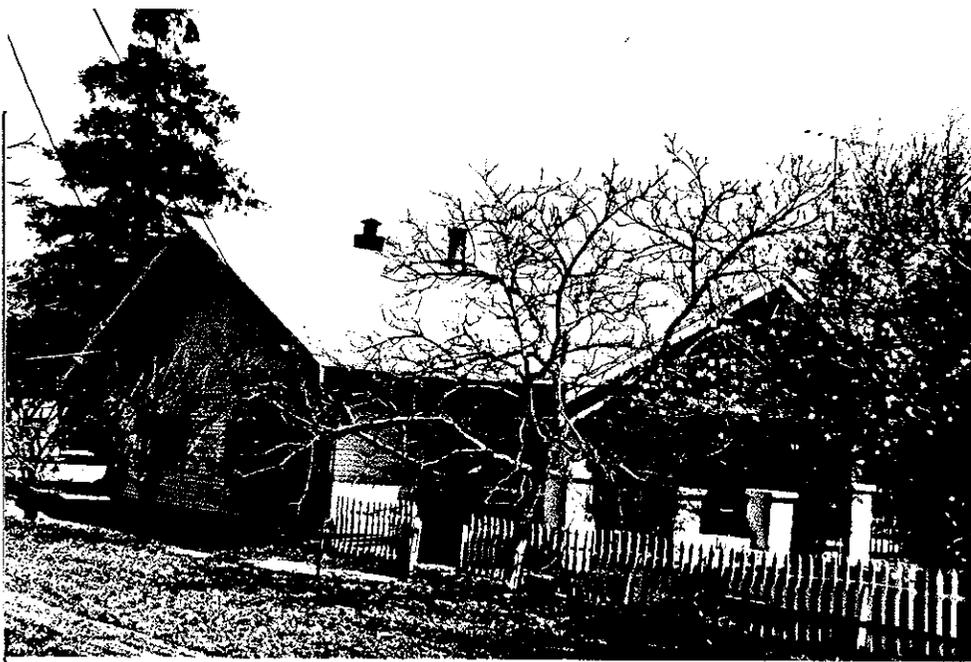
This single story rectangular shaped residence has a low pitched side facing gable roof with a gable over the front porch. Under the broad eaves are exposed beams and decorative vertical board vents. The porch is supported by two square tapered and capped wood columns. The lower half are concrete square posts, of which there are four. The house rests on a concrete foundation and is covered with clapboard siding. There is a brick chimney.

13. Condition: Excellent ___ Good Fair ___ Deteriorated ___ No longer in existence ___
14. Alterations: none apparent
15. Surroundings: (Check more than one if necessary) Open land ___ Scattered buildings Densely built-up ___
 Residential Industrial ___ Commercial ___ Other agricultural
16. Threats to site: None known Private development ___ Zoning ___ Vandalism ___
 Public Works project ___ Other: _____
17. Is the structure: On its original site? Moved? ___ Unknown? ___
18. Related features: detached garage, shed

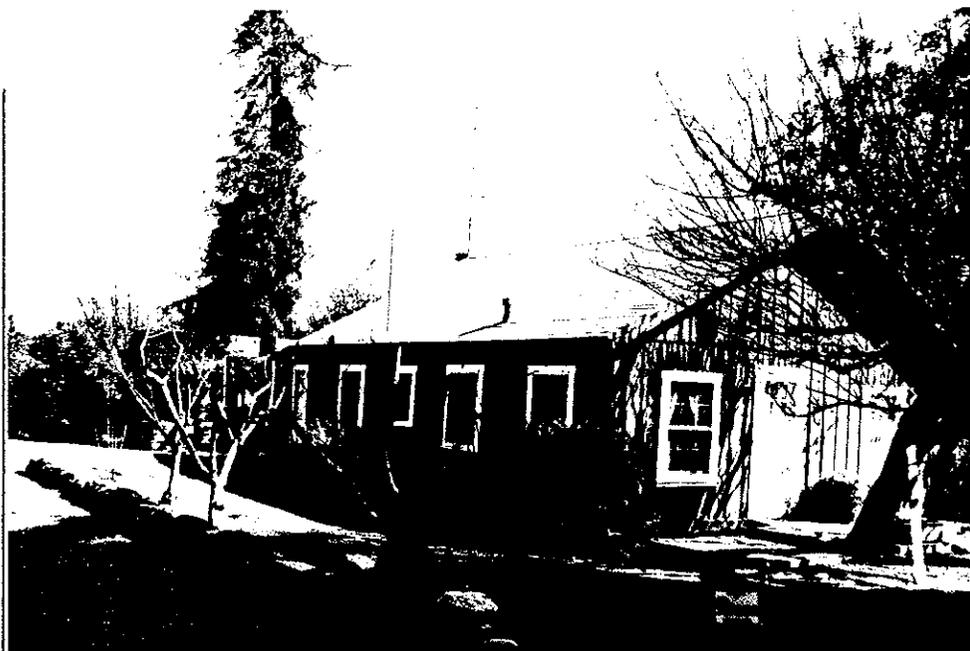
This single story rectangular shaped bungalow has a medium gable roof with exposed rafters under the eaves. The windows are multi-paned double hung with flat wood mouldings. The front door has six panes in the upper portion and recessed vertical panels in the lower portion. The house is covered with board and batten siding and has a small shed roof portion in the rear.

13. Condition: Excellent ___ Good Fair ___ Deteriorated ___ No longer in existence ___
14. Alterations: none apparent
15. Surroundings: (Check more than one if necessary) Open land ___ Scattered buildings Densely built-up ___
Residential Industrial ___ Commercial ___ Other agricultural
16. Threats to site: None known Private development ___ Zoning ___ Vandalism ___
Public Works project ___ Other: _____
17. Is the structure: On its original site? Moved? ___ Unknown? ___
18. Related features: mature trees-Norfolk Island pine, redwood, stone wall, detached porch in rear

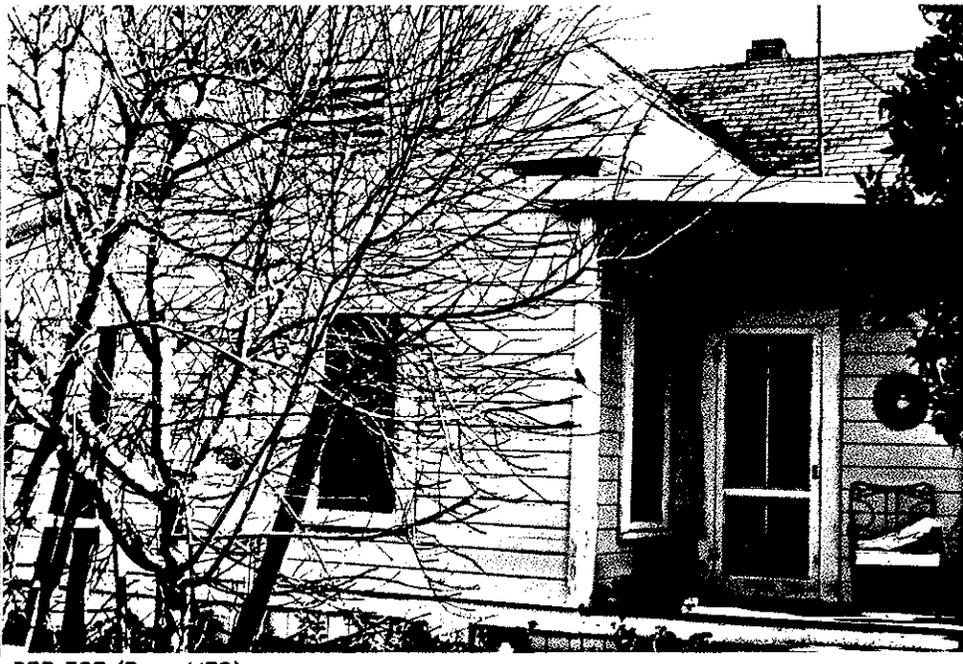
This single story residence has a modified L-shape with high intersecting gable roofs. The Victorian era detailing is seen in the classical eave treatment with boxed beams and returned eaves. Windows are narrow and rectangular in shape and siding is wide shiplap. A portion of the roof is almost flat over the porch. The porch is supported by slender chamfered wood columns. The house rests on a sespe stone foundation and has a vertical board skirt. A chimney punctuates the roofline.

13. Condition: Excellent ___ Good X Fair ___ Deteriorated ___ No longer in existence ___
14. Alterations: back porch - concrete steps and new roof
15. Surroundings: (Check more than one if necessary) Open land ___ Scattered buildings X Densely built-up ___
 Residential X Industrial ___ Commercial ___ Other agricultural
16. Threats to site: None known X Private development ___ Zoning ___ Vandalism ___
 Public Works project ___ Other: _____
17. Is the structure: On its original site? X Moved? ___ Unknown? ___
18. Related features: shed, carport, mature trees

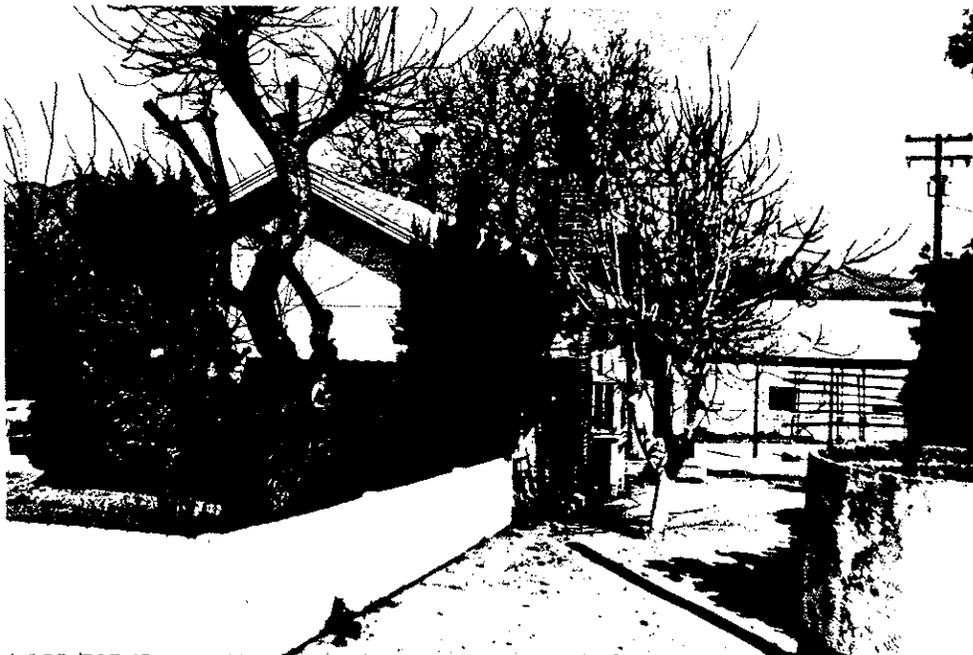
This single story bungalow is rectangular in shape with a medium gable roof and offset front gable. The porch is recessed and supported by square columns. Windows are double hung and fixed with flat wood mouldings. Under the front gable is a decorative lattice vent and exposed rafters under the eaves. There is an exterior brick chimney. The house rests on a concrete foundation and is covered with clapboard siding.

13. Condition: Excellent ___ Good Fair ___ Deteriorated ___ No longer in existence ___
14. Alterations: rear addition, windows
15. Surroundings: (Check more than one if necessary) Open land ___ Scattered buildings Densely built-up ___
 Residential Industrial ___ Commercial ___ Other agricultural
16. Threats to site: None known Private development ___ Zoning ___ Vandalism ___
 Public Works project ___ Other: _____
17. Is the structure: On its original site? ___ Moved? Unknown? ___
18. Related features: barn
