CULTURAL HERITAGE SURVEY PHASE IV SANTA CLARA VALLEY

**COUNTY OF VENTURA
CULTURAL HERITAGE SURVEY
PHASE IV - SANTA CLARA VALLEY**

**Prepared by Judy Triem
San Buenaventura Research Associates**

January 1988

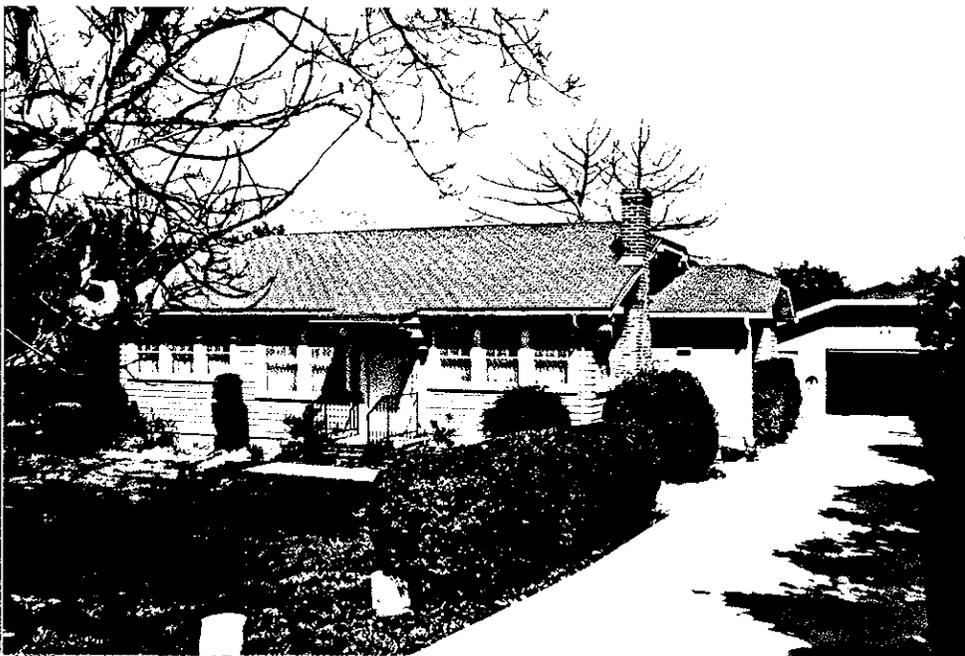
This single story rectangular shaped bungalow has a medium clipped gable roof with a shed roof over the entrance. Under the eaves are exposed beams. Windows are in bands of twos and threes and are double hung with wood frames and mouldings and multi-panes in the upper half. On the east side of the house is an exterior brick chimney. The porch has a brick stoop and metal railing. The house rests on a concrete foundation and is covered with medium clapboard siding.

13. Condition: Excellent ___ Good Fair ___ Deteriorated ___ No longer in existence ___
14. Alterations: addition - 1973
15. Surroundings: (Check more than one if necessary) Open land ___ Scattered buildings Densely built-up ___
Residential Industrial ___ Commercial ___ Other agricultural
16. Threats to site: None known Private development ___ Zoning ___ Vandalism ___
Public Works project ___ Other: _____
17. Is the structure: On its original site? Moved? ___ Unknown? ___
18. Related features: detached double-car garage

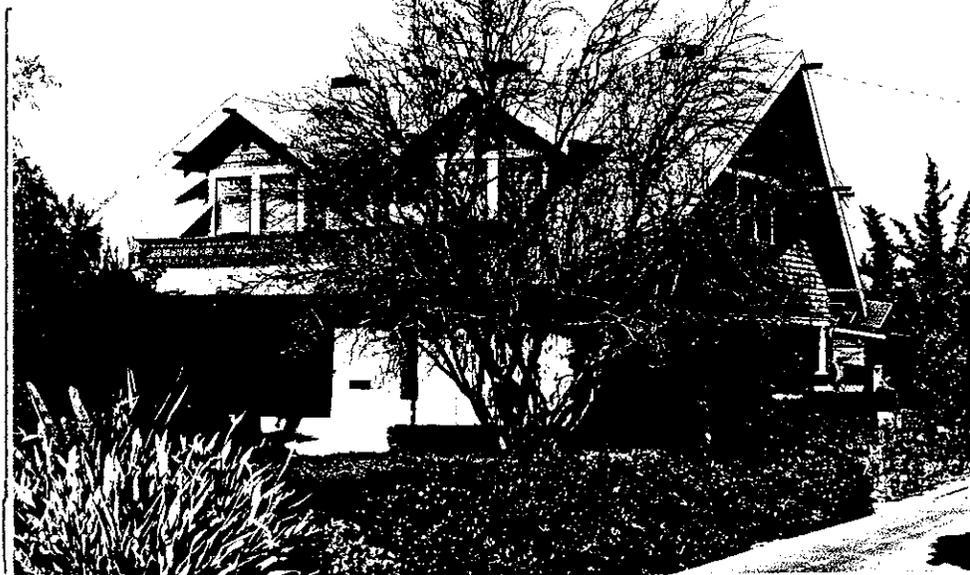
This large 1 1/2 story residence has a high pitched sidefacing gable roof with two gabled dormers connected by a balcony. This same arrangement is repeated in the rear of the house. The balcony has a low shingled railing. Under the broad eaves are exposed projecting beams. The front porch is recessed under the main gable on the west side. Massive tapered stucco columns and railing support the porch. These were originally native stone. Next to the porch is a large slanted bay window with fixed panes and wood mouldings. The remaining windows are double hung with wood frames and mouldings. The large oak front door has metal straps with a poinsettia flower design. The house rests on a raised concrete foundation and is covered with dark stained shingled siding, typical of many Craftsman homes.

13. Condition: Excellent ____ Good Fair ____ Deteriorated ____ No longer in existence ____
14. Alterations: cast concrete addition in rear, porch columns stuccoed over
15. Surroundings: (Check more than one if necessary) Open land ____ Scattered buildings Densely built-up ____
Residential Industrial ____ Commercial ____ Other agricultural
16. Threats to site: None known Private development ____ Zoning ____ Vandalism ____
Public Works project ____ Other: _____
17. Is the structure: On its original site? Moved? ____ Unknown? ____
18. Related features: metal shed

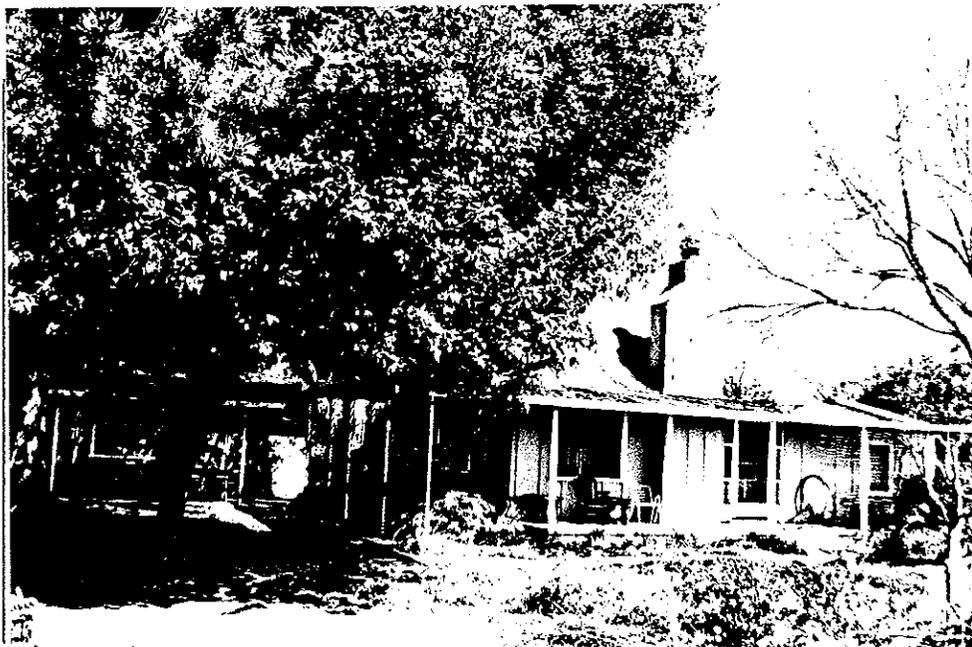
This single story residence is rectangular in shape with a medium gable roof sloping to a low pitch over south and east side. The porch is located on the south and west sides and is supported by four wood posts on south side and metal columns with aluminum roof on west side. The exterior chimney is of brick surrounded by board and bat siding. The house is covered with the same siding. The windows are both fixed and double hung with wood frames and mouldings. The foundation is concrete and wood.

13. Condition: Excellent ___ Good ___ Fair ___ Deteriorated ___ No longer in existence ___
14. Alterations: _____
15. Surroundings: (Check more than one if necessary) Open land ___ Scattered buildings Densely built-up ___
 Residential Industrial ___ Commercial ___ Other agricultural
16. Threats to site: None known Private development ___ Zoning ___ Vandalism ___
 Public Works project ___ Other: _____
17. Is the structure: On its original site? Moved? ___ Unknown? ___
18. Related features: guest house, garage

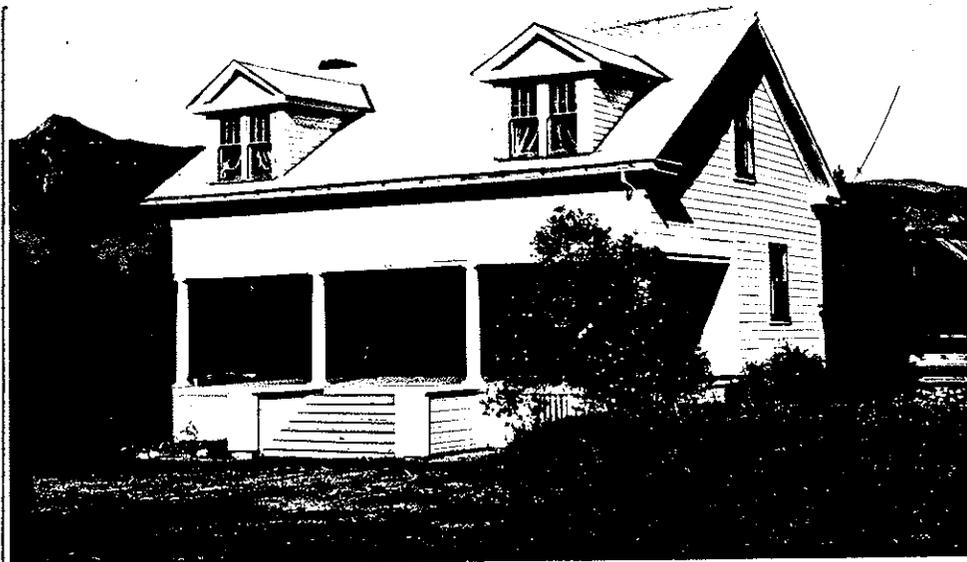
The front portion of the house is 1 1/2 stories tall and rectangular in shape. The facade is symmetrical with two gabled dormers projecting from the sidefacing gable roof. Eaves are boxed and returned. The front porch is recessed under the roof and is unusually deep with four turned and capped columns. Windows are fixed or double hung with multi-panes in the upper portions and wood mouldings. In the rear of the house is a large hipped roof one story portion. The house rests on a raised concrete block foundation and is covered with wide shiplap siding. The skirt around the base of the house is of clapboards, and the dormer windows are covered with shingles. The house has been added to over the years.

13. Condition: Excellent ___ Good ___ Fair X Deteriorated ___ No longer in existence ___
14. Alterations: uncertain
15. Surroundings: (Check more than one if necessary) Open land ___ Scattered buildings X Densely built-up ___
 Residential X Industrial ___ Commercial ___ Other agricultural
16. Threats to site: None known X Private development ___ Zoning ___ Vandalism ___
 Public Works project ___ Other: _____
17. Is the structure: On its original site? X Moved? ___ Unknown? ___
18. Related features: barn, storage, outbuildings

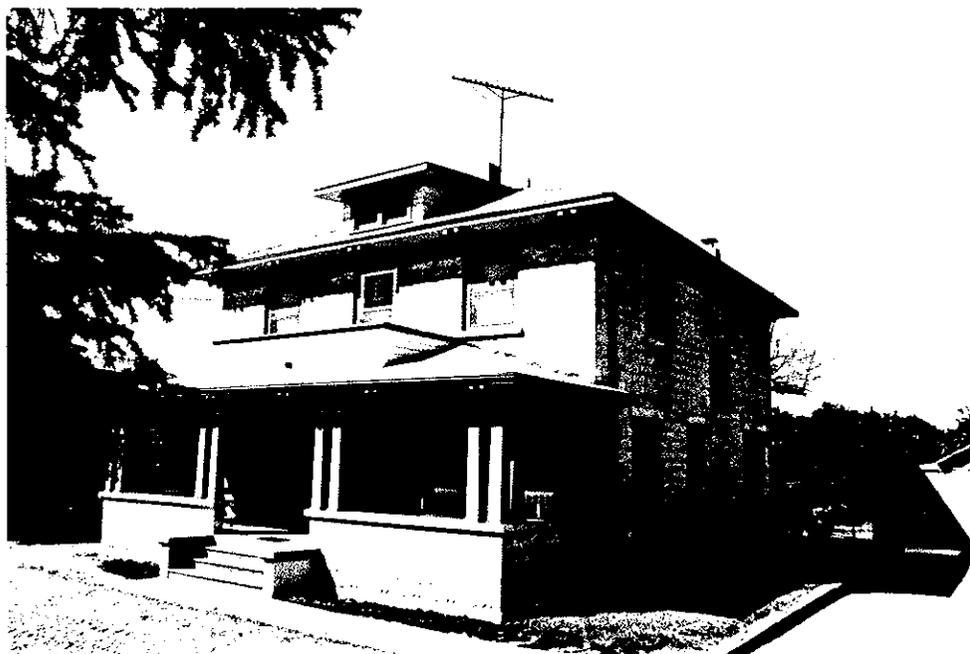
Built of cast stone (concrete), this large two-story residence is completely symmetrical in shape. The medium pitched hip roof has a centrally located shed roof dormer window. Under the broad boxed eaves are double wood brackets. The porch extends across the front of the house and is covered with a hip roof and balcony. The balcony is covered with horizontal wood siding to match the siding on the dormer window. The porch eaves treatment is the same as the main roof treatment -- boxed eaves and double brackets. The porch is supported by double wood columns tapered and capped at the top. The porch railing is of cast stone. The windows have cast stone lintels and bases. The wood frames are slightly recessed and windows are double hung. The two front windows on the first floor have a diamond shaped pattern in the upper portion. This pattern is repeated in the dormer windows. The house rests on a concrete perimeter foundation.

13. Condition: Excellent Good ___ Fair ___ Deteriorated ___ No longer in existence ___
14. Alterations: uncertain
15. Surroundings: (Check more than one if necessary) Open land Scattered buildings ___ Densely built-up ___
Residential Industrial ___ Commercial ___ Other agriculture
16. Threats to site: None known Private development ___ Zoning ___ Vandalism ___
Public Works project ___ Other: _____
17. Is the structure: On its original site? Moved? ___ Unknown? ___
18. Related features: large bellcast roof barn; garage with shed attached, addit. sheds

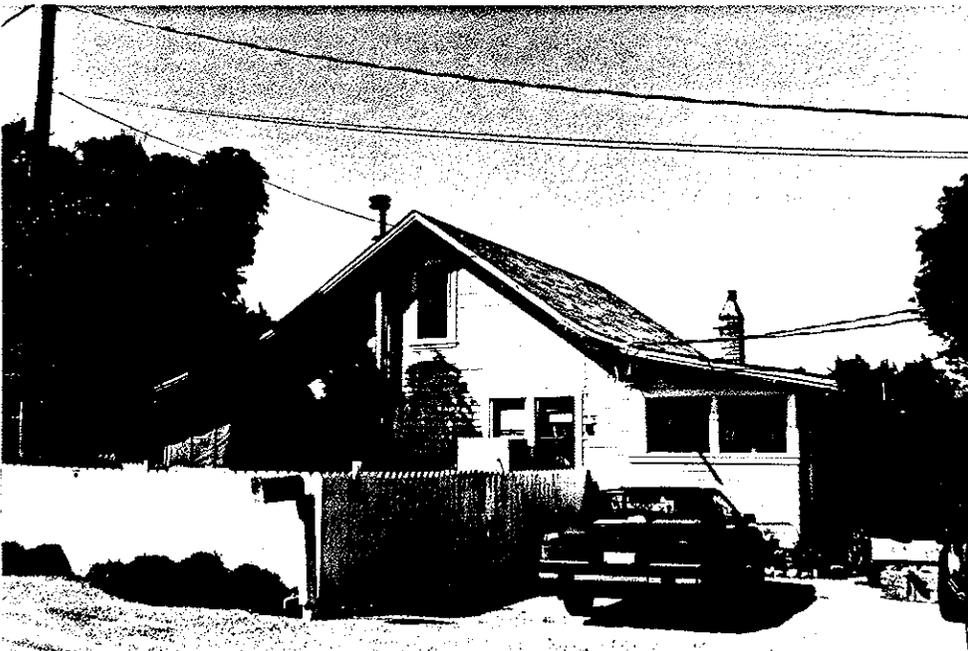
This 1- 1/2 story rectangular shaped residence has a medium pitched gable roof slightly bellcast over the porch and rear portion. The porch is recessed under the gable and has been enclosed with screens. Windows are double hung with wood frames and flat wood mouldings. The house is covered with medium wide clapboard siding. There is a small brick chimney on one side.

13. Condition: Excellent Good Fair Deteriorated No longer in existence
14. Alterations: none apparent
15. Surroundings: (Check more than one if necessary) Open land Scattered buildings Densely built-up
Residential Industrial Commercial Other agriculture
16. Threats to site: None known Private development Zoning Vandalism
Public Works project Other: _____
17. Is the structure: On its original site? Moved? Unknown?
18. Related features: various sheds

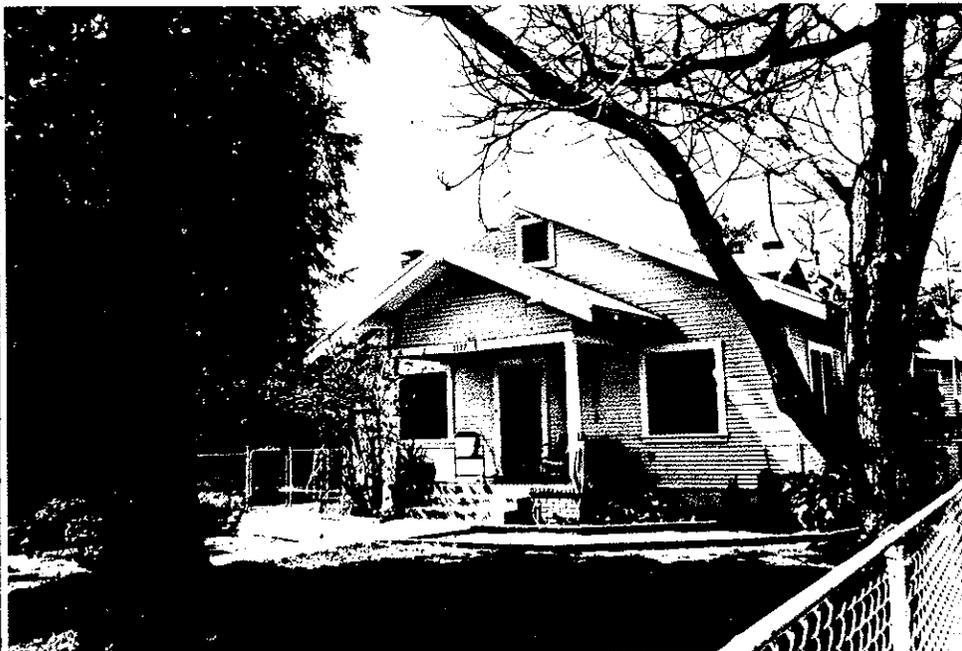
This single story bungalow has a medium gable roof with a gabled dormer on the north side. Beams and rafters are exposed under the broad eaves. The front porch is attached with a gable roof and square capped support columns. The porch foundation is concrete with a brick facing. The house rests on a concrete foundation and is covered with narrow clapboard siding. Windows are double hung with wood frames and flat wood mouldings. There are two brick chimneys.

13. Condition: Excellent Good ___ Fair ___ Deteriorated ___ No longer in existence ___
14. Alterations: shed roof addition on north side
15. Surroundings: (Check more than one if necessary) Open land ___ Scattered buildings Densely built-up ___
 Residential Industrial ___ Commercial ___ Other agricultural
16. Threats to site: None known Private development ___ Zoning ___ Vandalism ___
 Public Works project ___ Other: _____
17. Is the structure: On its original site? Moved? ___ Unknown? ___
18. Related features: two garages, sheds

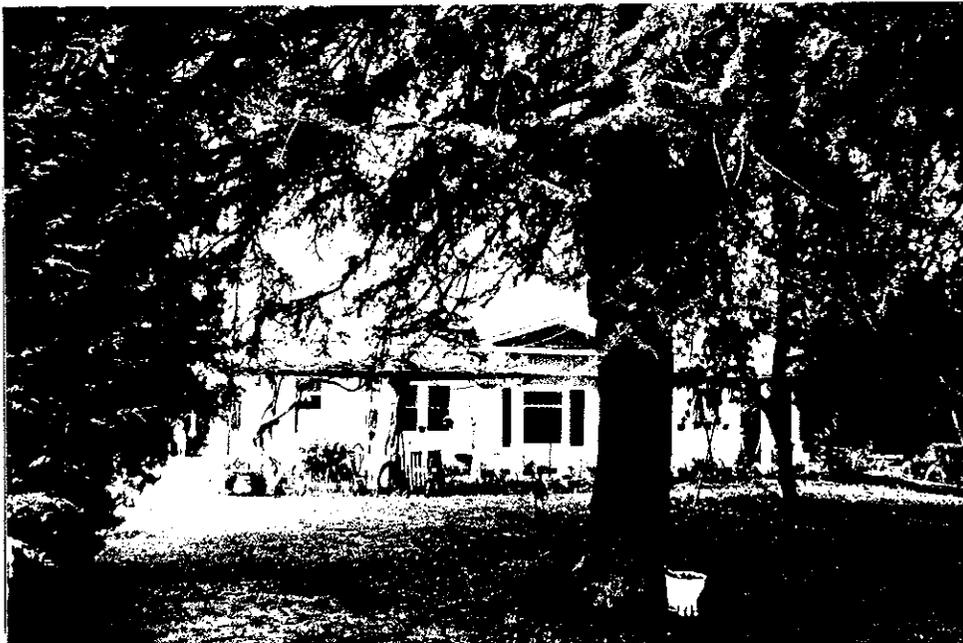
Across the facade of this single story bungalow is a pergola supported by four round columns. The porch is located under the main gable at the north side of the house. The low pitched side facing gable roof has a small front facing gable over the bay window. This large fixed window is flanked by two narrow windows all of which have elongated diamond shaped panes in the upper portion. The remaining facade windows also have the elongated diamond shaped panes. All windows have wood mouldings and frames and are a combination of fixed, double hung and casement. The house is built of concrete blocks and has an exterior chimney on the facade.

- 8. Construction date: 1912
Estimated Factual _____
- 9. Architect unknown
- 10. Builder unknown
- 11. Approx. property size (in feet)
Frontage _____ Depth _____
or approx. acreage 10.86
- 12. Date(s) of encl. photograph(s)
3/87 102

13. Condition: Excellent ___ Good Fair ___ Deteriorated ___ No longer in existence ___
14. Alterations: uncertain
15. Surroundings: (Check more than one if necessary) Open land ___ Scattered buildings Densely built-up ___
 Residential Industrial ___ Commercial ___ Other Agricultural
16. Threats to site: None known Private development ___ Zoning ___ Vandalism ___
 Public Works project ___ Other: _____
17. Is the structure: On its original site? Moved? ___ Unknown? ___
18. Related features: detached two-car garage, mature trees

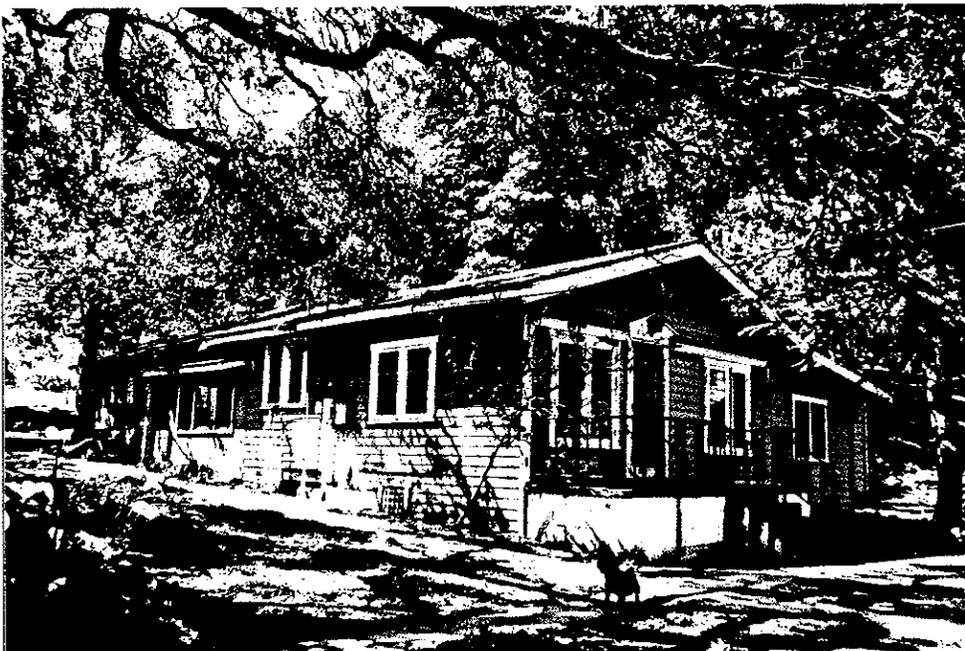
This modest single story bungalow has a low gable roof with knee brackets under the eaves. The influence of the Colonial Revival is seen in the broken pediment over the front door. Windows are casement with wood frames, mouldings and multi panes in upper portion. The front porch has been changed to concrete block foundation, concrete steps and wrought iron railing.

8. Construction date: 1920
Estimated Factual _____
9. Architect unknown
10. Builder unknown
11. Approx. property size (in feet)
Frontage _____ Depth _____
or approx. acreage 2.17
12. Date(s) of encl. photograph(s)
2/87 103

13. Condition: Excellent ___ Good Fair ___ Deteriorated ___ No longer in existence ___
14. Alterations: front porch, rear addition
15. Surroundings: (Check more than one if necessary) Open land ___ Scattered buildings Densely built-up ___
 Residential Industrial ___ Commercial ___ Other agricultural
16. Threats to site: None known Private development ___ Zoning ___ Vandalism ___
 Public Works project ___ Other: _____
17. Is the structure: On its original site? Moved? ___ Unknown? ___
18. Related features: workshop, detached two-car garage

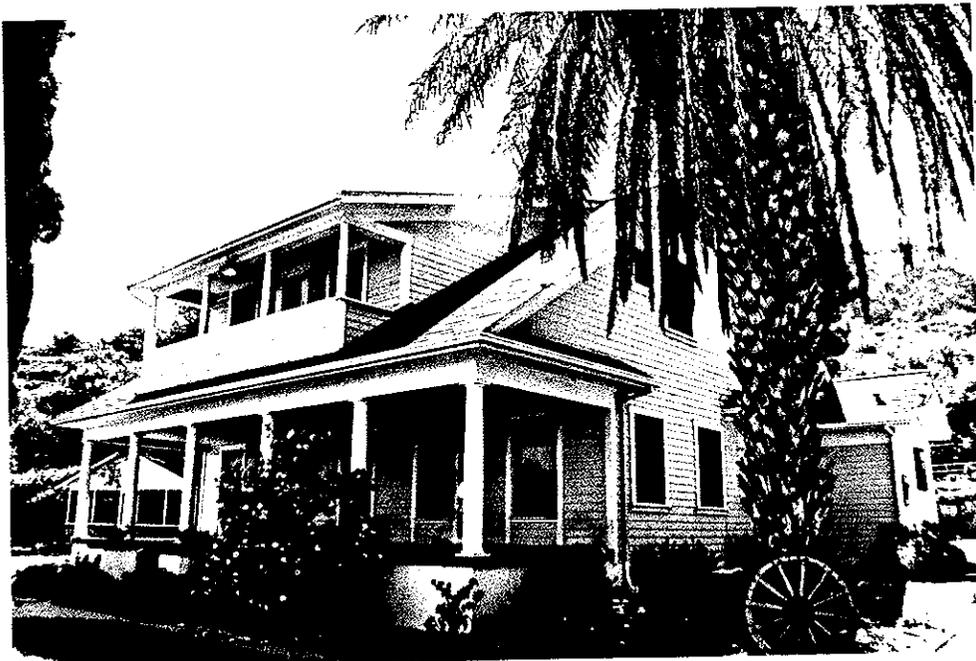
This large 1 1/2 story residence has a symmetrical facade. The high pitched sidelacing gable roof has a large shed roof dormer window with open balcony. The balcony is recessed under the roof and contains four rounded and tapered columns above a solid wood railing. The roof eaves are boxed. The front porch runs the length of the facade under the main gable and is supported by six round capped columns. The porch has a raised concrete and brick foundation. The front door is centered with two windows on each side. Windows are double hung with wood frames and mouldings. The house rests on a concrete and wood foundation and is covered with wide board horizontal siding.

- 8. Construction date: 1918
Estimated _____ Factual _____
- 9. Architect unknown
- 10. Builder unknown
- 11. Approx. property size (in feet)
Frontage _____ Depth _____
or approx. acreage 10.94
- 12. Date(s) of encl. photograph(s)
2/87 104

13. Condition: Excellent Good ___ Fair ___ Deteriorated ___ No longer in existence ___
14. Alterations: addition in rear
15. Surroundings: (Check more than one if necessary) Open land ___ Scattered buildings Densely built-up ___
 Residential Industrial ___ Commercial ___ Other agricultural
16. Threats to site: None known Private development ___ Zoning ___ Vandalism ___
 Public Works project ___ Other: _____
17. Is the structure: On its original site? Moved? ___ Unknown? ___
18. Related features: brick barn, enclosed freestanding patio

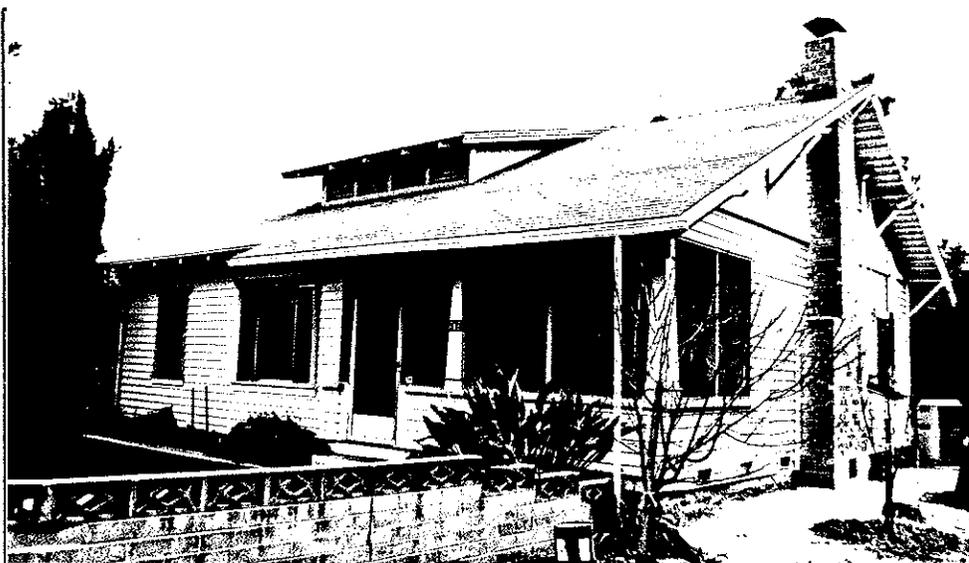
This single story residence has a medium pitched side facing gable roof with shed roof dormer. Under the broad eaves are exposed rafters and knee brackets. A brick chimney is located on the south side. The porch is recessed under the gable roof and supported by tapered wood columns. The columns rest on an enclosed wood railing covered with medium clapboard siding. The porch has been enclosed with screens. Windows are double hung and fixed with wood frames. The flat wood mouldings are angled at the top corners. The house rests on a concrete foundation and is covered with medium clapboard siding.

8. Construction date: 1915
Estimated Factual _____
9. Architect unknown
10. Builder unknown
11. Approx. property size (in feet)
Frontage _____ Depth _____
or approx. acreage 9.11
12. Date(s) of encl. photograph(s)
3/87 105

13. Condition: Excellent ___ Good Fair ___ Deteriorated ___ No longer in existence ___
14. Alterations: none apparent
15. Surroundings: (Check more than one if necessary) Open land Scattered buildings ___ Densely built-up ___
 Residential Industrial ___ Commercial ___ Other agricultural
16. Threats to site: None known Private development ___ Zoning ___ Vandalism ___
 Public Works project ___ Other: _____
17. Is the structure: On its original site? Moved? ___ Unknown? ___
18. Related features: detached garage

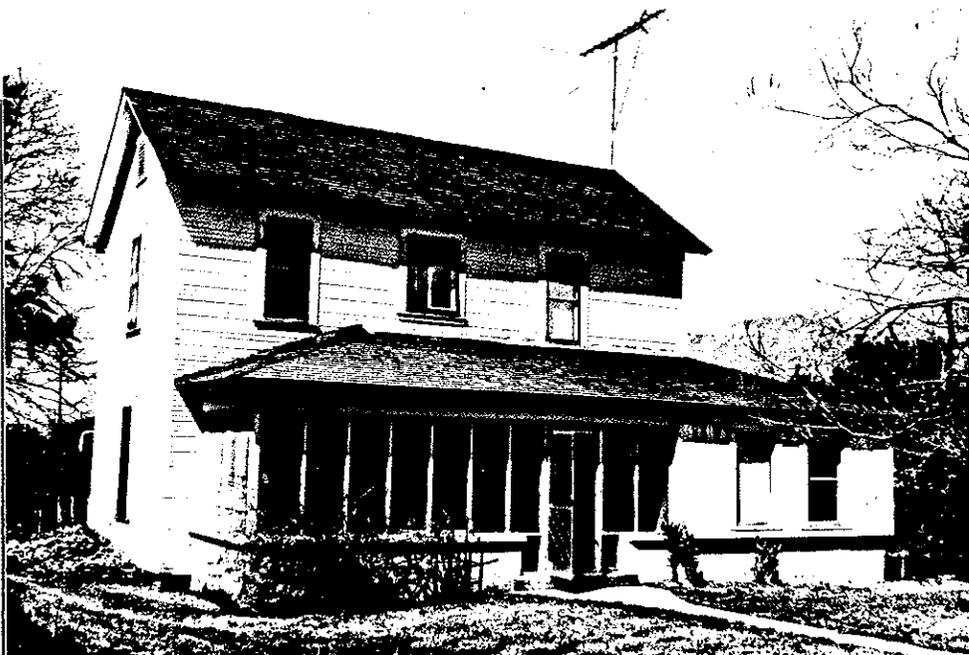
This two story rectangular shaped farm house is quite plain except for one window which has decorative wood panes in the upper portion. The roof is medium gable with a hip roof over the porch. The eaves are boxed. The porch is in an L-shape and has been enclosed on the north side and screened in on the south side. Windows are a combination of double hung, fixed and casement with flat wood mouldings. The house is covered with narrow clapboard siding and rests on a stone foundation.

8. Construction date: 1900
Estimated Factual _____

13. Condition: Excellent Good Fair Deteriorated No longer in existence
14. Alterations: porch enclosed
15. Surroundings: (Check more than one if necessary) Open land Scattered buildings Densely built-up
Residential Industrial Commercial Other agricultural
16. Threats to site: None known Private development Zoning Vandalism
Public works project Other: _____
17. Is the structure: On its original site? Moved? Unknown?
18. Related features: shed, two double garages

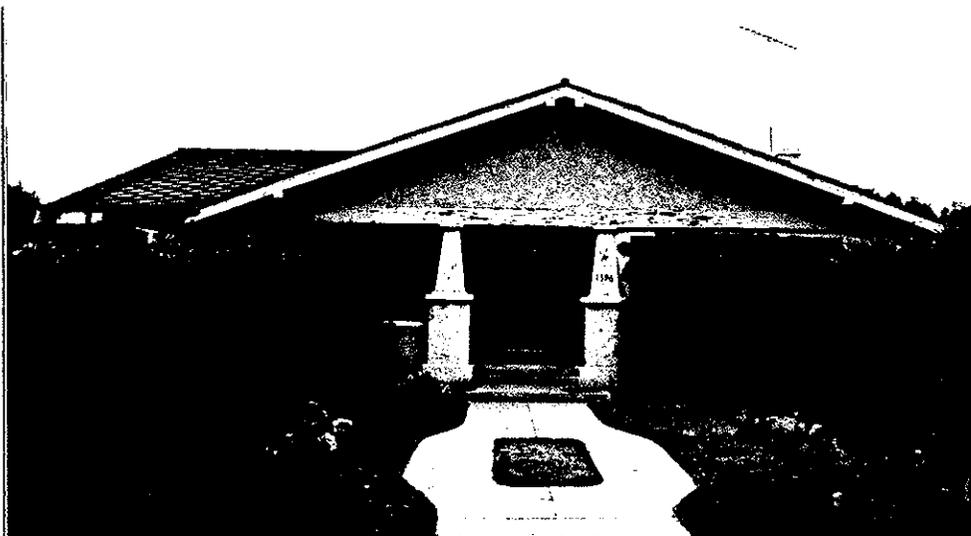
The low-pitched roof on this single story California bungalow is side facing with a front facing gable over the attached porch. The porch is an L-shape and extends on north side. Large beams extend from under the wide eaves. The porch is supported by square capped concrete and stucco columns on lower half and tapered wood columns on upper half. Connecting the columns is a low concrete and stucco railing. Windows are double hung with wood frames and wood mouldings. The house is built of hollow tile and covered with stucco. The foundation is concrete.

8. Construction date: 1922
Estimated Factual _____

13. Condition: Excellent Good Fair Deteriorated No longer in existence

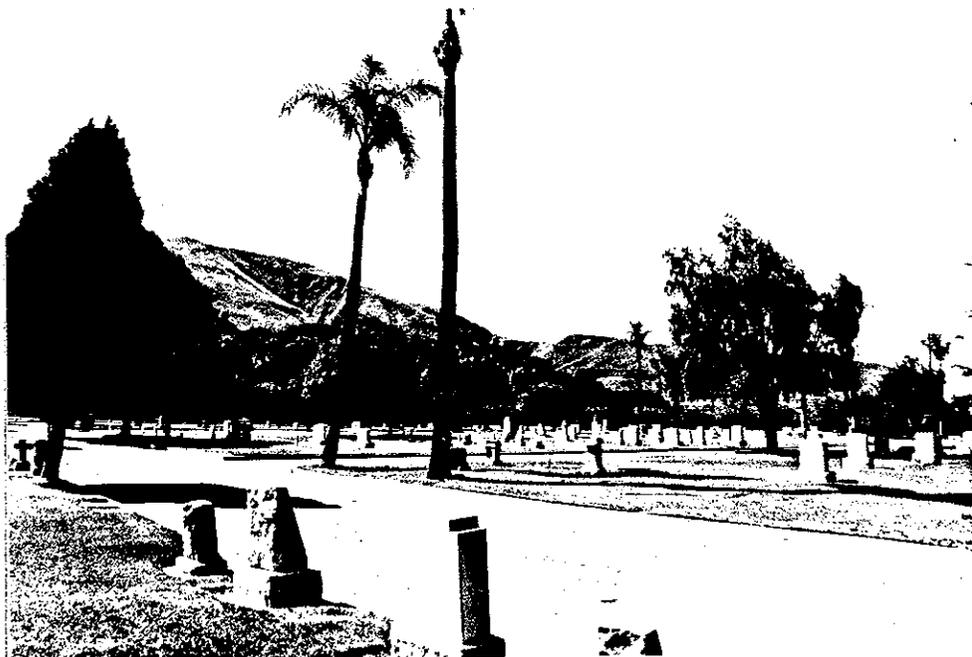
This 11.20 acre cemetery site is well maintained and beautifully landscaped with mature trees. It lies at the base of the foothills with a commanding view of the Santa Clara Valley. The grounds also has a bungalow residence for the caretaker. It has a gable roof and is single story and rectangular in shape. A small gable extends over the porch. The house is covered with clapboards and has exposed rafters under the eaves. Windows are double hung with wood frames and mouldings.

13. Condition: Excellent Good ___ Fair ___ Deteriorated ___ No longer in existence ___
14. Alterations: not applicable
15. Surroundings: (Check more than one if necessary) Open land Scattered buildings ___ Densely built-up ___
 Residential Industrial ___ Commercial ___ Other cemetery
16. Threats to site: None known Private development ___ Zoning ___ Vandalism ___
 Public Works project ___ Other: _____
17. Is the structure: On its original site? Moved? ___ Unknown? ___
18. Related features: caretaker's residence, sheds

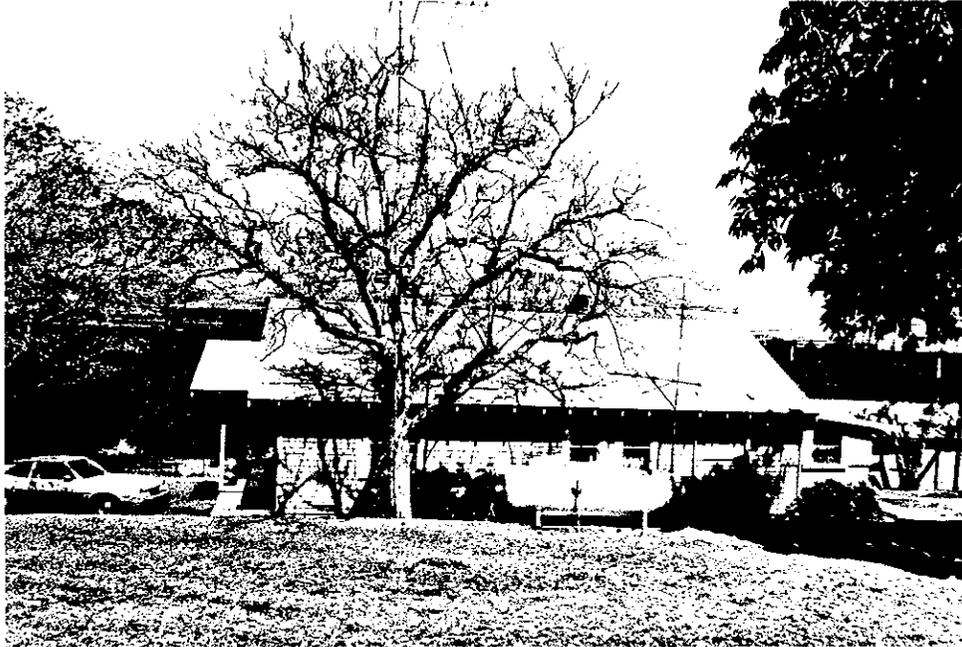
Caretaker's residence

This California Bungalow style house was built about 1915. It is located directly north of the cemetery. It is described on the first page.

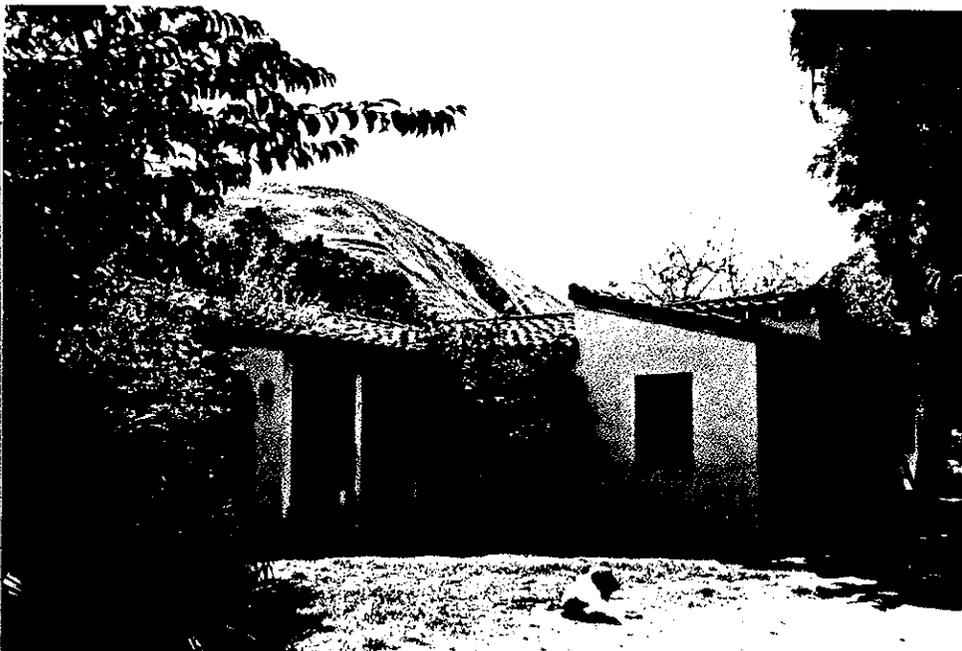
The residence at 1845 is the foreman's house. It has a combination of roof shapes from flat to shed and gable with exposed rafters under the eaves. Spanish Colonial Revival features are seen in the tile roof, arched openings and stucco siding. This single story residence has an L-shape with the porch recessed under the gable and supported by square wood posts with brackets at the top. Windows are flush with wood frames and mouldings. They are both fixed and double hung. A rear addition was built in 1964.

- 8. Construction date: various
Estimated Factual _____
- 9. Architect unknown
- 10. Builder unknown
- 11. Approx. property size (in feet)
Frontage _____ Depth _____
or approx. acreage 154.44
- 12. Date(s) of encl. photograph(s)
3/87 110

13. Condition: Excellent ___ Good Fair ___ Deteriorated ___ No longer in existence ___
14. Alterations: see individual buildings
15. Surroundings: (Check more than one if necessary) Open land ___ Scattered buildings Densely built-up ___
 Residential Industrial ___ Commercial ___ Other agricultural
16. Threats to site: None known Private development ___ Zoning ___ Vandalism ___
 Public Works project ___ Other: _____
17. Is the structure: On its original site? Moved? ___ Unknown? ___
18. Related features: farmworker cottages, sheds, barns, etc.

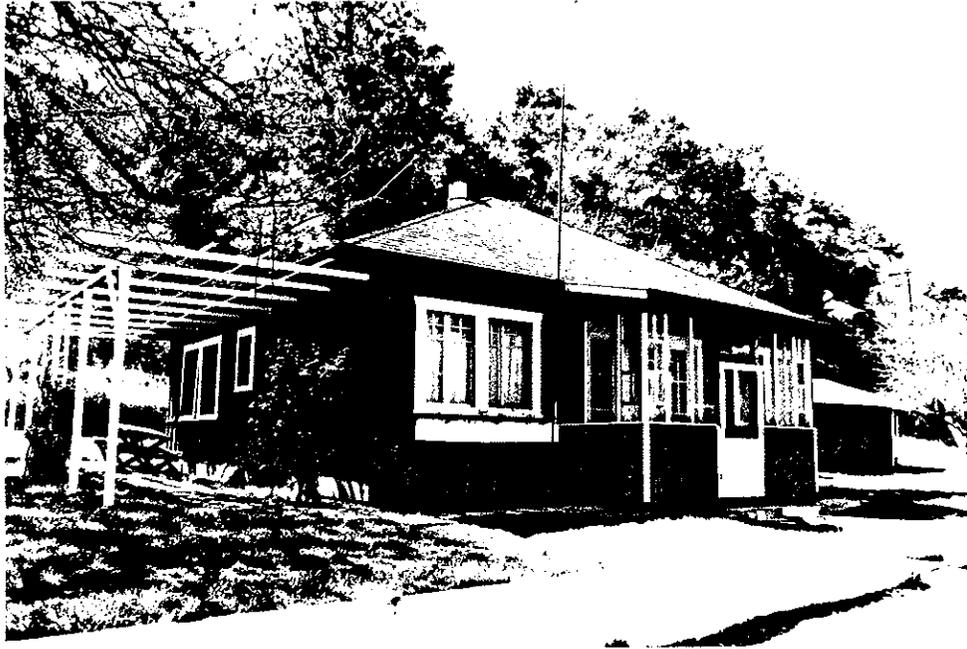
1856 Sespe Ave.

This residence was constructed about 1922 for the Ladera Citrus Co. It has a hip roof and is rectangular in shape. Rafters are exposed under the eaves. The porch is attached with a shed roof and has been recently enclosed with windows on the upper half and siding on the lower half. The windows are multi-paned casement with wood frames and mouldings. The building rests on a concrete foundation and is covered with board and batten siding.

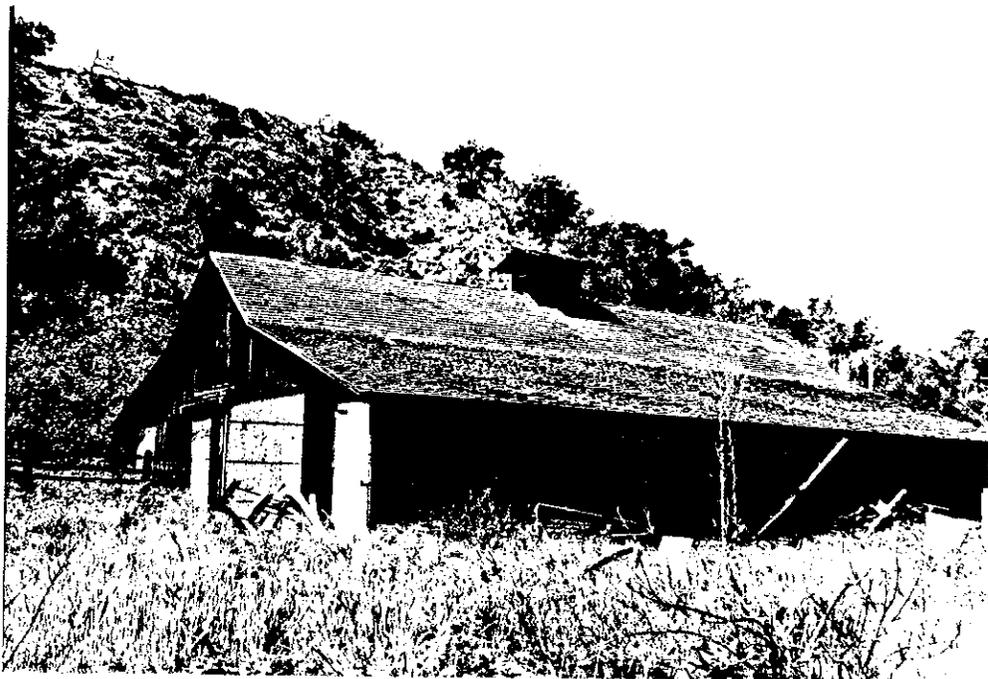
Barn

Further up the canyon on the Ladera Ranch is this large redwood barn, built about 1922. It has a high pitched gable roof with sloping sides. A small cupola is located at the ridge line. The barn has had some changes with the addition of a door and windows. It is covered with board and batten siding.

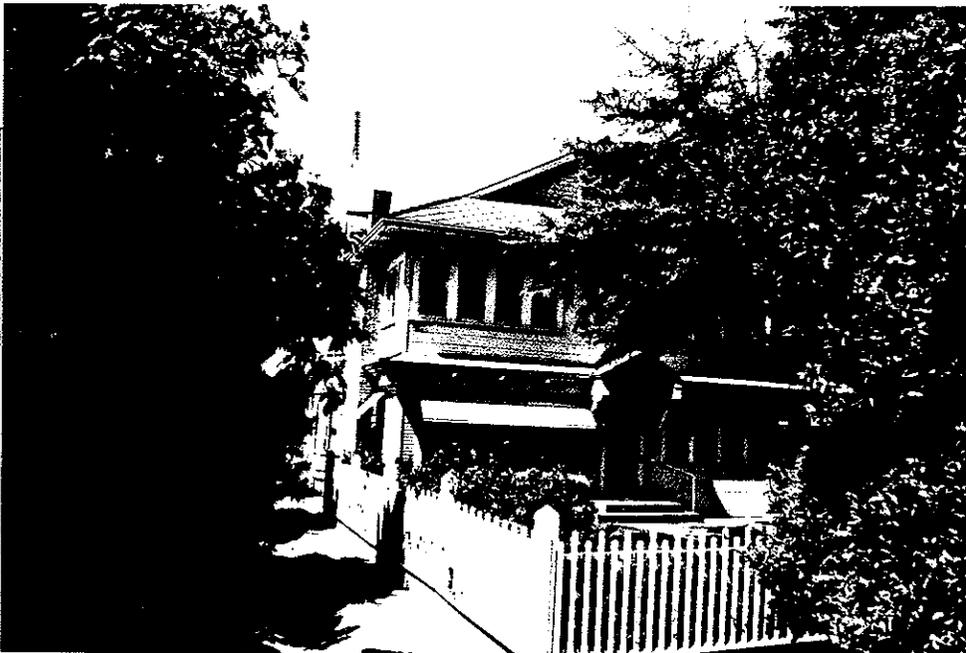
This large square shaped residence is two stories tall with a medium hipped gable roof. The eaves are boxed with curved brackets underneath. The front porch is enclosed and above the porch is a long sleeping porch enclosed with a long row of windows across the facade. The first floor is divided from the second story porch with a mansard frieze with brackets underneath. Above the entry is a small gable roof supported by heavy beams and brackets. The steps are brick with a metal railing alongside. Windows are double hung with wood frames and mouldings. On the south side is a two-story slanted bay window. Siding is narrow clapboard with shingles under the gable peak. There is an exterior brick chimney on the south side.

- 8. Construction date: 1908
Estimated Factual _____
- 9. Architect unknown
- 10. Builder Harry Peyton
- 11. Approx. property size (in feet)
Frontage _____ Depth _____
or approx. acreage 16.14
- 12. Date(s) of encl. photograph(s) 113
3/87

13. Condition: Excellent ___ Good X Fair ___ Deteriorated ___ No longer in existence ___

The house is an excellent example of a transition period residence built between the Victorian Era and the California Bungalow period. Its influences are Colonial Revival with its symmetry and porch treatment. Harry Peyton, local builder, constructed the house. Mr. Hastings designed and made the wrought iron work seen in the chandeliers. Robert Cluny, noted California landscape painter, handpainted the interior woodwork to resemble eucalyptus wood.

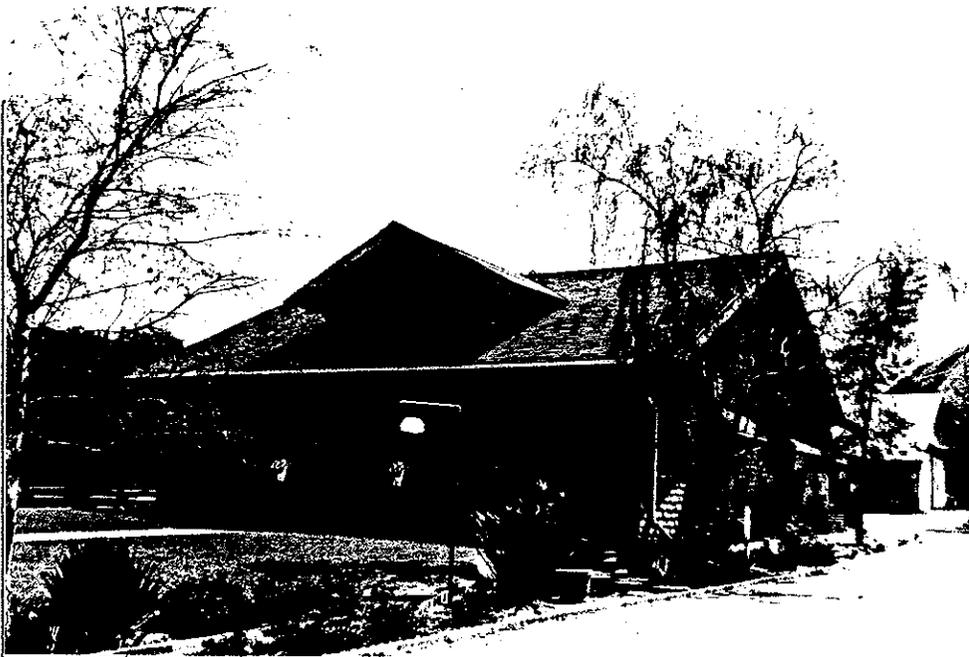
This large 1 1/2 story rectangular shaped bungalow has a medium gable roof with gable dormer window. Under the broad eaves are decorative knee brackets and exposed rafters. The porch is recessed under the main gable and supported by slumpstone railing and columns. Originally the railing and columns were of native stone. Double columns were added in the center. Windows are both double hung and casement with wood frames and mouldings. The house rests on a concrete foundation and is covered with clapboard siding.

8. Construction date: 1913
Estimated Factual _____
9. Architect Unknown
10. Builder unknown
11. Approx. property size (in feet)
Frontage _____ Depth _____
or approx. acreage 17.50
12. Date(s) of encl. photograph(s)
3/87 114

13. Condition: Excellent Good ___ Fair ___ Deteriorated ___ No longer in existence ___
14. Alterations: none apparent
15. Surroundings: (Check more than one if necessary) Open land ___ Scattered buildings Densely built-up ___
 Residential Industrial ___ Commercial ___ Other agricultural
16. Threats to site: None known Private development ___ Zoning ___ Vandalism ___
 Public Works project ___ Other: _____
17. Is the structure: On its original site? Moved? ___ Unknown? ___
18. Related features: carport

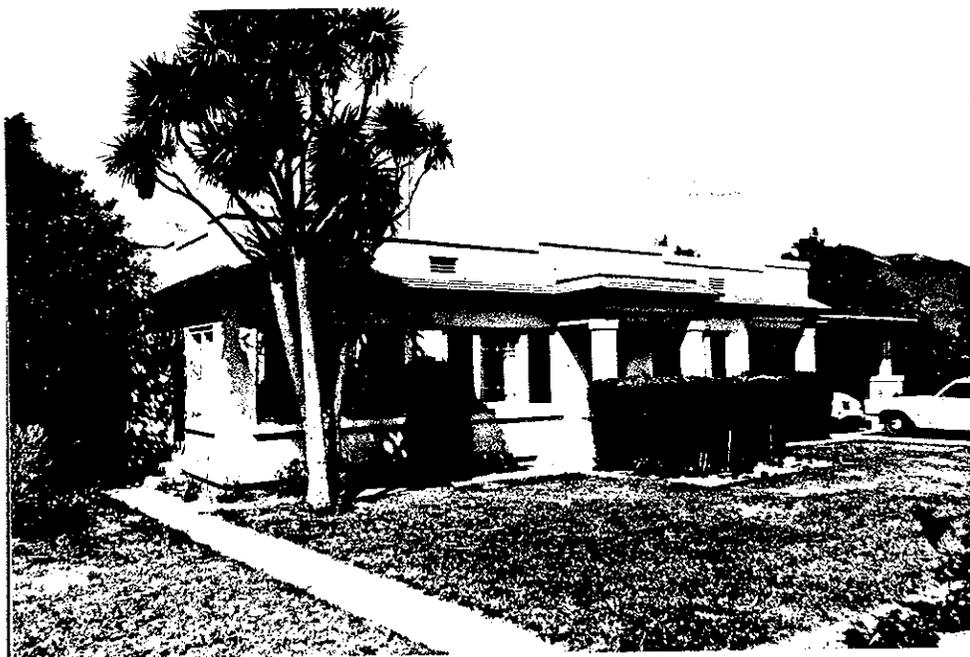
This unusual flat roofed bungalow has a raised and capped parapet. Basically rectangular in shape, the front porch is attached with a mansard roof that extends as a freize across the remainder of the facade. The mansard roof is covered with shingles. The porch is supported by heavy square posts capped at the top. At the north side of the house is another porch recessed under the main roof with similar heavy square post supports. A porte cochere extends from this porch to the north and has a concrete and wood support. Windows run in bands of three across the front and side of the house. They have wood frames and are casement on the sides and fixed in the center. The house is covered with stucco and rests on a concrete foundation.

8. Construction date: 1922

13. Condition: Excellent ___ Good Fair ___ Deteriorated ___ No longer in existence ___
14. Alterations: none apparent
15. Surroundings: (Check more than one if necessary) Open land ___ Scattered buildings Densely built-up ___
Residential Industrial ___ Commercial ___ Other agricultural
16. Threats to site: None known Private development ___ Zoning ___ Vandalism ___
Public Works project ___ Other: _____
17. Is the structure: On its original site? Moved? ___ Unknown? ___
18. Related features: detached garage

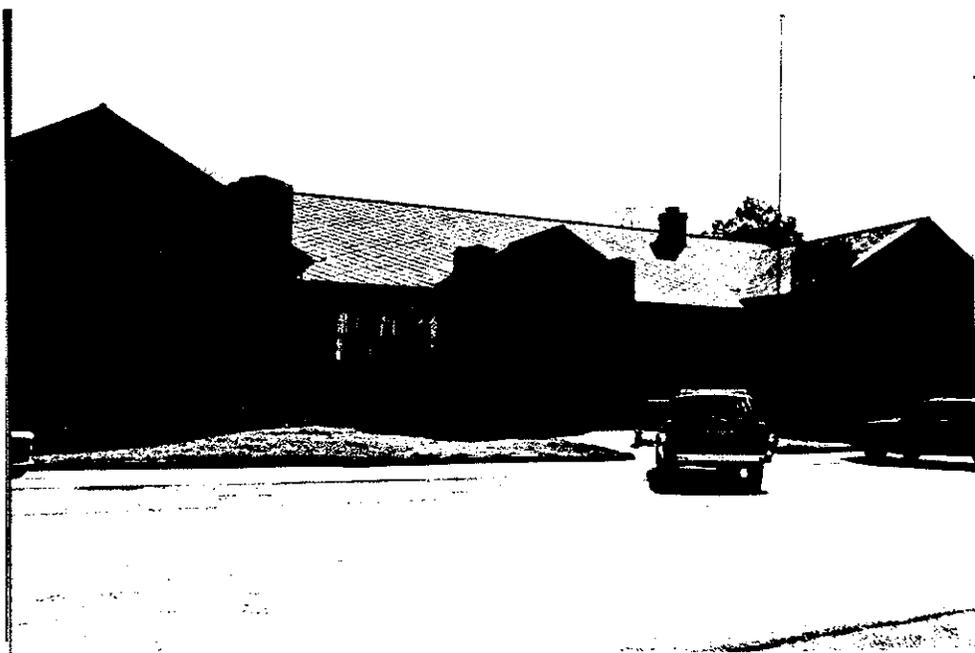
Built in a H-shape, This single story school building has a medium high gable roof with exposed beams and rafters. The front entrance is symmetrically placed with a small gable roof flanked by two large stucco columns that extend up above the roof line. These columns are repeated at the corners of the gable wings. The top of the columns are pointed with recessed panels. Colorful tiles are recessed on the entry columns and under the gabled wings. Under each gable is a carved wood bracket and decorative lattice wood vent. Under the main gable the entrance has double doors surrounded by windows forming a segmented arch. The windows in the wings are in bands of four with wood frames and double hung. On each side of the entrance, the original porch was enclosed and covered with wood siding and bands of four windows. The building is covered with stucco and rests on a raised concrete foundation.

- 8. Construction date: 1918
Estimated Factual _____
- 9. Architect Homer Glidden
- 10. Builder Hastings & Yeakle
- 11. Approx. property size (in feet)
Frontage _____ Depth _____
or approx. acreage 2.04
- 12. Date(s) of encl. photograph(s)
3/87 117

13. Condition: Excellent ___ Good ___ Fair Deteriorated ___ No longer in existence ___
14. Alterations: front porch enclosed
15. Surroundings: (Check more than one if necessary) Open land ___ Scattered buildings Densely built-up ___
 Residential Industrial ___ Commercial ___ Other agricultural
16. Threats to site: None known Private development ___ Zoning ___ Vandalism ___
 Public Works project ___ Other: _____
17. Is the structure: On its original site? Moved? ___ Unknown? ___
18. Related features: mature trees - deodar cedars, chinese elms, bus garage, tennis courts

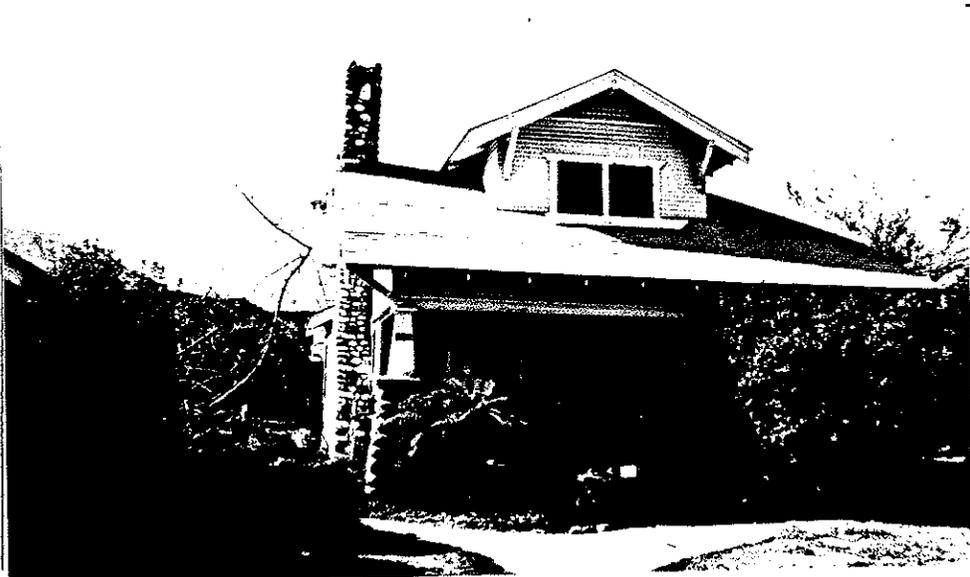
This 1 1/2 story bungalow has a high side facing gable roof and is rectangular in shape. Under the broad eaves are exposed rafters and knee brackets. The roof is punctuated with a gabled dormer window and stone exterior chimney. The Craftsman influence is seen in the use of stonework. The recessed porch is supported by tapered stone columns with tapered wood columns on the upper third. The low stair railing and foundation are of stone. A wrought iron railing is located on each side of the concrete steps. Windows are both fixed and double hung with flat wood mouldings. The house is covered with clapboard siding. The house is covered with medium clapboard siding. A lattice vent is a decorative feature under the dormer gable.

- Construction date: 1914
Estimated X Factual _____
- Architect unknown
- Builder unknown
- Approx. property size (in feet)
Frontage _____ Depth _____
or approx. acreage 8.05
- Date(s) of encl. photograph(s)
3/87 118

13. Condition: Excellent ___ Good Fair ___ Deteriorated ___ No longer in existence ___
14. Alterations: rear addition - 1965
15. Surroundings: (Check more than one if necessary) Open land ___ Scattered buildings Densely built-up ___
 Residential Industrial ___ Commercial ___ Other agricultural
16. Threats to site: None known Private development ___ Zoning ___ Vandalism ___
 Public Works project ___ Other: _____
17. Is the structure: On its original site? Moved? ___ Unknown? ___
18. Related features: stone garage

It is an excellent example of the Craftsman Bungalow with its use of stonework seen in the porch, chimney, foundation and garage.

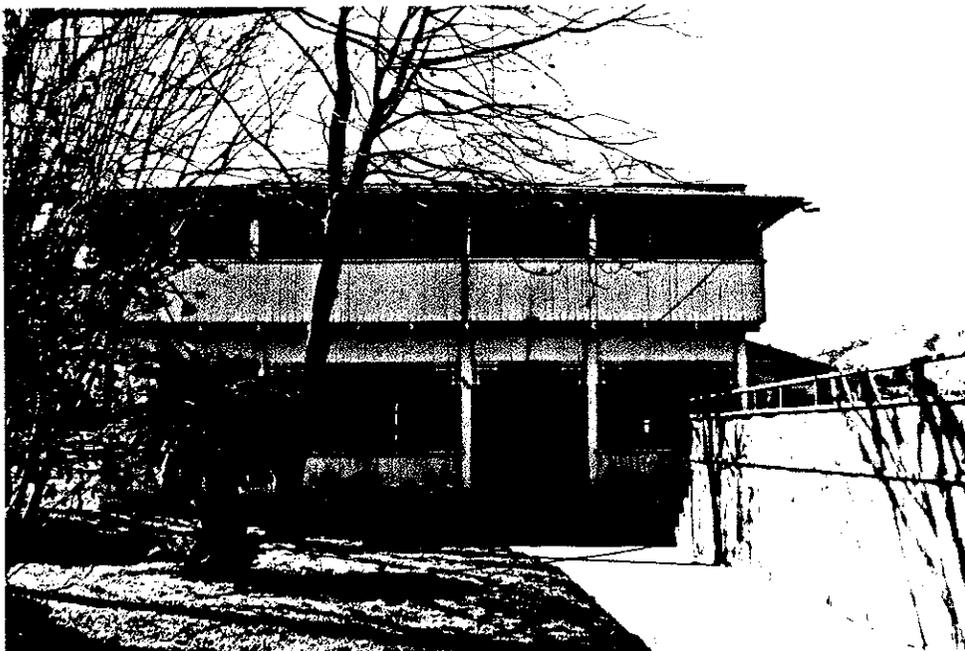
This large rectangular shaped two-story residence has a medium pitched hip roof with a one story hip roofed wing on the west side. A hipped roof porch runs across the front and east side of the house with a screened porch balcony on top. This was added later. The porch columns are square wood with stickwork brackets in the corners and vertical board siding on the porch railing. The eaves are boxed with curved brackets at the corners. The double hung windows are long and narrow and in pairs with raised decorative mouldings. Over the front door is a transom window. The house rests on a concrete and wood foundation and is covered with wide board siding.

13. Condition: Excellent ___ Good ___ Fair X Deteriorated ___ No longer in existence ___
14. Alterations: second floor sleeping porch
15. Surroundings: (Check more than one if necessary) Open land ___ Scattered buildings X Densely built-up ___
 Residential X Industrial ___ Commercial ___ Other agricultural
16. Threats to site: None known ___ Private development ___ Zoning ___ Vandalism ___
 Public Works project ___ Other: resident said owner may tear down
17. Is the structure: On its original site? ___ Moved? ___ Unknown? ___
18. Related features: detached garage, barn across street
