CULTURAL HERITAGE SURVEY PHASE IV SANTA CLARA VALLEY

**COUNTY OF VENTURA
CULTURAL HERITAGE SURVEY
PHASE IV - SANTA CLARA VALLEY**

**Prepared by Judy Triem
San Buenaventura Research Associates**

January 1988

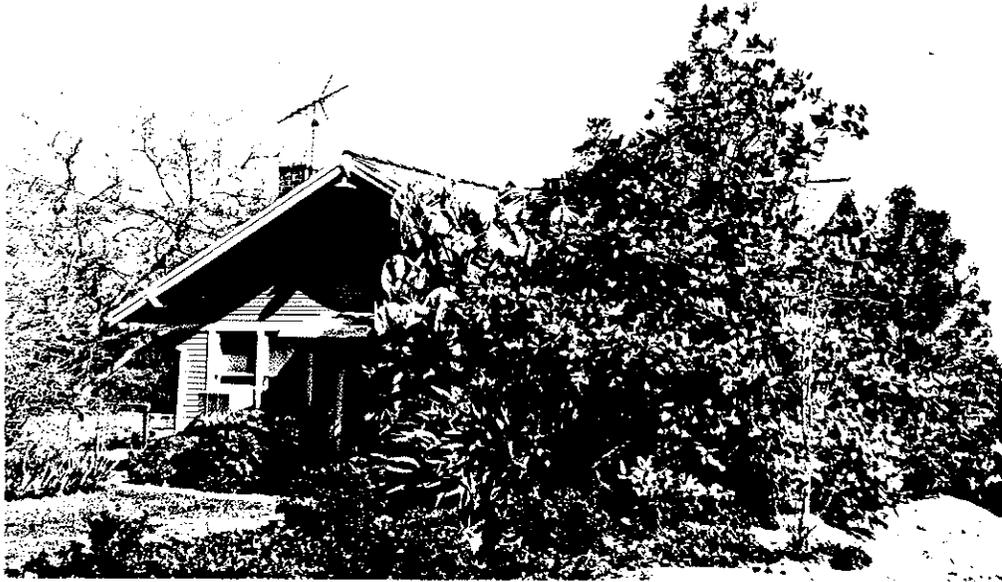
575 W. Guiberson Rd.
Parcel#: 500-010-110
Owner: Robert McNeill

This house was built about 1926 for Leslie Burson, son of Willis Burson. It is California Bungalow in style with a medium cross gable roof and exposed rafters under the eaves. It is 1 1/2 stories tall. Windows are double hung with wood frames and mouldings. There is a brick chimney on the west side. The front entrance has a door flush with the facade and a metal awning above. Siding is clapboard.

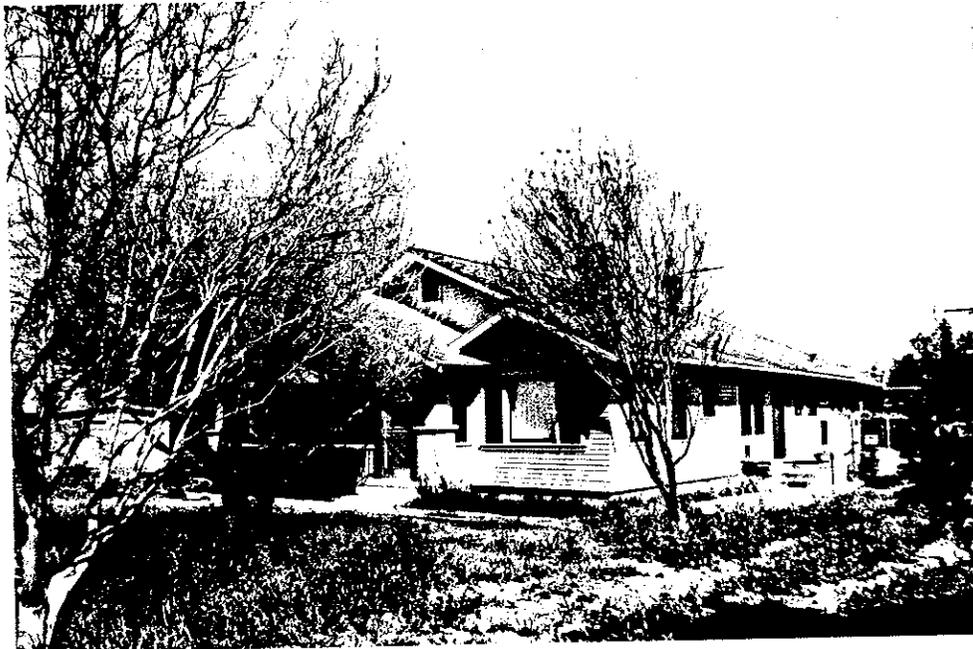
521 W. Guiberson Rd.
Parcel #: 500-010-030
Owner: Helen M. Burson

This residence was built about 1929 for Carl E. Burson, son of George Burson. This California Bungalow has a front gable roof with two offset gables. Under the broad eaves are exposed beams. The porch is attached with two large support columns, the lower half of concrete and the upper half of wood. The porch has been partially enclosed with screens and has a wood railing. Windows are fixed or double hung with wood frames and mouldings. The house rests on a concrete foundation and is covered with clapboard siding.

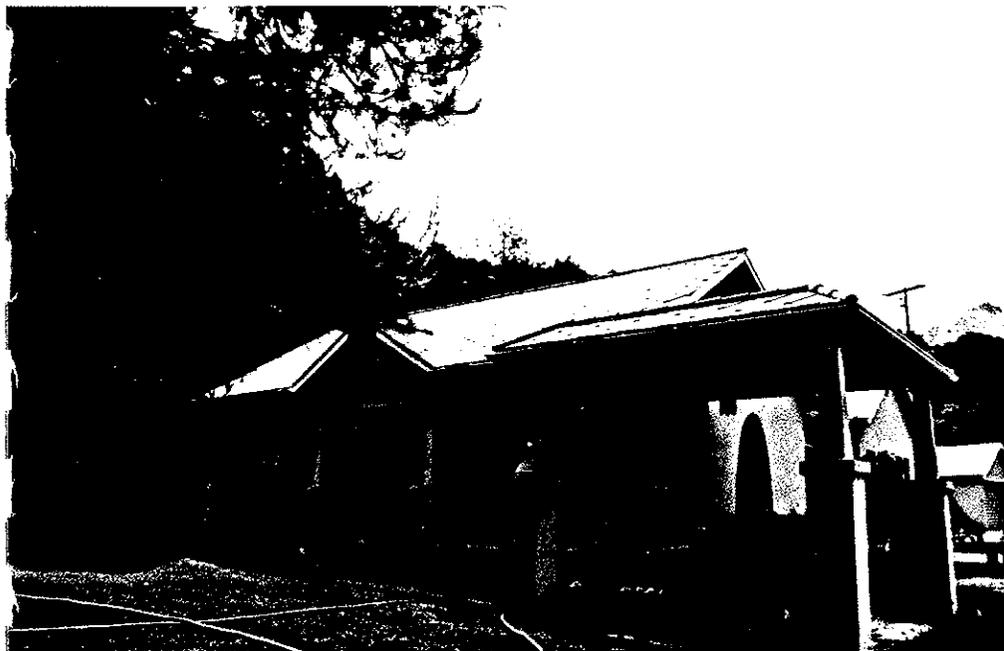
Nestled against the hillside with a commanding view of the valley, this large single story residence has a medium pitched gable roof and is built in an H-shape. Attached to the corner front portion of the house is a hipped roof port-cochere. The port-cochere is now used as a patio. The roof is supported by square capped stucco columns with tapered wood on the upper third of the column. This same type of column is found supporting the recessed front porch. There is a small front gable intersecting the main sidefacing gable directly over the front steps. The house is built on a sloping hillside and the foundation is raised with stucco covering. The house is covered with stucco as well. Windows are wood frame fixed or double hung. The front windows have multi-panes in the upper portion. On the side of the house is a large fixed arched window.

13. Condition: Excellent ___ Good ___ Fair ___ Deteriorated ___ No longer in existence ___
14. Alterations: none apparent
15. Surroundings: (Check more than one if necessary) Open land ___ Scattered buildings Densely built-up ___
 Residential Industrial ___ Commercial ___ Other agricultural
16. Threats to site: None known Private development ___ Zoning ___ Vandalism ___
 Public Works project ___ Other: _____
17. Is the structure: On its original site? Moved? ___ Unknown? ___
18. Related features: detached garage, mature trees

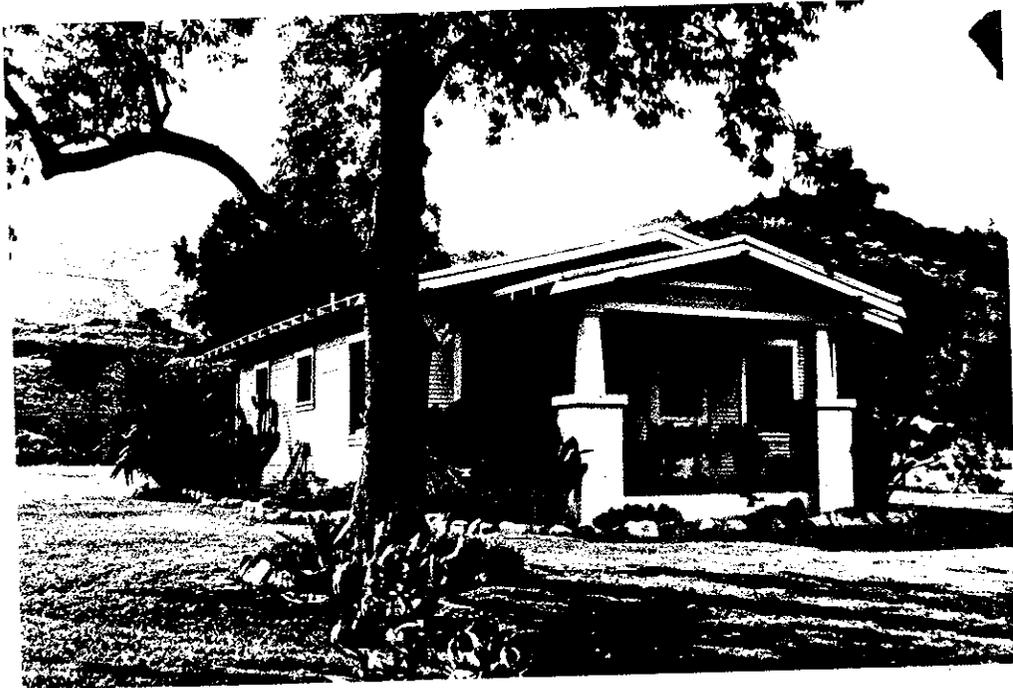
136 W. Guiberson Rd.
Parcel #: 500-020-065

C.C. Elkins had this house built about 1921 for his son Will Elkins, his wife May (Mary Maria Ward) and their family. The house was a pre-fab model, with sections of the house cut in the East, shipped out here, and assembled on the building site. Other members of the Elkins family to live in the house were Dorothy Elkins Hall and Claude Hall from 1933 to 1942 and Emily Anne Elkins and Manning Goularte from 1942 to 1944. After 1944, various Elkins Ranch Golf Course employees have resided in the house, including the present occupant, Mike Udem.

The house is a typical California Bungalow with a low pitched gable roof and smaller gable over the front porch. Rafters are exposed under the eaves. The raised concrete porch is supported by two massive columns, the lower half of capped stucco or concrete and the upper half of tapered wood. Windows are double hung with wood frames and mouldings. The house rests on a concrete foundation and is covered with clapboard siding.

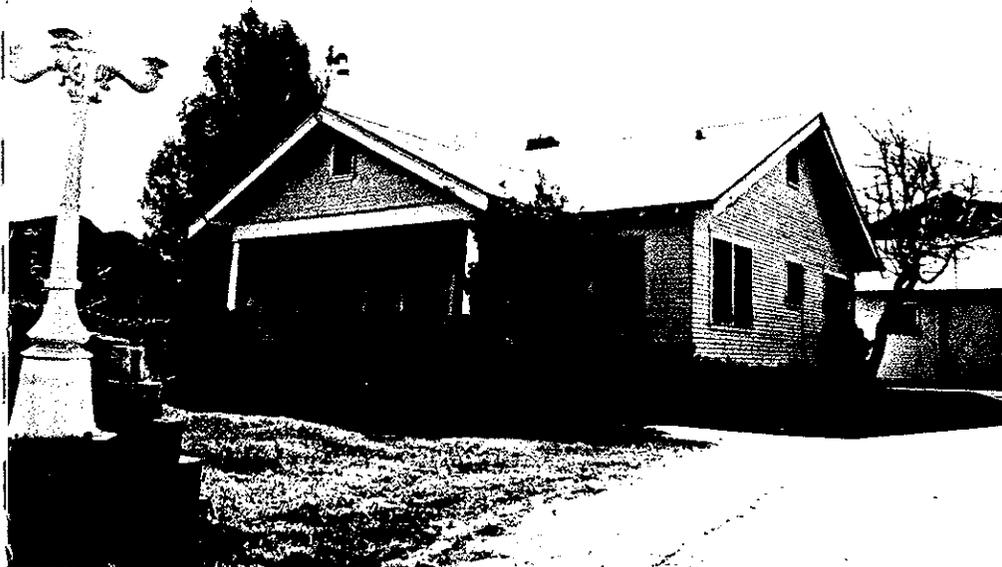
This single story bungalow has a medium pitched side facing gable with front gable over the porch. The attached porch is raised with two support columns. The lower half of the columns are of brick with concrete caps and the upper half are square wood with caps. Under the eaves are exposed rafters and beams. Windows are wood frame and double hung with flat wood mouldings. On the east side of the house is a gabled wing attached at the rear side of the house. The house is covered with clapboard siding.

13. Condition: Excellent ___ Good Fair ___ Deteriorated ___ No longer in existence ___
14. Alterations: none apparent
15. Surroundings: (Check more than one if necessary) Open land ___ Scattered buildings Densely built-up ___
 Residential Industrial ___ Commercial ___ Other agricultural
16. Threats to site: None known Private development ___ Zoning ___ Vandalism ___
 Public Works project ___ Other: _____
17. Is the structure: On its original site? Moved? ___ Unknown? ___
18. Related features: detached garage, shed

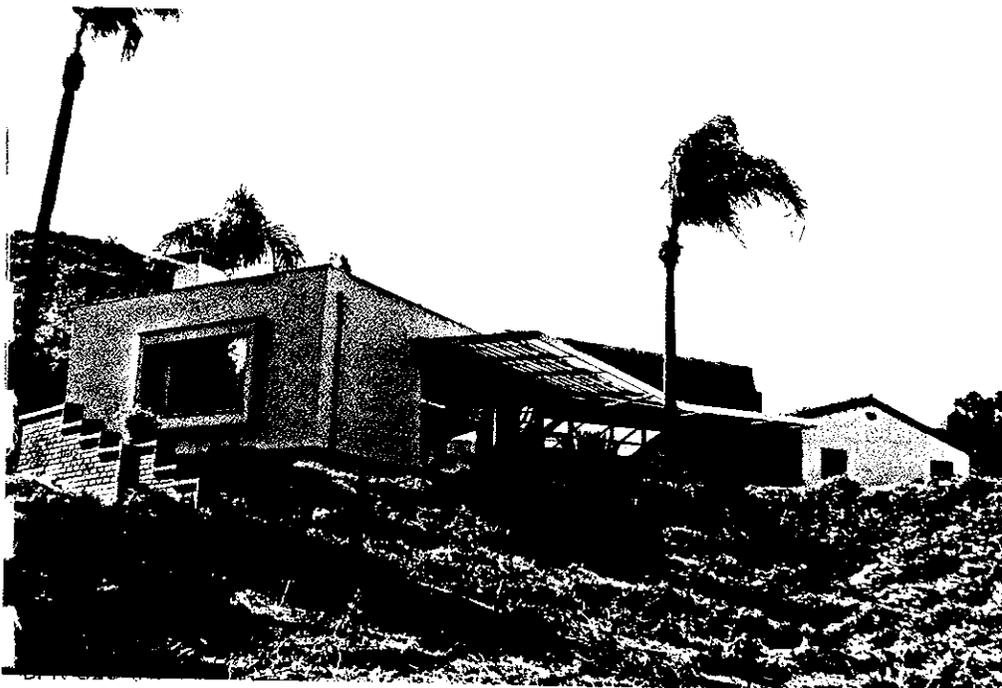
The main portion of the original house is L-shaped with a low pitched gable tile roof. Windows are steel casement. The house rests on a concrete foundation and is covered with stucco. The large flat roofed addition is attached to the original house creating a modified U-shape. The atrium portion in the center has a shed roof of fiberglass and large floor to ceiling windows facing north toward the mountains. Next to the atrium is the flat roofed living room with a tall stucco chimney. Windows are large and fixed with a rectangular shape. One of the windows has an exterior stucco raised moulding. On the south side over the large windows is a projecting flat louvered wood roof. The front entrance has a flat roof with steel supports. Next to the entrance is another flat open wood roof supported by steel double columns. A low stone wall is attached along the curved portion of the front of the house creating a planter with another lower stone wall next to the large circular driveway.

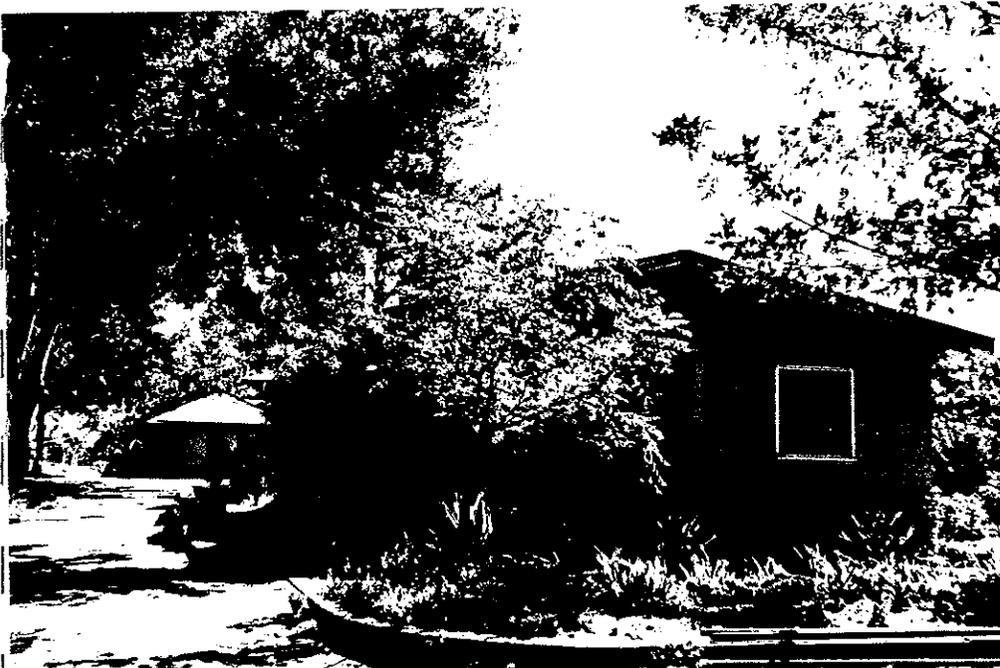
This modest single story bungalow has a low pitched gable roof with a hip roof portion on the north rear side. The front porch is recessed under the main gable and has been enclosed on the south side. The porch is supported by a square column and wood railing. Under the broad eaves are exposed rafters and curved brackets. Windows are wood frame double hung with flat wood mouldings. One window is sliding aluminum. The house rests on a raised concrete foundation and is covered with clapboard siding.

13. Condition: Excellent ___ Good Fair ___ Deteriorated ___ No longer in existence ___
14. Alterations: Porch enclosed on one side
15. Surroundings: (Check more than one if necessary) Open land ___ Scattered buildings Densely built-up ___
 Residential Industrial ___ Commercial ___ Other agricultural
16. Threats to site: None known Private development ___ Zoning ___ Vandalism ___
 Public Works project ___ Other: _____
17. Is the structure: On its original site? Moved? ___ Unknown? ___
18. Related features: detached garage, oak trees, shed

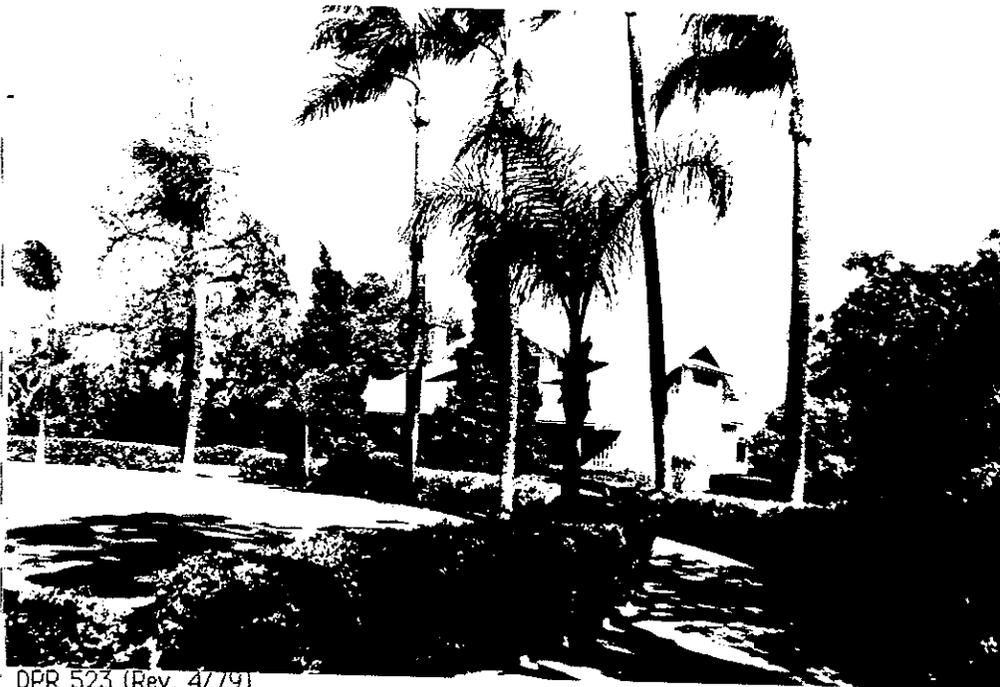
This large two-story bungalow has a high side facing gable roof with a gabled dormer window across the front. This large dormer is slanted with four front windows and two side windows. Under the broad eaves are exposed rafters and beams. The front porch is recessed under the roof and supported by stone columns and railing. The original chimney was redone and is now brick. Windows are a combination of fixed, double hung and casement with wood frames and mouldings. The house rests on a concrete foundation and is covered with narrow clapboard siding. Attached to the house on the west side is a gabled port cochere. The grounds around the house contain many mature trees, a circular drive and formal lawn and hedge.

13. Condition: Excellent Good Fair Deteriorated No longer in existence
14. Alterations: none apparent
15. Surroundings: (Check more than one if necessary) Open land Scattered buildings Densely built-up
 Residential Industrial Commercial Other agricultural
16. Threats to site: None known Private development Zoning Vandalism
 Public Works project Other: _____
17. Is the structure: On its original site? Moved? Unknown?
18. Related features: carport, garage, barbecue house

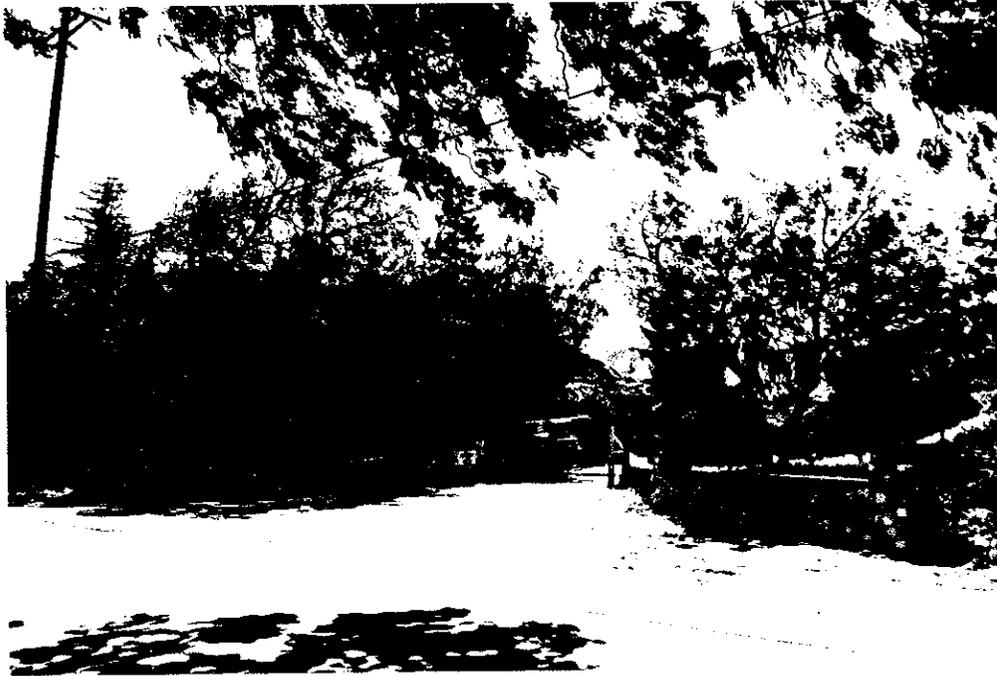
Entrance to Montebello Oil Co. -- Shiells Lease

Across from Wm. Shiells' residence is the entrance to the Montebello Oil Co., Shiells Lease in Shiells Canyon. The entrance is flanked by low stone walls and two stone pillars. One of the pillars has a plaque that reads "Montebello Oil Company -- Shiells Lease." The stone is beaded.

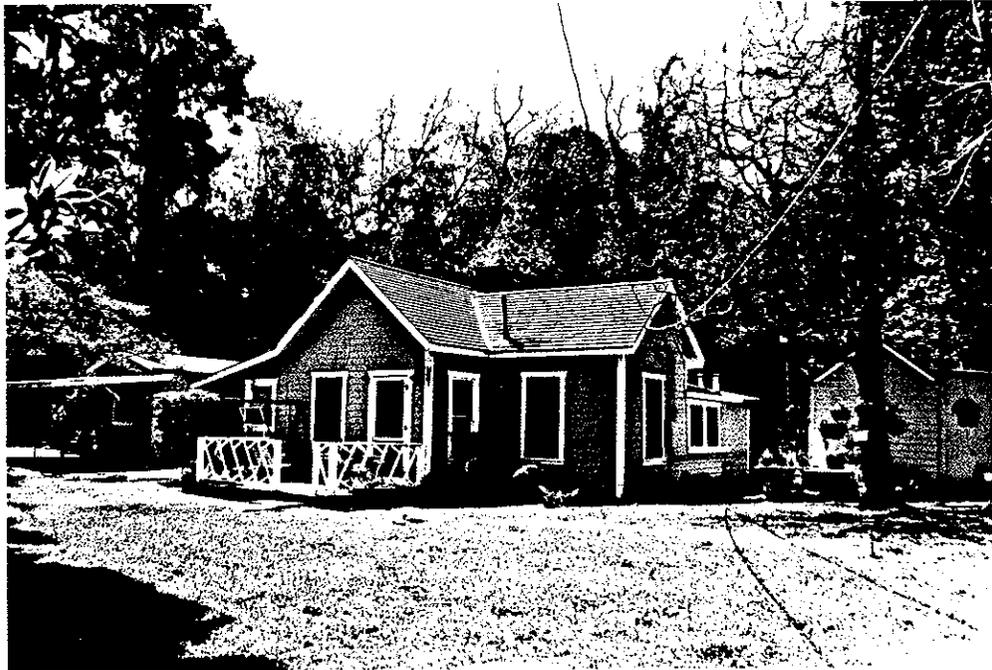
858 E. Guiberson Rd.-- Shiells Canyon
Parcel #: 500-020-095

This house was the original house William Shiells had built for his family when they came to the Bardsdale area about 1884 and homesteaded in the canyon that now bears the family name.

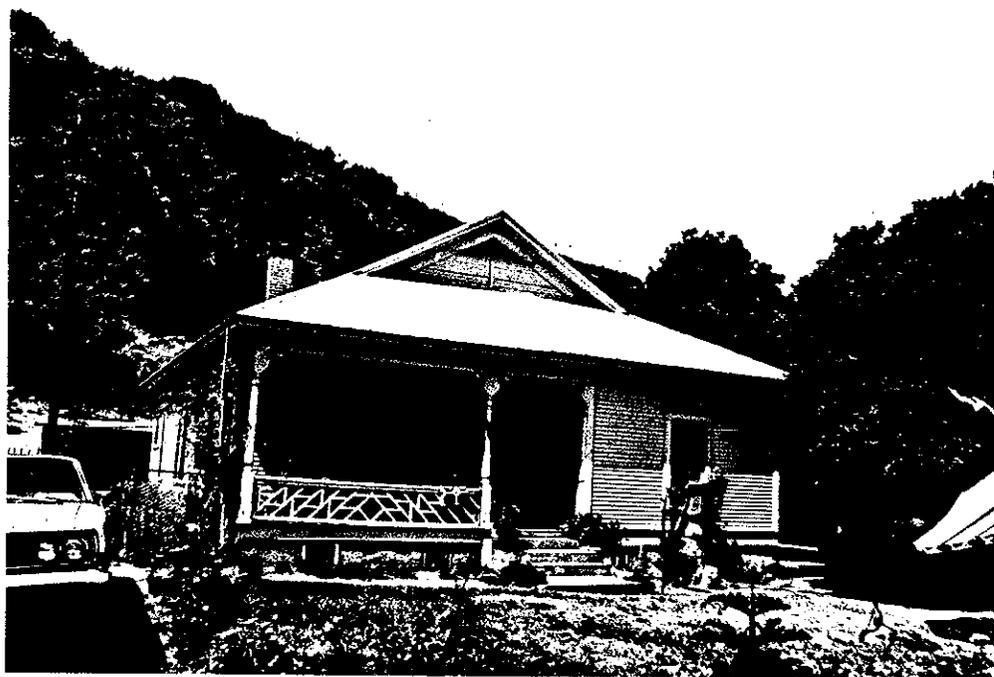
1110 E. Guiberson Rd. -- Calumet Canyon
Parcel #:055-260-295

Located next to 1102 on the hillside, this single story residence has a medium hip roof with a gablet in front. The roof is covered with metal sheeting. Eaves are boxed with a frieze and panels. The front porch is recessed on one side and supported by decorative turned columns with carved brackets in the corners. The railing is in an unusual geometric shaped design. Windows are double hung with wood frames and shelf mouldings. The house rests on a raised concrete foundation and is covered with narrow clapboard siding. A brick chimney is located toward the rear of the house.

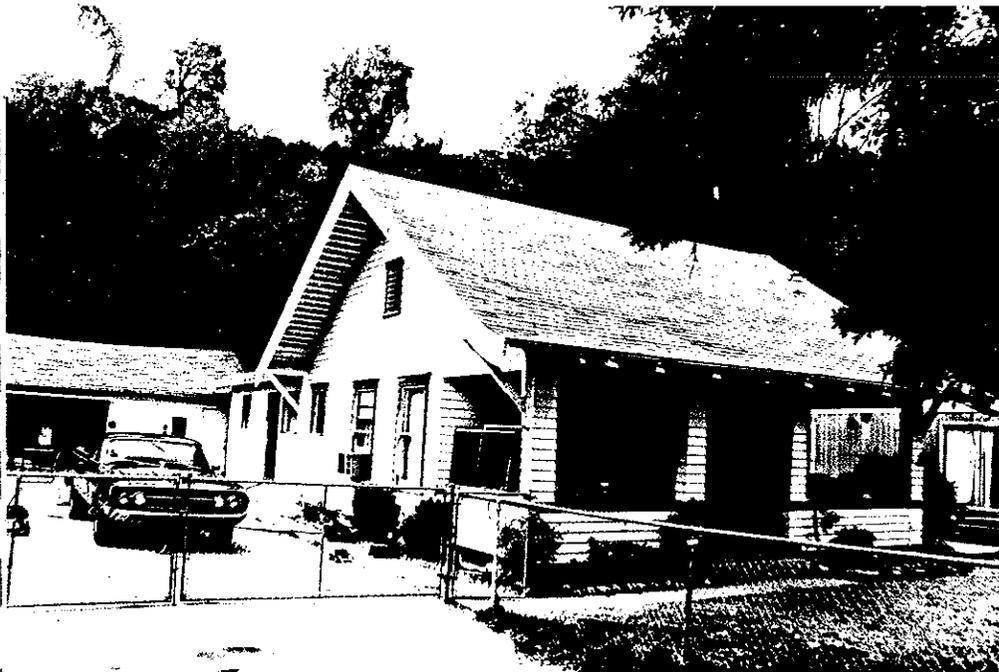
This single story bungalow has a medium high sidfacing gable roof slightly flared at the ends with curved and notched ends on the rafters. Knee brackets are also located at the corners of the roof ends. The porch is recessed under the main gable and supported by four square posts and solid wood railing. The posts and railing are covered with clapboard siding to match the house exterior. Windows are double hung with wood frames and raised mouldings. An addition is being put on the rear with wood siding and sliding aluminum windows.

13. Condition: Excellent ___ Good ___ Fair Deteriorated ___ No longer in existence ___
14. Alterations: new addition on rear
15. Surroundings: (Check more than one if necessary) Open land ___ Scattered buildings Densely built-up ___
 Residential Industrial ___ Commercial ___ Other agricultural
16. Threats to site: None known Private development ___ Zoning ___ Vandalism ___
 Public Works project ___ Other: _____
17. Is the structure: On its original site? Moved? ___ Unknown? ___
18. Related features: detached garage/shed, mature trees

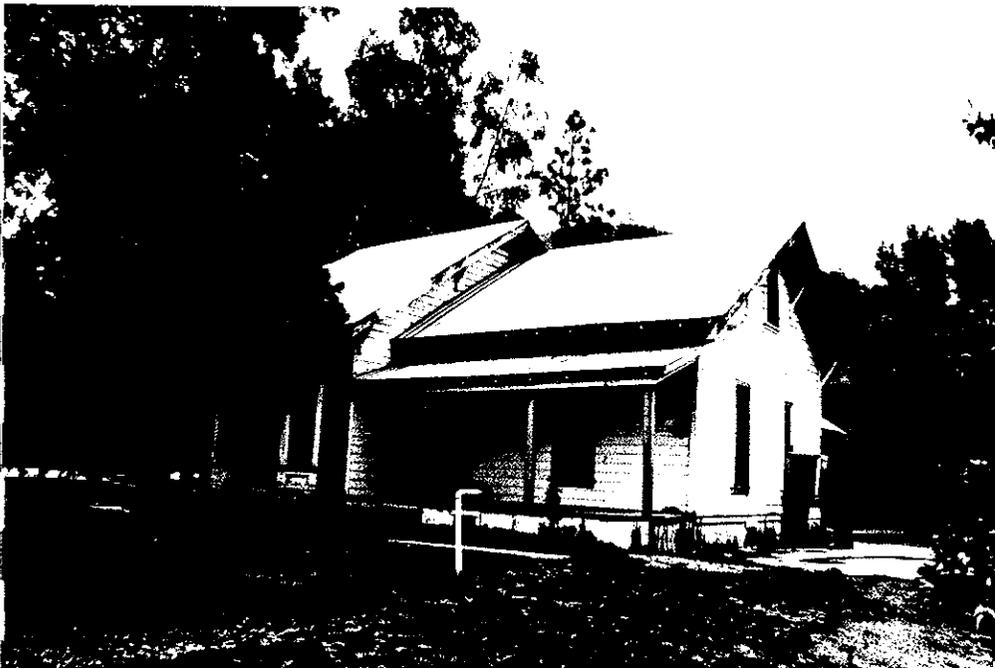
This 1 1/2 story residence was originally 2 1/2 stories tall. The entire second story was removed probably during the teens or 20s. The house now has two side facing gable roofs with a shed roof over the porch. The original slanted bay window still exists with its narrow double hung windows and decorative panels. Remaining windows are the same on the first floor -- double hung wood frames with raised wood mouldings. The front porch is supported by three plain square posts. The original porch had decorative brackets at the top of the posts and a balcony above with a decorative cut-out wood railing. The original eaves were boxed and returned. Now the eaves are open with exposed rafters and knee brackets. The house rests on a wood foundation and has a vertical board skirt similar to the original skirt. At the rear of the house is a single story shed roof wing.

13. Condition: Excellent ____ Good ____ Fair Deteriorated ____ No longer in existence ____
14. Alterations: second story removed
15. Surroundings: (Check more than one if necessary) Open land ____ Scattered buildings Densely built-up ____
 Residential Industrial ____ Commercial ____ Other agricultural
16. Threats to site: None known Private development ____ Zoning ____ Vandalism ____
 Public Works project ____ Other: _____
17. Is the structure: On its original site? Moved? ____ Unknown? ____
18. Related features: mature trees

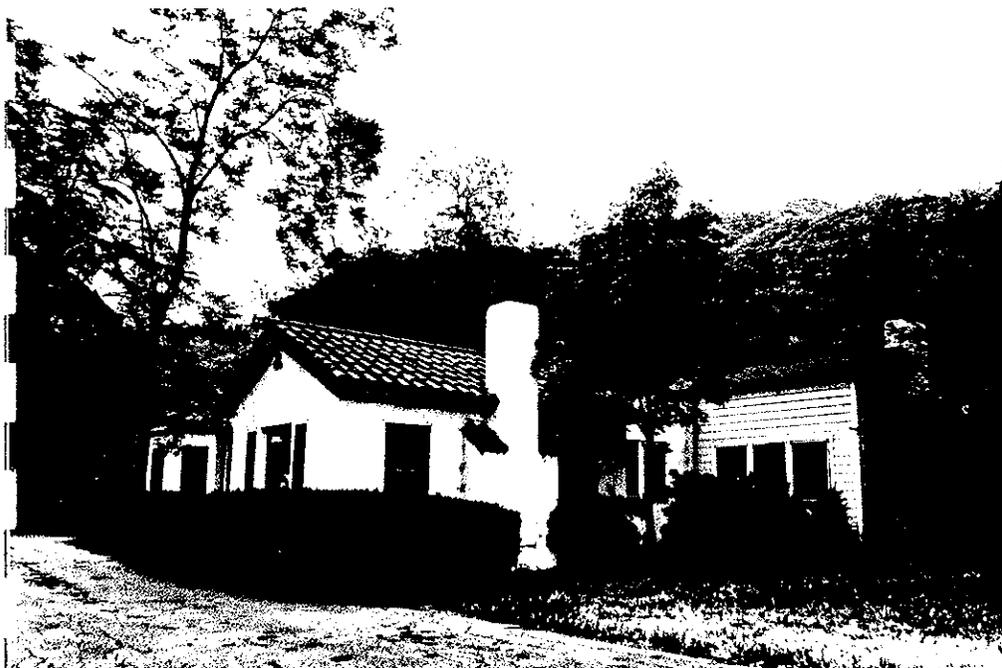
Located on a hillside, this single story residence is a combination of apparently two buildings. The first is a gabled roof single story rectangular shaped building with wood siding and exterior brick chimney. Windows are double hung with wood frames and flat mouldings. This part of the house is connected to the single story Spanish style residence by a flat roofed portion. The front of the stucco house has a five sided small towered portion with double hung windows with flush wood frames. At the rear of the house is an exterior stucco chimney. The front entry has a small concrete patio timmed with brick.

13. Condition: Excellent ___ Good ___ Fair Deteriorated ___ No longer in existence ___
14. Alterations: uncertain
15. Surroundings: (Check more than one if necessary) Open land ___ Scattered buildings Densely built-up ___
 Residential Industrial ___ Commercial ___ Other agricultural
16. Threats to site: None known Private development ___ Zoning ___ Vandalism ___
 Public Works project ___ Other: _____
17. Is the structure: On its original site? Moved? ___ Unknown? ___
18. Related features: mature trees

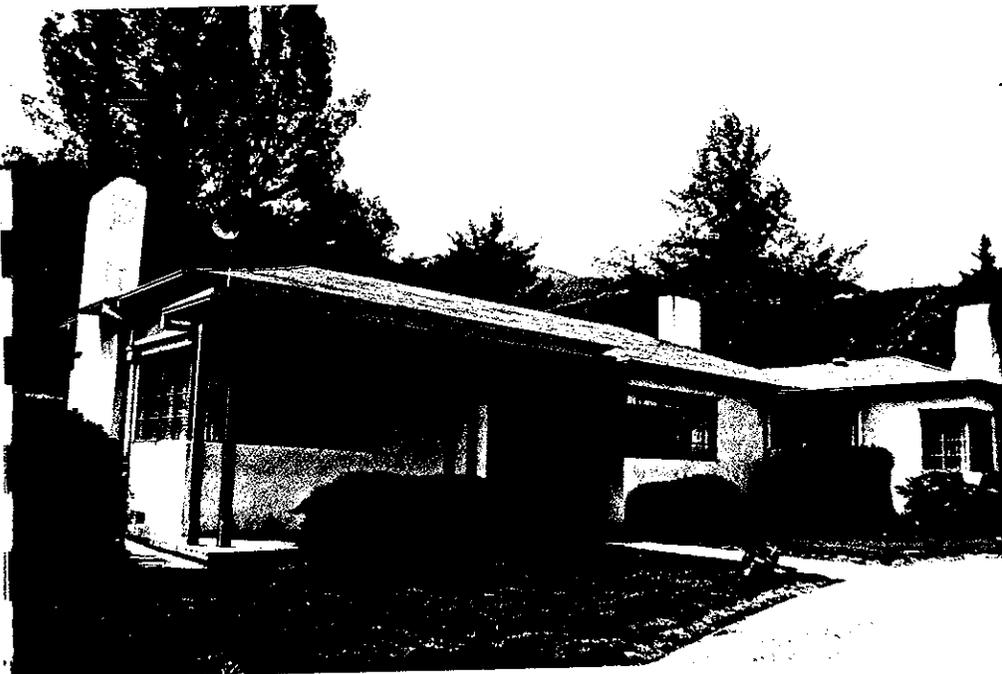
This single story residence is basically rectangular in shape with an L-shaped wing. The hip roofs are low pitched and the eaves are closed. The front entry is recessed and the porch has a flat roof supported by double wood chamfered columns. The metal multi-paned casement windows are in bands and wrap around the corners of the house. The house has a tall chimney at each end and one in the middle. Resting on a concrete foundation, the house is covered with stucco siding. In the corner of the front L-portion is a curved window. This type of window is repeated at the rear of the house.

13. Condition: Excellent Good Fair Deteriorated No longer in existence
14. Alterations: none apparent
15. Surroundings: (Check more than one if necessary) Open land Scattered buildings Densely built-up
 Residential Industrial Commercial Other agricultural
16. Threats to site: None known Private development Zoning Vandalism
 Public Works project Other: _____
17. Is the structure: On its original site? Moved? Unknown?
18. Related features: circular drive, mature trees, shed, pump house, detached garage

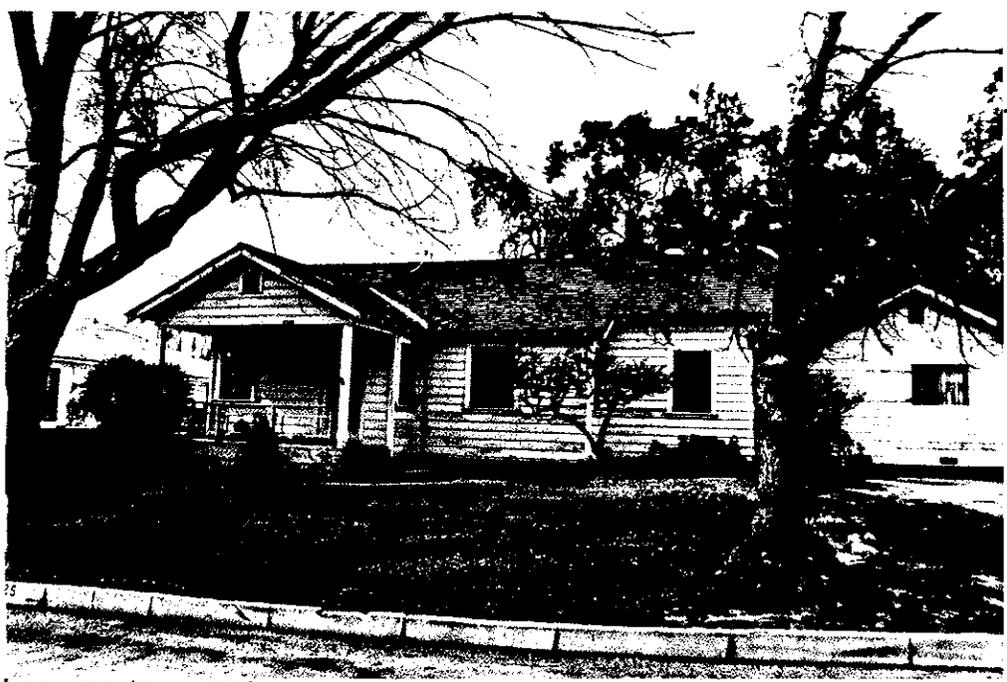
This single story residence is a modified L- shape with a side facing gable roof and an offset front gable over the porch. The porch is attached with a gable roof supported by two square wood posts. Rafters are exposed under the eaves. Windows are double hung with wood frames and mouldings. On the north side is a separate gable roofed addition attached at the corner. Windows on the addition are sliding aluminum frame. The house rests on a concrete foundation and is covered with wide board siding.

13. Condition: Excellent ___ Good Fair ___ Deteriorated ___ No longer in existence ___
14. Alterations: addition on north side
15. Surroundings: (Check more than one if necessary) Open land ___ Scattered buildings ___ Densely built-up
 Residential Industrial ___ Commercial ___ Other ___
16. Threats to site: None known ___ Private development ___ Zoning ___ Vandalism ___
 Public Works project ___ Other: _____
17. Is the structure: On its original site? ___ Moved? Unknown? ___
18. Related features: mature trees

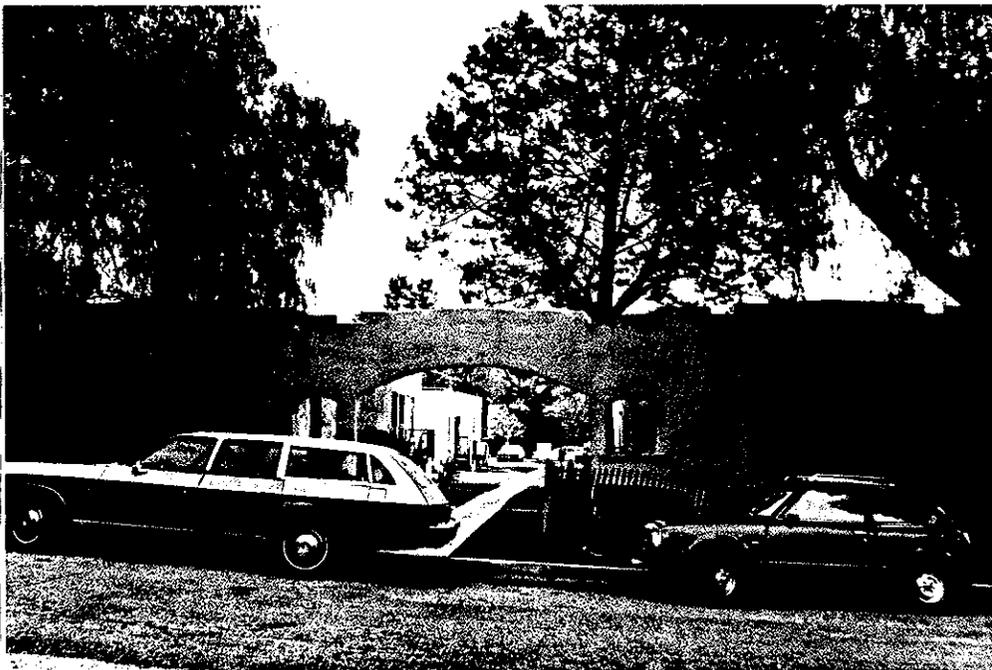
This bungalow court contains eight attached units with flat roofs with tile caps. There are four units on each side with a courtyard in the middle. The units are tied together in front by a segmented arched wall. On each side of the main opening are two small round arched openings. The Church Street facade has raised parapets. Windows have wood frames and are double hung and flush with the stucco siding. Each unit has a small concrete stoop and wrought iron railing for the front porch.

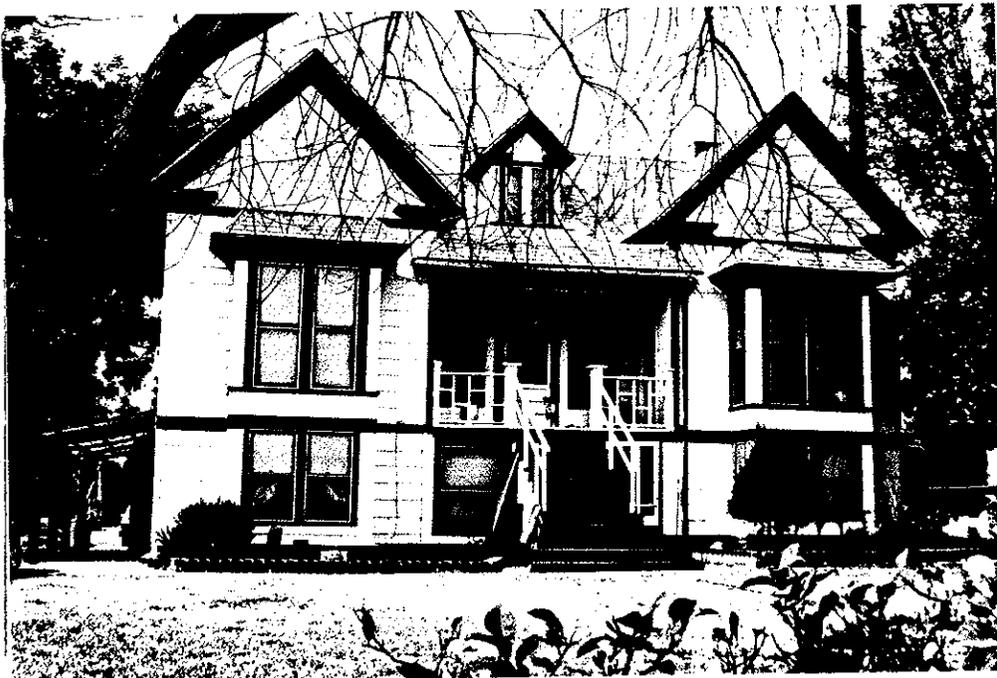
This rectangular shaped residence has a raised basement creating livable space. The house is divided symmetrically with a medium high sidefacing gable and projecting gables at each side creating a u-shape. The porch is recessed in the U under the main gable. Above the porch is a gabled dormer window. All gables have returned boxed eaves. The roof treatment and the square bays demonstrate influences of the Italianate style. The porch has half wood columns and wood railing which is probably not original. The steps are concrete. On the front of each gable is a square bay window with mansard roof. These bays continue down to the basement level. Windows are long and narrow with wood frames and are double hung. There is a brick chimney on the north side and a shed attached on the northwest side.

13. Condition: Excellent ___ Good Fair ___ Deteriorated ___ No longer in existence ___
14. Alterations: asbestos siding over original wood
15. Surroundings: (Check more than one if necessary) Open land ___ Scattered buildings ___ Densely built-up
 Residential Industrial ___ Commercial ___ Other ___
16. Threats to site: None known Private development ___ Zoning ___ Vandalism ___
 Public Works project ___ Other: _____
17. Is the structure: On its original site? ___ Moved? ___ Unknown?
18. Related features: mature trees, citrus trees, arbor on south side

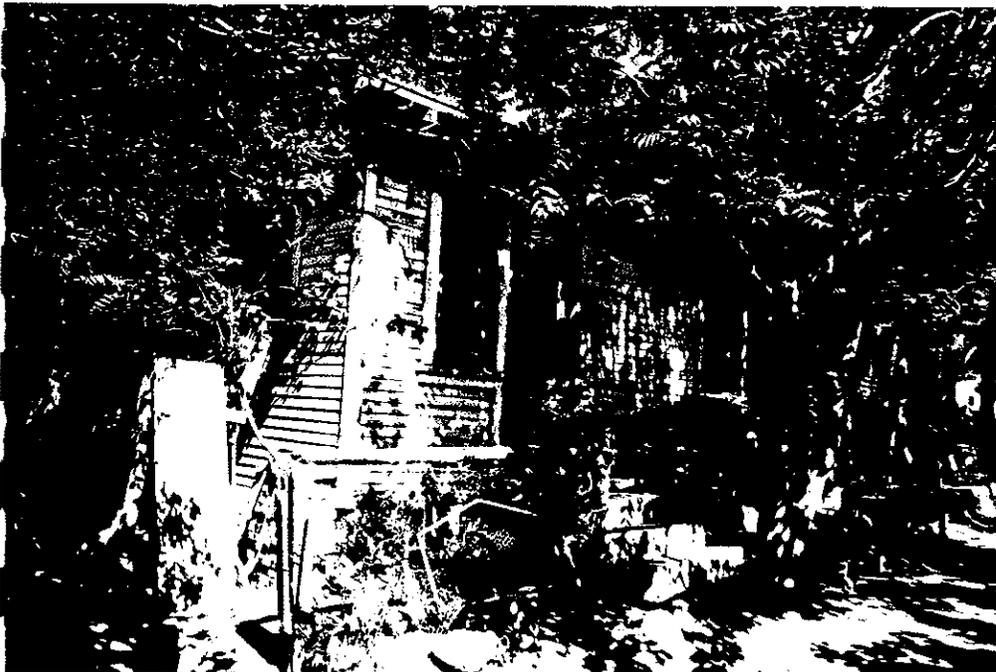
This single story residence has a low gable roof and is basically rectangular in shape. Windows are double hung with wood frames and flat wood mouldings. The house is sheathed in narrow clapboards with a clapboard skirt around the concrete foundation.

13. Condition: Excellent ___ Good ___ Fair X Deteriorated ___ No longer in existence ___
14. Alterations: none apparent
15. Surroundings: (Check more than one if necessary) Open land ___ Scattered buildings X Densely built-up ___
 Residential X Industrial ___ Commercial ___ Other across from Piru cemetery
16. Threats to site: None known X Private development ___ Zoning ___ Vandalism ___
 Public Works project ___ Other: ___
17. Is the structure: On its original site? X Moved? ___ Unknown? ___
18. Related features: mature trees, shrubs

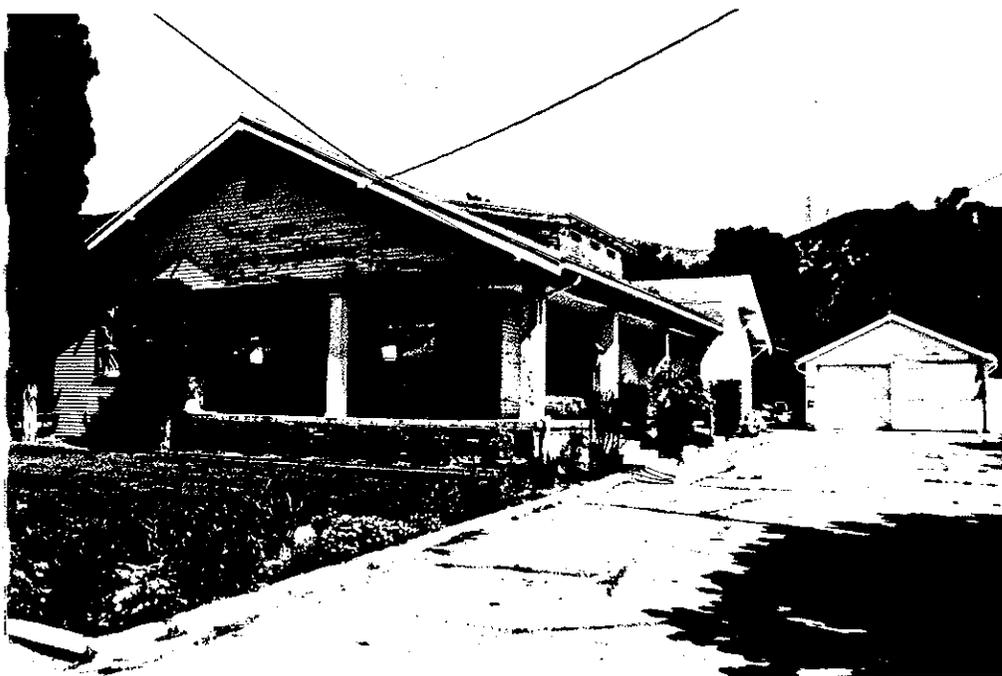
This single story residence is primarily rectangular in shape with a medium gable roof. A shed roof dormer extends from the east side. The porch is L-shaped and recessed under the main gable. Square wood porch supports have caps at the top. There are knee brackets under the gable roof. Windows are double hung and casement with wood mouldings. The house is covered with clapboard siding and rests on a concrete block foundation.

13. Condition: Excellent ___ Good ___ Fair X Deteriorated ___ No longer in existence ___
14. Alterations: _____
15. Surroundings: (Check more than one if necessary) Open land ___ Scattered buildings X Densely built-up ___
 Residential X Industrial ___ Commercial ___ Other agricultural
16. Threats to site: None known X Private development ___ Zoning ___ Vandalism ___
 Public Works project ___ Other: _____
17. Is the structure: On its original site? X Moved? ___ Unknown? ___
18. Related features: detached garage - same style as house

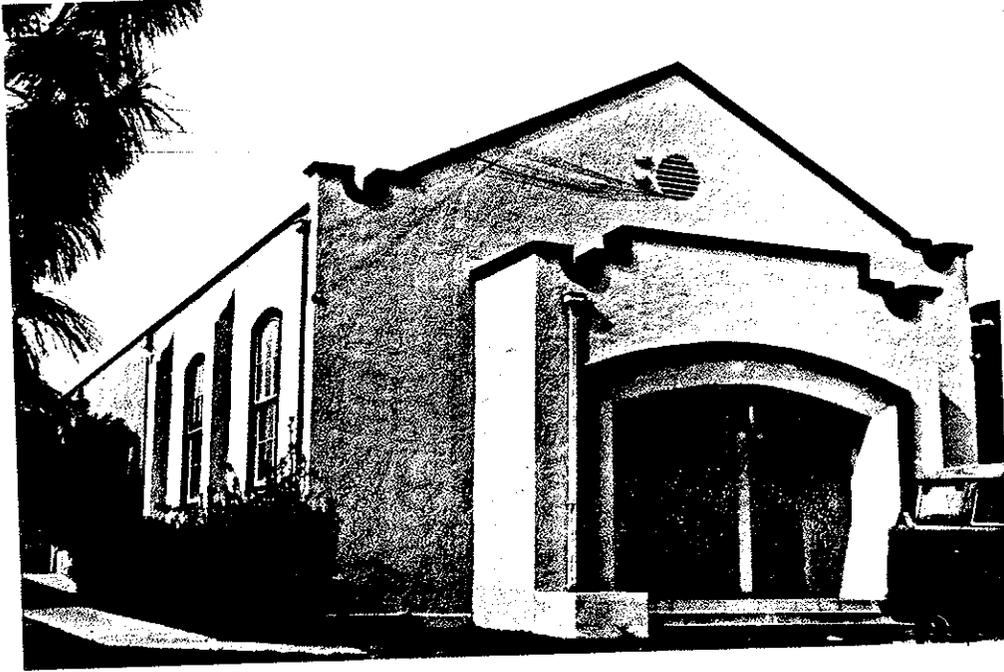
Auditorium - this building was constructed about 1922, at the same time the main building was built. It was designed, as well, by architect Roy C. Wilson of Santa Paula.

The building is rectangular in shape with a gable roof. The facade is a modified Mission Revival style with curved corner parapets. The front entrance has a raised parapet. The entry is recessed beneath a large square arch and has four wooden doors with multi-paned windows. Above the doors are multi-paned transom windows. The double hung windows are also square arches with multi-panes and wood frames. At the sides of the building are modified buttresses. The building is covered with stucco siding.

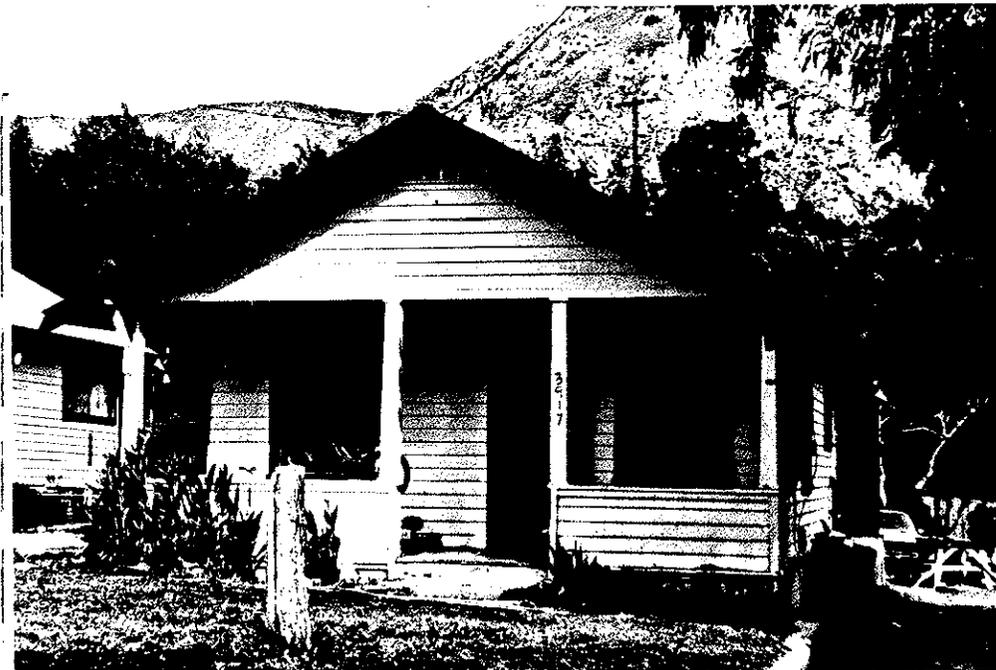
This single story bungalow is rectangular in shape with a medium gable roof and decorative vertical vent under the gable. Exposed rafters and knee brackets are located under the eaves. The porch is recessed under the main gable and is supported by four square columns capped at the top. The lower portion has an enclosed railing covered with medium clapboard siding. The house rests on a wood foundation and has a wood skirt. Siding is medium clapboards.

13. Condition: Excellent ____ Good Fair ____ Deteriorated ____ No longer in existence ____
14. Alterations: none apparent
15. Surroundings: (Check more than one if necessary) Open land ____ Scattered buildings ____ Densely built-up
Residential Industrial ____ Commercial ____ Other ____
16. Threats to site: None known Private development ____ Zoning ____ Vandalism ____
Public Works project ____ Other: _____
17. Is the structure: On its original site? Moved? ____ Unknown? ____
18. Related features: detached three-car wood garage

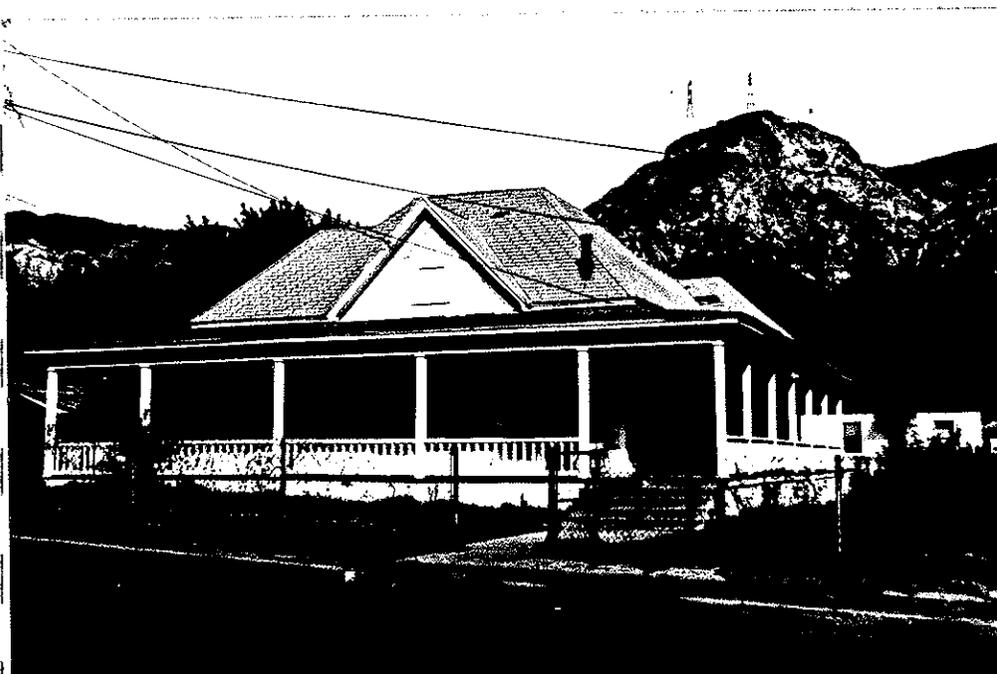
This single story residence has a high hip roof with high pitched gable over the front porch. Under the gable are boxed eaves and decorative shingles. The porch extends across the front and east side of the house covered by a low hip roof and supported by square capped posts and wood railing. There is an entrance on both the south and east side of the porch. Windows are double hung with wood mouldings. The foundation is part concrete and part wood piers covered by a wood skirt. Siding is wide clapboard.

13. Condition: Excellent ____ Good Fair ____ Deteriorated ____ No longer in existence ____
14. Alterations: concrete front steps
15. Surroundings: (Check more than one if necessary) Open land ____ Scattered buildings ____ Densely built-up
 Residential Industrial ____ Commercial ____ Other ____
16. Threats to site: None known Private development ____ Zoning ____ Vandalism ____
 Public Works project ____ Other: ____
17. Is the structure: On its original site? ____ Moved? Unknown? ____
18. Related features: duplex in rear

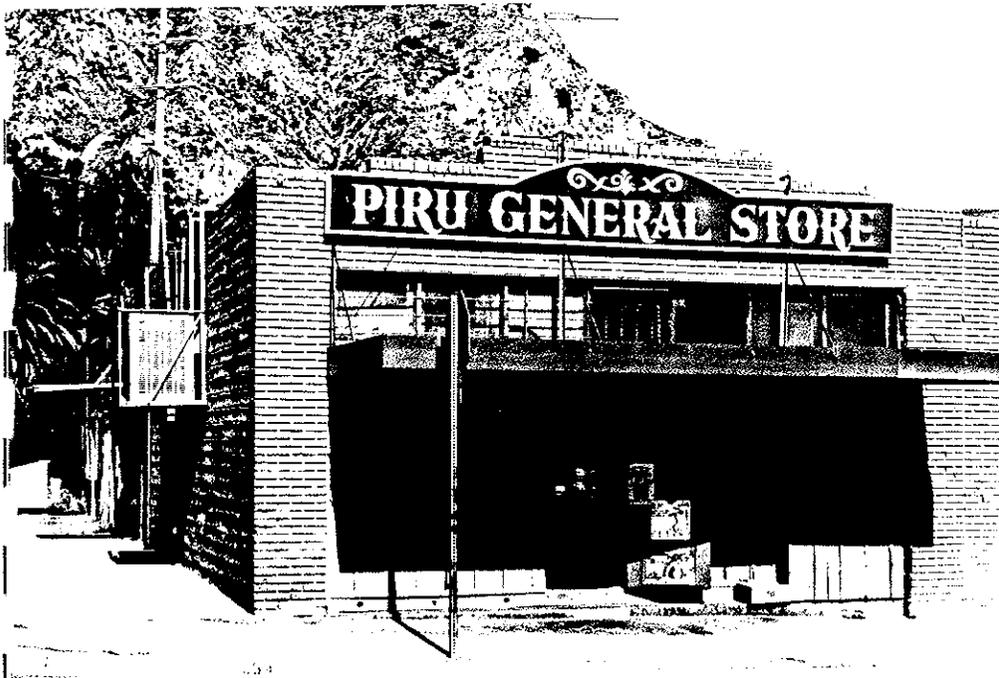
This rectangular shaped building is one story tall and constructed of hollow tile with a brick facing. The roof is flat except for the facade which has a stepped parapet with the brick laid vertically. The facade has been changed with the windows covered over with board and batten siding, leaving only a small portion of the window visible. The transom windows across the upper portion have also been altered by being boarded up in places. The rear of the building has a wood frame structure attached, whose entrance faces Main Street. This building has narrow clapboard siding and double-hung windows with wood mouldings.

13. Condition: Excellent ___ Good ___ Fair Deteriorated ___ No longer in existence ___
14. Alterations: front windows altered
15. Surroundings: (Check more than one if necessary) Open land ___ Scattered buildings ___ Densely built-up
 Residential ___ Industrial ___ Commercial Other ___
16. Threats to site: None known Private development ___ Zoning ___ Vandalism ___
 Public Works project ___ Other: ___
17. Is the structure: On its original site? Moved? ___ Unknown? ___
18. Related features: wood building attached to rear of structure
