CULTURAL HERITAGE SURVEY PHASE IV SANTA CLARA VALLEY

**COUNTY OF VENTURA
CULTURAL HERITAGE SURVEY
PHASE IV - SANTA CLARA VALLEY**

**Prepared by Judy Triem
San Buenaventura Research Associates**

January 1988

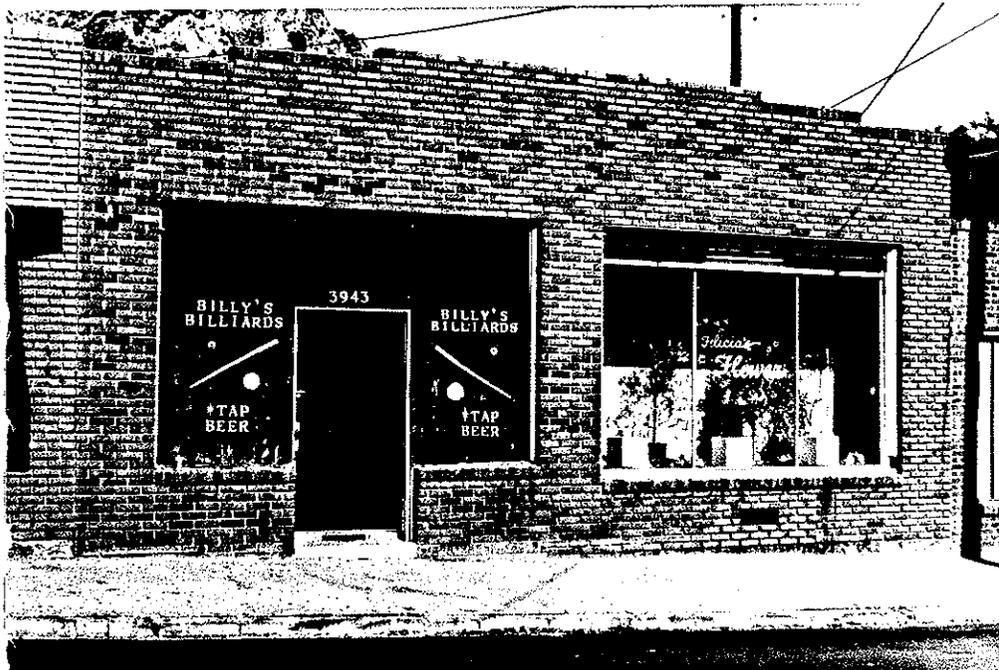
This single story flat roofed building is rectangular in shape with a raised parapet. The building is constructed of hollow clay tile with a brick facade. The facade has two rectangular openings. One is a large plate glass window with wood frame and the other is the entrance with plate glass windows on each side which have been covered up with plywood. The building rests on a concrete foundation.

Adjacent on the east is a second building on the same parcel. Its facade is slightly different than the above building. It has a recessed entrance with wood framed plate glass windows on either side and across the front. At the corners of the entrance, the bricks project slightly creating an interesting pattern. The cornice is plain brick laid on end and slightly raised parapet.

At the east end of the building is another entrance flanked by two rectangular wood frame double hung windows.

13. Condition: Excellent ___ Good ___ Fair X Deteriorated ___ No longer in existence ___
14. Alterations: window boarded up, front door changed
15. Surroundings: (Check more than one if necessary) Open land ___ Scattered buildings ___ Densely built-up X
 Residential ___ Industrial ___ Commercial X Other _____
16. Threats to site: None known X Private development ___ Zoning ___ Vandalism ___
 Public Works project ___ Other: _____
17. Is the structure: On its original site? X Moved? ___ Unknown? ___
18. Related features: none

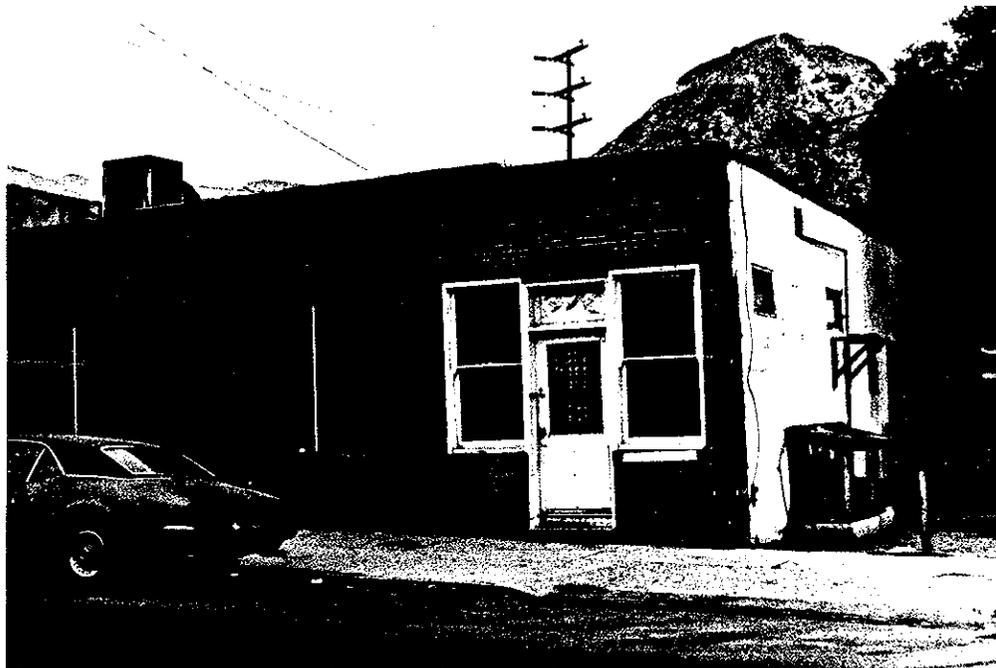
3943 E. Center St.
Photo Attachments

This building, east of 3943, was constructed in 1929 for E. W. Brehm who operated a drug store. The building is described on the first sheet.

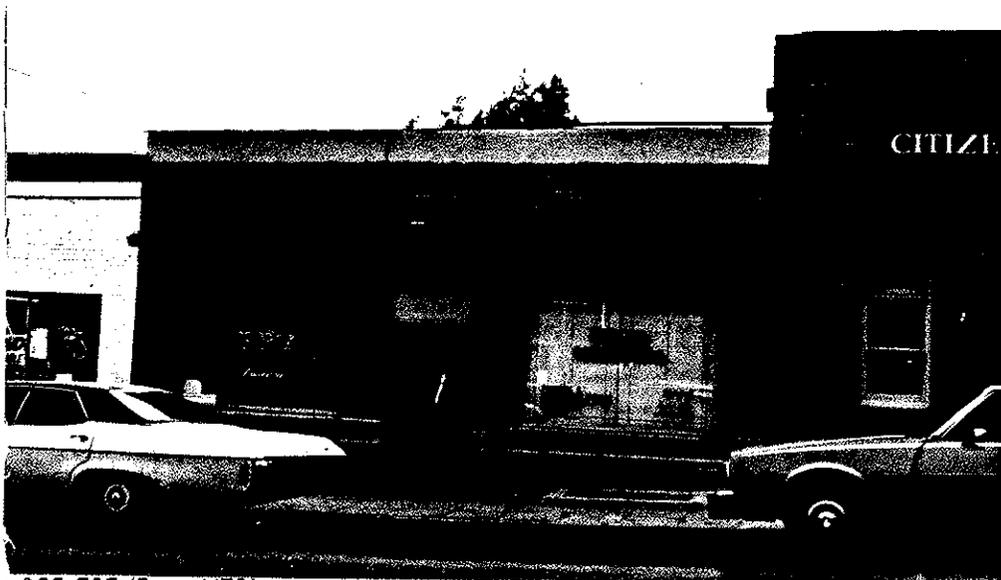
This flat-roofed rectangular shaped building has a plain cornice with a row of brick laid vertically. The front of the building is divided symmetrically with a centered recessed entrance with large plate glass windows on either side. Above entrance is a decorative vent with vertical openings. The windows are slightly recessed with wood frames. The building has a brick facade with plain concrete bulkheads.

13. Condition: Excellent ___ Good Fair ___ Deteriorated ___ No longer in existence ___
14. Alterations: transom closed
15. Surroundings: (Check more than one if necessary) Open land ___ Scattered buildings ___ Densely built-up
 Residential ___ Industrial ___ Commercial Other _____
16. Threats to site: None known Private development ___ Zoning ___ Vandalism ___
 Public Works project ___ Other: _____
17. Is the structure: On its original site? Moved? ___ Unknown? ___
18. Related features: none apparent

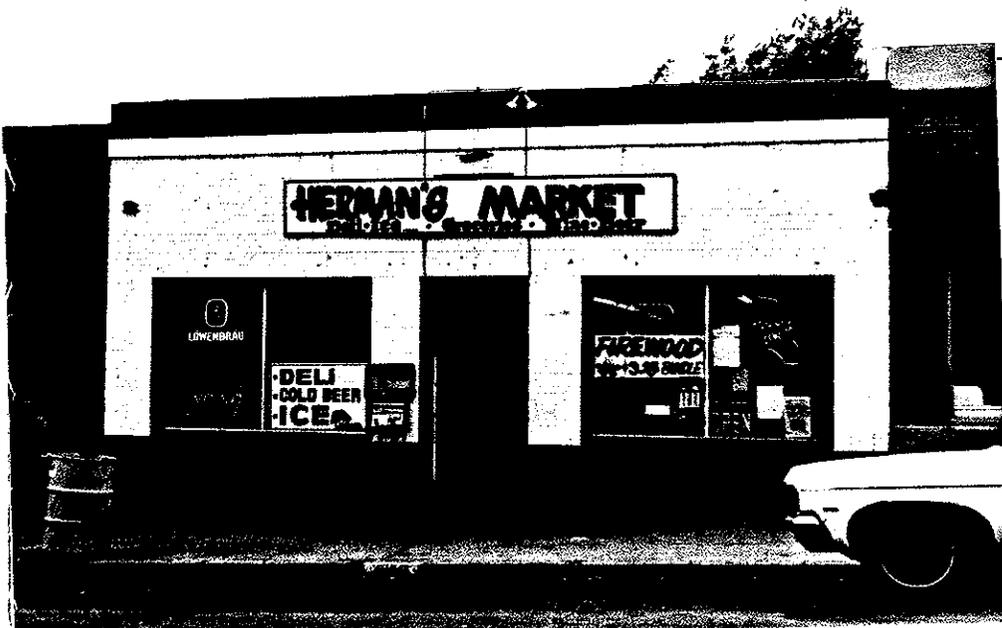
This single story building has a flat roof with plain cornice. Under the cornice are a row of vertical bricks. The building is symmetrically divided across the facade with the main entrance flanked by two large display windows. The windows have wood frames but have aluminum sashes. The front door is of wood and glass. The transom window has been boarded up. The building has a brick facade with concrete bulkhead.

13. Condition: Excellent ___ Good ___ Fair X Deteriorated ___ No longer in existence ___
14. Alterations: windows, transom over entrance
15. Surroundings: (Check more than one if necessary) Open land ___ Scattered buildings ___ Densely built-up X
 Residential ___ Industrial ___ Commercial X Other ___
16. Threats to site: None known X Private development ___ Zoning ___ Vandalism ___
 Public Works project ___ Other: ___
17. Is the structure: On its original site? X Moved? ___ Unknown? ___
18. Related features: None

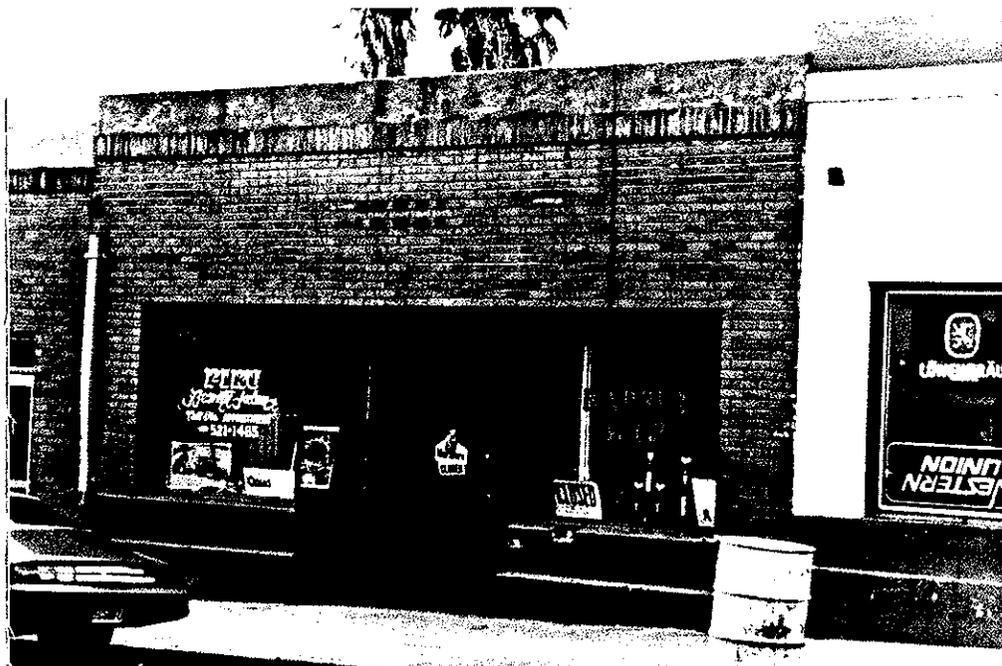
This single story building is rectangular in shape with a flat roof. The cornice is plain with a band of bricks placed vertically across the top. The entrance is recessed with double wood doors. The upper portion of the door is glass and the lower portion is wood. The plate glass windows with their wood frames extend across the facade and around the corners of the entrance. Above the entrance are cut out squares between the bricks which act as vents. The bulkheads are of smooth concrete.

13. Condition: Excellent ___ Good ___ Fair X Deteriorated ___ No longer in existence ___
14. Alterations: transom boarded up
15. Surroundings: (Check more than one if necessary) Open land ___ Scattered buildings ___ Densely built-up X
 Residential ___ Industrial ___ Commercial X Other _____
16. Threats to site: None known ___ Private development ___ Zoning ___ Vandalism ___
 Public Works project ___ Other: _____
17. Is the structure: On its original site? X Moved? ___ Unknown? ___
18. Related features: corrugated metal storage unit in rear

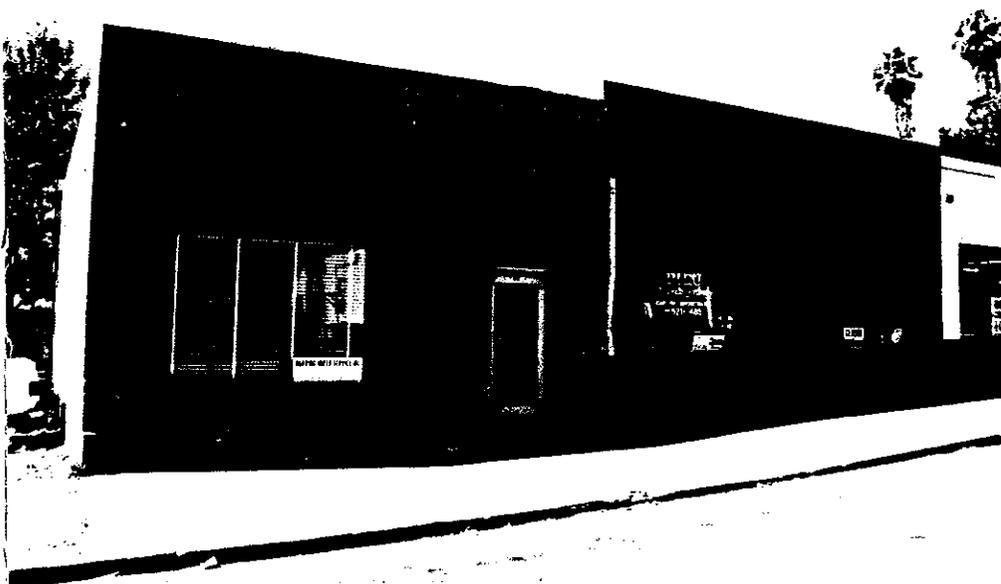
This single story building is rectangular in shape with a plain brick facade. The cornice is plain except for a row of bricks placed vertically. The entrance is slightly recessed with a wood and glass door and transom above. There is one rectangular shaped window with a wood frame and plate glass. The bulkhead is plain concrete. There are eight vent holes where the bricks have been removed to create square openings.

13. Condition: Excellent ___ Good X Fair ___ Deteriorated ___ No longer in existence ___
14. Alterations: none apparent
15. Surroundings: (Check more than one if necessary) Open land ___ Scattered buildings ___ Densely built-up X
 Residential ___ Industrial ___ Commercial X Other ___
16. Threats to site: None known X Private development ___ Zoning ___ Vandalism ___
 Public Works project ___ Other: ___
17. Is the structure: On its original site? X Moved? ___ Unknown? ___
18. Related features: none

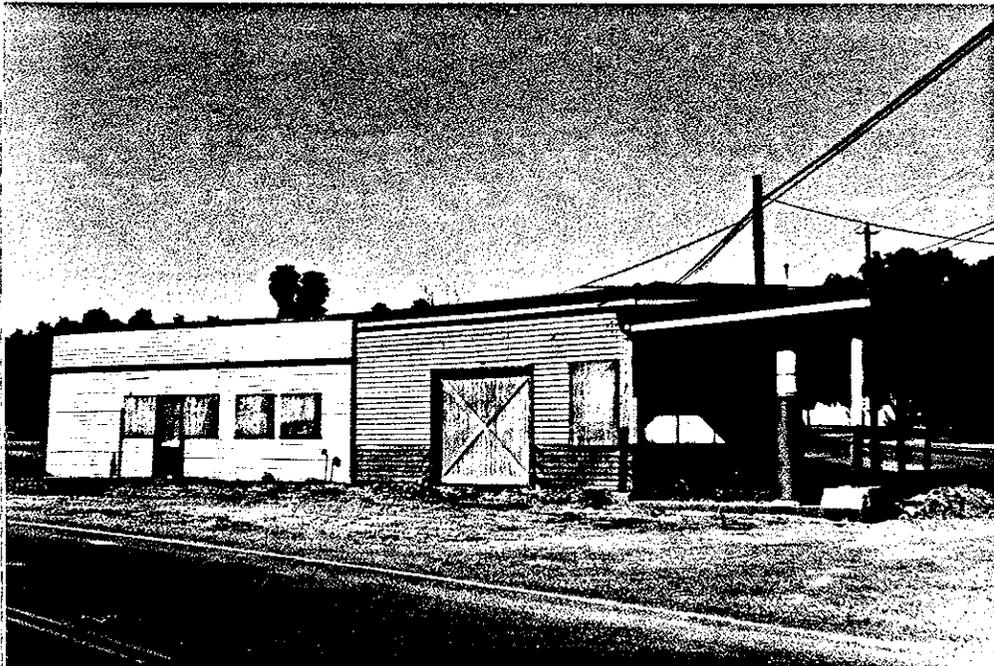
Located on a small corner lot, this small wood gas station has a flat roof. The corner of the building is cut off and a flat roof projects as a canopy over the gas pump. The roof is supported by several wood posts. Entrances and windows have been covered with boards. Windows have wood frames. At the rear of the building is an attached unit with entry and windows. Siding is medium clapboard. A large entrance with wood door is located on the east side.

13. Condition: Excellent Good Fair Deteriorated No longer in existence
14. Alterations: decorative wood oil well removed from roof
15. Surroundings: (Check more than one if necessary) Open land Scattered buildings Densely built-up
 Residential Industrial Commercial Other
16. Threats to site: None known Private development Zoning Vandalism
 Public Works project Other:
17. Is the structure: On its original site? Moved? Unknown?
18. Related features: old gasoline pump

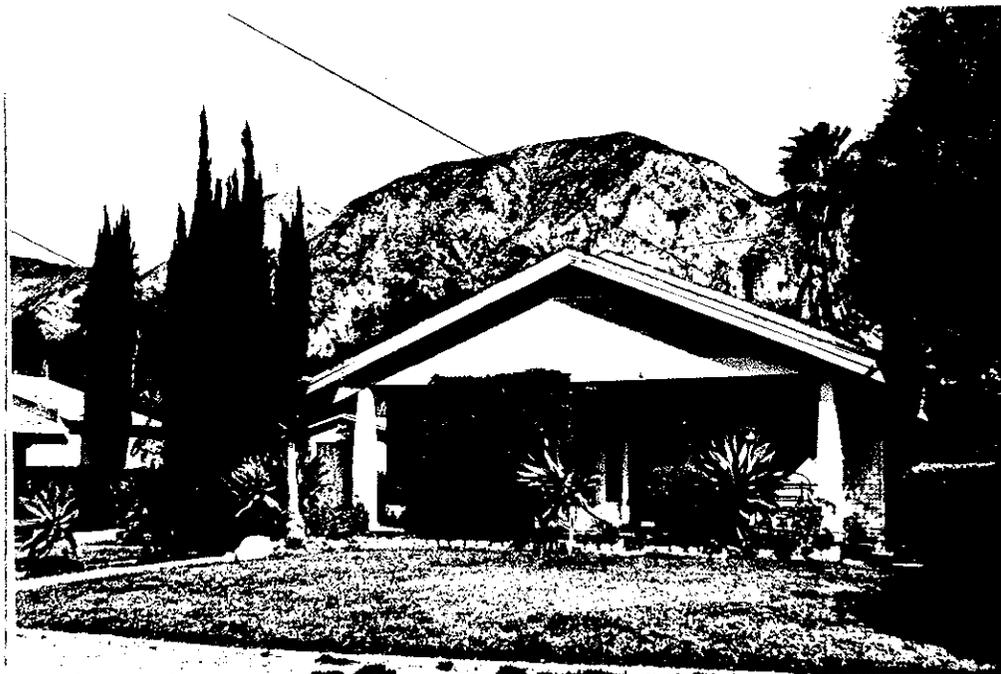
This single story rectangular shaped bungalow has a medium gable roof with an offset gable over the porch. The front porch is supported by tapered wood columns. Rafters are exposed under the eaves. Siding is narrow clapboard. Windows are double hung with wood frames. Mouldings are angled at the corners. The front door is flanked by multi-paned windows. There is a brick chimney on the east side of the house.

13. Condition: Excellent Good Fair Deteriorated No longer in existence
14. Alterations: none apparent
15. Surroundings: (Check more than one if necessary) Open land Scattered buildings Densely built-up
 Residential Industrial Commercial Other
16. Threats to site: None known Private development Zoning Vandalism
 Public Works project Other:
17. Is the structure: On its original site? Moved? Unknown?
18. Related features: detached single car garage

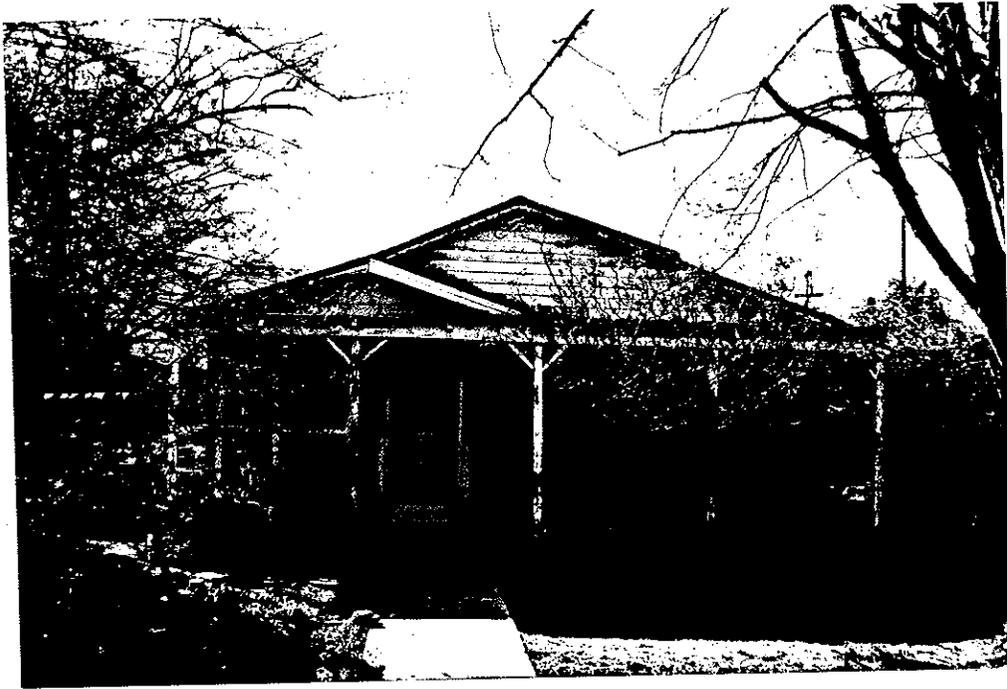
Bowdle & Bowdle Service
Photo Attachments

Main house - located west of cottages. This bungalow was built in 1925 possibly for Frank Woods. Frank W. Bowdle purchased the house for his family in 1928 and enlarged it. The house and cabins are still owned by the Bowdle family.

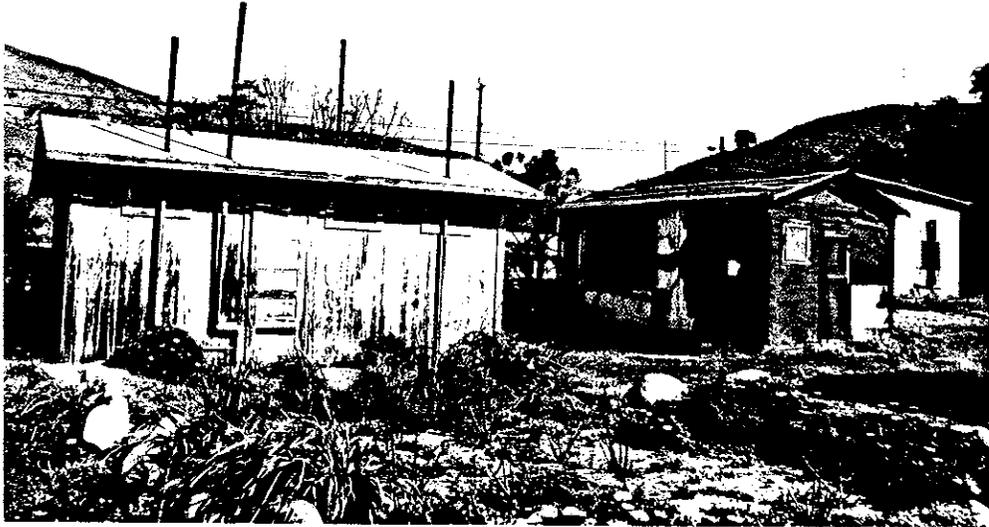
Bowdle & Bowdle Service
Photo Attachments

Cabins - This is another view of the cabins. All of the cabins are quite deteriorated and are no longer in use.

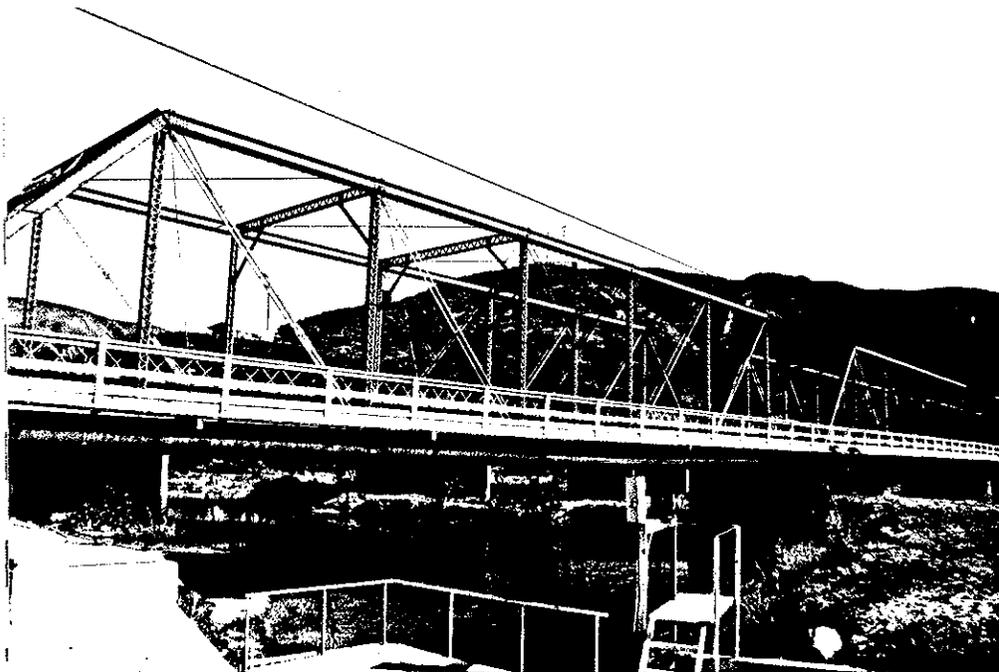
This is a steel through Pratt truss bridge with reinforced concrete dumbbell piers and reinforced concrete straight abutments and cement rubble slope protection. The deck is corrugated metal on timber stringers with p.m.s. surfacing. The width is 20' and the spans are 3 @ 129'-6". The total length is 397'. The roadway width is 19'-7" between steel rails. There is one sidewalk on the south @ 3'-9". The railings are steel lattice. The overhead clearance is 14'-7" @ portal frames.

13. Condition: Excellent ___ Good ___ Fair X Deteriorated ___ No longer in existence ___
14. Alterations: none apparent
15. Surroundings: (Check more than one if necessary) Open land ___ Scattered buildings X Densely built-up ___
 Residential X Industrial ___ Commercial ___ Other Sespe Creek
16. Threats to site: None known ___ Private development ___ Zoning ___ Vandalism ___
 Public Works project ___ Other: bridge no longer in use
17. Is the structure: On its original site? X Moved? ___ Unknown? ___
18. Related features: new bridge built on north side

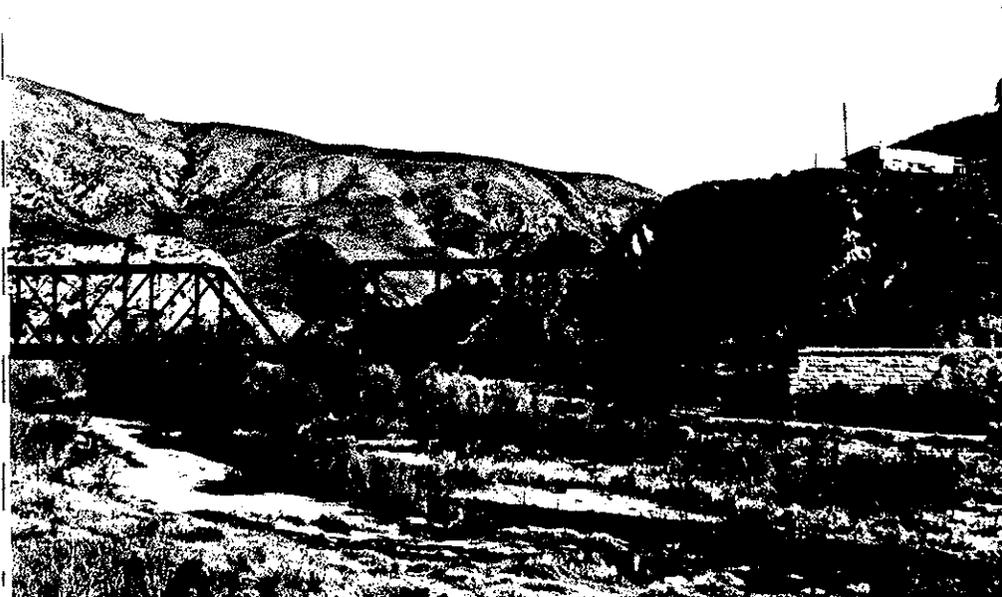
The bridge is a typical steel through-truss, two-span railroad bridge of turn-of-the-century construction type, approximately 300 feet in total length with a concrete center pier. The west abutment and upstream rip rap appear to be in good structural condition, and its load-carrying ability appears to far exceed the county's abandoned Center Street steel truss road bridge. No utilities (i.e. water lines, etc.) exist on the bridge.

13. Condition: Excellent ___ Good Fair ___ Deteriorated ___ No longer in existence ___
14. Alterations: none
15. Surroundings: (Check more than one if necessary) Open land Scattered buildings ___ Densely built-up ___
 Residential ___ Industrial ___ Commercial ___ Other Sespe Creek
16. Threats to site: None known Private development ___ Zoning ___ Vandalism ___
 Public Works project ___ Other: _____
17. Is the structure: On its original site? Moved? ___ Unknown? ___
18. Related features: none

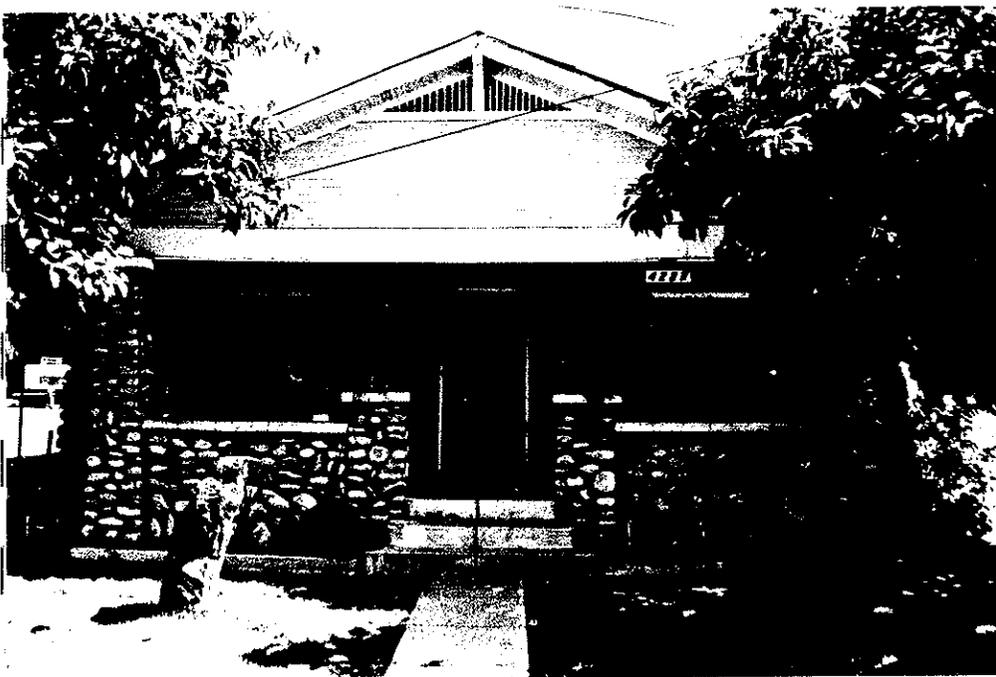
Built of native stone, this house is an outstanding example of hand craftsmanship seen in the arrangement of stones around the doors and windows. This single story residence has a medium gable roof and is rectangular in shape. Under the gable are exposed beams and clapboard siding. The double hung windows are recessed and have wood frames. The front porch is recessed across the front of the house and is supported by tapered stone columns and a stone railing. Both columns and railing are capped with concrete. The corners of the house are tapered. Under the eaves on the sides of the house are round vents with stone arranged in a circular fashion.

13. Condition: Excellent ___ Good Fair ___ Deteriorated ___ No longer in existence ___
14. Alterations: sleeping room addition
15. Surroundings: (Check more than one if necessary) Open land ___ Scattered buildings Densely built-up ___
 Residential Industrial ___ Commercial ___ Other ___
16. Threats to site: None known Private development ___ Zoning ___ Vandalism ___
 Public Works project ___ Other: ___
17. Is the structure: On its original site? Moved? ___ Unknown? ___
18. Related features: mature trees

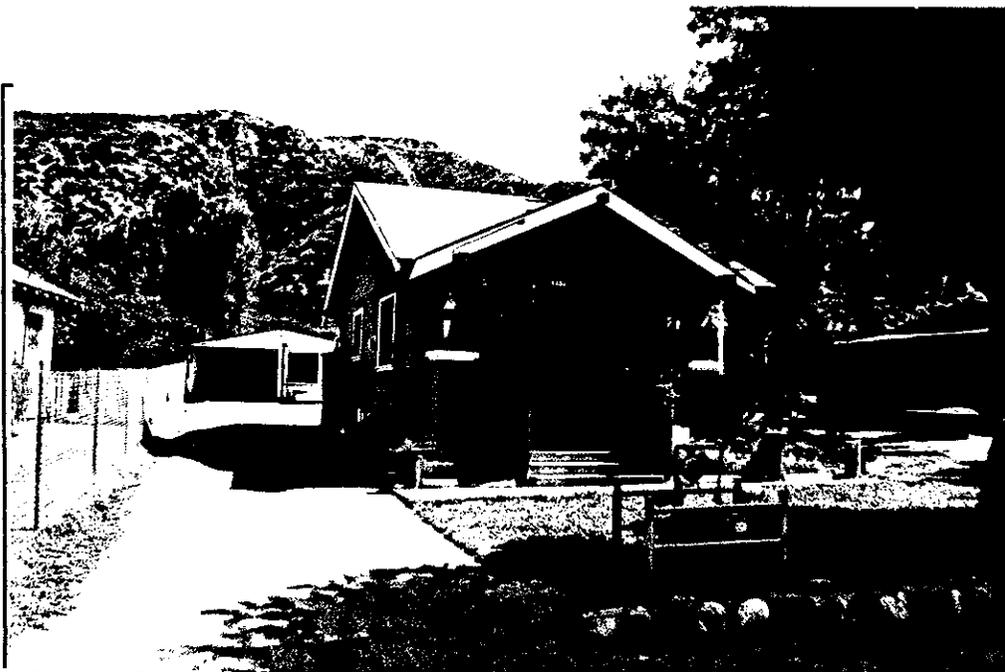
This single story residence has a medium gable roof and is rectangular in shape. The front porch is attached with a gable roof supported by two square columns. Each column is covered with wood siding on the lower half with two smaller columns on the upper half. Beams and rafters are projecting. There is decorative vertical board stickwork under the porch gable as well. Windows are double hung and casement with wood frames and mouldings. The house rests on a raised concrete foundation and is covered with clapboard siding.

13. Condition: Excellent ___ Good Fair ___ Deteriorated ___ No longer in existence ___
14. Alterations: none apparent
15. Surroundings: (Check more than one if necessary) Open land ___ Scattered buildings Densely built-up ___
 Residential Industrial ___ Commercial ___ Other ___
16. Threats to site: None known Private development ___ Zoning ___ Vandalism ___
 Public Works project ___ Other: ___
17. Is the structure: On its original site? Moved? ___ Unknown? ___
18. Related features: detached garage in rear/stone borders

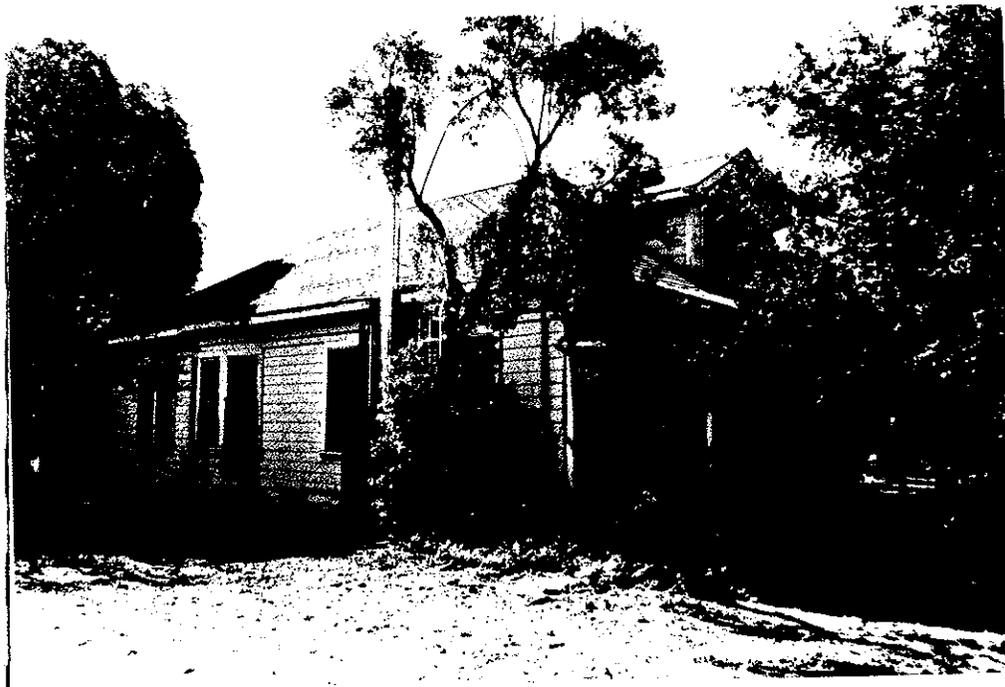
This 1 1/2 story rectangular shaped residence has a medium-high hip roof with gabled dormer windows on the front and side. A shed roof extends across the front porch and is supported by square columns. Eaves are boxed, and there is a slanted bay window on the north side. Windows are double hung and fixed with wood frames and mouldings. On the north side was a brick chimney which has recently been removed. The house rests on a concrete block foundation and is covered with wide board siding.

13. Condition: Excellent ___ Good ___ Fair Deteriorated ___ No longer in existence ___
14. Alterations: front door and windows changed
15. Surroundings: (Check more than one if necessary) Open land ___ Scattered buildings Densely built-up ___
Residential Industrial ___ Commercial ___ Other agricultural
16. Threats to site: None known Private development ___ Zoning ___ Vandalism ___
Public Works project ___ Other: _____
17. Is the structure: On its original site? Moved? ___ Unknown? ___
18. Related features: shed, garage, mature trees, citrus orchard

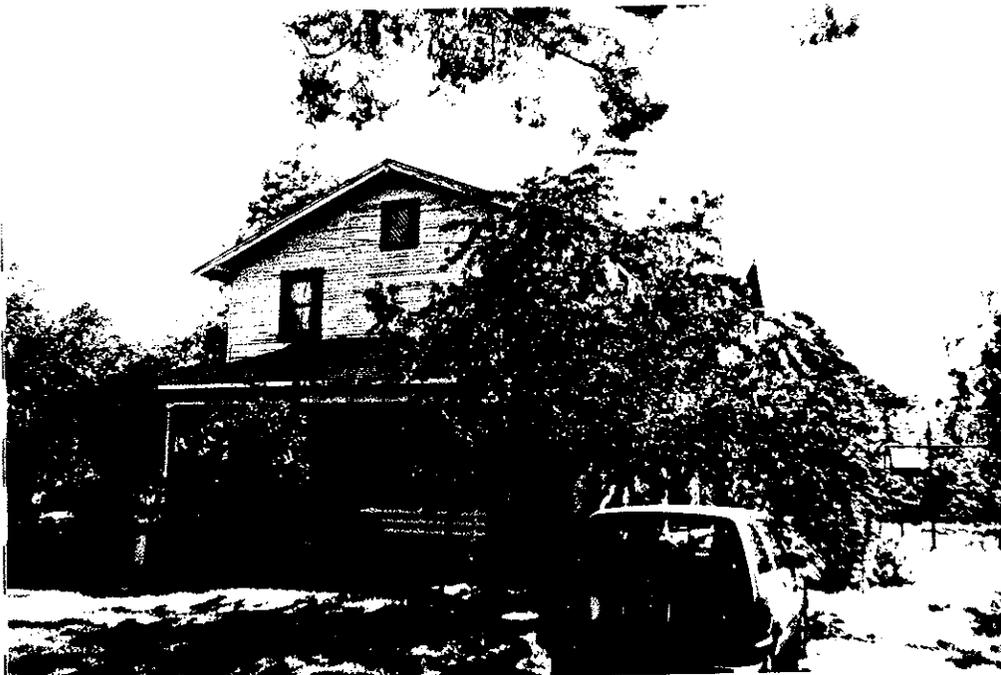
This large rectangular shape two-story residence has a medium pitched gable roof with with cross gabled. Under the eaves are exposed beams and rafters. The front porch is attached with a hip roof and supported by four round and capped columns. The porch wraps around the side of the house. The windows are double hung and casement with wood frames and mouldings. The front first floor windows are decorative with diamond shaped patterns. The house rests on a raised concrete foundation and is covered with narrow clapboard siding.

13. Condition: Excellent ___ Good ___ Fair X Deteriorated ___ No longer in existence ___
14. Alterations: uncertain
15. Surroundings: (Check more than one if necessary) Open land ___ Scattered buildings X Densely built-up ___
 Residential X Industrial ___ Commercial ___ Other agricultural
16. Threats to site: None known X Private development ___ Zoning ___ Vandalism ___
 Public Works project ___ Other: _____
17. Is the structure: On its original site? X Moved? ___ Unknown? ___
18. Related features: Mature pines, palms, round rocks, orange grove

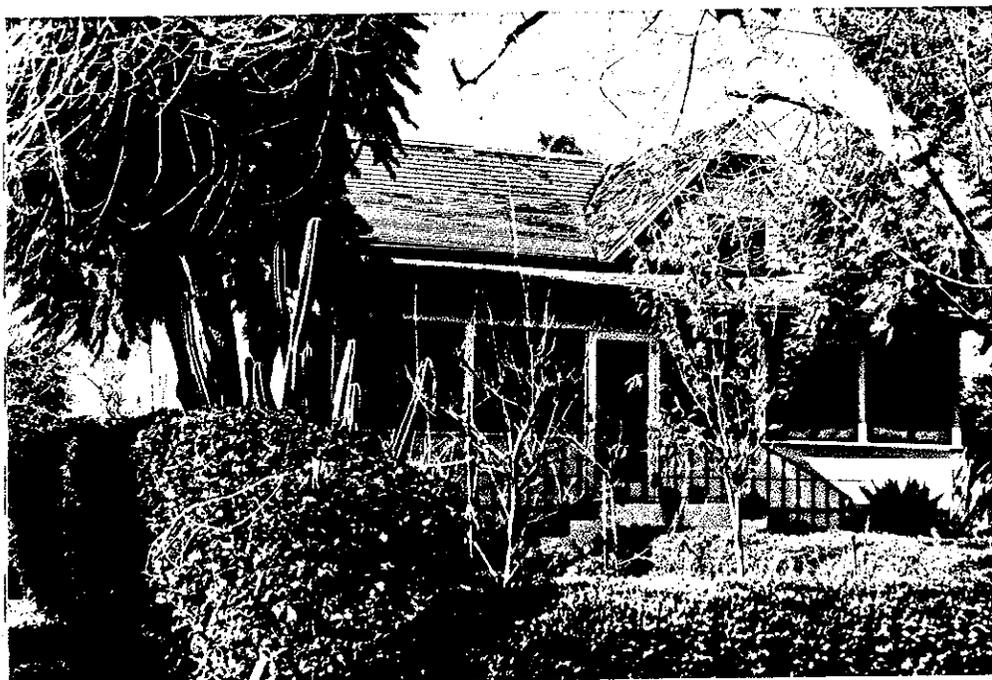
This single story residence has a medium gable roof with offset front gable. Under the front gable are decorative fishscale shingles and carved design of 5 fleur-de-lis cutouts and a shell. Steps lead up to the porch on two sides, both with wrought iron railings. The porch is attached with a shed roof and a row of screened windows with wide siding below. Windows have wood frames and are double hung. The house is built on a concrete block foundation. The house is covered with wide board siding.

13. Condition: Excellent ____ Good Fair ____ Deteriorated ____ No longer in existence ____
14. Alterations: enclosed front porch, addition at rear side
15. Surroundings: (Check more than one if necessary) Open land ____ Scattered buildings ____ Densely built-up
 Residential Industrial ____ Commercial ____ Other ____
16. Threats to site: None known Private development ____ Zoning ____ Vandalism ____
 Public Works project ____ Other: _____
17. Is the structure: On its original site? Moved? ____ Unknown? ____
18. Related features: small barn in rear, small stucco residence in rear

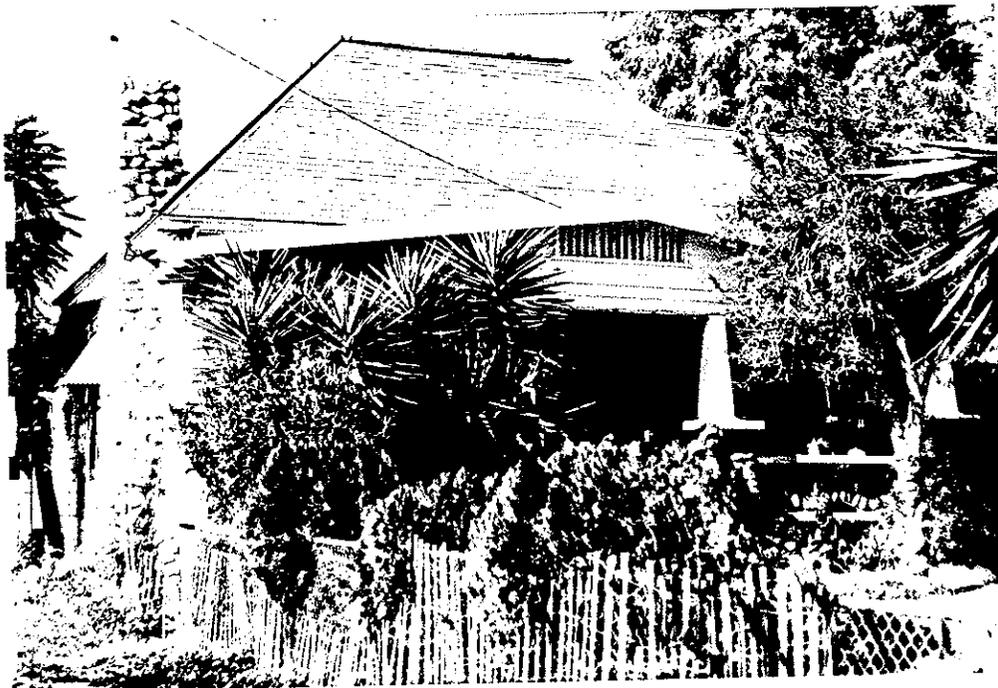
Basically rectangular in shape, this one story residence has a medium hip roof. Attached to the front is a low gable roofed porch supported by tapered stone columns and railing and tapered wood columns on upper portion. A large tapered stone chimney is located on the south side of the house. The main roof has boxed beams, and the porch roof has exposed rafters. The house rests on a raised stone foundation and is covered with wide board siding. Windows are double hung with wood frames and mouldings. Some windows have multi-panes and are probably later additions.

13. Condition: Excellent ___ Good Fair ___ Deteriorated ___ No longer in existence ___
14. Alterations: porch addition, rear addition
15. Surroundings: (Check more than one if necessary) Open land ___ Scattered buildings ___ Densely built-up
 Residential Industrial ___ Commercial ___ Other ___
16. Threats to site: None known Private development ___ Zoning ___ Vandalism ___
 Public Works project ___ Other: _____
17. Is the structure: On its original site? Moved? ___ Unknown? ___
18. Related features: detached garage in rear, mature trees

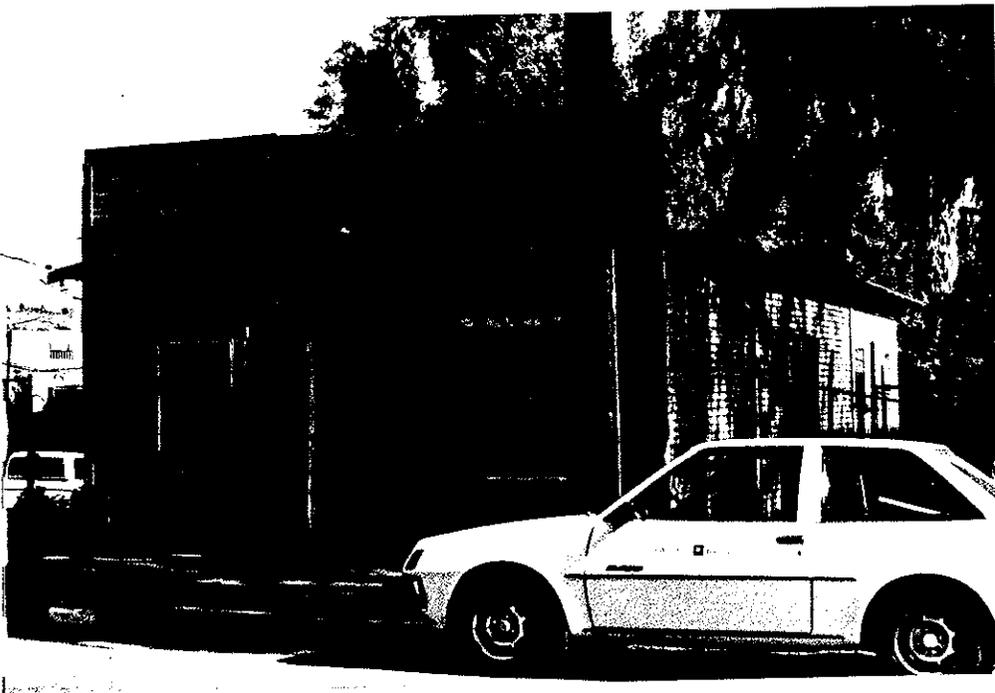
This rectangular shaped single story residence has a medium gable roof with a rectangular shaped false front. The corners and cornice of the building have simple wood trim. The trim is repeated around the windows. Windows are double hung with wood frames. The building is covered with medium-narrow clapboards and rests on a wood foundation.

13. Condition: Excellent ___ Good ___ Fair Deteriorated ___ No longer in existence ___
14. Alterations: aluminum siding on rear of north side
15. Surroundings: (Check more than one if necessary) Open land ___ Scattered buildings ___ Densely built-up
 Residential Industrial ___ Commercial ___ Other ___
16. Threats to site: None known Private development ___ Zoning ___ Vandalism ___
 Public Works project ___ Other: _____
17. Is the structure: On its original site? Moved? ___ Unknown? ___
18. Related features: none

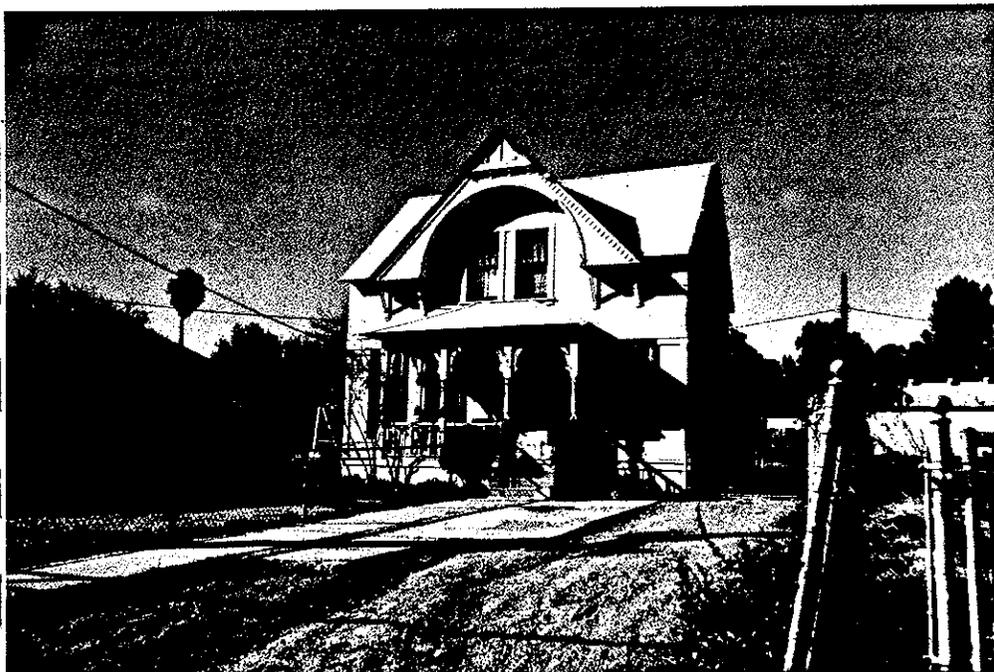
This house is identical to the house at 623 N. Park, except that this house has kept its original porch. The house is two stories in height with a steep pitched gable roof with returns at the corners. The intersecting front gable is the prominent feature with its horseshoe shaped arch and decorative details. At the peak of the gable are vertical boards, decorative brackets and under the eaves are details. Knee brackets are located under the gable. A hip roof covers the attached front porch and is supported by decorative turned columns and brackets that repeat the curve of the main arch. Siding is shingles on the second story and narrow clapboards on the first floor.

The house rests on a raised foundation and is covered with a vertical board skirt. Windows are double hung with wood frames and flat wood mouldings.

13. Condition: Excellent ___ Good ___ Fair Deteriorated ___ No longer in existence ___
14. Alterations: porch altered, cresting removed from roof
15. Surroundings: (Check more than one if necessary) Open land ___ Scattered buildings ___ Densely built-up
 Residential Industrial ___ Commercial ___ Other ___
16. Threats to site: None known Private development ___ Zoning ___ Vandalism ___
 Public Works project ___ Other: _____
17. Is the structure: On its original site? Moved? ___ Unknown? ___
18. Related features: addition in rear, garage in rear

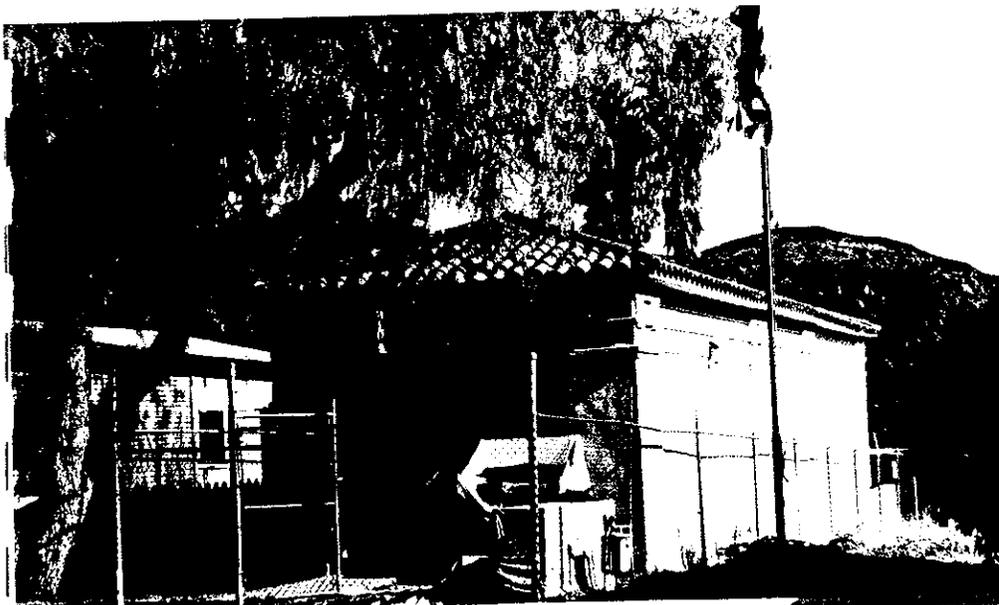
This small single story rectangular shaped building has a hip roof of clay tile with boxed eaves. The building is heavily decorated with large pilasters breaking up the stucco surface. The cornice is an extension of the pilasters, divided into two smaller units. There are only two openings, both in the facade. The door and window are slightly arched in the corners. The door is of metal with 3 large iron hasps. The window has multi paned beveled glass covered with iron bars. The building rests on a concrete foundation.

13. Condition: Excellent ___ Good Fair ___ Deteriorated ___ No longer in existence ___
14. Alterations: air conditioner above entrance
15. Surroundings: (Check more than one if necessary) Open land ___ Scattered buildings ___ Densely built-up
 Residential Industrial ___ Commercial ___ Other ___
16. Threats to site: None known Private development ___ Zoning ___ Vandalism ___
 Public Works project ___ Other: _____
17. Is the structure: On its original site? Moved? ___ Unknown? ___
18. Related features: mature pepper tree

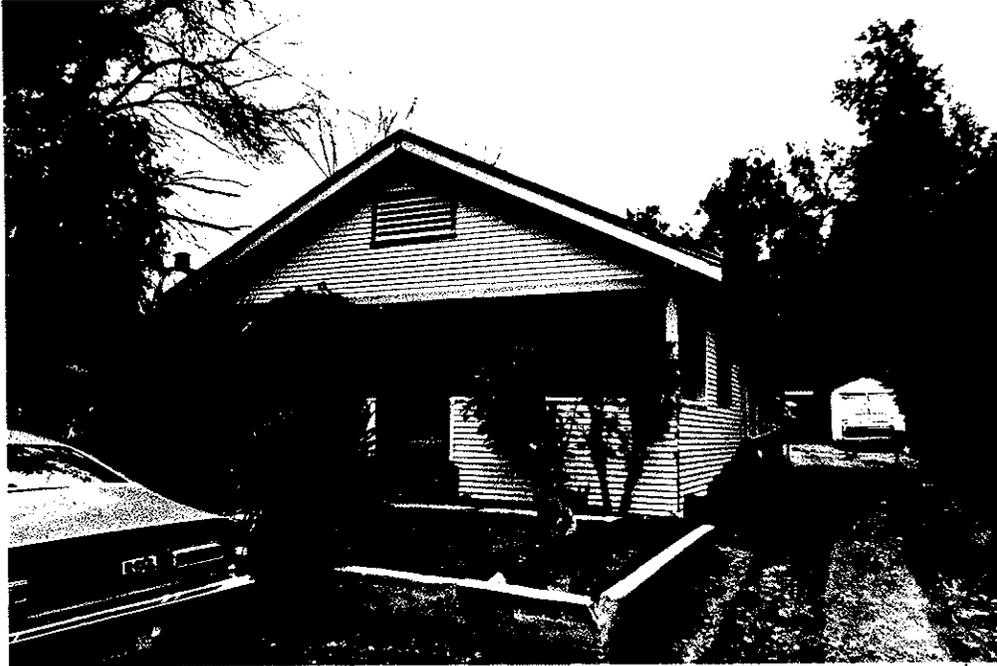
725 N. Main St.
Parcel #: 056-053-060
Owner: Luis Rodriguez

The house has a gable roof and is rectangular in shape with the front porch recessed under the main gable. The porch is supported by square capped columns on the upper half and an enclosed railing on the lower half. The windows are casement with wood frames and flat wood mouldings. The house rests on a concrete foundation and is covered with narrow clapboard siding.

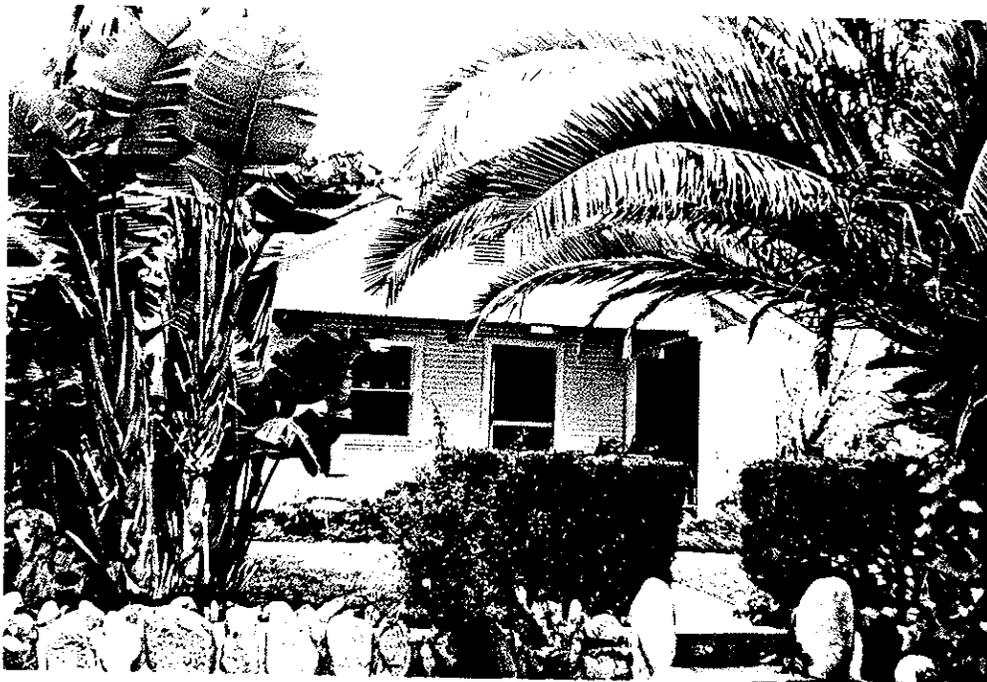
753 N. Main St.
Parcel #: 056-053-260
Owner: unknown

This one story bungalow has a medium gable roof with exposed rafters under the broad eaves. The house is rectangular in shape with an attached porch. The porch has a gable roof supported by two square wood columns. Windows are double hung with wood frames and mouldings. The house is covered with clapboard siding and rests on a concrete foundation.

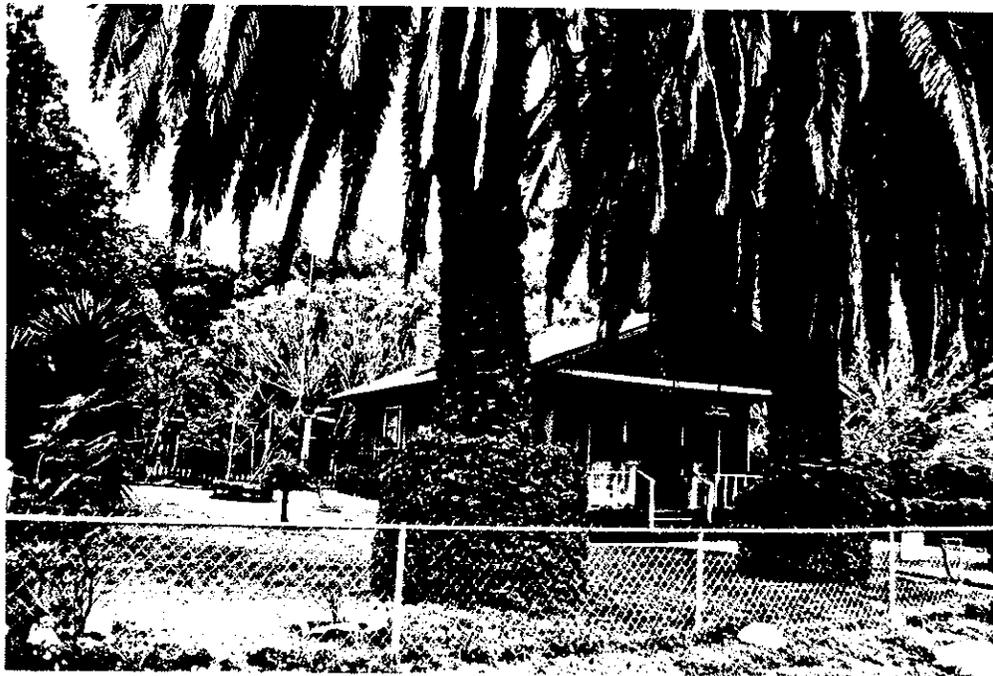
739 N. Main St.

The house is rectangular in shape with a medium gable roof. The porch is recessed under the main gable and is supported by two large square capped columns and an open wood porch railing. A brick chimney punctuates the roof line. Windows are double hung with wood frames and mouldings. The house is covered with board and batten siding.

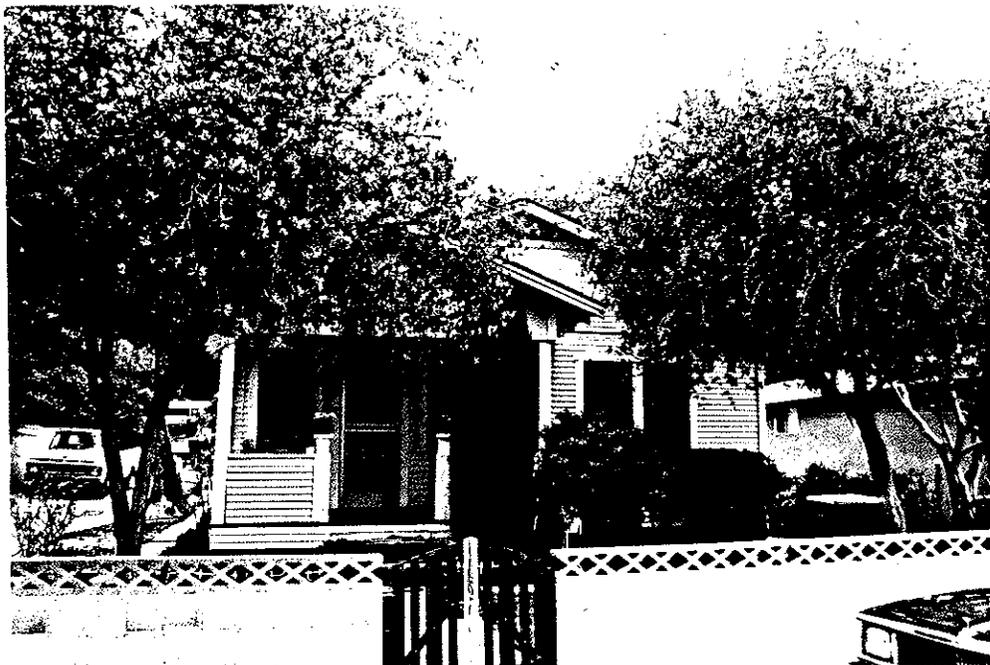
759 N. Main St.
Parcel #: 056-053-270
Owner: Benny/Angelina Vega

Rectangular in shape, this California Bungalow has a medium gable roof with an offset gable over the front porch. The porch is supported by capped columns and an enclosed railing. Windows are double hung with wood frames and mouldings. The house has exposed rafters under the eaves. Siding is medium clapboard. The house rests on a foundation of concrete blocks and wood piers
