CULTURAL HERITAGE SURVEY PHASE IV SANTA CLARA VALLEY

**COUNTY OF VENTURA
CULTURAL HERITAGE SURVEY
PHASE IV - SANTA CLARA VALLEY**

**Prepared by Judy Triem
San Buenaventura Research Associates**

January 1988

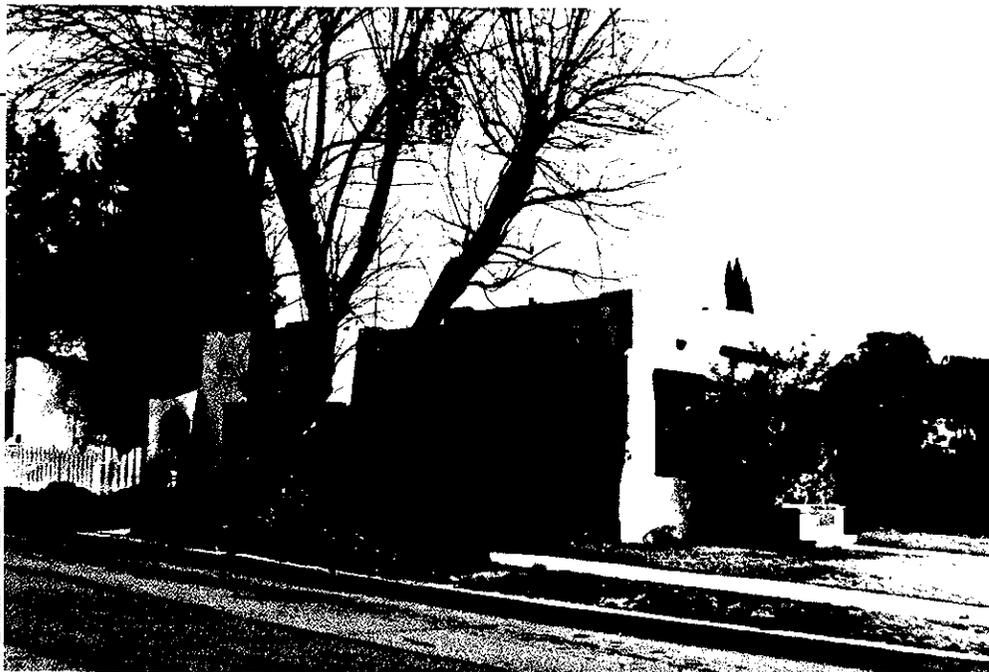
This rectangular shaped building has a flat roof with raised corner parapets and a gabled parapet over the entry. The front entrance has a shed roof of clay tiles and concrete steps leading up to the entry. The entrance has a stucco framed arch. Circular tile vents, located below the parapet, add a decorative effect. Windows are double hung with multi-panes at the top and wood frames. At the rear of the house is an arched wing wall. An additional decorative feature are the projecting wing walls at the corners of the facade. The house is covered with stucco and rests on a concrete foundation.

13. Condition: Excellent ___ Good Fair ___ Deteriorated ___ No longer in existence ___
14. Alterations: none apparent
15. Surroundings: (Check more than one if necessary) Open land ___ Scattered buildings ___ Densely built-up
 Residential Industrial ___ Commercial ___ Other ___
16. Threats to site: None known Private development ___ Zoning ___ Vandalism ___
 Public Works project ___ Other: ___
17. Is the structure: On its original site? Moved? ___ Unknown? ___
18. Related features: detached two-car garage in rear - same style as house

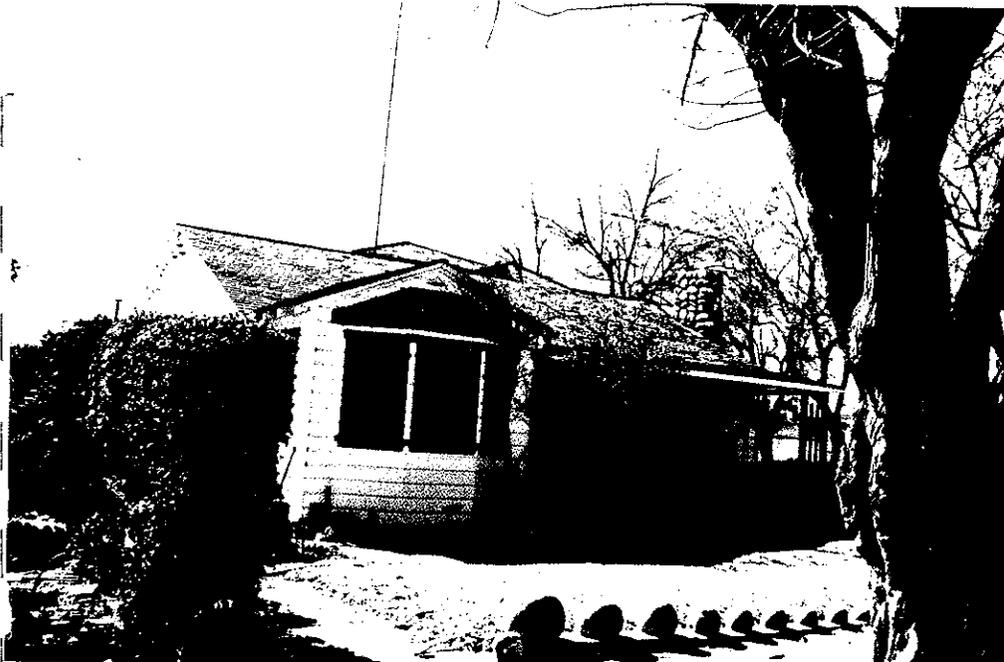
The original portion of the house was one-story and L-shaped with a slanted bay window on the front wing. The roof is a medium pitched gable with a shed roof over the porch supported by square posts. A tapered stone chimney is located on the west side. At the rear of the house is a second story hipped roof addition with a slanted bay window on the first floor. Windows have wood frames and are double hung with wood mouldings. The front slanted bay window has multi-panes and a hip roof. The house rests on a concrete foundation and is covered with wide board siding.

13. Condition: Excellent Good ___ Fair ___ Deteriorated ___ No longer in existence ___
14. Alterations: 2nd story addition in rear
15. Surroundings: (Check more than one if necessary) Open land ___ Scattered buildings ___ Densely built-up
Residential Industrial ___ Commercial ___ Other ___
16. Threats to site: None known Private development ___ Zoning ___ Vandalism ___
Public Works project ___ Other: ___
17. Is the structure: On its original site? Moved? ___ Unknown? ___
18. Related features: 2-car garage; 2nd building in rear - Lechler's Museum

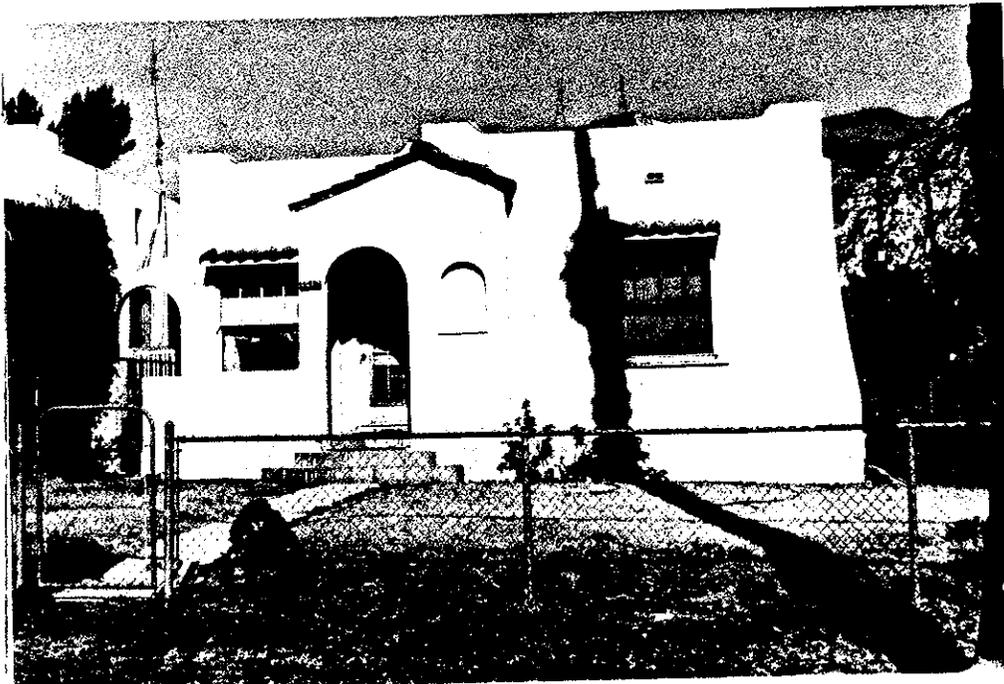
Primarily square in shape, this single story residence has a flat roof with raised parapet at the corners. The porch has a gable roof and a rounded arched opening with low wall to one side. On the west side is an arched wing wall with a tapered wing wall on the east side. Over the two front windows are small shed roofs of clay tile. The house is covered with stucco. Windows are wood frame and double hung with wood mouldings. There are four glass panes in the upper half and one large pane in the lower half of the two front windows. The house rests on a concrete foundation and the porch is raised with concrete steps.

13. Condition: Excellent ___ Good Fair ___ Deteriorated ___ No longer in existence ___
14. Alterations: none apparent
15. Surroundings: (Check more than one if necessary) Open land ___ Scattered buildings Densely built-up
 Residential Industrial ___ Commercial ___ Other Other
16. Threats to site: None known Private development ___ Zoning ___ Vandalism ___
 Public Works project ___ Other: ___
17. Is the structure: On its original site? Moved? ___ Unknown? Yes
18. Related features: detached garage in rear

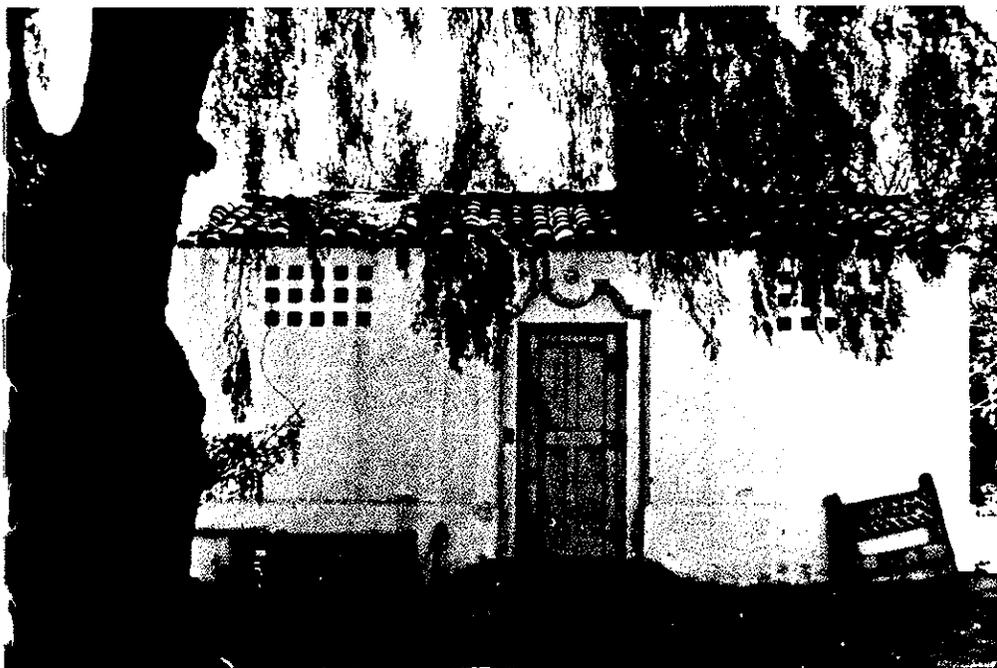
This small rectangular shaped one story building features a gable roof covered with tiles. There are no windows, only decorative square shaped vents on each side of the entrance. The entrance has a Mission style feeling with a scalloped recessed portion surrounding the paneled heavy metal door. Two concrete steps lead to the door. The building is covered with stucco. The interior has four small cells with two bunks in each cell.

13. Condition: Excellent ____ Good ____ Fair Deteriorated ____ No longer in existence ____
14. Alterations: none apparent
15. Surroundings: (Check more than one if necessary) Open land ____ Scattered buildings ____ Densely built-up
 Residential Industrial ____ Commercial ____ Other _____
16. Threats to site: None known Private development ____ Zoning ____ Vandalism ____
 Public Works project ____ Other: _____
17. Is the structure: On its original site? Moved? ____ Unknown? ____
18. Related features: mature pepper tree

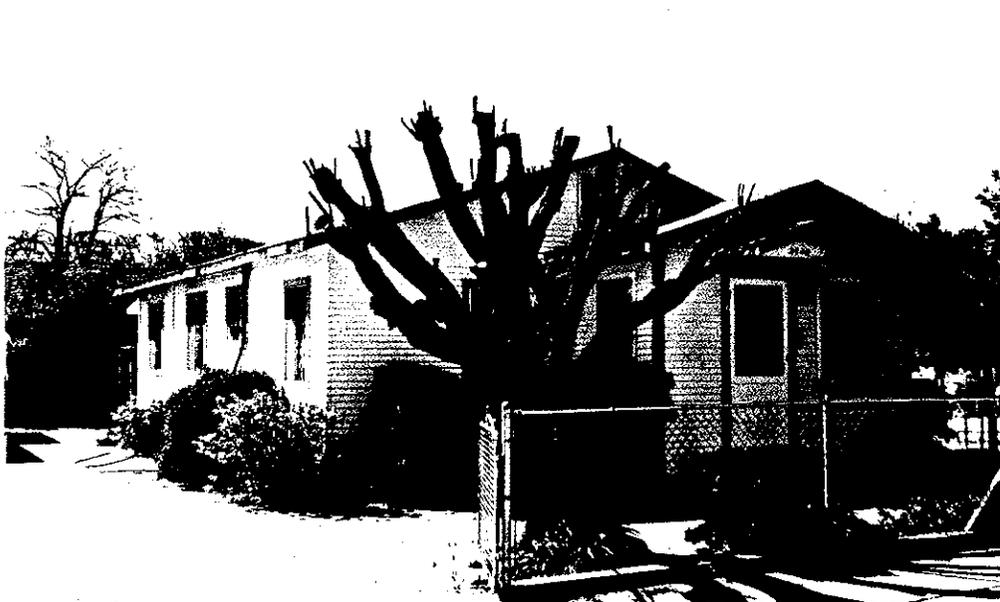
This single story gable roofed residence is rectangular in shape with an offset gable. A small gable is braced over the front door. The offset gable was probably a porch at one time. Windows have wood frames and are double hung. Some windows have sliding aluminum frames. The house rests on a concrete foundation and is covered with narrow clapboards. On the west side of the house is a shed roof porch supported by square posts. Rafters are exposed under the eaves.

13. Condition: Excellent Good Fair Deteriorated No longer in existence
14. Alterations: porch may have been open originally
15. Surroundings: (Check more than one if necessary) Open land Scattered buildings Densely built-up
 Residential Industrial Commercial Other
16. Threats to site: None known Private development Zoning Vandalism
 Public Works project Other:
17. Is the structure: On its original site? Moved? Unknown?
18. Related features: second unit - small gabled residence; detached stucco garage

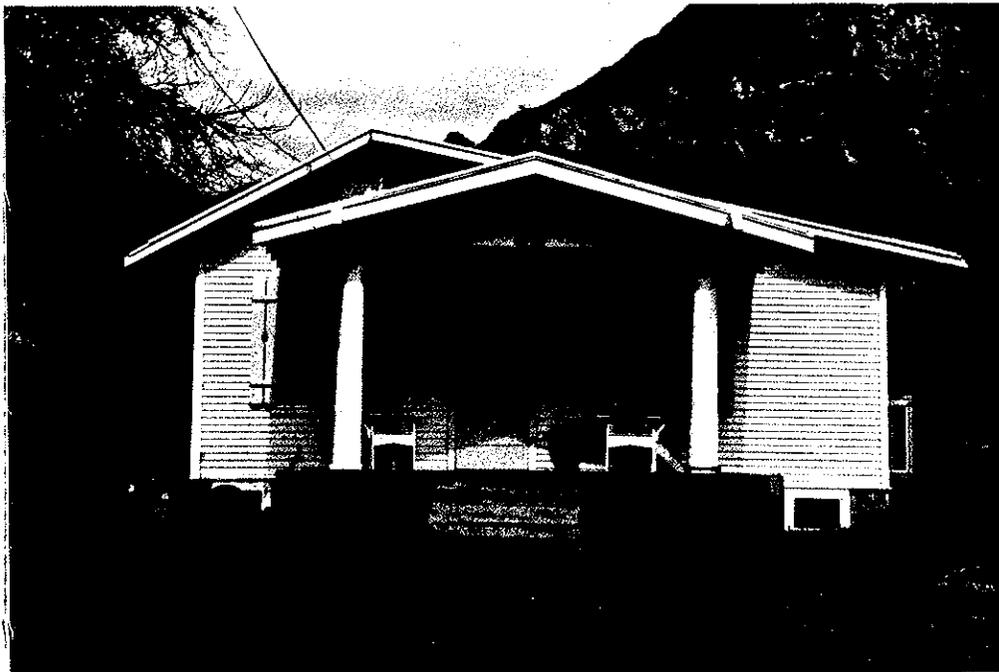
This single story residence has an unusual gable roof which is longer on one side. Exposed rafters are located under the eaves. The front porch is attached with a gable roof supported by two large round Doric style columns. Windows are double hung with wood frames and mouldings. Decorative shutters are located on each side of the front windows. The house rests on a raised concrete foundation and is covered with narrow clapboard siding.

13. Condition: Excellent Good Fair Deteriorated No longer in existence
14. Alterations: none apparent
15. Surroundings: (Check more than one if necessary) Open land Scattered buildings Densely built-up
 Residential industrial Commercial Other
16. Threats to site: None known Private development Zoning Vandalism
 Public Works project Other:
17. Is the structure: On its original site? Moved? Unknown?
18. Related features: post-1940s house on Park St. side of lot

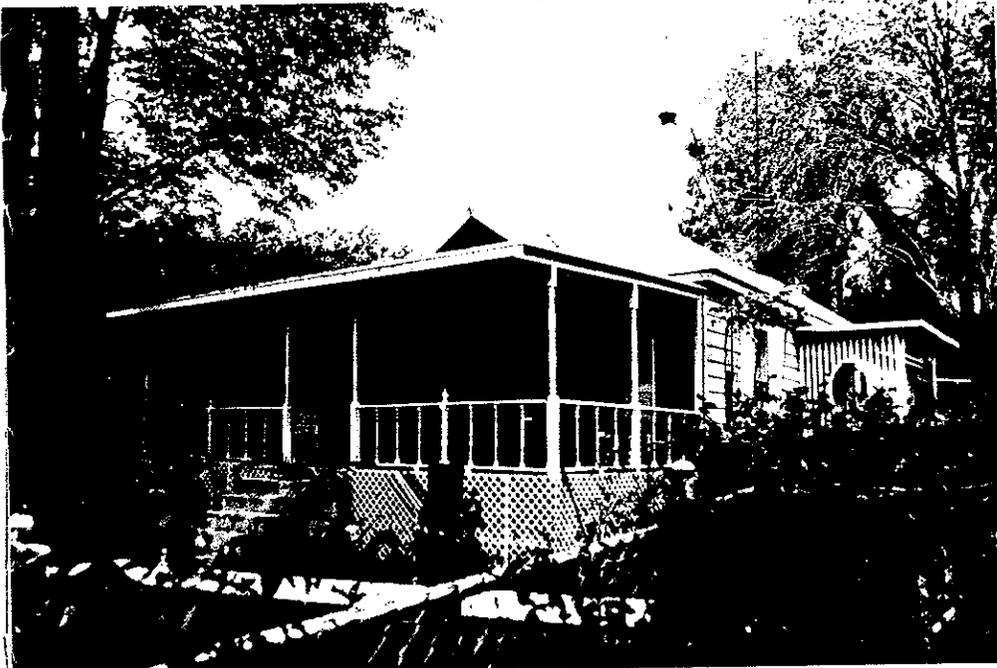
This rectangular shaped single story residence has a hip roof with a gable over the front porch. The porch roof has been altered to include a broad shed roof supported by turned wood columns and railing with a lattice skirt and concrete steps. A shed roof porch on the north side is a later addition with wood slats and oval opening. Windows are long and narrow and double hung with wood frames and moulding. Shutters have been added. Siding is wide shiplap. The house is on a raised foundation of concrete and wood posts.

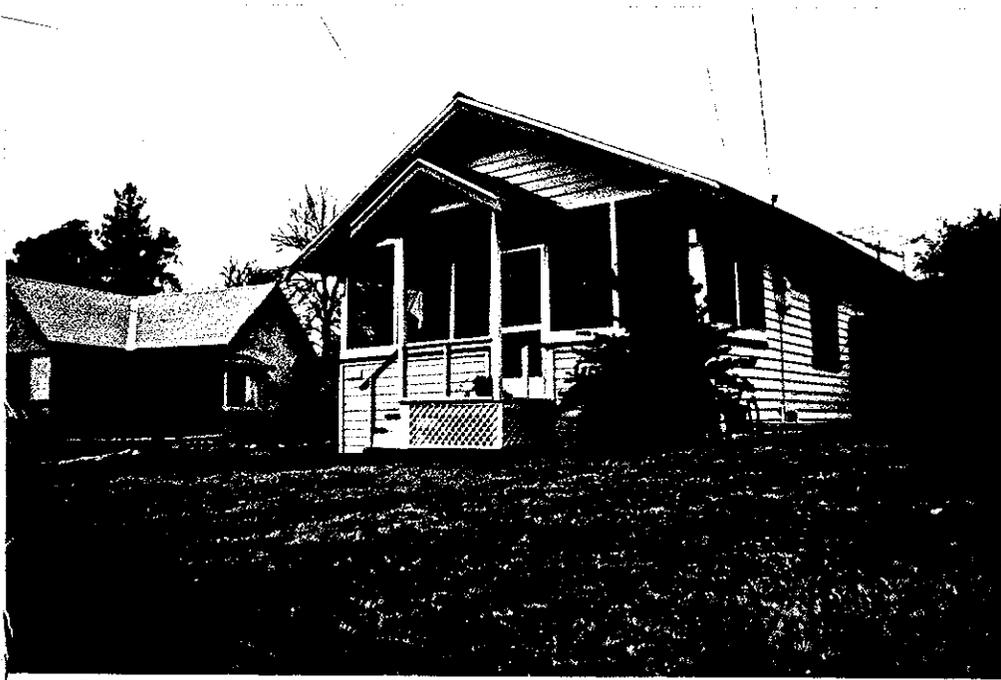
This single story rectangular shaped residence has a medium pitched gable roof with the front porch recessed under the main gable. The porch has been enclosed with screens. A small gabled roof is attached under the main gable and is supported by wood posts and railing, thereby creating a second small porch. Windows are double hung with wood frames and wood mouldings. There are knee brackets under the front gable at the corners of the house. A lattice skirt is located on the small front porch and a lattice vent under the main gable. The house has a wood skirt and rests on concrete and wood piers. Siding is medium clapboard.

13. Condition: Excellent Good Fair Deteriorated No longer in existence
14. Alterations: none apparent
15. Surroundings: (Check more than one if necessary) Open land Scattered buildings Densely built-up
 Residential Industrial Commercial Other
16. Threats to site: None known Private development Zoning Vandalism
 Public Works project Other:
17. Is the structure: On its original site? Moved? Unknown?
18. Related features: two-car garage in rear

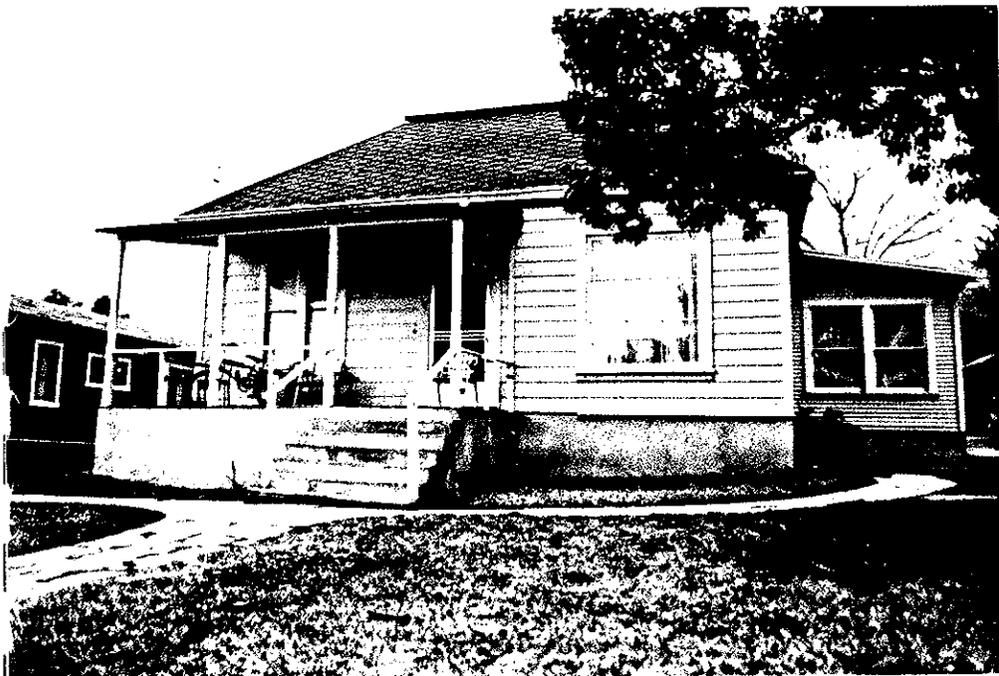
This single story residence has a square shape except for the rear addition. The roof is a truncated hip with a shed roof over the porch. The porch is supported by chamfered columns and has a simple wood railing. The railing is not original. The house has a raised concrete perimeter foundation. Windows are double hung with wood frames and mouldings. The front window on the north side is fixed multi-paned and is probably not original. The front door is paneled and has a semi-circular paned top window. Siding is wide shiplap.

13. Condition: Excellent Good Fair Deteriorated No longer in existence
14. Alterations: shed roof addition on north side in rear
15. Surroundings: (Check more than one if necessary) Open land Scattered buildings Densely built-up
 Residential Industrial Commercial Other
16. Threats to site: None known Private development Zoning Vandalism
 Public Works project Other:
17. Is the structure: On its original site? Moved? Unknown?
18. Related features: detached garage

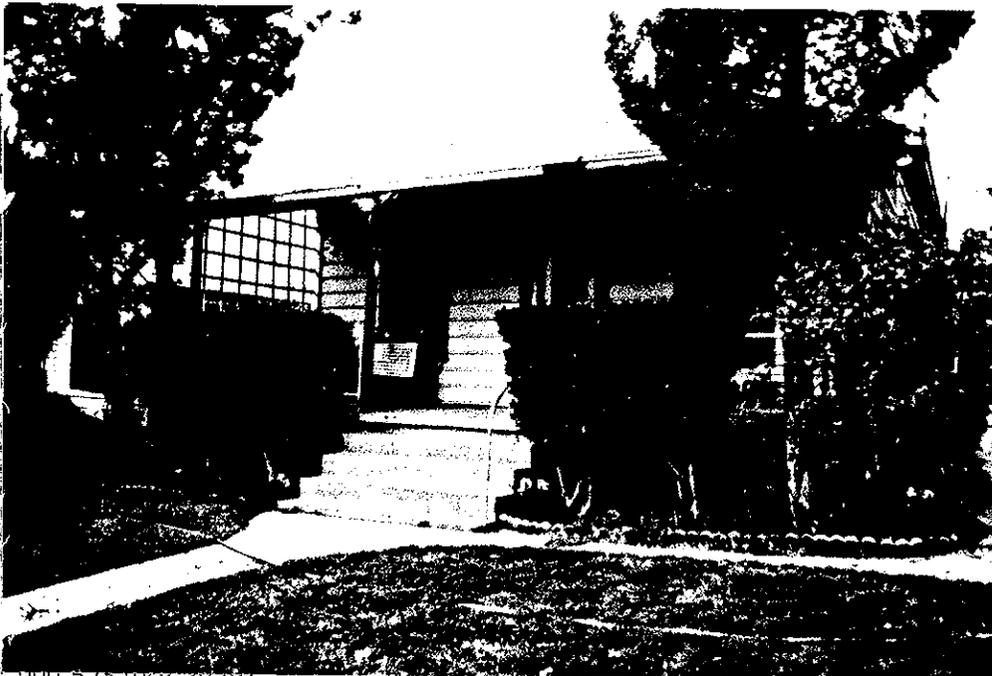
This one story residence is rectangular in shape with a pyramid shaped roof. A shed roof covers the front porch and is supported by square wood columns. The concrete perimeter foundation is raised and concrete steps lead to the front porch. Windows are double hung with wood frames and mouldings. Siding is wide shiplap. A wood lattice has been attached to the south side of the front porch.

13. Condition: Excellent ___ Good ___ Fair Deteriorated ___ No longer in existence ___
14. Alterations: porch
15. Surroundings: (Check more than one if necessary) Open land ___ Scattered buildings ___ Densely built-up
 Residential Industrial ___ Commercial ___ Other ___
16. Threats to site: None known Private development ___ Zoning ___ Vandalism ___
 Public Works project ___ Other: ___
17. Is the structure: On its original site? Moved? ___ Unknown? ___
18. Related features: detached two-car garage

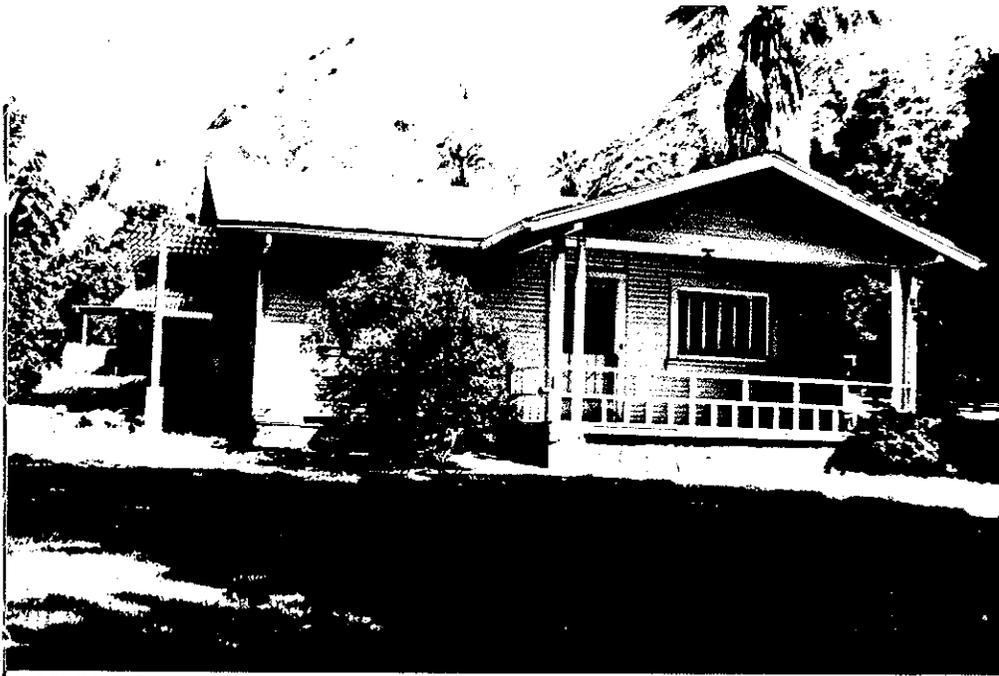
This single story rectangular shaped residence has a medium-low side facing gable roof with an offset gable over the front porch. The attached porch has exposed beams and is supported by three square wood posts at each corner. The posts are tapered at the top. Windows are fixed or double hung with wood frames and flat wood mouldings. The house is covered with narrow clapboard siding and rests on a concrete foundation.

13. Condition: Excellent Good Fair Deteriorated No longer in existence
14. Alterations: none apparent
15. Surroundings: (Check more than one if necessary) Open land Scattered buildings Densely built-up
Residential Industrial Commercial Other
16. Threats to site: None known Private development Zoning Vandalism
Public Works project Other:
17. Is the structure: On its original site? Moved? Unknown?
18. Related features: small house in rear - same style

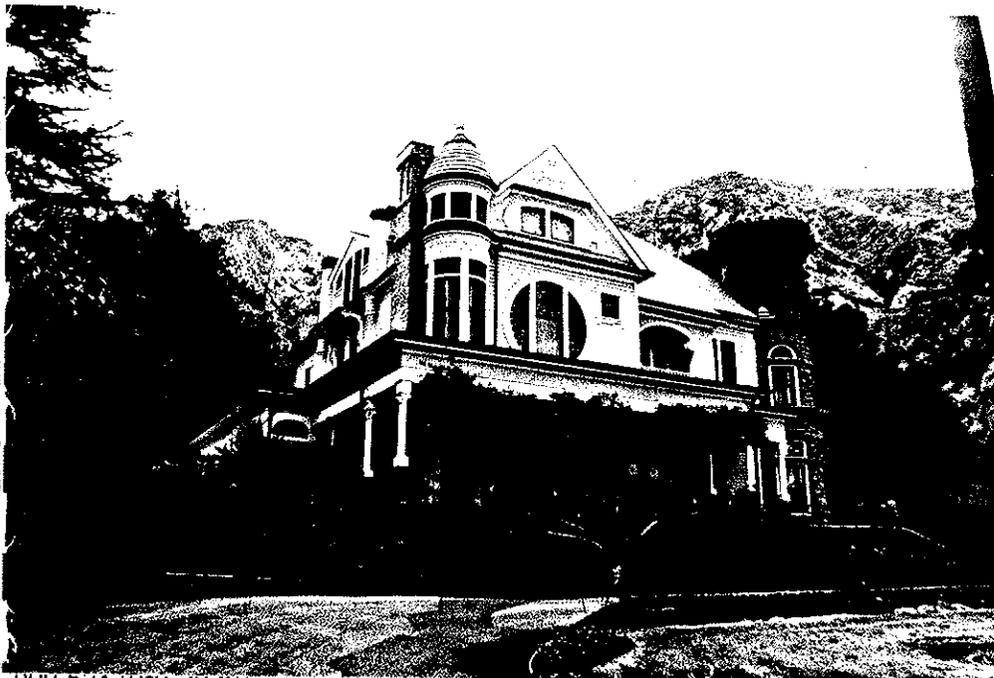
The Queen Anne style is at its highest with this two and a half story multi-gabled residence, whose three story Sespe stone tower vies for prominence with the three story pointed wood tower capped with the Phoenix bird finial - a new symbolic addition to this rebuilt mansion. The main roof is a truncated hip with several high peaked gables extending from each side. Decorative applied wood embellishments are found under the gables. Another prominent feature are the moon windows and recessed arched balconies. A profusion of wood is found on the surface in the form of various shingle patterns, etc. The house is on a raised Sespe stone foundation and located on the hillside. The wrap-around porch is supported by stone on the lower portion and wood columns on the upper part. The railing is of wrought iron with carved sea horses. Two magnificent brick and Sespe stone fireplaces are found on the north and south sides of the house. There are seven stained glass windows. The mountains and heavy landscaping provide a magnificent backdrop for the house, which can be seen at a great distance from the highway.

13. Condition: Excellent Good ___ Fair ___ Deteriorated ___ No longer in existence ___
14. Alterations: completely rebuilt after fire in 1981 - built as close to original as possible
15. Surroundings: (Check more than one if necessary) Open land ___ Scattered buildings Densely built-up ___
Residential Industrial ___ Commercial ___ Other ___
16. Threats to site: None known Private development ___ Zoning ___ Vandalism ___
Public Works project ___ Other: ___
17. Is the structure: On its original site? Moved? ___ Unknown? ___
18. Related features: mature trees, pool house, pump house, outhouse, storage shed

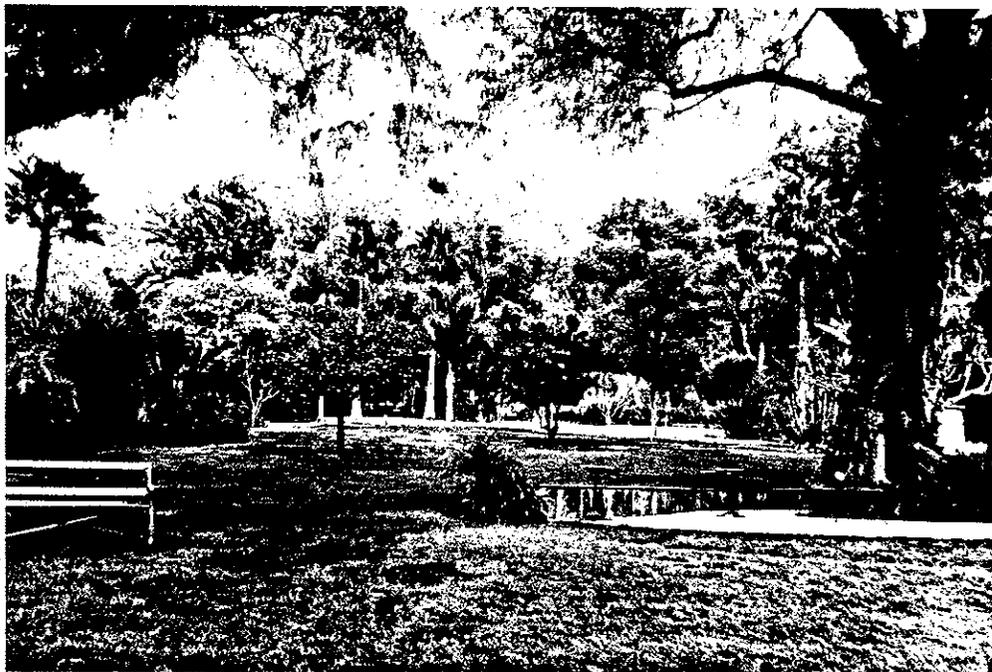
Rear of main house

The grounds around the house are heavily landscaped with many varieties of ornamental and native trees. Cook himself had many trees planted. It is uncertain how many remain from the time that Cook lived here.

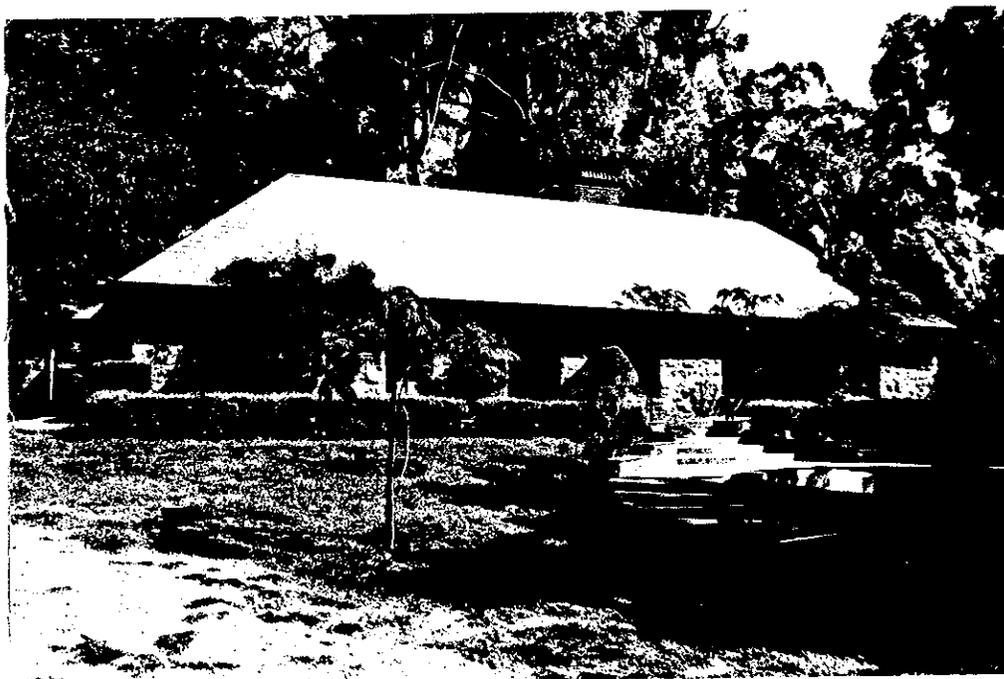
This long rectangular house has a high hip roof of slate with copper gutters and downspouts. It is built entirely of native stone, except the brick chimney. The large rectangular windows are multi-paned metal casements and are recessed. The front entrance is quite impressive with a circular pond with stone walls and surrounding walkway leading to the front entry. The entry itself is recessed with a copper canopy and paneled wood door. The house rests on a concrete foundation. The house had a fire in 1984 and the roof was replaced and interior redone.

13. Condition: Excellent Good Fair Deteriorated No longer in existence
14. Alterations: none apparent
15. Surroundings: (Check more than one if necessary) Open land Scattered buildings Densely built-up
Residential Industrial Commercial Other
16. Threats to site: None known Private development Zoning Vandalism
Public Works project Other:
17. Is the structure: On its original site? Moved? Unknown?
18. Related features: attached garage, breezeway

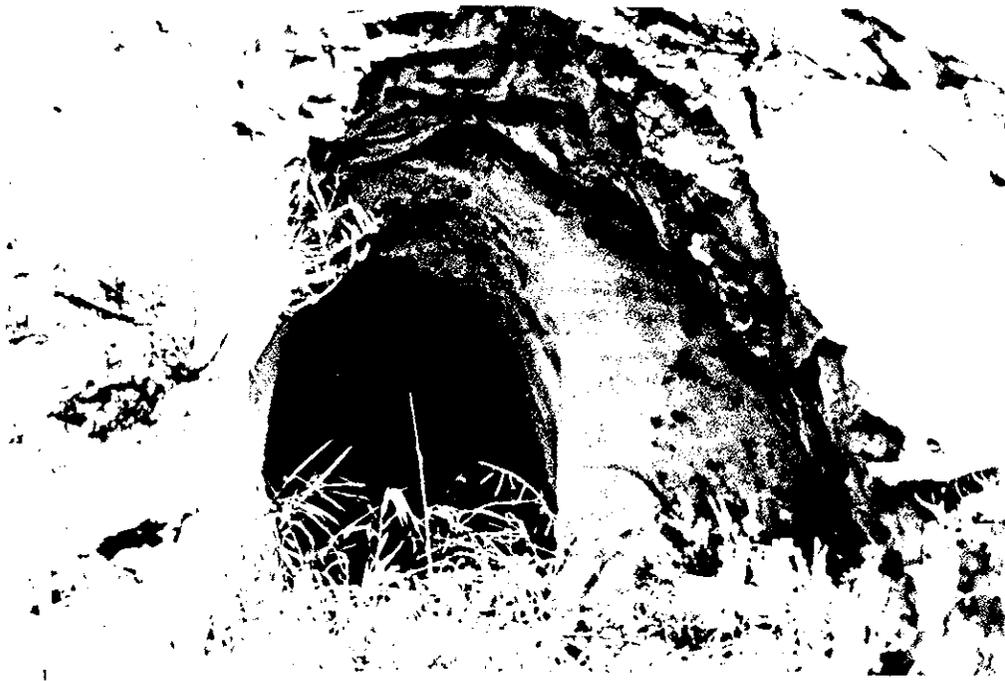
Piru Water System tunnel
Parcel #: 55-080-050
Owner: Texaco, Inc.

This entrance to the tunnel is located on the east side of Piru Canyon Rd. on land owned by Texaco Oil Co. The tunnel is located near Holser Canyon above Holser Creek about 1/4 of a mile above the wash. The tunnel was built for David C. Cook's water system that originated at the head of Piru Creek in Piru Canyon. It is uncertain who built the tunnel but the laborers probably included local Indians, Mexicans and Spaniards and perhaps some Chinese.

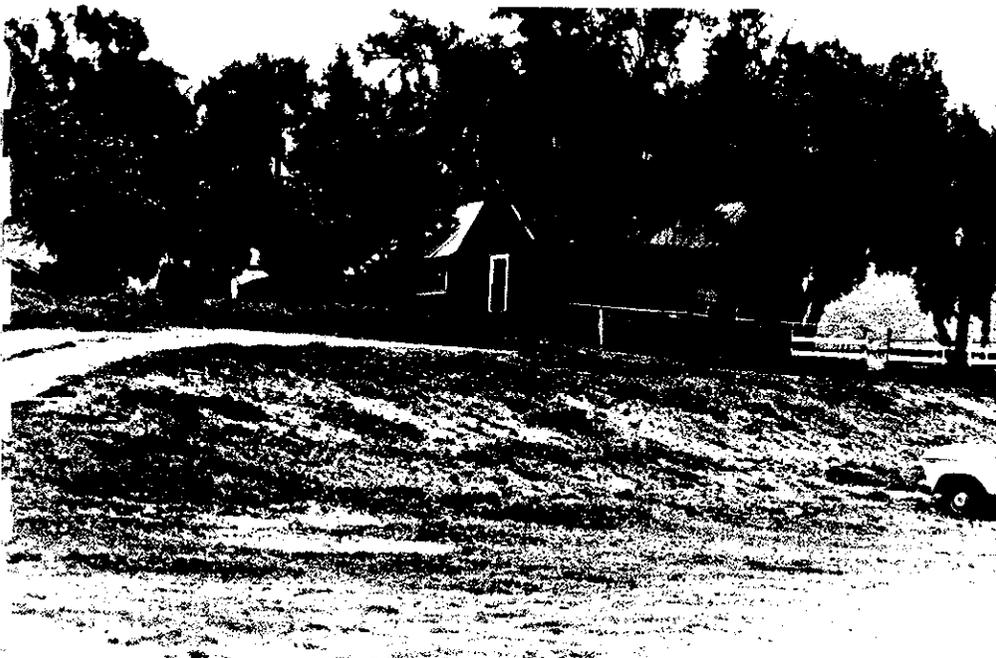
This one story residence has a high pitched cross gable roof. The front entrance is located in the L-shaped portion of the house and has a shed roof. The porch has been enclosed, and another small covered entry has been added with a shed roof and square wood supports. Windows are double hung and casement with wood frames and mouldings. Some windows are fixed with multi-panes. This was probably the addition put on in 1966 or else a change to the original window. Siding is board and bat and the foundation is wood. The house is located on a small knoll surrounded by olive trees and a wood fence.

13. Condition: Excellent Good Fair Deteriorated No longer in existence
14. Alterations: various
15. Surroundings: (Check more than one if necessary) Open land Scattered buildings Densely built-up
Residential Industrial Commercial Other cattle ranch/oil
16. Threats to site: None known Private development Zoning Vandalism
Public Works project Other: _____
17. Is the structure: On its original site? Moved? Unknown?
18. Related features: barns, sheds, olive trees

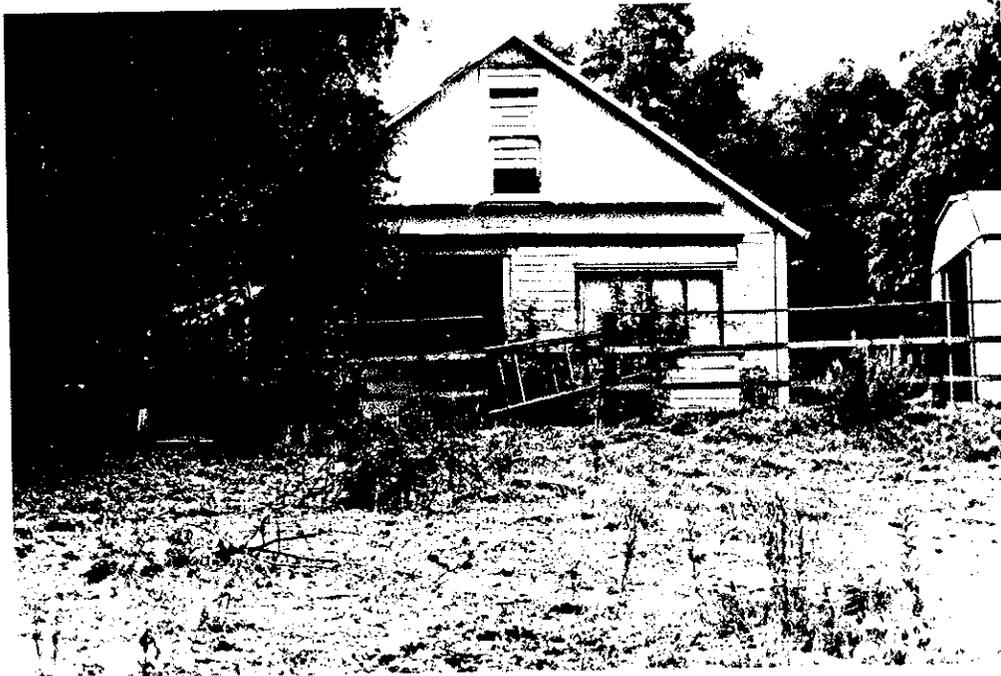
The second house on the property is located directly north of the board and batten structure. According to the Assessor's records, the house was built about 1910. It probably was built before 1900 for David C. Cook and used as a ranch hand's house.

The house has a high gable roof with a shed roof over the porch. The porch is enclosed on one side. The house is deteriorated and has had several changes including the porch enclosure. The windows are double hung with wood frames and mouldings. Siding is horizontal wide board. The house rests on a wood foundation.

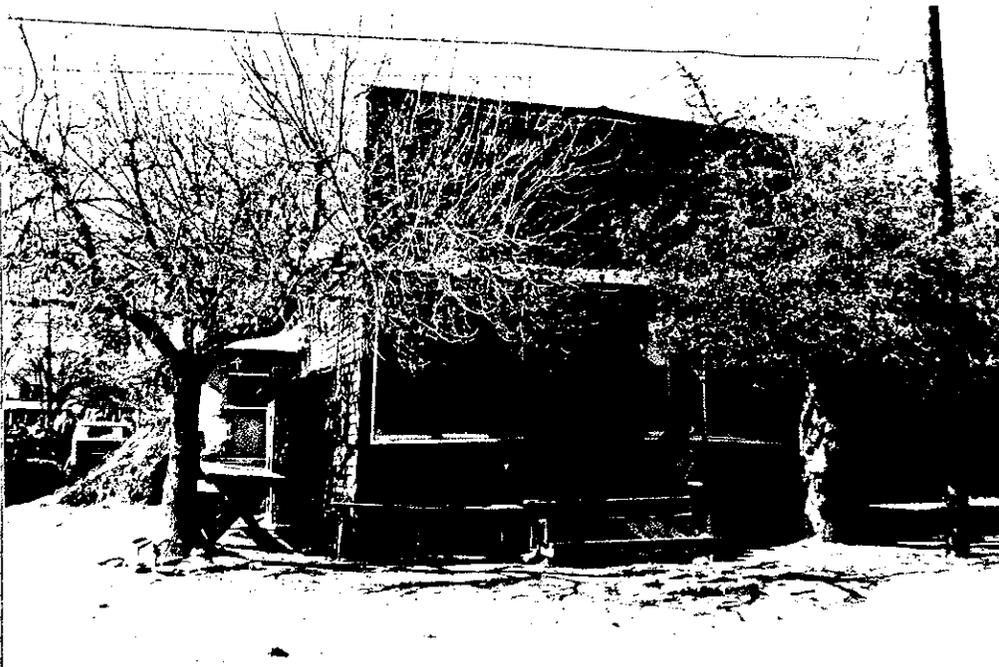
This single story structure is rectangular in shape with a gable roof. The facade has a wood false front. The entry is raised and recessed with double doors and transoms above. The doors have recessed panels on the lower portion and glass in the upper portion. Windows are located on each side of the entry and have wood frames. The glass has been removed and boards have been inserted. The building rests on a raised wood foundation and has a vertical board skirt at the base. Siding is wide board.

13. Condition: Excellent Good Fair Deteriorated No longer in existence
14. Alterations: shed attached on south side
15. Surroundings: (Check more than one if necessary) Open land Scattered buildings Densely built-up
Residential Industrial Commercial Other
16. Threats to site: None known Private development Zoning Vandalism
Public Works project Other:
17. Is the structure: On its original site? Moved? Unknown?
18. Related features: none

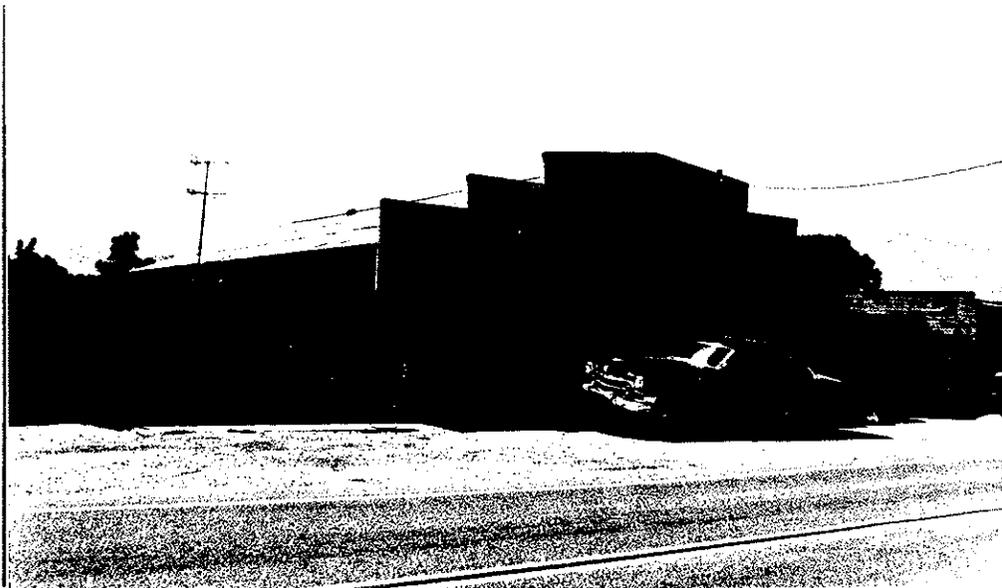
This large rectangular shaped commercial building has a gabled truss roof. The roof is covered with corrugated metal. The false front facade is flat with a stepped parapet and stucco siding. Windows are evenly placed on each side of the main entrance. The large plate glass windows are rectangular in shape with wood frames.

13. Condition: Excellent ___ Good ___ Fair X Deteriorated ___ No longer in existence ___
14. Alterations: none apparent
15. Surroundings: (Check more than one if necessary) Open land ___ Scattered buildings X Densely built-up ___
 Residential ___ Industrial ___ Commercial X Other ___
16. Threats to site: None known X Private development ___ Zoning ___ Vandalism ___
 Public Works project ___ Other: ___
17. Is the structure: On its original site? X Moved? ___ Unknown? ___
18. Related features: none

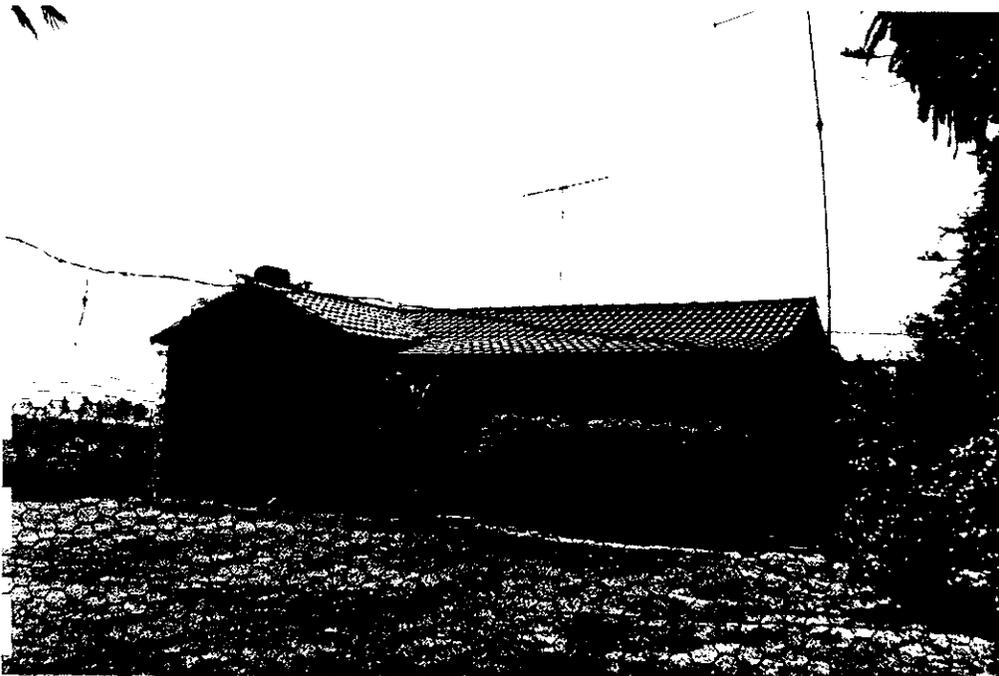
This single story residence has a low pitched cross gable roof of tile. A stucco chimney is located on the east side. The front porch is recessed under a shed roof with a flat arched opening. This same flat arch is repeated in the picture window. The windows are fixed and double hung with wood frames and slightly recessed into the stucco surface. The house rests on a concrete foundation.

13. Condition: Excellent ___ Good ___ Fair Deteriorated ___ No longer in existence ___
14. Alterations: none apparent
15. Surroundings: (Check more than one if necessary) Open land ___ Scattered buildings Densely built-up ___
 Residential Industrial ___ Commercial ___ Other agricultural
16. Threats to site: None known Private development ___ Zoning ___ Vandalism ___
 Public Works project ___ Other: _____
17. Is the structure: On its original site? Moved? ___ Unknown? ___
18. Related features: mature palms.

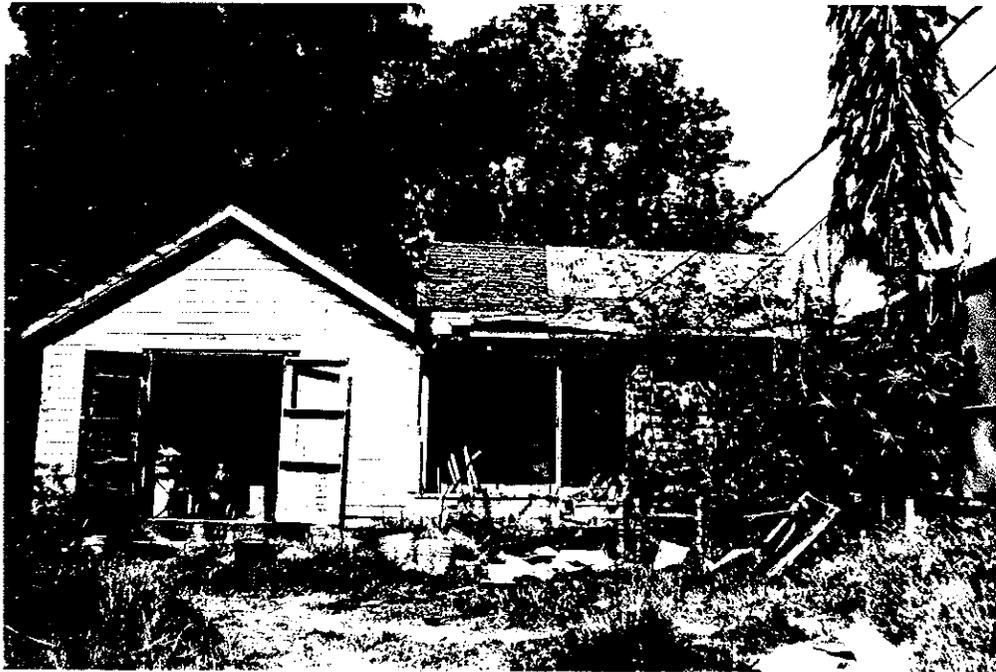
Pyle Rd. Residence

This is presumed to be the first Pyle residence built probably about 1890. W. J. Pyle came to Ventura County in 1887 from Orange County and purchased 182 acres, according to the Ventura Free Press for August 25, 1899.

The house is quite deteriorated and has had a gabled addition put on the side. The house has a side facing gable roof with a shed roof over the porch. A portion of the porch has been enclosed. The open portion is supported by simple wood columns and a low railing of wood siding. The house is covered with wide shiplap siding and is of single wall construction. It rests on a wood foundation.

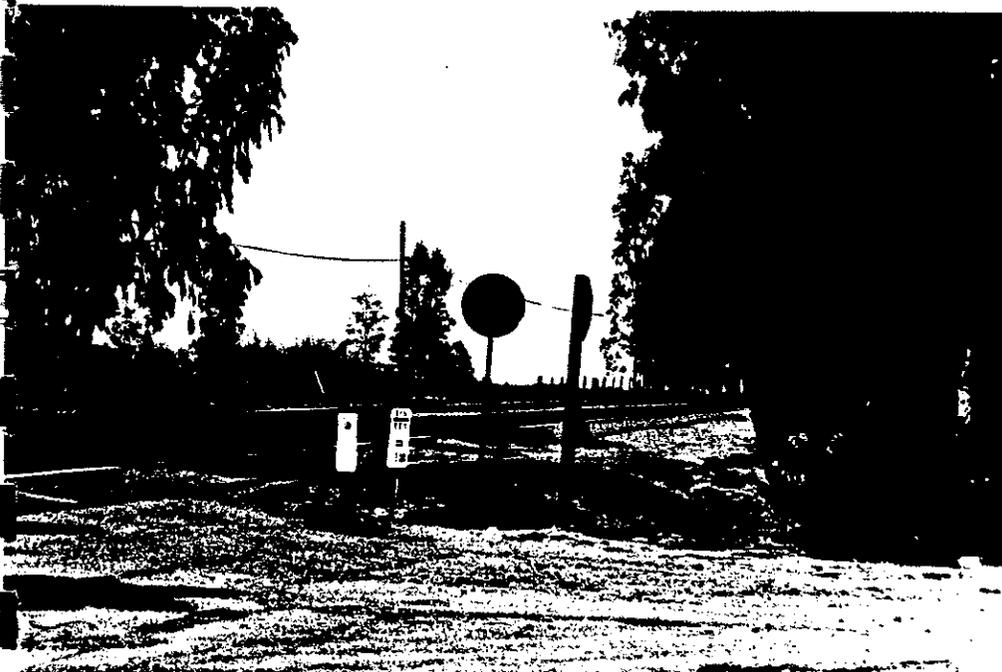
The entire ranch includes some 4,249 acres. The main ranch headquarters includes approximately 30 buildings. These buildings are mainly one-story gabled roof structures with board and batten or clapboard siding. The buildings include residences, an office, dormitories, storage sheds, a laboratory, carpenter shop, blacksmith shop, and other buildings listed individually in the following pages. These structures are clustered together along the main road. On other areas of the ranch are scattered residences, and two large villages. These villages, known as Sespe Village and Oak Village, contain several dozen worker's houses. Elsewhere on the ranch is a steam generating plant and several reservoirs. The ranch is bisected by Highway 126 also known as Telegraph Rd. The road is lined with towering eucalyptus trees. Several small roads criss cross the ranch. The major agricultural crop is lemons. The main ranch residence is located on a small hill with a winding driveway leading to the top. It is surrounded by two guest houses, a reservoir, a greenhouse and a garage.

13. Condition: Excellent ___ Good X Fair X Deteriorated ___ No longer in existence ___

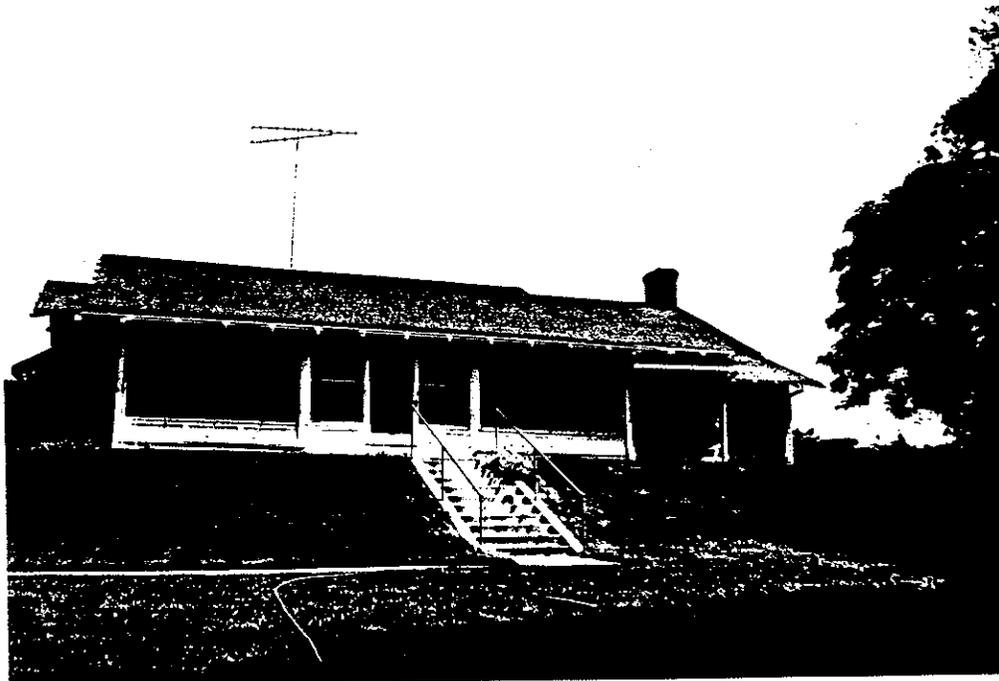
Main residence -- 3165 Telegraph Rd.

This house was built about 1910 for Eudora and Keith Spalding. It was built as their residence when they stayed at the ranch. They also lived at the Huntington Hotel in Pasadena and came to the ranch for a few days at a time. The house was built at the same time as the bunkhouse, designed by Greene and Greene, noted Pasadena architects. It is possible that the Greenes designed the house as well, since it was built at the same time as the bunk house and in somewhat the same style as other work done by the Greenes during this time period. However, to date no records have been found to substantiate this. The year 1910 was a slow year for the Greenes and only three new works were shown to be built during this year: Ernest W. Smith bungalow, the Sam L. Merrill house and the Keith Spalding bunk house. (Makinson, Greene and Greene, 1977.) In an interview with Rodney Peyton (October, 1987), Mr. Peyton stated that his father Harry Peyton built many of the Spalding residences. He remembered his father building the main house for Keith Spalding and using architectural plans. He did not remember who designed the plans.

In 1934 Roy C. Wilson, Santa Paula architect, made changes and additions to the house. Originally the wood on the house had been stained dark brown. It was later painted white. An addition was made on the east side using the same materials as the original. Multi-paned casement windows were added and an enclosed porch put on the east side. The main front porch was enclosed with windows and recessed panels in the lower portion. The stone chimney and fireplace were removed and a new brick chimney and fireplace added. The interior has open beam ceilings and hardwood floors. The kitchen and bathrooms were modernized.

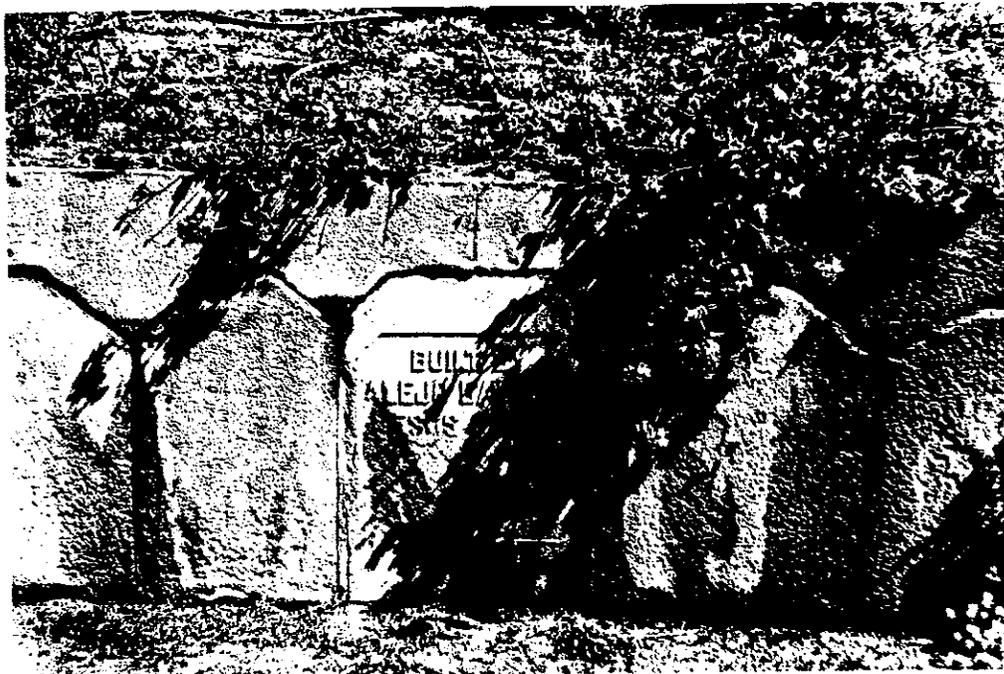
3165 Telegraph Rd. -- stone wall

This stone wall was built for Mrs. Spalding in the 1930s. It is about one-eighth mile in length leading up the road to the main residence. It took three men almost five years to build. The names of the men, inscribed in the stone, were Alejo Davalos and Jesus Garcia. The third name has worn off and is unknown. The stones came from Santa Paula. They were cut in flat slabs and laid in the pattern shown in the photograph. The wall is about three feet in height.
