CULTURAL HERITAGE SURVEY PHASE IV SANTA CLARA VALLEY

**COUNTY OF VENTURA
CULTURAL HERITAGE SURVEY
PHASE IV - SANTA CLARA VALLEY**

**Prepared by Judy Triem
San Buenaventura Research Associates**

January 1988

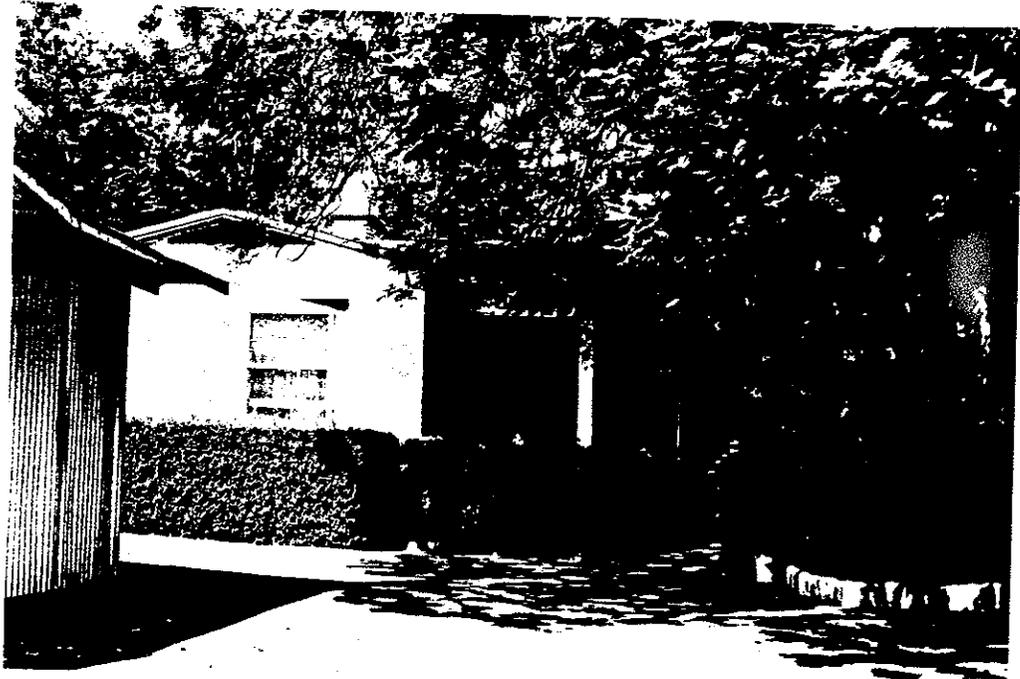
Caretaker's house -- 3165 Telegraph Rd.

This one story residence has a low gable roof with a flat roof over the porch. The porch was probably added later. A portion of the porch is enclosed and the rest open and supported by a square post. A chimney punctuates the roofline. Windows are double hung with wood frames and mouldings. The house is covered with clapboard siding.

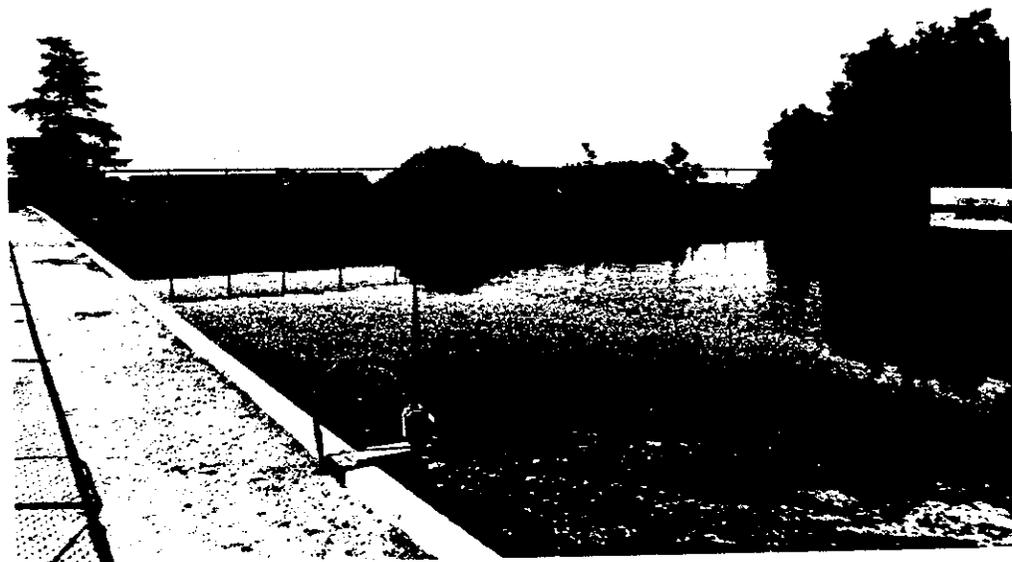
Reservoir -- 3165 Telegraph Rd.

This concrete lined reservoir was built west of the main residence. An article in the Fillmore Herald Industrial and Homes Edition of 1911 mentions the reservoir. It describes it as a 1,000,000 gallon reservoir "located on a hill near the center of the property, from which water can be distributed to every acre of the ranch. The water was pumped to the reservoir, in the early days, using a 250 horse-power Corliss engine. This engine was located in the pumping plant below the main highway.

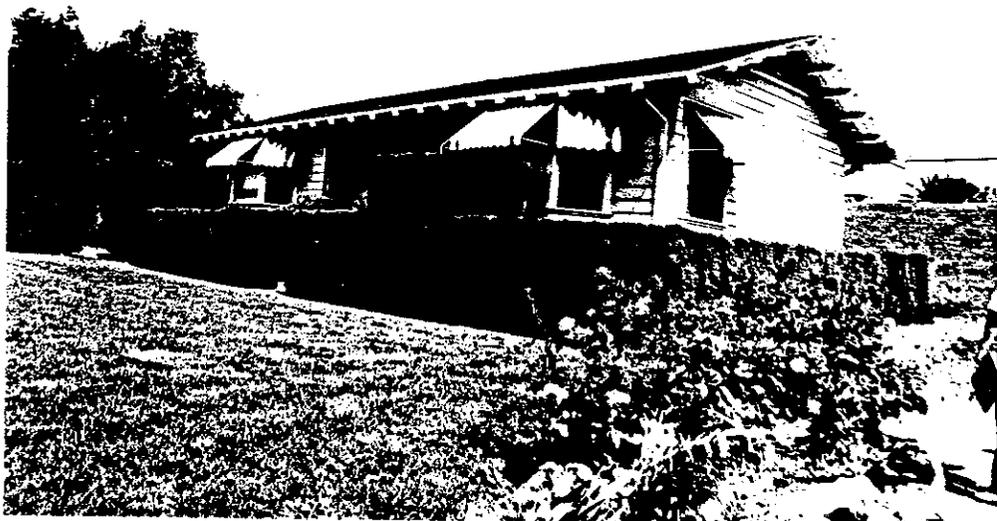
Guest house -- 3151 Telegraph Rd.

West of the main residence is a small guest house. It is similar in style to the main residence. It may have been built shortly after the main house was built, ca 1912. Symmetrical in shape, it features two slanted bay windows and two entrances. The roof shape is a low gable with exposed beams and rafters, similar in treatment to the main house, under the broad eaves. The entries are recessed under the main gable. Siding is wide clapboard. Windows are double hung with wood frames and mouldings.

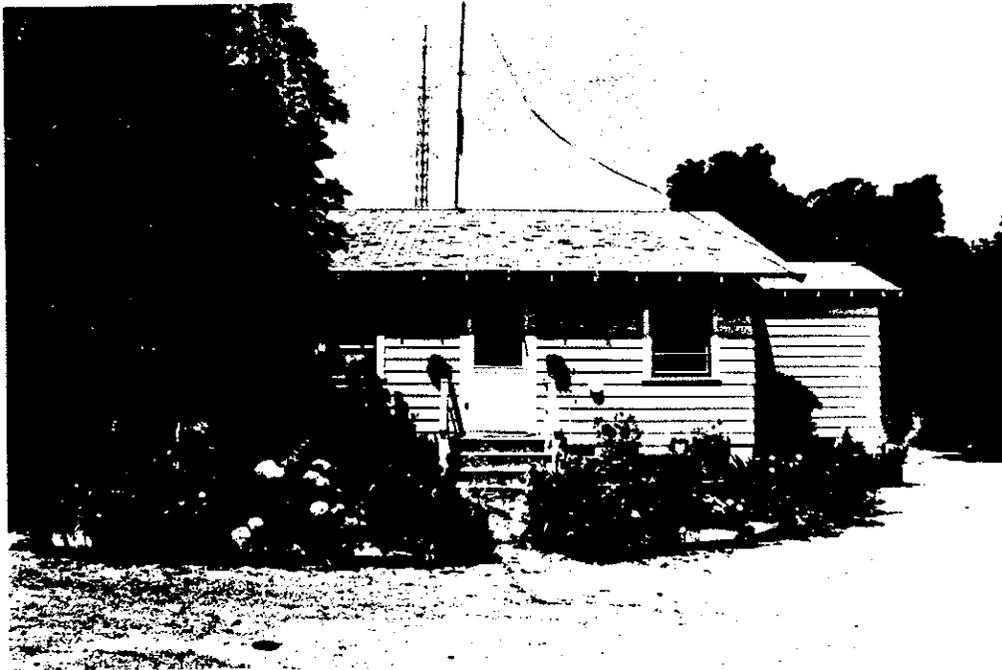
Ranch hand's house -- 3165 Telegraph Rd.

This small California Bungalow has a low gable roof with exposed rafters under the eaves. The entry is flush with the siding and has concrete steps and wood railing. The house is covered with wide clapboard siding. Windows are double hung with wood frames and mouldings.

It is uncertain when this house was built but its style would indicate a date of about 1930.

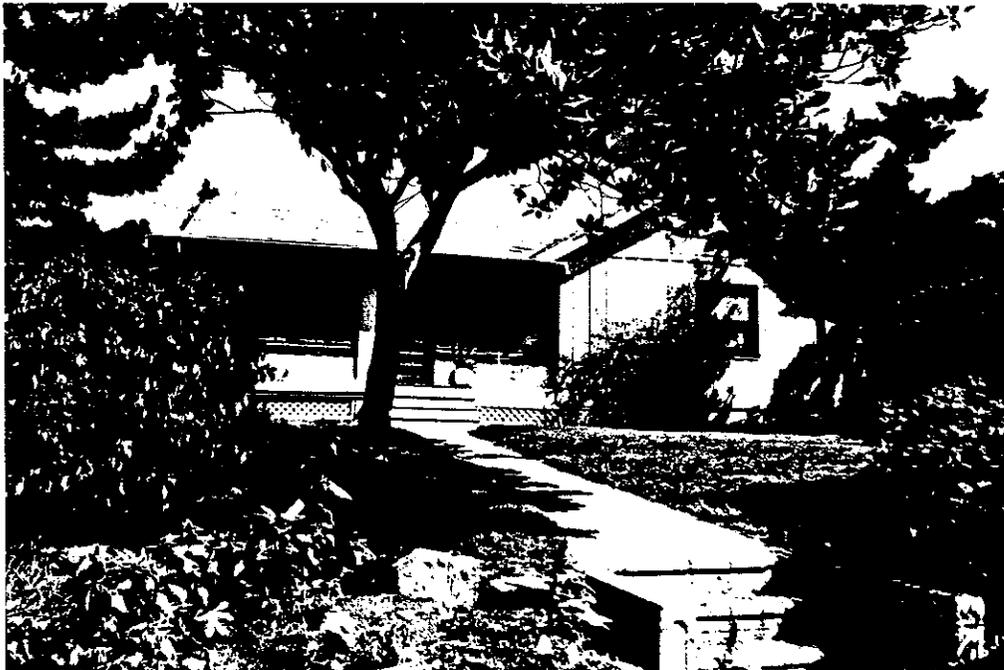
2871 W. Telegraph Rd.

On the north side of the highway, across from general headquarters, are a group of six bungalows that house ranch employees. The residences were built about 1910 or later. These houses share common characteristics -- one story in height, gable roofs, board and batten siding, double hung windows with wood frames and mouldings and raised concrete foundations.

This house, whose address is 2871 W. Telegraph, is representative of the six houses and will be described in detail. The house has a modified L-shape. The side facing gable roof has an offset gable on the east side. Rafters are exposed under the eaves. The porch has been enclosed with screens on the upper half and board and batten siding on the lower portion. The porch is recessed under the gable roof and supported by tapered capped wood columns. Windows are double hung with wood frames and mouldings. The house has a raised concrete foundation with a lattice skirt. There is a small yard in front of the house and many trees and shrubs. Steps and a sidewalk lead to the front entrance. There is a retaining wall of Sespe stone.

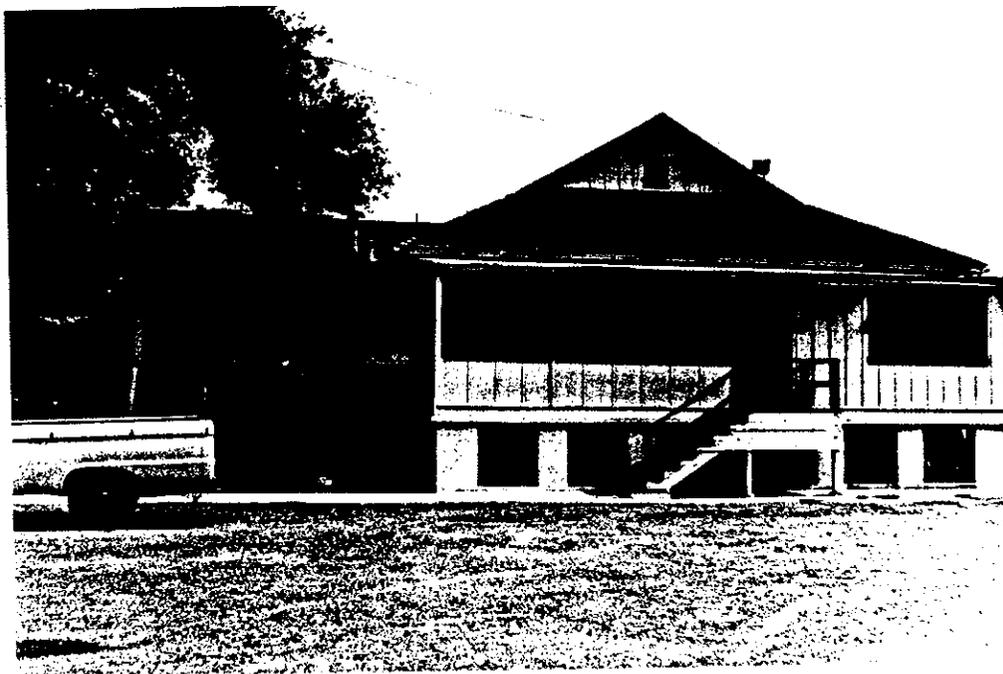
Laboratory

Located directly south of Highway 126 (Telegraph Rd.), this building is among a group of buildings comprising the general ranch headquarters. It was built as a residence originally for the men in charge and referred to as the "officer's cottage." Originally five single men lived there. Eventually they married and moved into other houses. The residence was converted to a laboratory for testing soils. A basement was added and a photography lab installed.

According to Ventura County Assessor's records, the building was constructed about 1913. It is one story tall with a gable on hip roof. The basic shape is rectangular with a gabled wing extending from the west side. The building has a raised basement with a concrete foundation. Windows are double hung and casement with wood frames and mouldings. Siding is board and batten. The porch is enclosed with screens and board and batten siding. Wood steps and railing lead up to the porch. A shed roof covers a large below ground entrance. There is a second entrance located on the gabled wing portion of the building.

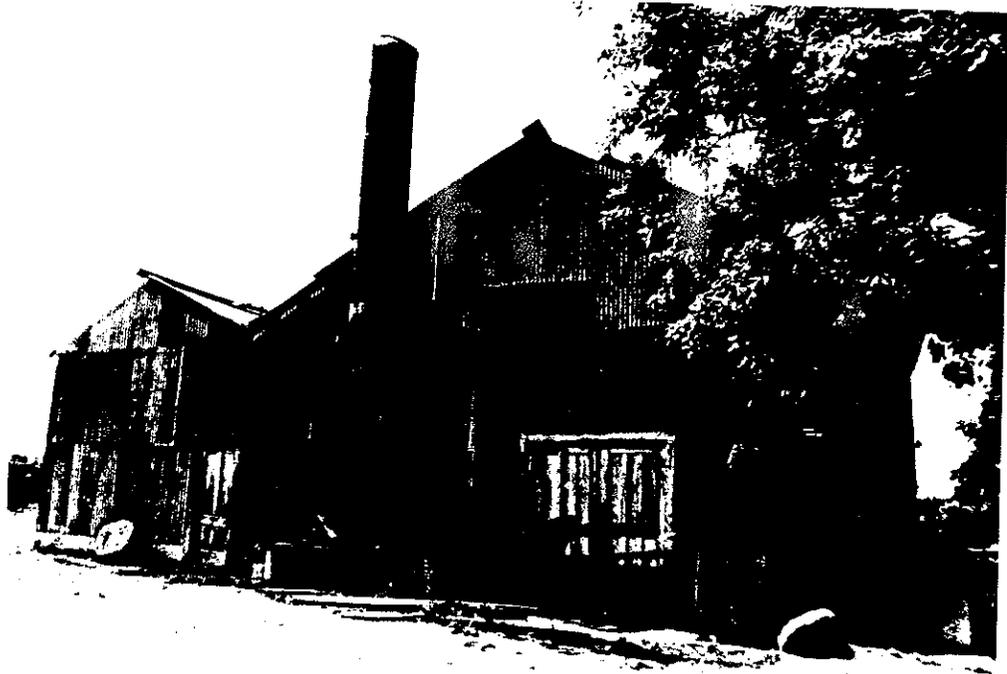
Steam plant

Built about 1910, this corrugated metal building has a high gable roof with an open truss ceiling. There is a second lower gabled roof section attached to the main portion of the building. There are a few windows in the building with wood frames and mouldings. The main entry has double doors with recessed panels. There is a second entrance on the shorter gabled portion. This door is wood with recessed panels as well. A large metal stack is attached to the front of the building. At the rear of the building is a further addition with a gable roof and corrugated metal siding. On the interior are the remains of the wood water wheel.

The steam plant was used to provide water to the ranch. The Fillmore Herald Industrial and Homes Edition for 1911 mentions the pumping plant. It states that "The ranch has about 600 inches of available water, more than will ever be needed. The pumping plant is equipped with a 250 horse-power Corliss engine, which drives a 4-step centrifugal pump, lifting 300 inches to the great reservoir, having a capacity of 1,000,000 gallons and located on a hill near the center of the property, from which water can be distributed to every acre of the ranch.

According to Roland Leach, employee at Rivcom Ranch, the pump was not powerful enough to pump the water above the highway. A gasoline pump was later installed to bring the water to the rest of the ranch.

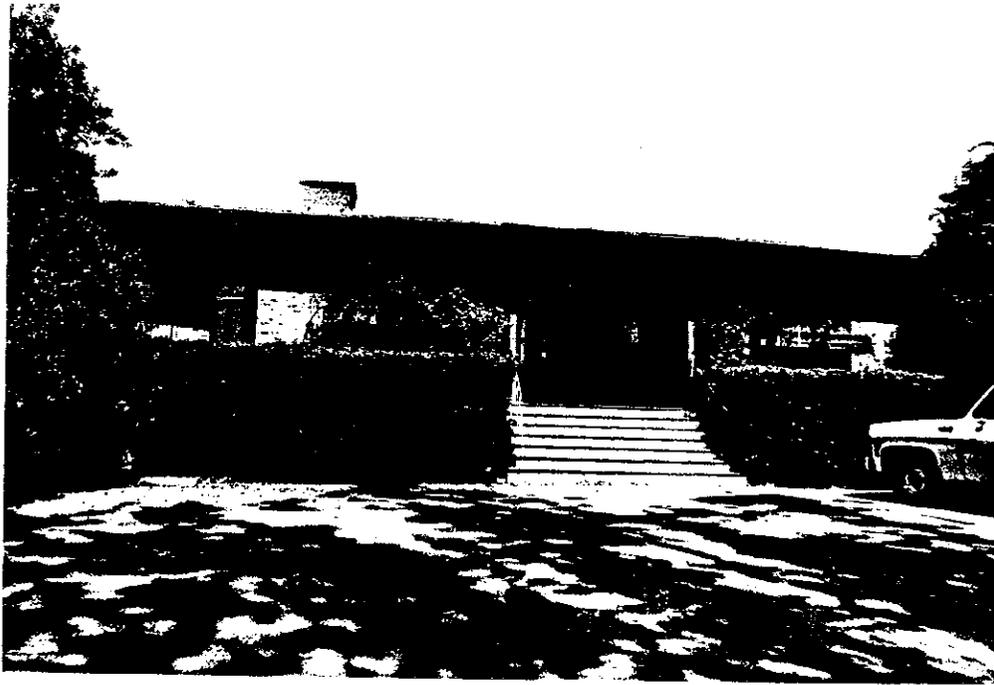
2707 W. Telegraph Rd. -- Rivcom Ranch office

This building was constructed about 1932, according to a Cal-Trans report. It may have been designed by Santa Paula architect, Roy C. Wilson, who was remodeling the Spalding residence at the same time. It was the second office. The first office was across the street and converted to a residence. The building has a low gable roof with exposed rafters under the eaves. The front porch is recessed under the gable and supported by wood columns. Steps and a wrought iron railing lead up to the porch. The front entrance has a solid door with vertical board siding flanked by sidelights. The large multi-paned windows are double hung. A stucco chimney punctuates the roof line. Some of the interior walls are paneled.

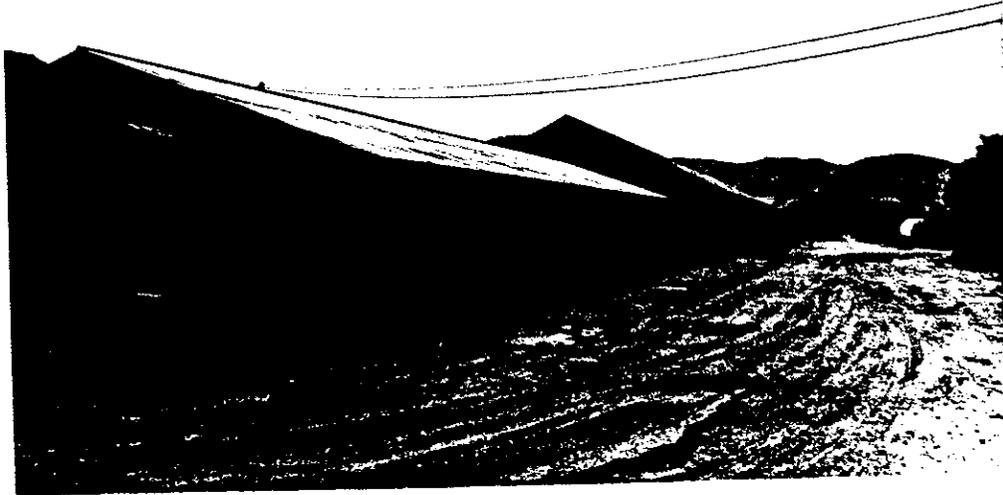
Auto garage - hay barn

Located behind the shower house, this long rectangular building has a low gable roof. The building is constructed of corrugated iron and rests on a concrete foundation. It was used as a garage.

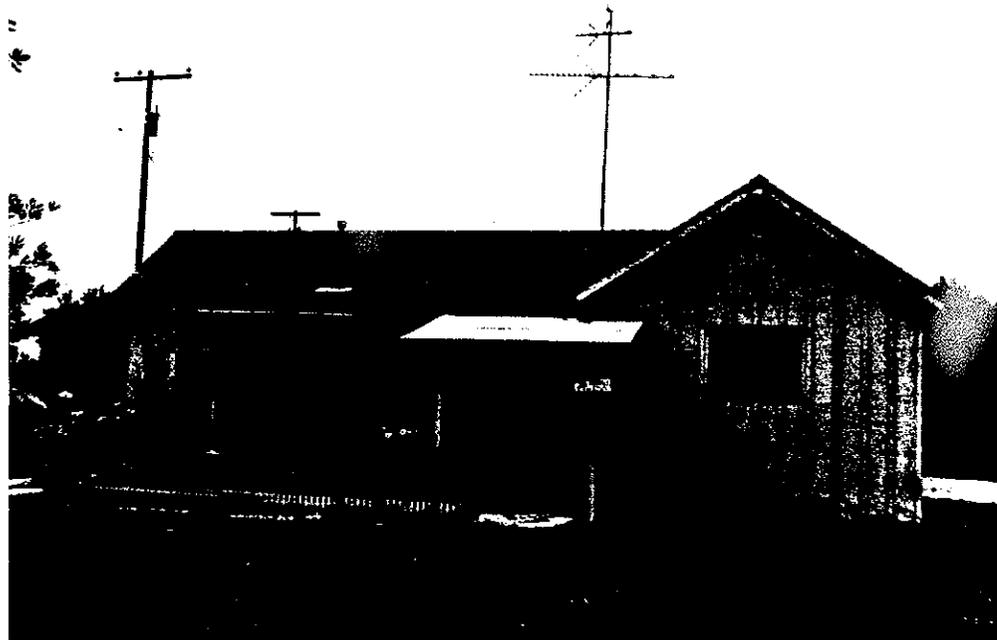
2940 Telegraph Rd. -- ranch hand's residence

Located directly south of the main highway and west of the bunkhouse is this worker's cottage. It is typical of the many cottages that are located on the ranch. The cottages not located in the farmworker's villages were no doubt used to house the foremen, carpenters, blacksmith, etc. This house, located next to the kitchen, was usually the cook's house. Built about 1910, this residence has a modified L-shape. The side facing gable has an offset gable at the west end. The porch has a shed roof and has been enclosed with screens and board and batten siding. Windows are double hung and fixed with wood frames and mouldings. The house rests on a concrete foundation and is covered with board and batten siding. Under the front gable is a circular vent.

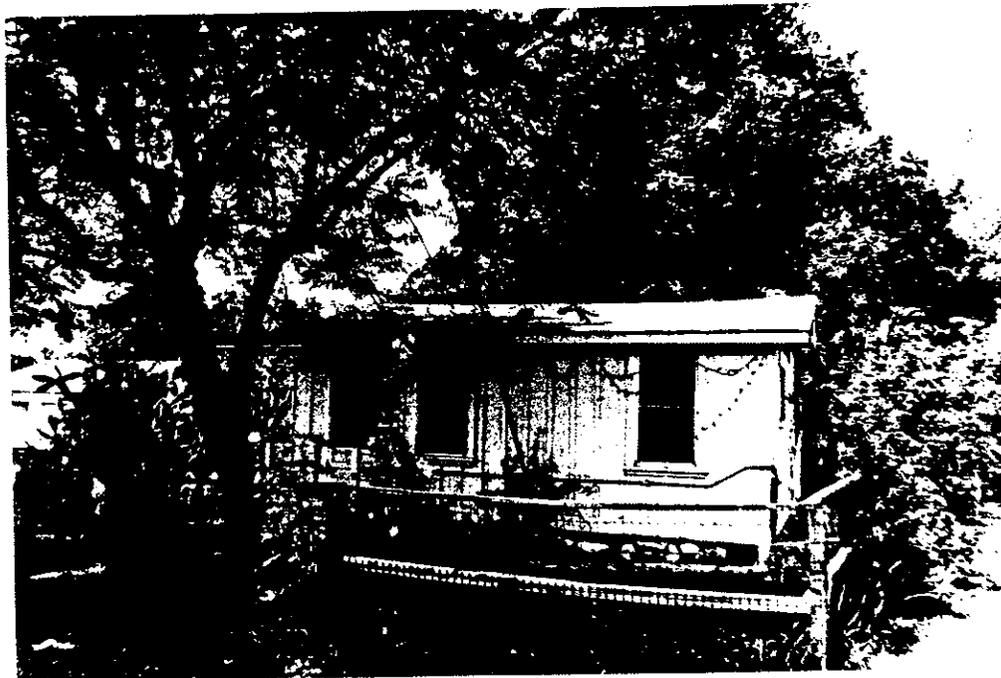
Sespe Village

East of the main headquarters not far from the Santa Clara River, is the area known as Sespe Village. Dozens of cottages once lined the dirt roads. Many have recently been torn down. The Fillmore U.S.G.S. map for 1969 shows approximately 100 cottages existed at that time. The cottages were all quite similar in style -- gable roof, board and batten siding; double hung windows with wood frames and mouldings, stone or wood posts and concrete foundations. The houses are interspersed with mature oaks, and eucalyptus trees line the road that runs along the river bank. Each house has a small fenced-in yard. The cottages were built between 1912 and 1920. They housed the Mexican families. The dormitory and bunkhouse housed the single men.

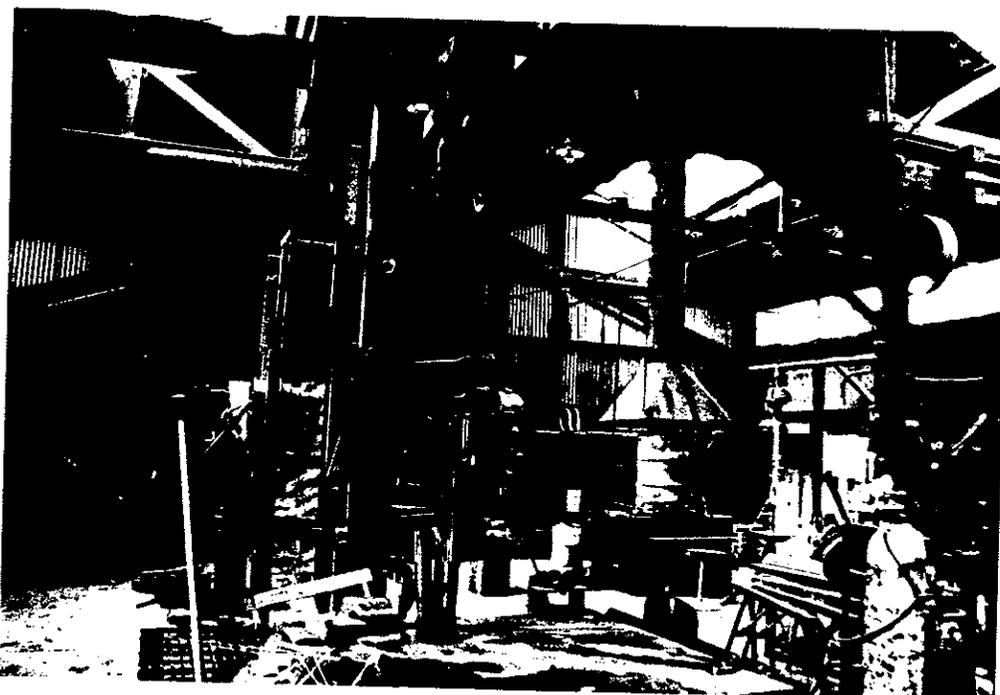
Blacksmith shop interior

The inside of the blacksmith shop still contains much of the equipment used originally on the ranch. In the foreground is the blacksmith's anvil.

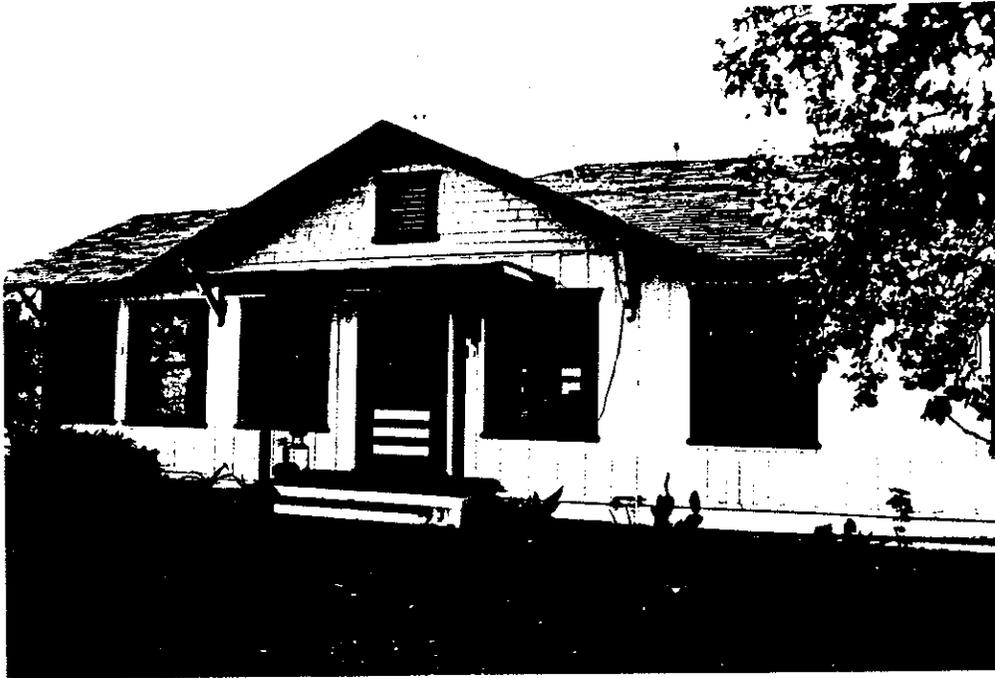
2690 W. Telegraph Rd. (across Highway 126 from present office)

This building, built about 1910, served as the first office for the ranch. It was later converted to a residence. The building directly to the west at 2708 W. Telegraph Rd. was the ranch manager's house, also built about 1910.

Both houses have gable roofs, shingles under the main gable and board and batten siding on the rest of the house. Knee brackets are located under the eaves. Windows are double hung with wood frames and mouldings.

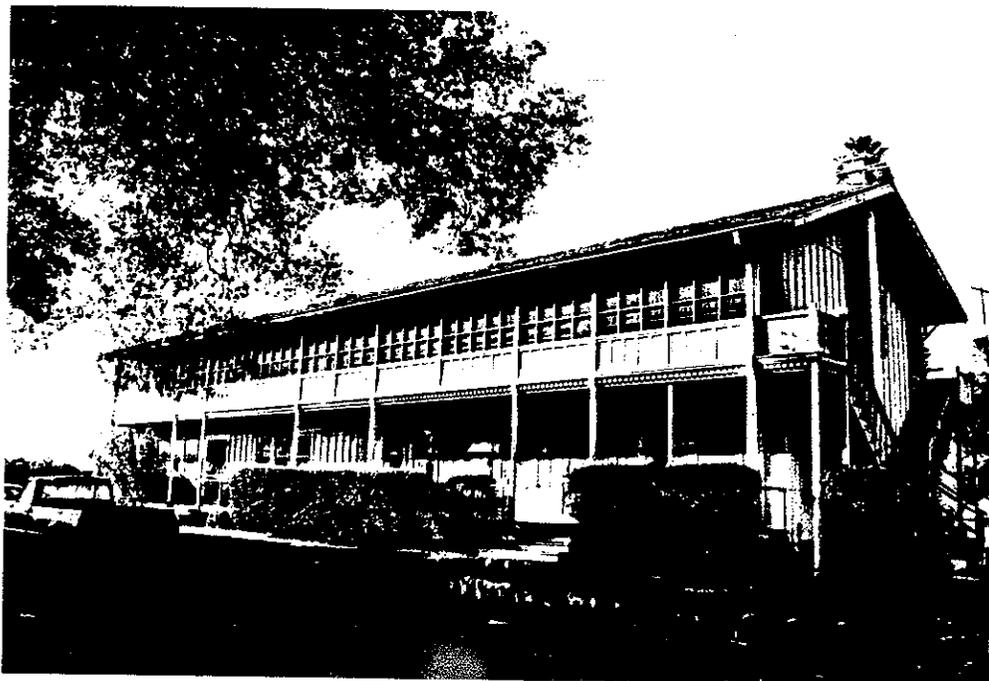
Bunkhouse

Located north of Hwy. 126 and west of Oak Street, is this large two-story bunkhouse. The long rectangular building has a medium gable roof with broad eaves and knee brackets under the eaves. The porch is located beneath the enclosed balcony. Square posts support the porch and a board and batten railing is found on the lower half of the second floor balcony. The porch has an open wood railing. A distinctive feature is the decorative classic detail found underneath the porch balcony. Steps to the upstairs are located at both ends of the building. Windows are double hung with wood frames and mouldings. The building is covered with board and batten siding.

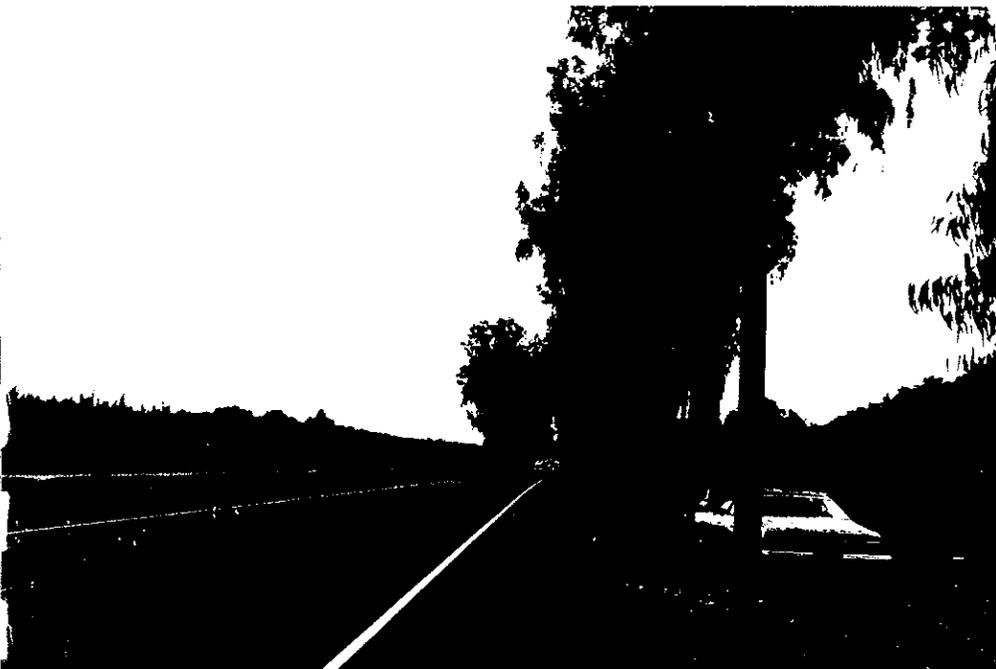
Approximately 300 mature Eucalyptus trees line both sides of Route 126 between the intersection of Old Telegraph Road west, approximately 1-1/2 miles to the railroad crossing. Trees are the remainder of the original stands which grew along the route and extended along Old Telegraph Road. Over the years many have been lost for various reasons.

*Destroyed
1989*

13. Condition: Excellent ___ Good Fair ___ Deteriorated ___ No longer in existence ___
14. Alterations: some trees have been removed over the years
15. Surroundings: (Check more than one if necessary) Open land ___ Scattered buildings Densely built-up ___
 Residential ___ Industrial ___ Commercial ___ Other agricultural
16. Threats to site: None known ___ Private development ___ Zoning ___ Vandalism ___
 Public Works project Other: _____
17. Is the structure: On its original site? Moved? ___ Unknown? ___
18. Related features: ranch buildings, sycamore trees, citrus orchard

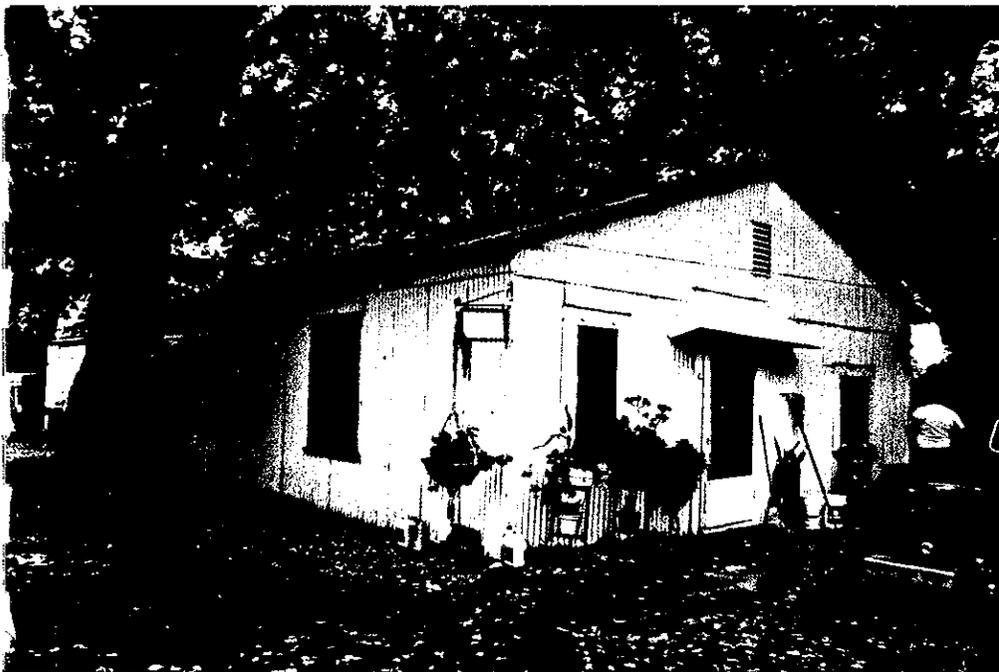
This building is rectangular in shape with a low gable roof. Under the eaves are exposed rafters. Windows are covered with flat board mouldings and are double hung with wood frames. Over the concrete slab entrance is a small hip roof of metal. The house is covered with corrugated metal siding. There is an entrance on the east side near the rear. The building has a concrete foundation.

13. Condition: Excellent ____ Good ____ Fair ____ Deteriorated No longer in existence ____
14. Alterations: none apparent
15. Surroundings: (Check more than one if necessary) Open land ____ Scattered buildings Densely built-up ____
 Residential Industrial ____ Commercial ____ Other agricultural
16. Threats to site: None known Private development ____ Zoning ____ Vandalism ____
 Public Works project ____ Other: _____
17. Is the structure: On its original site? Moved? ____ Unknown? ____
18. Related features: mature trees, board & bat residence, post-1940 residence

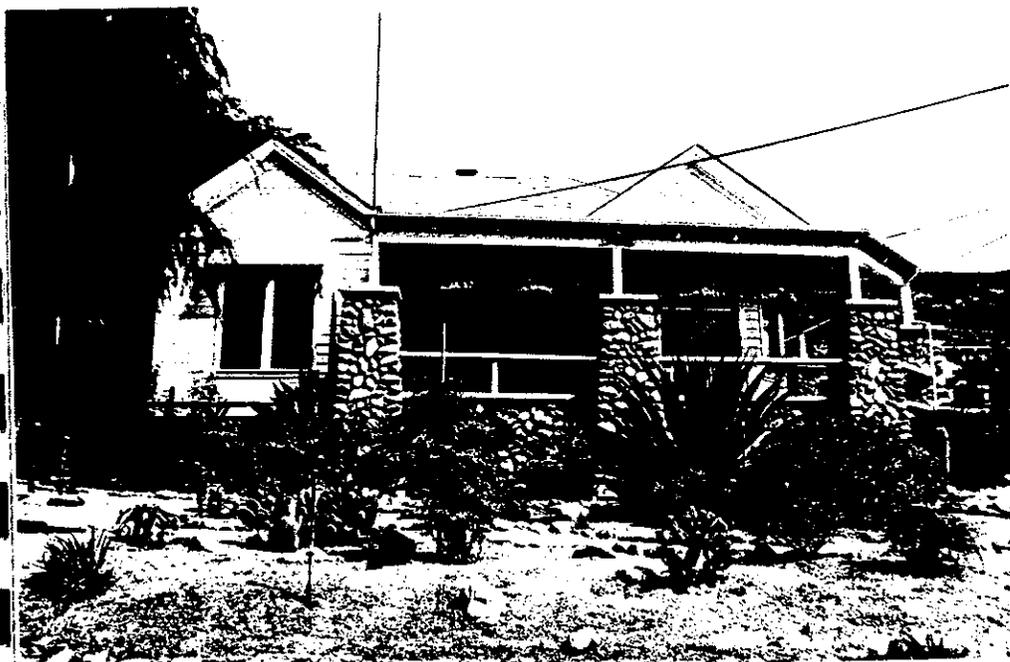
Two twin gables with fishscale shingles under the boxed eaves form a modified U-shape on the facade of this single story residence. The main roof is a high hip. A later addition, probably in the teens, was the wrap around porch on the south east corner. The porch is a major feature of the house with its broad hip roof supported by massive tapered stone columns with square posts on the upper 1/4 of the columns. Under the eaves are exposed rafters. The porch foundation is of stone capped at the top with concrete as are the porch columns. Between the columns is a simple wood railing. Windows are double hung and fixed. The window on the south east bay may have originally been two narrow windows to match the window on the west facade. The house is covered with wide shiplap siding. The house is situated on a sloping site with a view to the south and is surrounded by mature trees, a cactus garden and rock wall.

13. Condition: Excellent Good Fair Deteriorated No longer in existence
14. Alterations: porch - stone columns
15. Surroundings: (Check more than one if necessary) Open land Scattered buildings Densely built-up
 Residential Industrial Commercial Other agricultural
16. Threats to site: None known Private development Zoning Vandalism
 Public Works project Other: _____
17. Is the structure: On its original site? Moved? Unknown?
18. Related features: two bungalows; detached garage

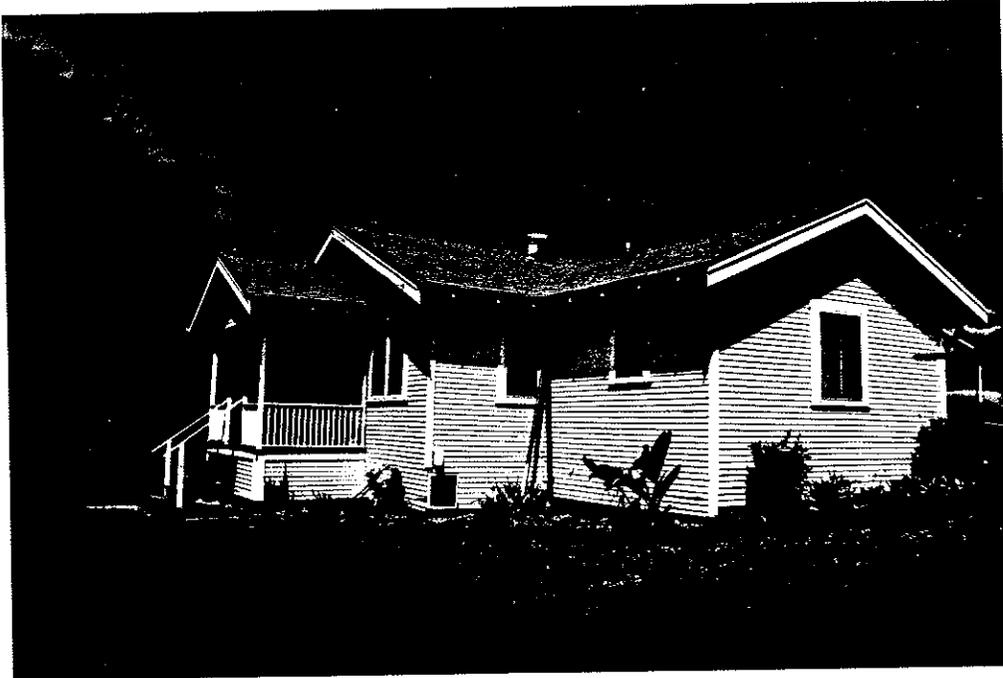
1103 E. Telegraph Rd.

This house was built in 1919 for Dr. Adams as a house for the ranch employees. It has a gable roof with a cross gable on the east side. Rafters are exposed under the eaves. The raised front porch is attached and has a gable roof supported by two square posts and an open wood railing. Windows are casement with wood frames and mouldings. The house rests on a concrete foundation and is covered with narrow clapboard siding.

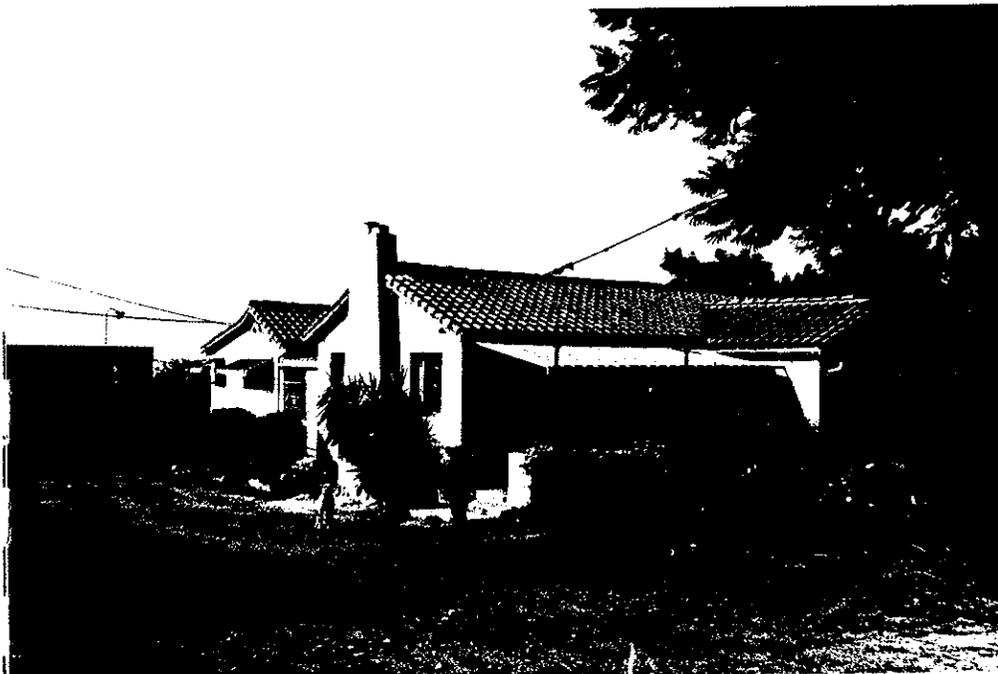
Built in an H-shape, this single story residence has a series of intersecting low pitched gable roofs of tile. Under the eaves are exposed rafters and beams. The front porch is open with a low stucco wall and shed roof awning supported by wrought iron posts. Windows are recessed with wood frames and are a combination of fixed, casement and double hung. A tapered stucco chimney is located on the east side. The house is covered with stucco.

13. Condition: Excellent ____ Good Fair ____ Deteriorated ____ No longer in existence ____
14. Alterations: none apparent
15. Surroundings: (Check more than one if necessary) Open land ____ Scattered buildings Densely built-up ____
Residential Industrial ____ Commercial ____ Other agricultural
16. Threats to site: None known Private development ____ Zoning ____ Vandalism ____
Public Works project ____ Other: _____
17. Is the structure: On its original site? Moved? ____ Unknown? ____
18. Related features: detached garage, barn, shed, mature trees

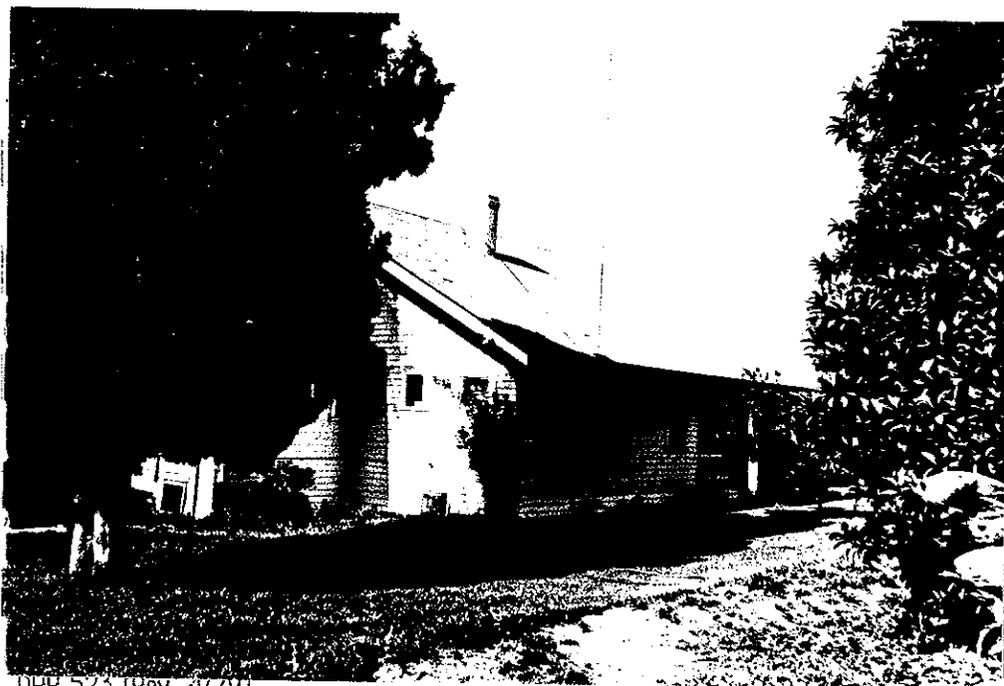
This large 1 1/2 story rectangular shaped residence has a high gable roof with the porch recessed under the main gable. Under the broad eaves are exposed rafters and brackets. The porch is supported by tapered wood columns on the upper half and square columns on the lower half. A wood railing connects the columns. Windows are double hung with wood frames and raised mouldings. The house rests on a raised concrete foundation and is covered with clapboard siding. A stucco chimney punctuates the roofline.

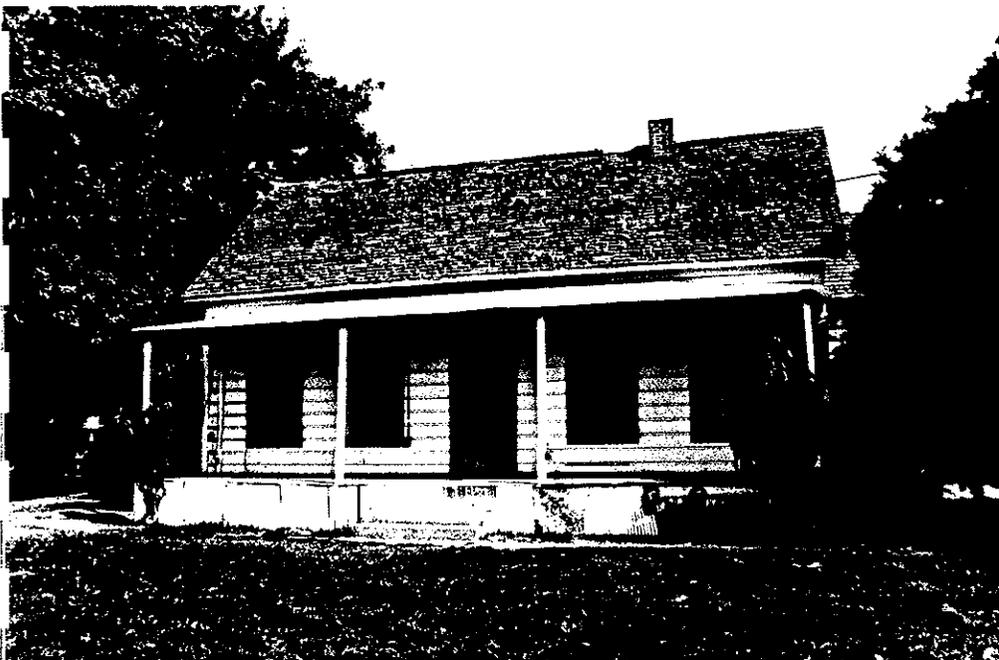
This single story residence has a medium high side facing gable roof with a wing attached at the rear east side. The eaves are closed. The wing was added around 1912 when the building was converted into a residence. A porch is attached across the front of the house and has a low hip roof supported by four chamfered wood columns. The windows are double hung with wood frames and mouldings. The house is built on a raised foundation and has a vertical board skirt. A brick chimney punctuates the roofline. The house is covered with shiplap siding.

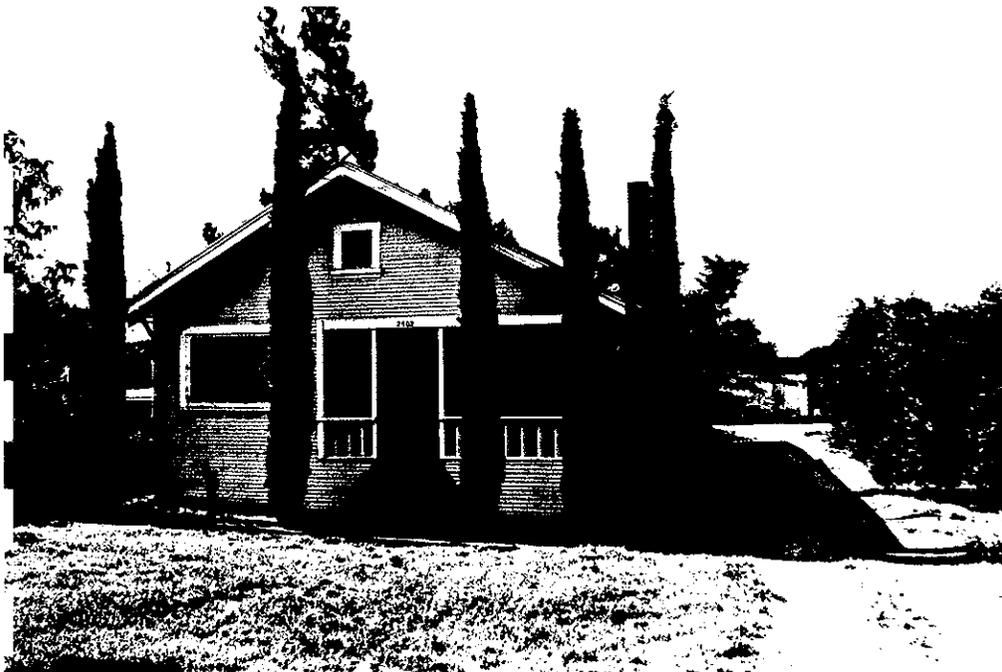
This single story bungalow is rectangular in shape and has a medium gable roof. The eaves are open with exposed rafters and knee brackets. The porch is recessed under the main gable on the west side of the house. The porch is supported by square columns and has a wood railing. Wood steps lead up to the front porch. Windows are fixed or double hung with flat wood mouldings. The front window has decorative wood diamond shaped panes. On the west side of the house is an exterior brick chimney. Siding is narrow clapboard. The house rests on a raised concrete foundation.

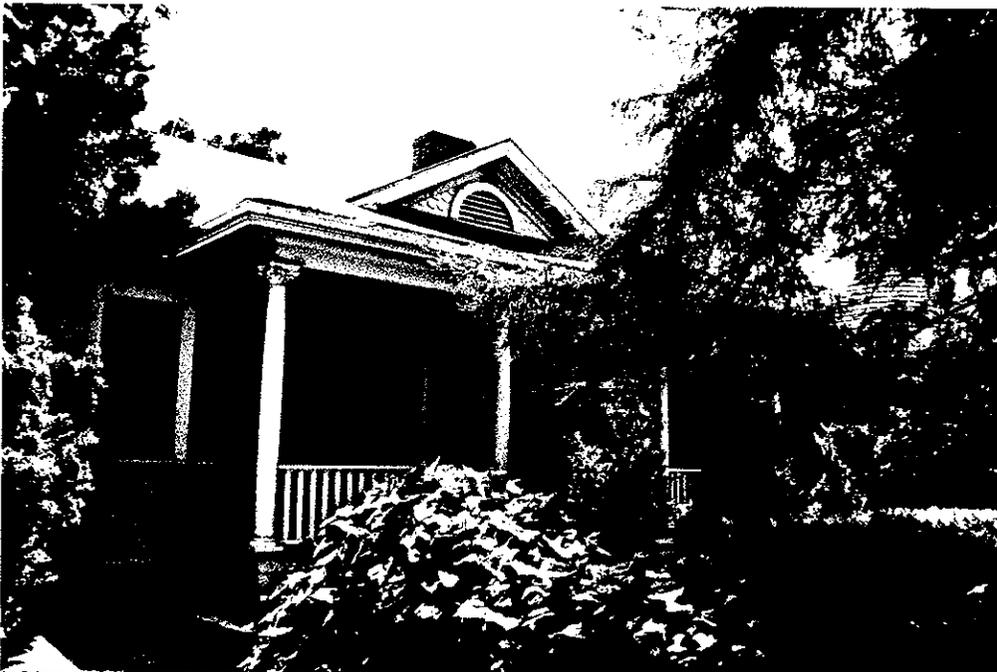
This house is single story and rectangular in shape with a main hip roof with intersecting gables at the front and rear. A brick chimney punctuates the roofline. In the gables are fish scale shingles and the roof eaves are boxed with curved brackets underneath. At the southwest corner of the house is a six sided pointed tower with narrow windows and vertical board siding. The front porch has a low almost flat roof supported by round Corinthian columns and a low wooden balustrade. The windows are double hung with wood frames and raised wood mouldings. The house is covered with narrow clapboard siding. The house rests on a stone foundation and has a decorative wood skirt with cut out diamond shapes.

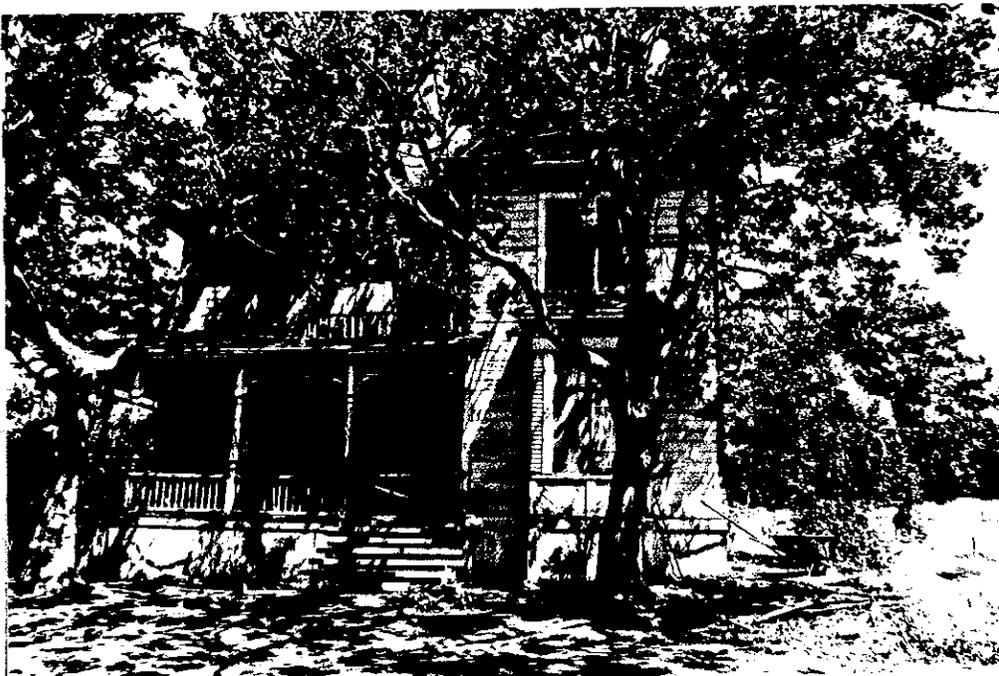
This large two-story farm house has a medium gable roof with an offset gable combined with a hip roof in the rear of the house. A brick chimney punctuates the roofline. Eaves are boxed with decorative small brackets underneath. Decorative Victorian treatment of the gable ends includes a sunburst design with spindle detail on the truss and square butt shingles. A prominent feature of the house is the decorative square bay window. Over the window is a hip roof with boxed beams and curved brackets. Below the narrow double hung windows is a diagonal stickwork design. The porch is L-shape with a hip roof and wood railing across the top. Some of the railing is missing. Eastlake influence is seen in the turned porch posts with curved brackets and narrow spindle railing. The windows are double hung with flat board mouldings. Over the front door is a transom window. The house rests on a raised wood foundation and is covered with a vertical board skirt. Siding is wide shiplap.

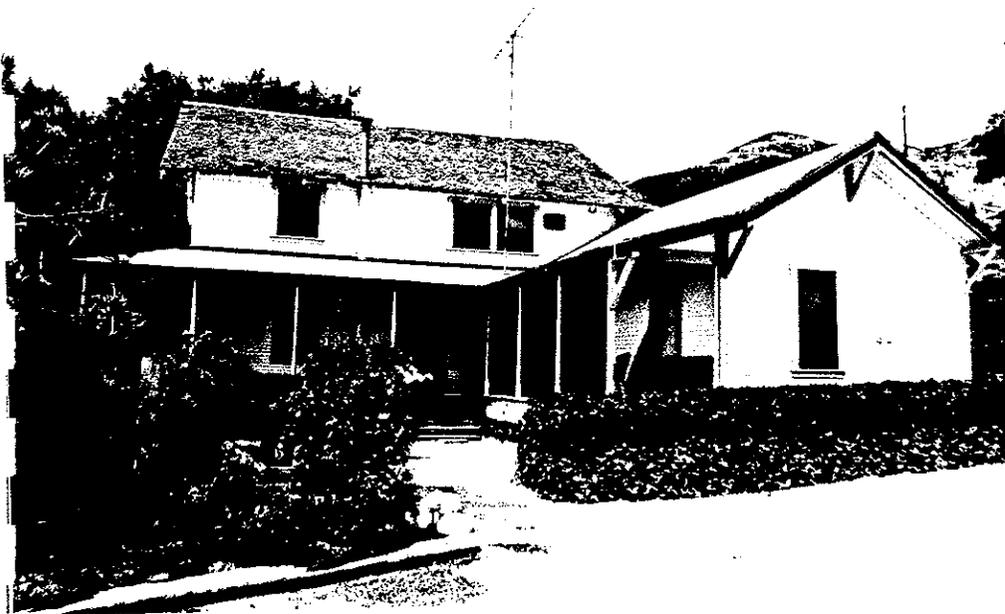
This two story residence is rectangular in shape with a one story wing on the east side that creates an L-shape. The medium pitched gable roof has exposed rafters and knee brackets under the broad eaves. The porch runs across the front of the house and wraps around the side continuing to the rear of the house where it connects with the wing. The porch is covered with a hip roof and supported by chamfered wood columns. The wing has a shed roof over the porch. The front porch is enclosed with screens and has brick steps and iron railing. Windows are double hung with wood frames and flat board mouldings. The house rests on a raised foundation and is covered with pressed metal sheets that resemble decorative stone blocks. The house is covered with clapboard siding.

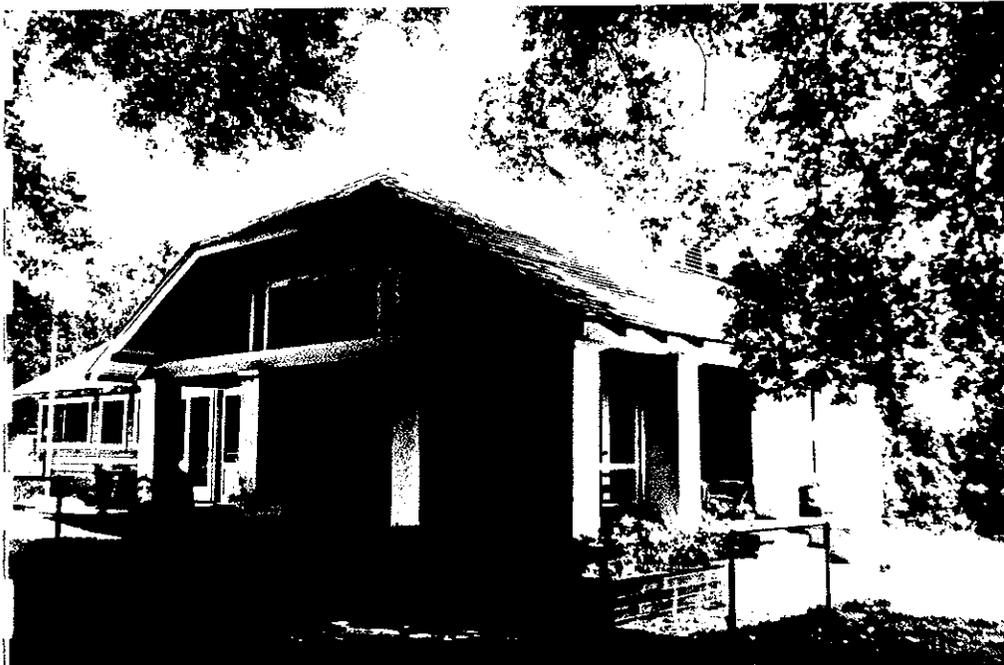
This single story residence has a clipped gable roof with porch on two sides. The porch is recessed under the main roof and supported by heavy square stuccoed columns. Under the broad eaves are exposed beams and rafters. The roofline is broken by a gabled dormer vent and stucco chimney. Windows are both double hung and casement with wood frames and flat wood mouldings. The house is built against the hillside on a concrete foundation. Siding is wide board. At the rear of the house is a gabled wing portion.
