CULTURAL HERITAGE SURVEY PHASE IV SANTA CLARA VALLEY

**COUNTY OF VENTURA
CULTURAL HERITAGE SURVEY
PHASE IV - SANTA CLARA VALLEY**

**Prepared by Judy Triem
San Buenaventura Research Associates**

January 1988

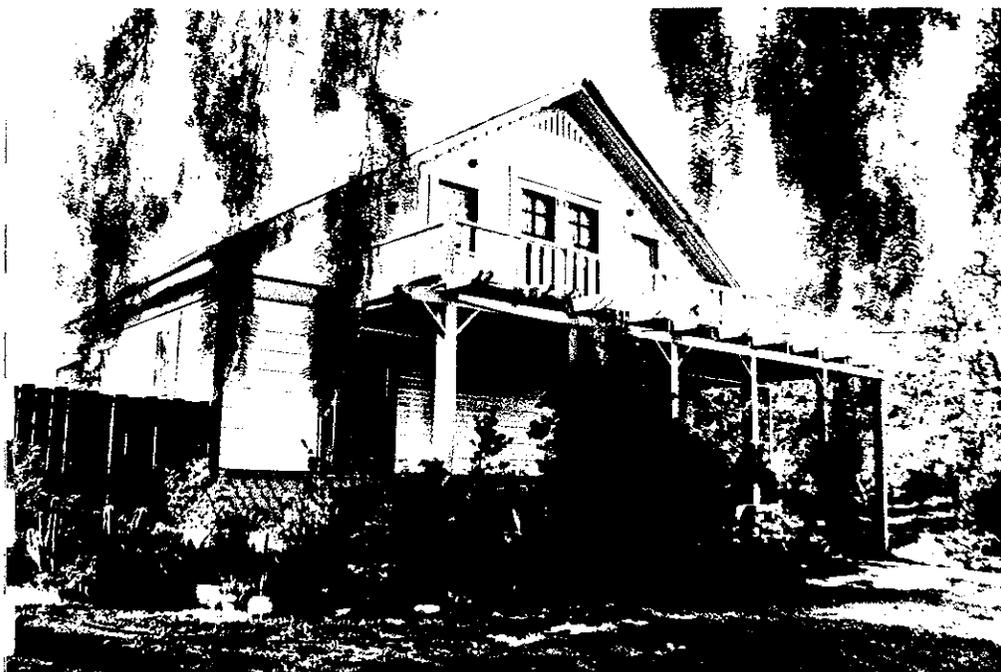
This 1 1/2 story residence has a high gable roof in front with a hipped gable in the rear. The eaves are boxed. The porch has a second story balcony with wood railing and is supported by square wood posts that rest on capped stone bases about three feet high. The porch beams are curved at the ends. The porch wraps around the west side of the house. The windows are double hung and casement with wood frames and mouldings. Double french doors open out onto the balcony. The house rests on a stone foundation and is covered with narrow clapboard siding except the lower facade which is covered with fishscale shingles. Punctuating the roofline are two stone chimneys.

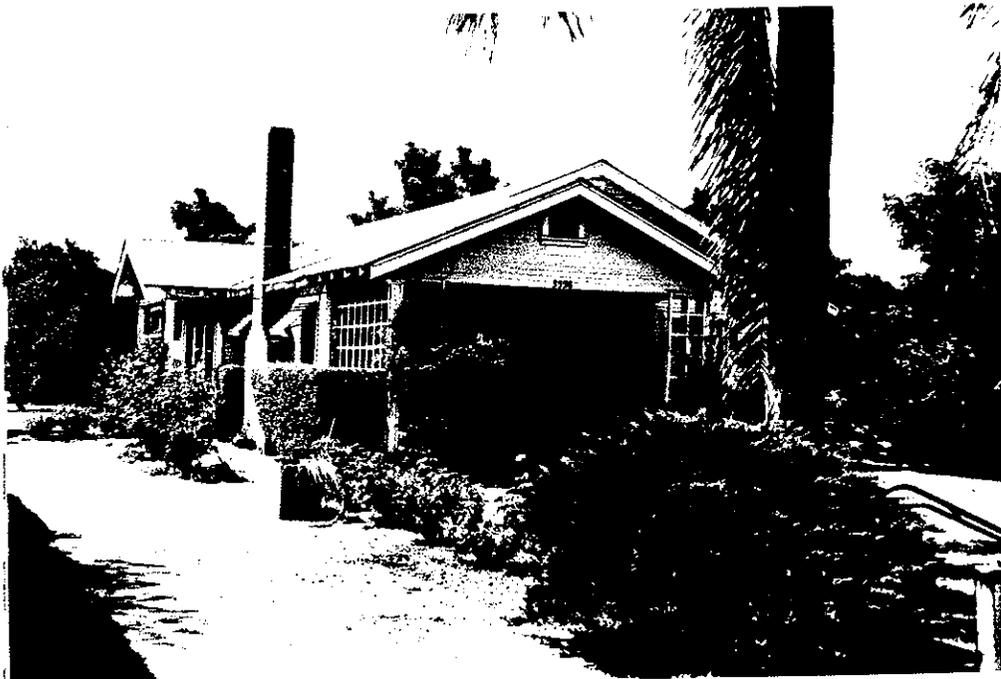
This single story rectangular shaped bungalow has a low pitched gable roof with an offset gable over the front porch. The porch is supported by square columns capped at the top. A wood trellis has been added to the porch. Under the broad eaves are exposed rafters. On the east side of the house is an exterior brick chimney and a side porch with a gable roof and square columns. Windows are fixed and double hung with wood frames and flat mouldings. The house rests on a concrete foundation and is covered with clapboard siding.

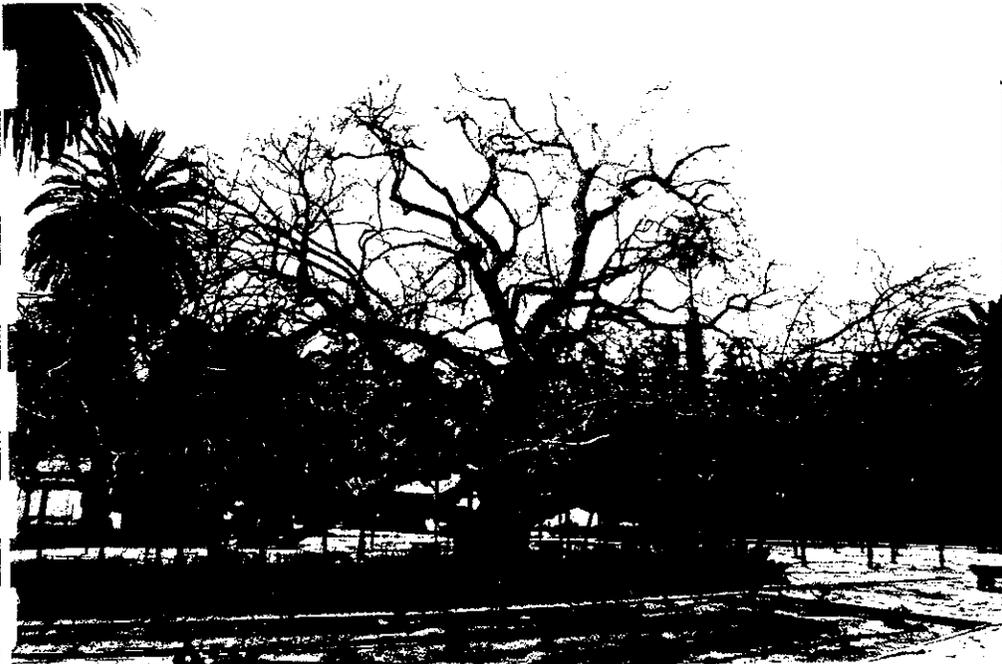
The entire ranch encompasses some 1800 acres with approximately 600 acres under cultivation to valencia, navel and lemon trees. The main ranch headquarters is south of Telegraph Rd. (Highway 126) and contains about ten structures. The main house is a U-shaped adobe. Surrounding the adobe is a winery, chapel, schoolhouse, barn, residence, bunk house, garage, and a few accessory buildings. Perhaps the largest black walnut tree in Ventura County is located next to the main adobe.

On the north side of Telegraph Road are several more buildings. They are primarily single story bungalows used as worker's housing. A railroad section house and water tank are still in existence near where the small Camulos Depot once stood. A more modern house, built in 1947 for the ranch foreman, is located at the top of the hill. The small Camulos Cemetery is located east of the worker's housing.

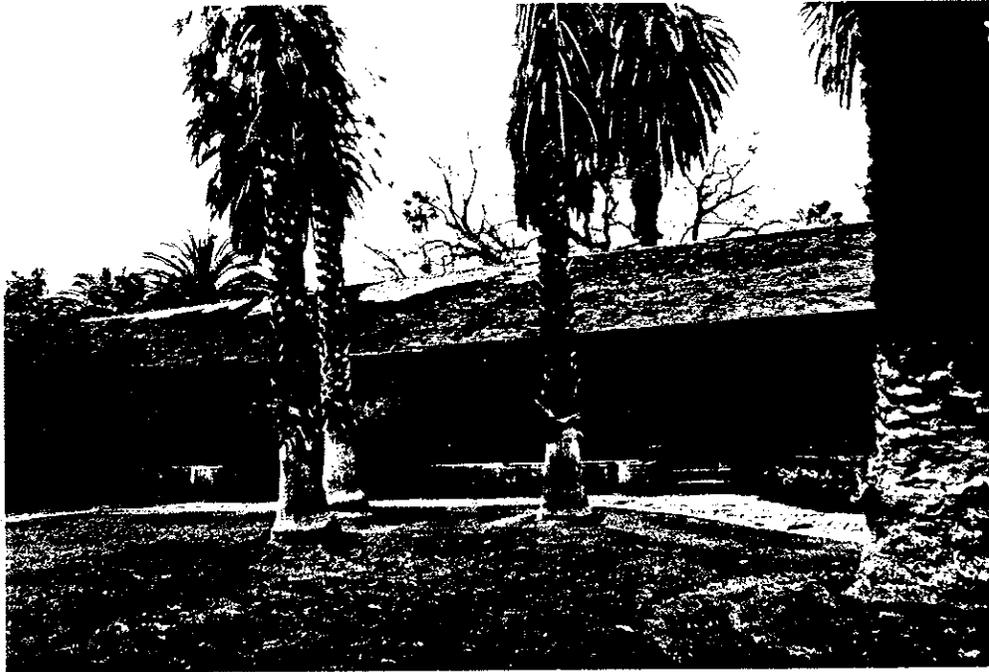
Main adobe

Originally this adobe consisted of just four rooms (east portion of south wing) when it was built in 1853. One account said it was built for the ranch foreman to live in and when the Del Valles moved in the remaining 16 rooms were added. The local Alliklik Indians are said to have made the adobe blocks. The building is now U-shaped. It is typical of many California adobes, built around a central patio laid out with flower beds and walkways. The roof is a low-pitched hip covered with wood shingles. The roof extends over the long corridors located on the inside of the U-shape and on the south side. These open corridors are supported by square wood posts. Portions of the corridors have been screened-in. Various entrances are located along the corridors and lead to the individual rooms. Windows have wood frames and are double hung with multi-panes. Some windows have shutters. Walls are made of adobe blocks and are 18" thick. Another account states that the walls are four feet thick. They are covered with a plaster wash.

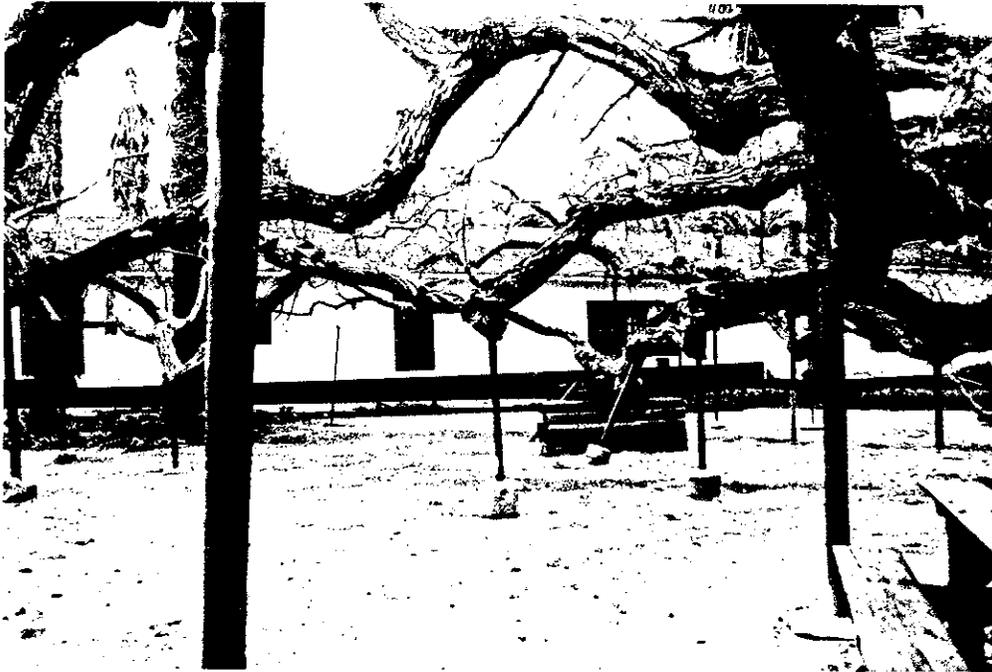
West side of adobe showing branches of black walnut tree.

The black walnut tree is the only survivor of four black eagle seedling walnut trees planted by Juventino del Valle about 1870. The tree covers about 3/4 of an acre. The branch spread is 129'. The trunk diameter is 69.2" where branching begins at two feet above ground.

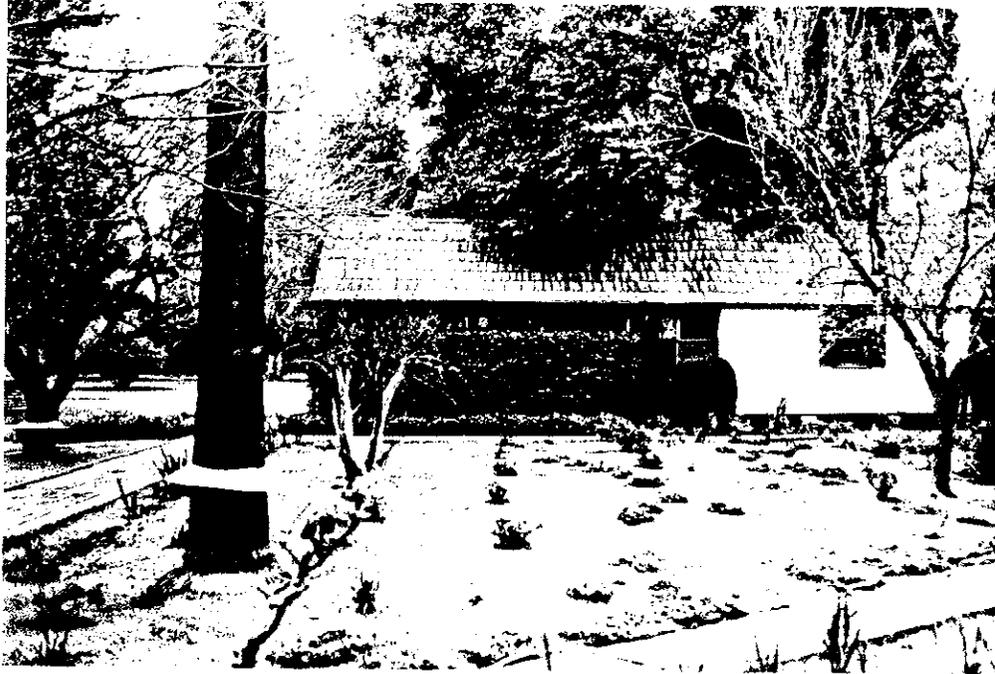
The Chapel

It is uncertain when the chapel was built, but photographs of the chapel were taken by Ventura photographer John C. Brewster about 1888. In the book *Ramona* by Helen Hunt Jackson, Mrs. Jackson, mentions the chapel numerous times, so it was probably built when she visited the ranch in 1882.

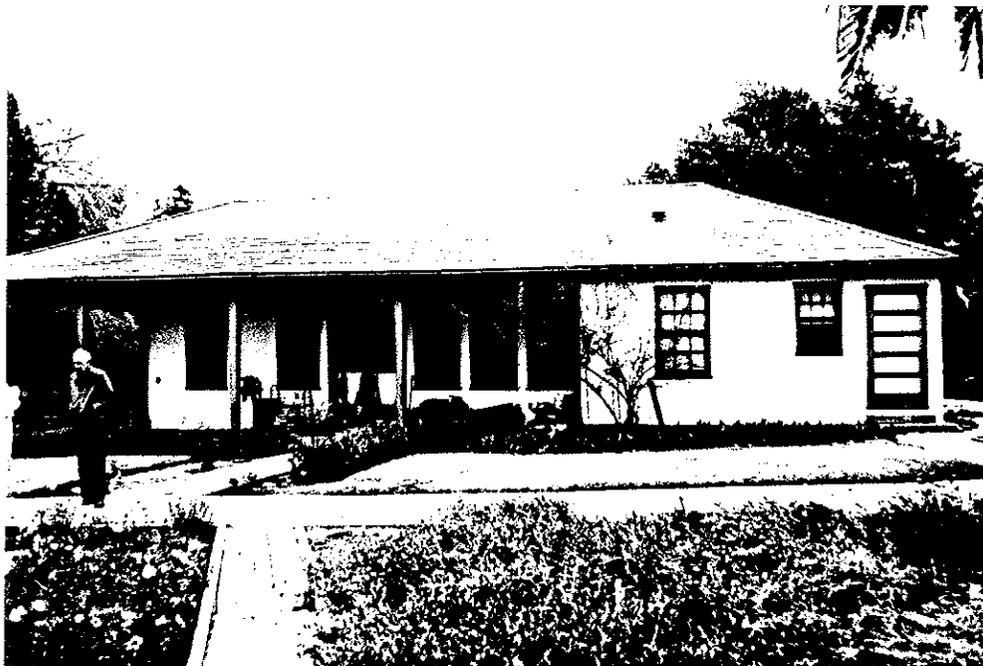
Schoolhouse

This school was built about 1933 by the August Rubel family. Members of the Rubel family and local children attended the school. It is rectangular in shape with a hip roof covered with slate. It is of wood frame construction and covered with stucco siding. Windows are double hung with multi-paned wood frames and mouldings. There is an open corridor on the south and east sides with square wood post supports. The floor is brick. The front door is of wood planks with iron handles. The school was later converted to a residence.

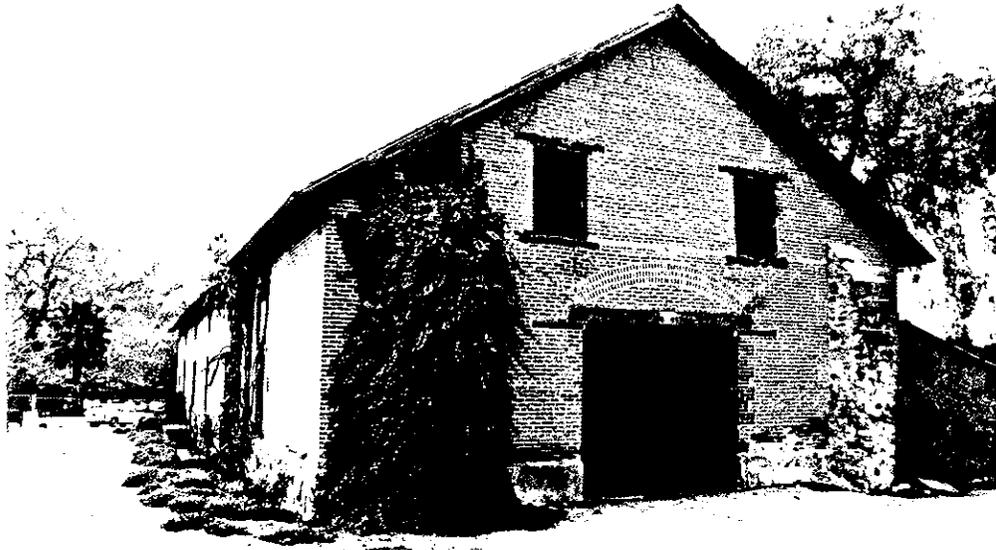
Winery

This large two-story structure has a medium high gable roof and is rectangular in shape. It is approximately 38' x 126'. It is constructed of brick with a concrete and stone foundation. The stone work is about three feet high. On the facade are two stone buttresses. The front entry is a square opening with wood lintels. The brick is positioned in a radiating arch pattern above the entrance, indicating that the original entry was arched. Wood lintels are also found above the other entrances and windows. Windows are double hung with wood frames and mouldings. On the west side of the building is a shed roof board and batten addition.

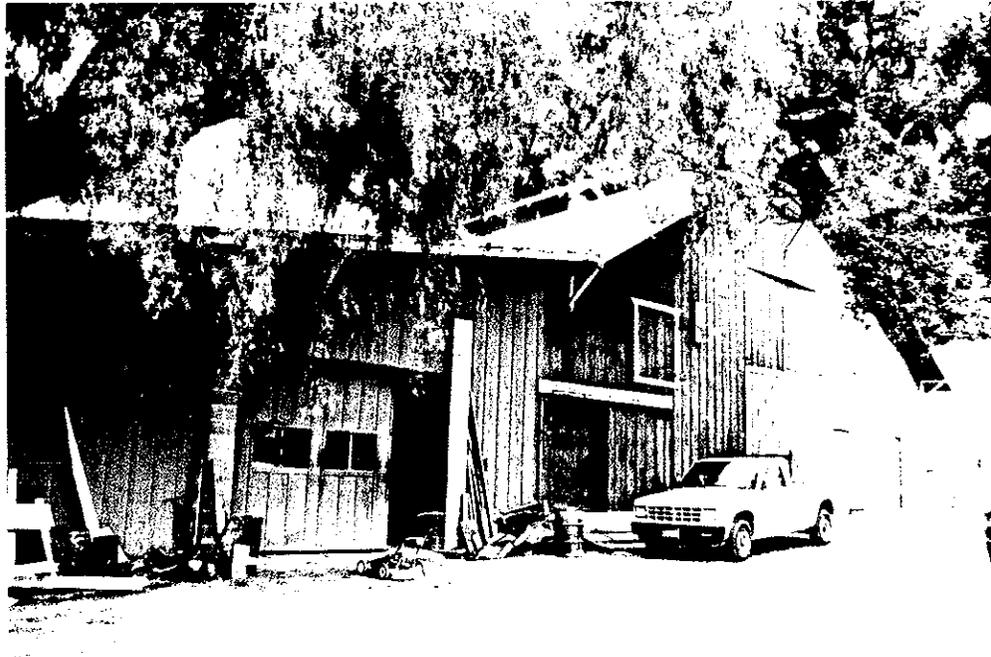
Barn

This large barn, located north of the winery, is approximately 54' x 64'. It is rectangular in shape with a high gable roof. Under the eaves are knee brackets. A gabled vent is located on the ridge line. The entry is a double barn-type door that is quite high. Siding is board and batten. The barn has a concrete floor. An addition was put on the south side and used for tractor storage and workshop. It is uncertain when the barn was built. It is said to have been used for harvesting walnuts at one time.

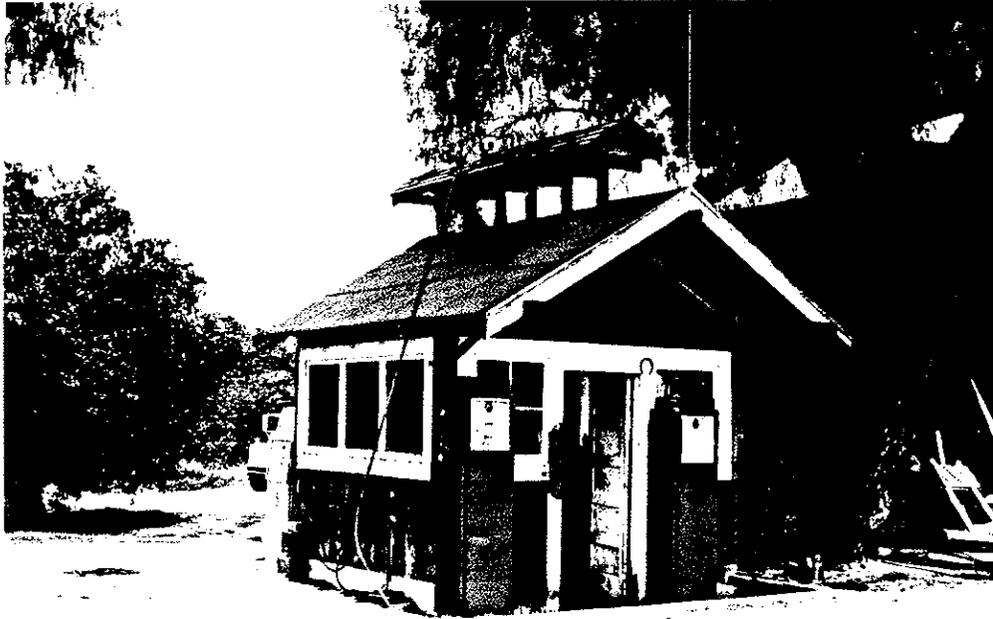
Gas and oil house

This small building is only 9' x 10' with a gable roof and gabled vent. Under the eaves are exposed beams and rafters. The building rests on a concrete foundation and is covered with board and batten siding. It is uncertain when this structure was built. It is located south of the barn.

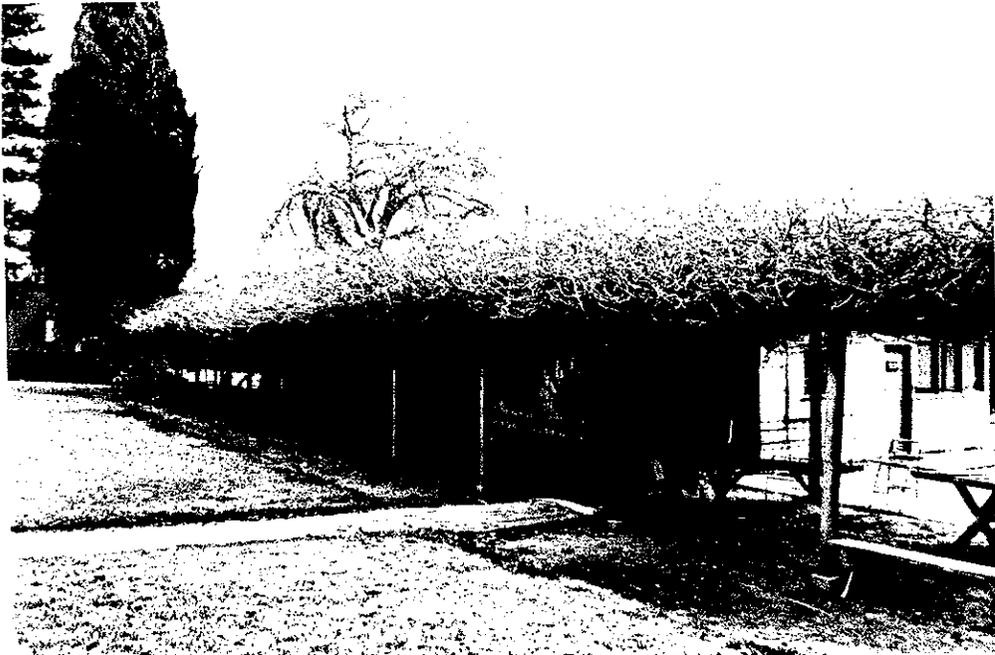
This long rectangular shaped building has a low gable roof with exposed rafters and brackets under the broad eaves. The front entrance is flush with the facade, and an enclosed porch is recessed on the south side of the entry. The windows are double hung and casement with wood frames and mouldings. The building is covered with shingles and rests on a concrete foundation. On the north side of the bunkhouse is a long arbor.

The bunkhouse was built about 1916 to house ranch employees.

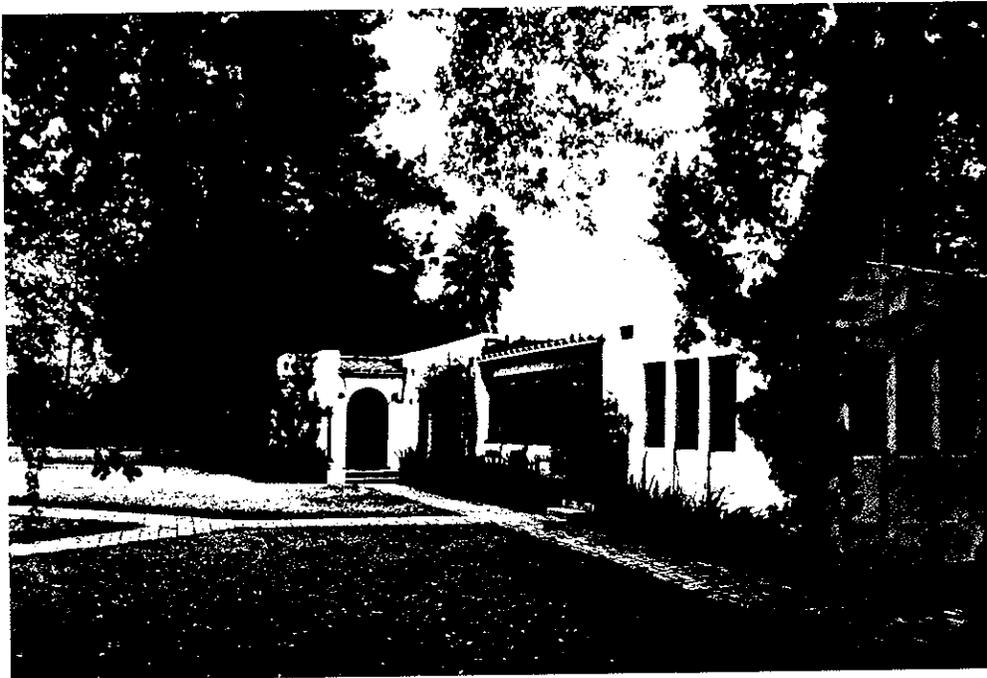
Residence/office

This is the house that is closest to the main highway (Rte. 126). The house is single story with a flat roof. It is built with a center courtyard portion. The entry has a small shed portion of tile and an arched opening. An additional porch is recessed in the center of the facade and has a tile roof with wood beam and columns. The front door is of wood planks with a decorative small window with a wood grille. The double hung and casement windows are wood frame and recessed. The windows are arranged in groups of threes and fours with stucco pilasters in between each window. The house has a stucco chimney. The house is 3/4 adobe construction and 1/4 frame construction. It is covered with stucco and rests on a concrete foundation. It is Spanish Colonial Revival in style.

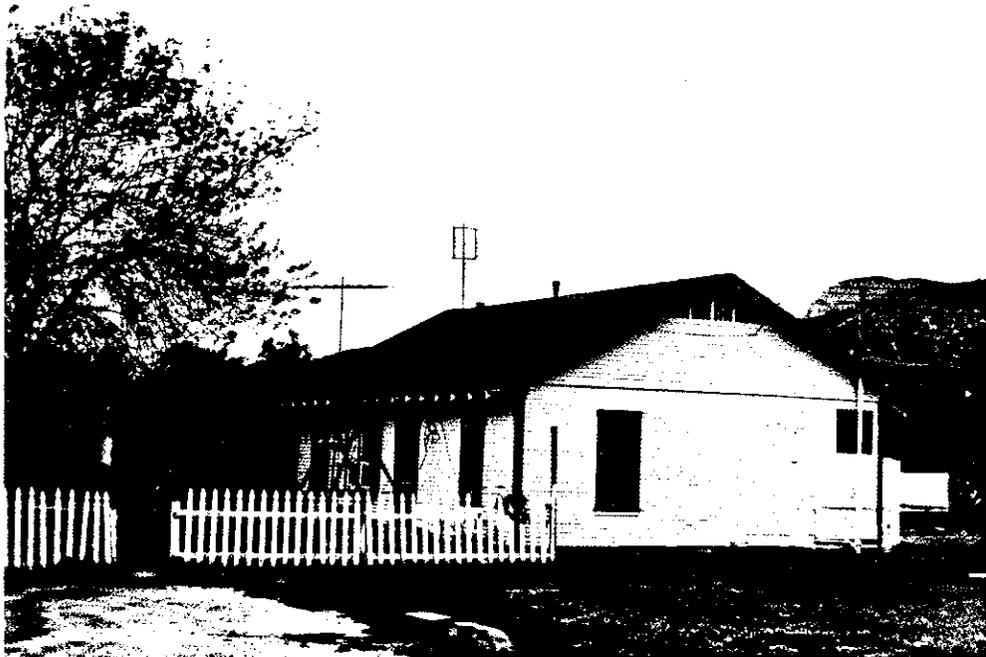
Worker's house

Located on the north side of Highway 126 above the railroad track is this single story residence. It is one of three houses built to house farmworkers. All three houses were built in 1916. This house is a typical example with its gable roof, double hung wood frame windows and clapboard siding.

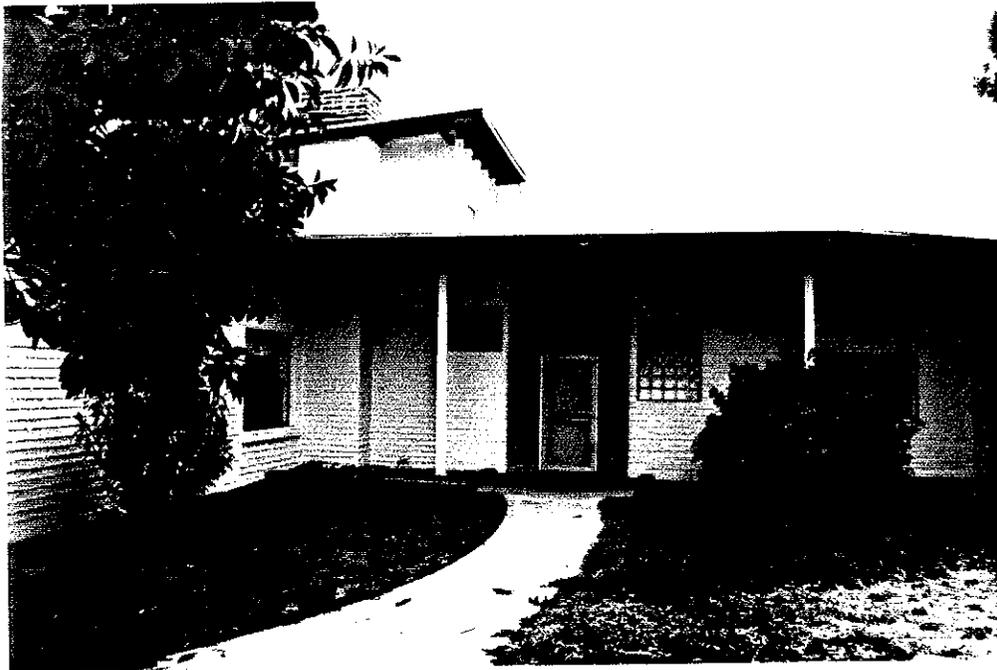
Foreman's House

This house was built in 1947 for Harry Forbes, foreman of Camulos Ranch. The L-shaped residence is a combination of one and two stories with a shed roof. The first floor is built of adobe bricks and has had a coating of white wash. The second floor is frame construction with board and batten siding. The front porch is open with a shed roof overhang supported by square columns. On either side of the door are windows with glass blocks. The remaining windows have metal frames and are both double hung and casement. A tall chimney punctuates the roofline.

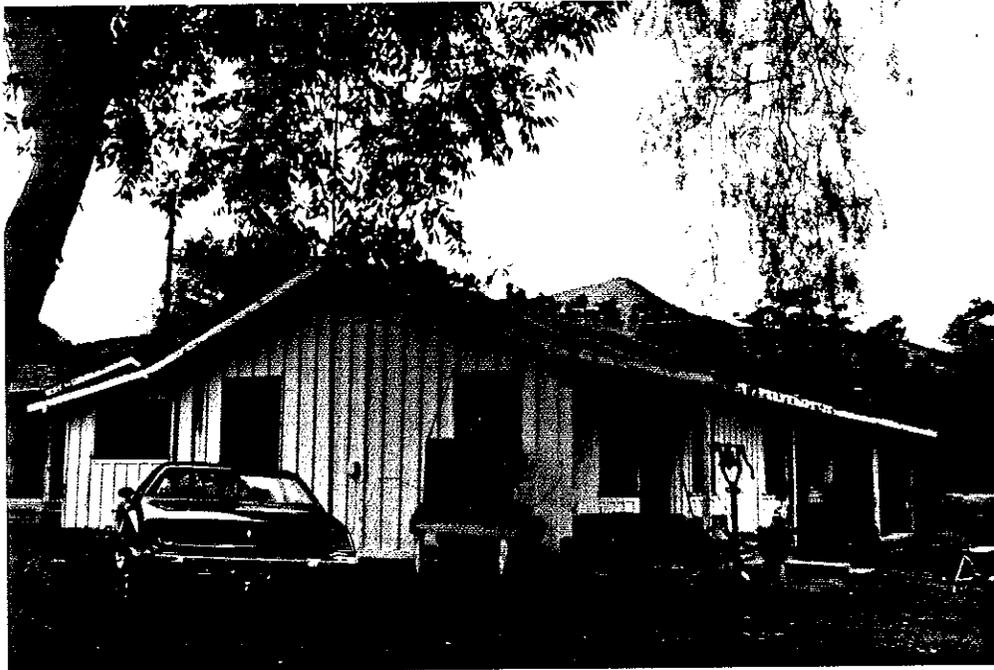
Railroad housing

This house, located directly east of the water tank, is said to have been built in 1916 for use by the Southern Pacific Railroad. It was later purchased by Camulos Ranch for worker's housing.

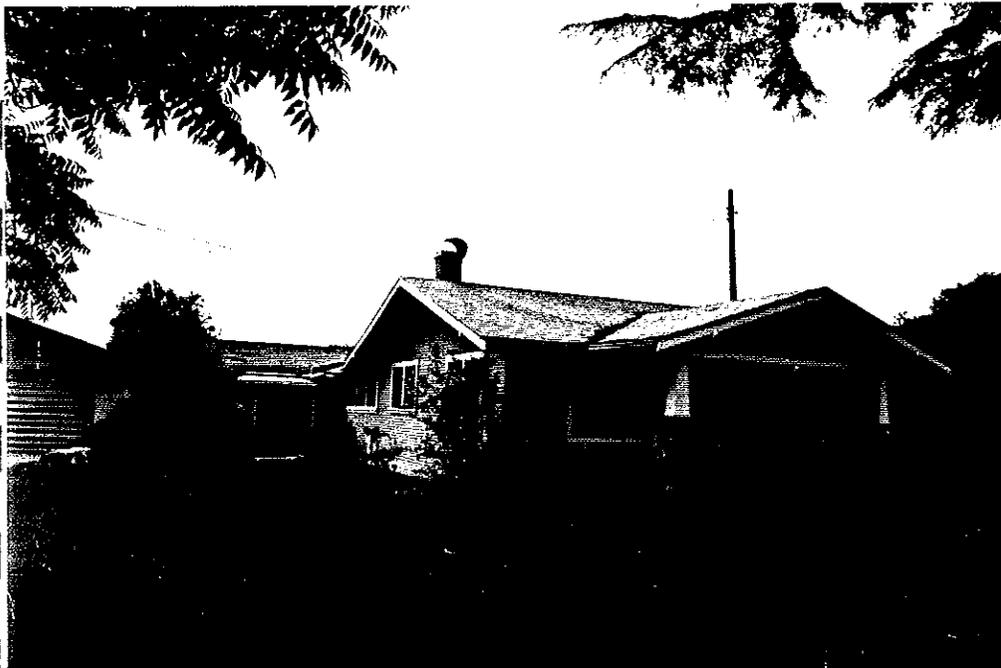
Rectangular in shape, this single story bungalow has a medium low pitched side facing gable roof with a centered gable over the porch. The Craftsman influence is seen in the tapered native stone porch columns. The columns are about two thirds stone with a concrete cap and one third tapered wood. Under the broad eaves are exposed beams with a decorative lattice vent under the front gable. There is a brick chimney. Windows are both fixed and double hung with wood mouldings. The house rests on a concrete foundation and is covered with clapboard siding.

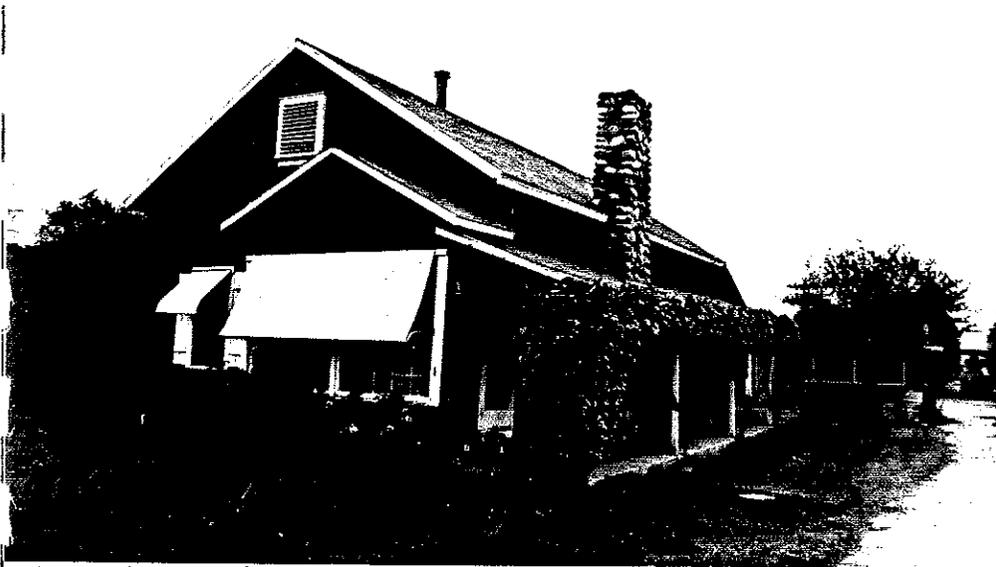
This rectangular shaped residence has a high pitched gable roof with offset front gable. This gable may have originally been the porch. A long shed roof supported by five small wood columns on the south side of the house provides a porch. A tall native stone chimney is located on the porch side of the house. Windows are double hung and fixed with wood mouldings. The large fixed front window is a later addition and has multi-panes. The house rests on a concrete foundation and is covered with board and batten on the upper two-thirds and clapboards on the lower one-third.

13. Condition: Excellent ____ Good ____ Fair X Deteriorated ____ No longer in existence ____
14. Alterations: windows
15. Surroundings: (Check more than one if necessary) Open land ____ Scattered buildings X Densely built-up ____
 Residential X Industrial ____ Commercial ____ Other agricultural
16. Threats to site: None known X Private development ____ Zoning ____ Vandalism ____
 Public Works project ____ Other: _____
17. Is the structure: On its original site? X Moved? ____ Unknown? ____
18. Related features: barn, shed, barbecue house

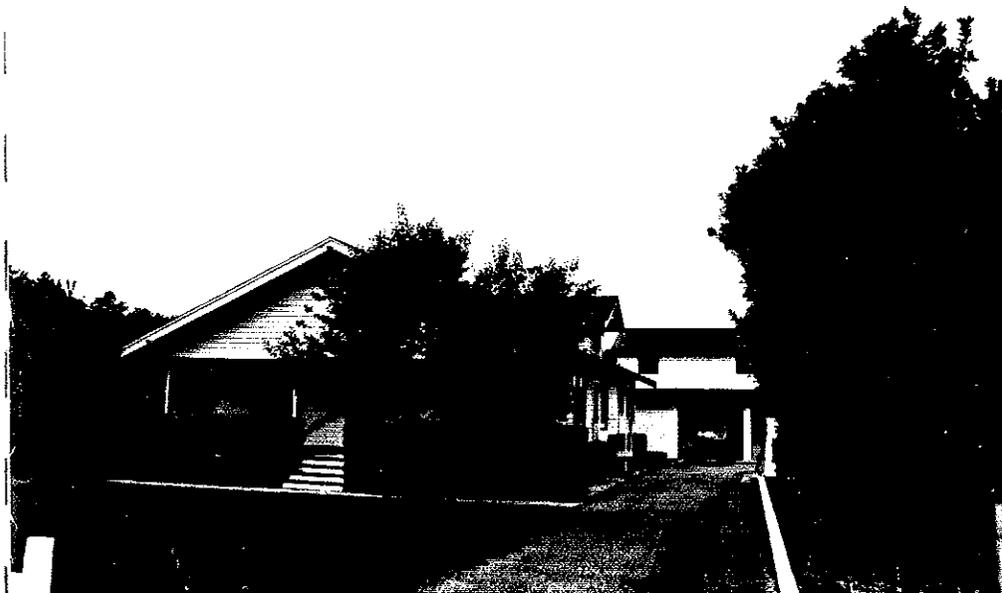
This 1 1/2 story residence is rectangular in shape with a medium gable roof. On the north side is a gabled dormer window. Under the broad eaves are exposed beams and rafters. Under the main gable is a decorative vent with vertical slats. The front porch is recessed under the main gable and supported by simple square columns. According to Mr. Hardison, the porch was enclosed at one time. Windows are double hung and fixed with wood frames and mouldings. The house rests on a raised concrete foundation and is covered with clapboard siding.

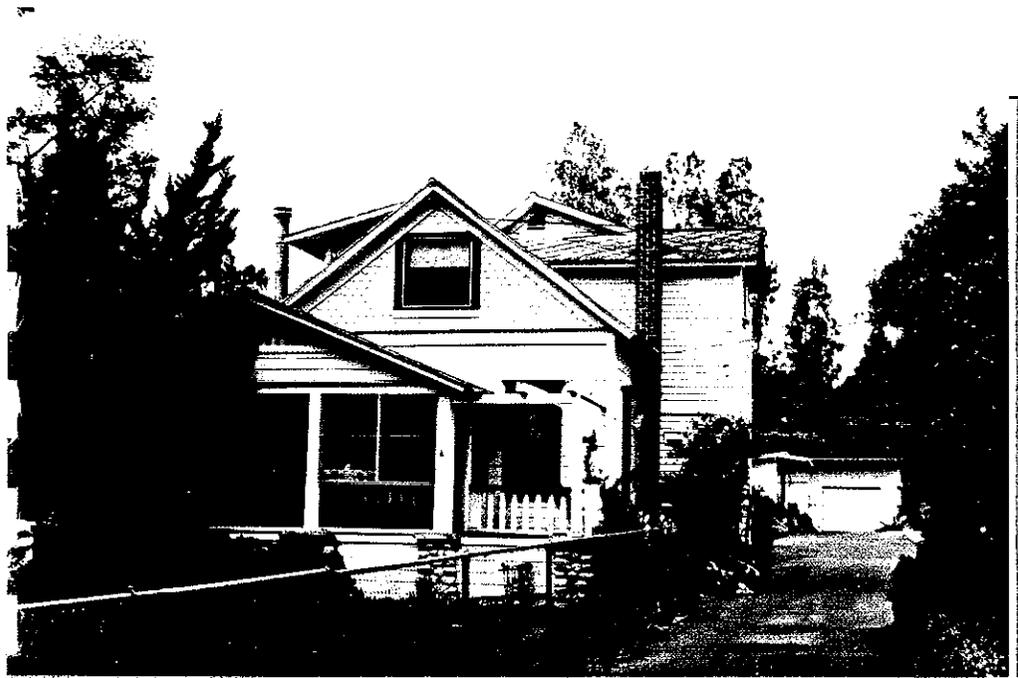
This house is a combination of one and two stories with intersecting high and medium gable roofs. The original part of the house has the high pitched gable with an offset gable on the rear and side. Under the eaves of the front gable are fishscale shingles. The window was probably a later addition. Eaves are boxed and siding is wide shiplap. The double hung windows on the first floor are long and narrow with capped mouldings. A low-pitched offset front gable roof was added as the front porch. It is supported by tapered wood columns on the upper portion and stone columns on the lower portion. A pergola extends from the porch across the front of the house. On the north side of the house is an exterior tall brick chimney.

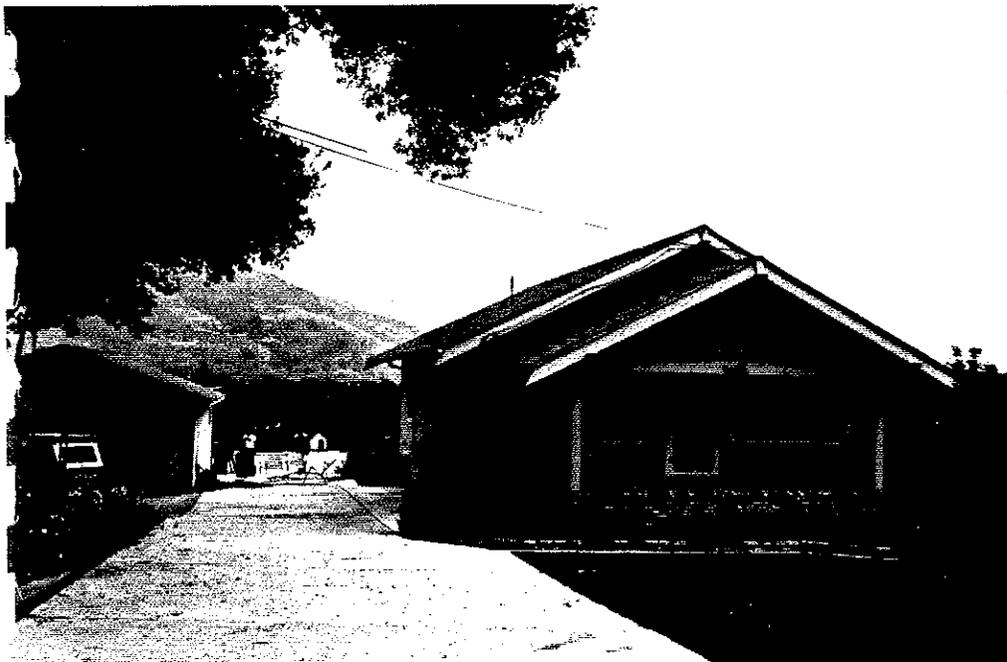
This single story bungalow is rectangular in shape with a medium gable roof and front gable over the porch. The porch is supported by square columns. Originally these columns were tapered. The porch has also had a new brick floor and wall added across the foundation. Under the broad eaves are exposed rafters and beams. Windows are both fixed and double hung with wood frames and mouldings. The house rests on a raised concrete foundation and is covered with clapboard siding.

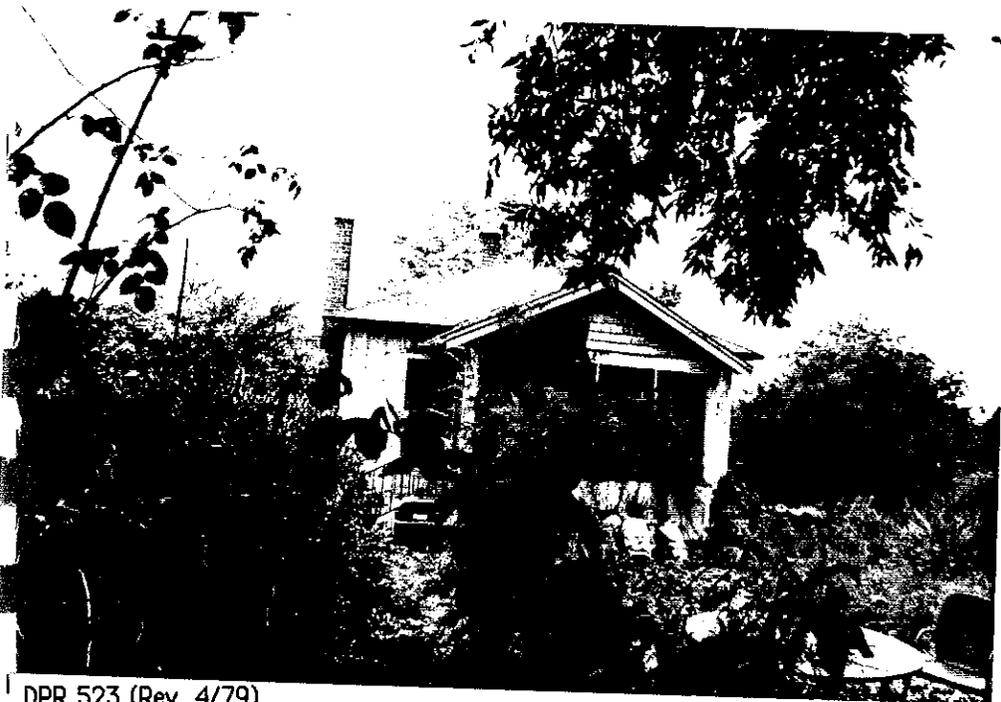
This small hipped roof cottage is one story in height with an offset gable roof over the front porch. This porch is probably a later addition. Under the gable roof is shingle siding supported by capped square columns. The porch has been enclosed with screens and a wrought iron railing added with concrete steps. The main part of the house is covered with board and bat siding. Windows are double hung with wood frames and mouldings. On the north side is a slanted bay window. Also on the north side is an exterior brick chimney. Another brick chimney punctuates the roof line. The house rests on a combination of stone, concrete and concrete block foundation.

13. Condition: Excellent ___ Good ___ Fair Deteriorated ___ No longer in existence ___
14. Alterations: porch
15. Surroundings: (Check more than one if necessary) Open land ___ Scattered buildings Densely built-up ___
 Residential Industrial ___ Commercial ___ Other agriculture
16. Threats to site: None known Private development ___ Zoning ___ Vandalism ___
 Public Works project ___ Other: _____
17. Is the structure: On its original site? ___ Moved? Unknown? ___
18. Related features: rock wall, metal water tank, mature trees

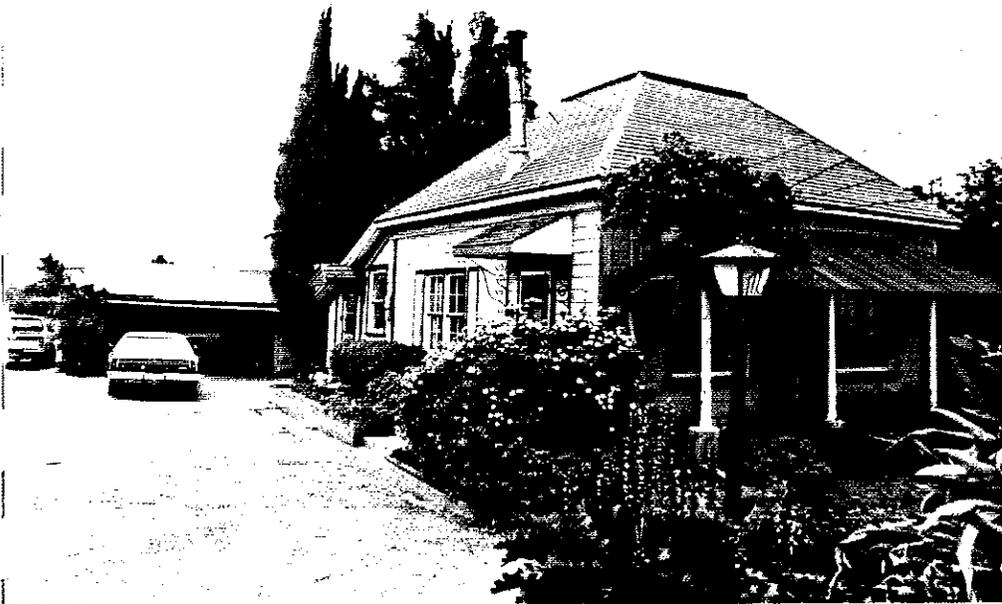
This single story rectangular shaped residence has a high truncated hip roof with a shed roof on the rear. The eaves are boxed. The facade has been changed with a new shed-type roof over the porch supported by chamfered wood columns on concrete bases. The door was originally on the front porch and was moved to the side. The present entrance has a shed roof with wrought iron brackets underneath. The front windows were changed to wide multi-paned wood frame windows. The rest of the windows are multi-paned and plain double hung with wood mouldings. Siding is wide shiplap. The house rests on a stone foundation.

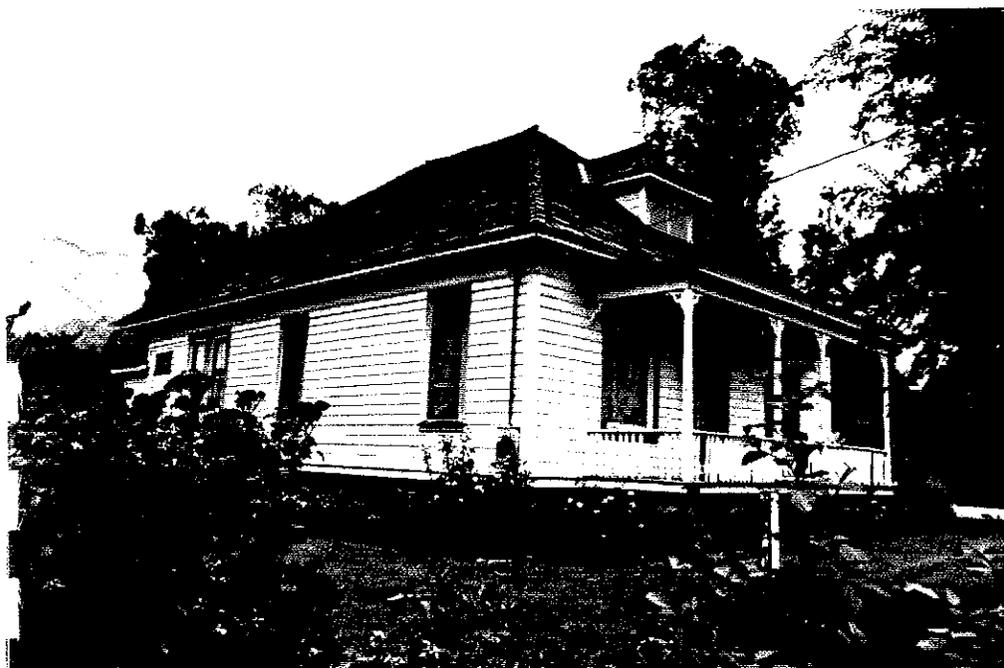
This single story rectangular shaped residence has a high pyramidal roof with hipped roof dormer and boxed eaves. The front porch is attached with a hip roof and supported by tapered wood columns with scrolled brackets and fluted wood railing. The windows are narrow and double hung with wood mouldings. The front windows are fixed with transoms above. The front door window has leaded glass. The house rests on a raised Sespe stone foundation. The chimney is brick.

13. Condition: Excellent ___ Good ___ Fair Deteriorated ___ No longer in existence ___
14. Alterations: dormer vent
15. Surroundings: (Check more than one if necessary) Open land ___ Scattered buildings Densely built-up ___
 Residential Industrial ___ Commercial ___ Other agricultural
16. Threats to site: None known Private development ___ Zoning ___ Vandalism ___
 Public Works project ___ Other: _____
17. Is the structure: On its original site? Moved? ___ Unknown? ___
18. Related features: detached garage

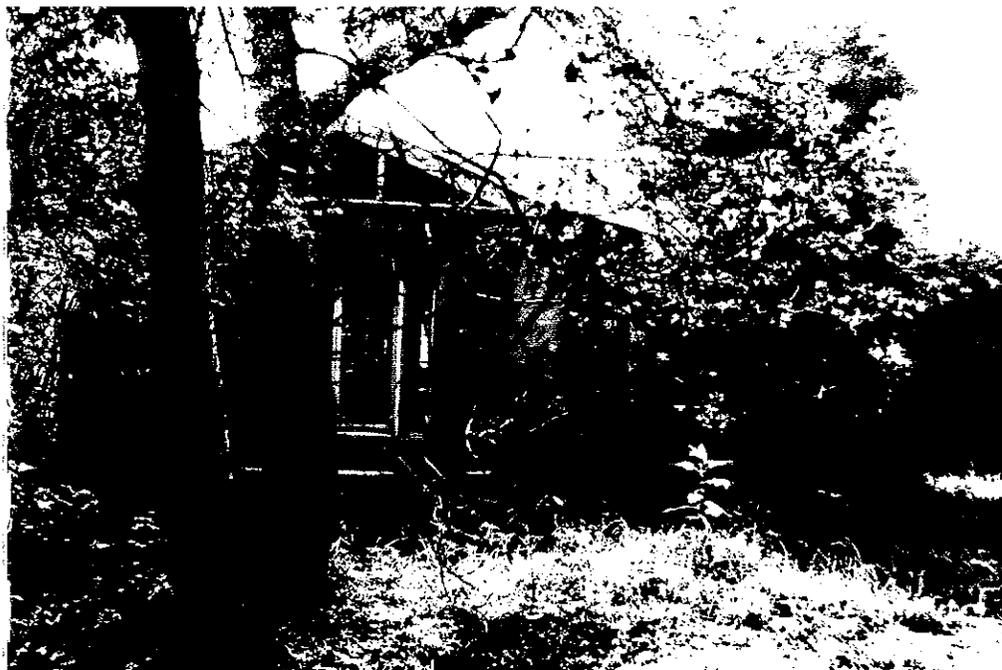
This single story residence has a low pitched intersecting gable roof and is built of adobe blocks. The gable roof ends are of wood and windows have wood frames with multi-panes. Windows are casement and fixed. The entrance is on the south side of the house. The house has had several additions in the rear with horizontal drop siding. The house has a basement which holds a cistern.

13. Condition: Excellent ___ Good ___ Fair Deteriorated ___ No longer in existence ___
14. Alterations: additions in rear
15. Surroundings: (Check more than one if necessary) Open land ___ Scattered buildings Densely built-up ___
Residential Industrial ___ Commercial ___ Other agricultural
16. Threats to site: None known Private development ___ Zoning ___ Vandalism ___
Public Works project ___ Other: _____
17. Is the structure: On its original site? Moved? ___ Unknown? ___
18. Related features: citrus orchard

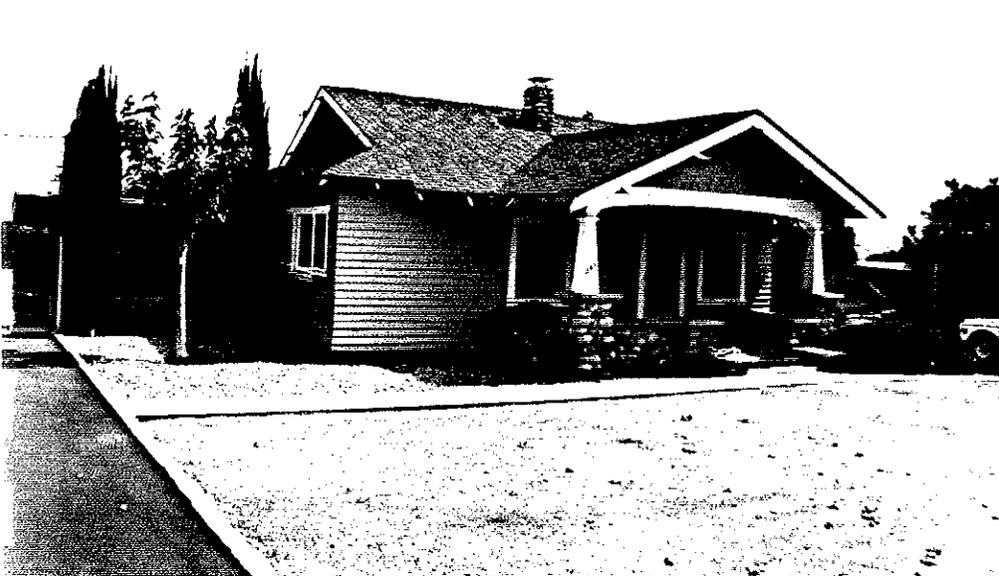
This single story rectangular shaped bungalow has a medium sidefacing gable roof with an offset gable over the front porch. Under the broad eaves are sharply pointed rafters and beams. The front porch is attached with a gable roof and supported by stone and wood columns. The native stone is used for the railing and has a concrete cap. Wood columns are tapered with caps at the top and connected to a curved beam. Windows are double hung with wood frames and flat mouldings angled at the top and tapered at the sides. A native stone chimney penetrates the roofline. The house rests on a concrete foundation and is covered with clapboard siding and shingles under the gables.

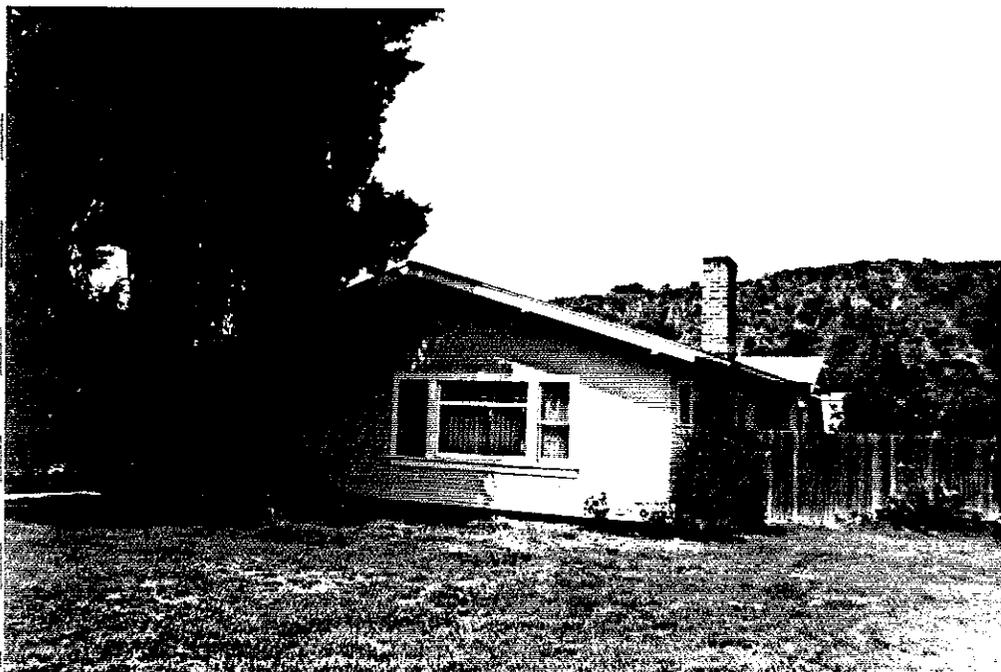
This single story residence has a low pitched gable roof with intersecting gables in the rear. Beams project from under the broad eaves. The porch is recessed under the main gable on the south side of the facade. It has been enclosed with brick on the lower half and wood casement windows on the upper half. The remaining windows are double hung and fixed with wood mouldings. Some wood windows have been replaced with aluminum frames. A brick chimney is located on the north side of the house. The house is covered with clapboard siding.

13. Condition: Excellent ____ Good ____ Fair Deteriorated ____ No longer in existence ____
14. Alterations: none apparent
15. Surroundings: (Check more than one if necessary) Open land ____ Scattered buildings Densely built-up ____
Residential Industrial ____ Commercial ____ Other agricultural
16. Threats to site: None known Private development ____ Zoning ____ Vandalism ____
Public Works project ____ Other: _____
17. Is the structure: On its original site? Moved? ____ Unknown? ____
18. Related features: mature tree

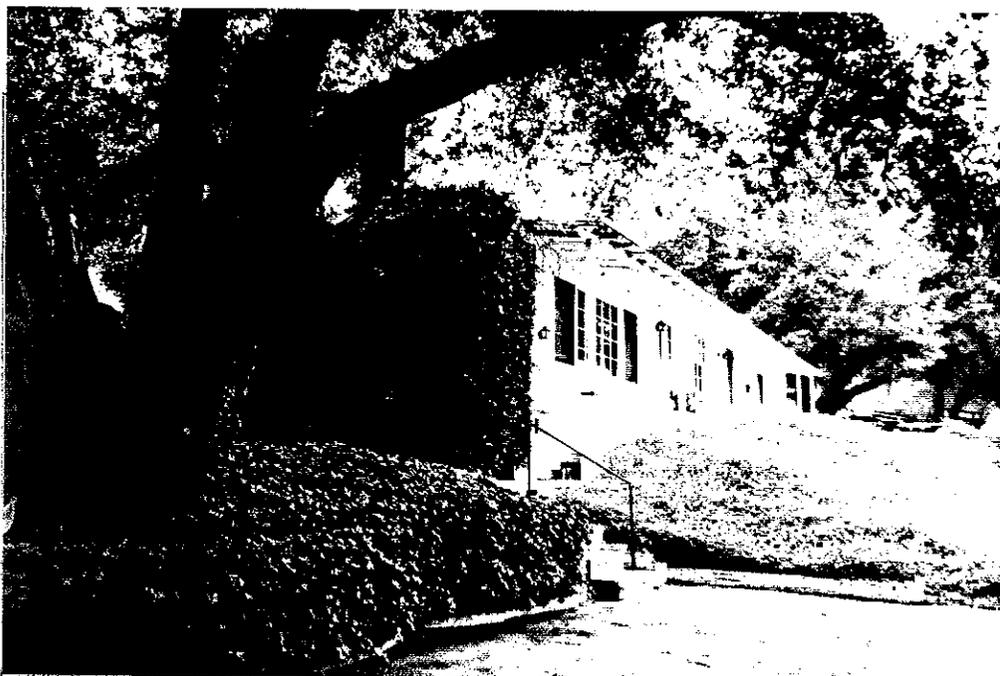
This long rectangular shaped single story residence has a low pitched gable roof with exposed rafters under the broad overhang. The porch runs the length of the facade of the house and is supported by square posts on a concrete block wall. The house is built on a raised foundation and has a basement. Windows are both double hung and casement with wood frames and multi-panes. A decorative feature are the shutters next to the windows. On the south side is a tall exterior brick chimney. The house is covered with board and batten siding and rests on a concrete block foundation. The house was almost doubled in size in 1946-47. The original portion of the house is single wall construction and the addition is double wall construction.
