CULTURAL HERITAGE SURVEY PHASE IV SANTA CLARA VALLEY

**COUNTY OF VENTURA
CULTURAL HERITAGE SURVEY
PHASE IV - SANTA CLARA VALLEY**

**Prepared by Judy Triem
San Buenaventura Research Associates**

January 1988

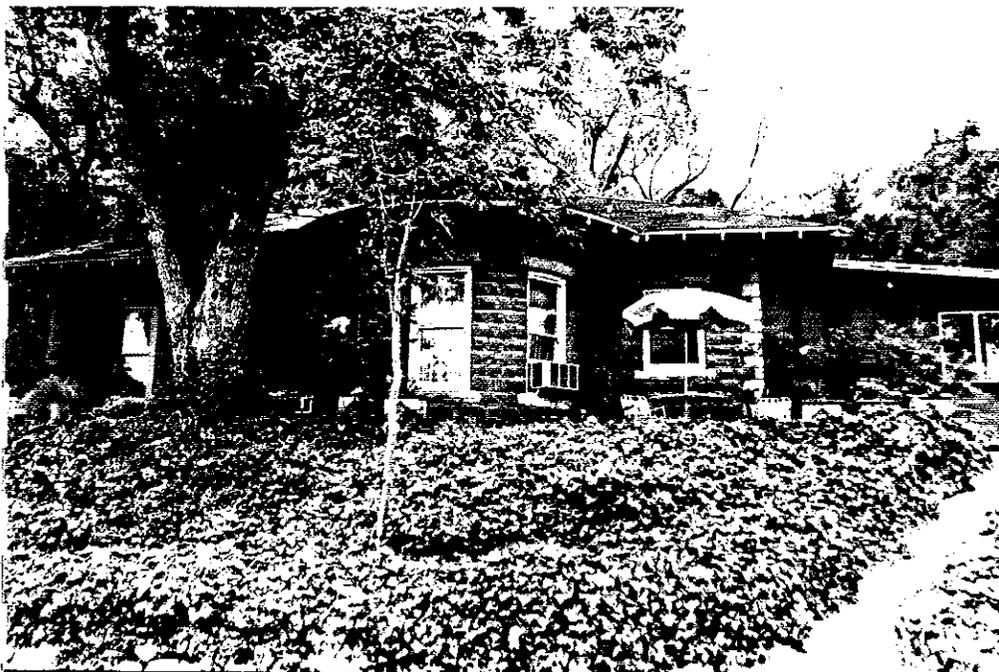
Located on a hillside setting surrounded by oak and other mature trees, this single story hip roofed residence is built primarily of Sespe stone. The house is rectangular in shape with a shed roof wing added on the north side. The broad eaves with their exposed rafters extend over the stone walls. The front entrance is recessed next to a semi-circular hipped roof portion that extends out creating a bay window. The front door has a circular arch with radiating stones. A narrow band of multi-paned frosted glass surrounds the arch. Massive granite stone lintels are located above the entrance and windows. Windows are wood frame and double hung. A Sespe stone fireplace is located on the south side of the house. On the corners of the house are contrasting granite stone quoins. A deck has been attached to the front of the house. The north side addition is constructed of concrete blocks and has sliding aluminum windows.

13. Condition: Excellent Good Fair Deteriorated No longer in existence
14. Alterations: addition on north side - concrete block
15. Surroundings: (Check more than one if necessary) Open land Scattered buildings Densely built-up
 Residential Industrial Commercial Other agricultural
16. Threats to site: None known Private development Zoning Vandalism
 Public Works project Other: _____
17. Is the structure: On its original site? Moved? Unknown?
18. Related features: oak trees, other mature trees - Arizona ash; modern guest house, workshop, pond

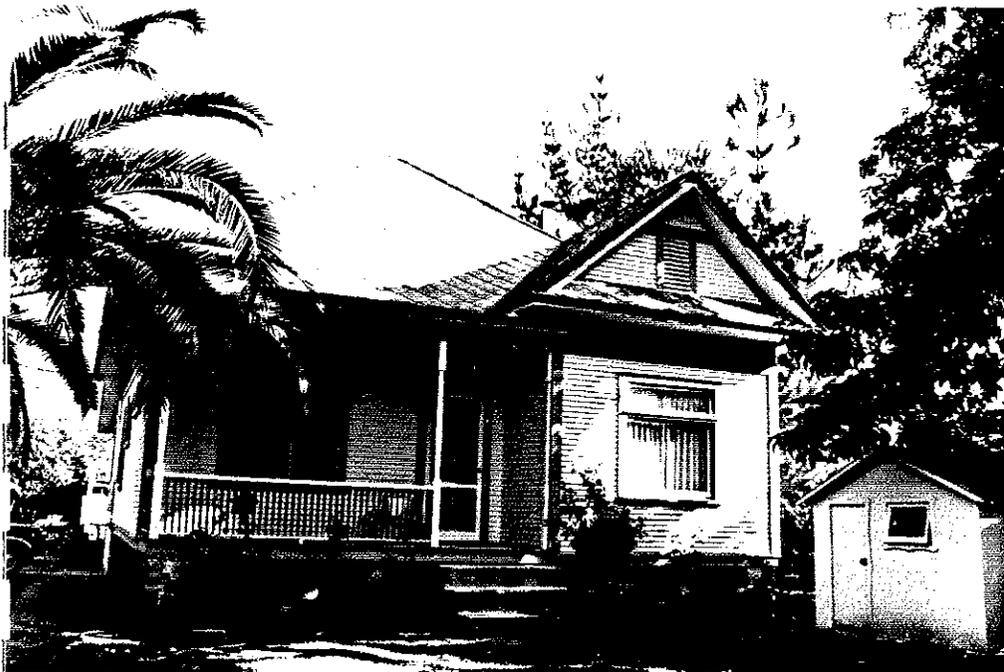
This single story rectangular shaped residence has a medium high hip roof with offset front gable with boxed eaves. A shed roof portion extends from the rear of the house. The porch is recessed on the north side of the facade and supported by square wood columns and wood railing. The upper portion of the columns have curved brackets. Windows are double hung or fixed with wood mouldings. The house rests on a Sespe stone foundation and is covered with narrow clapboard siding. At the rear of the house a brick chimney punctuates the roofline.

13. Condition: Excellent ___ Good ___ Fair Deteriorated ___ No longer in existence ___
14. Alterations: none apparent
15. Surroundings: (Check more than one if necessary) Open land ___ Scattered buildings Densely built-up ___
Residential Industrial ___ Commercial ___ Other agricultural
16. Threats to site: None known Private development ___ Zoning ___ Vandalism ___
Public Works project ___ Other: _____
17. Is the structure: On its original site? Moved? ___ Unknown? ___
18. Related features: mature trees, bungalow residence, garage, stone & wood shed

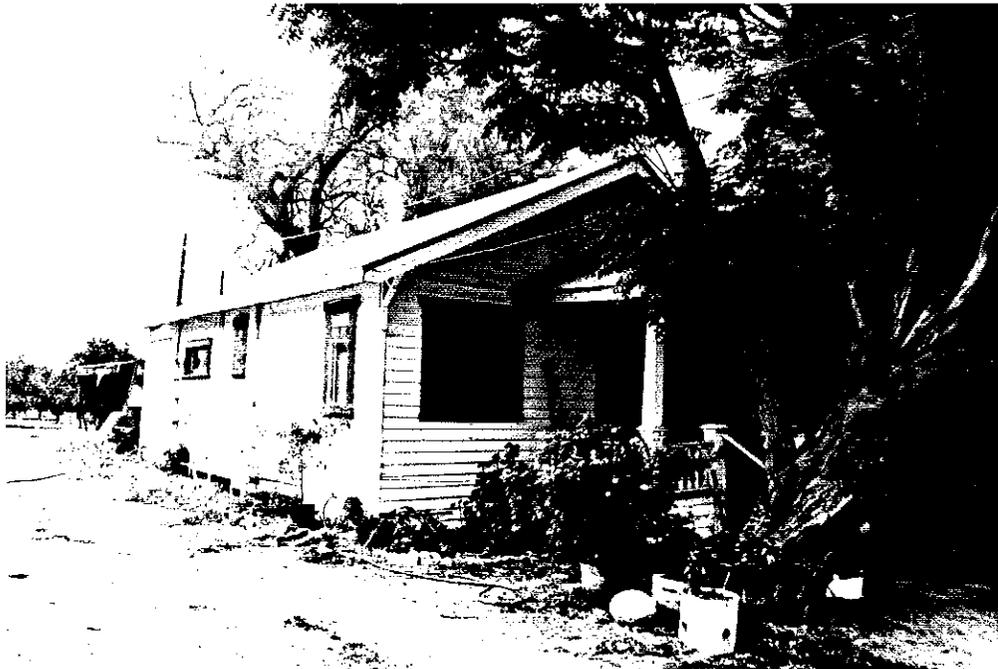
2224 Grand Ave.

This California Bungalow was built about 1919. It is located behind the main house. It is one story with a gable roof and is rectangular in shape. The porch is attached with a gable roof supported by tapered capped columns and wood railing. Classical dentil moulding is located under the porch gable above the support beam. Windows are double hung and casement with wood frames and mouldings. The house is covered with clapboard siding and rests on a wood foundation.

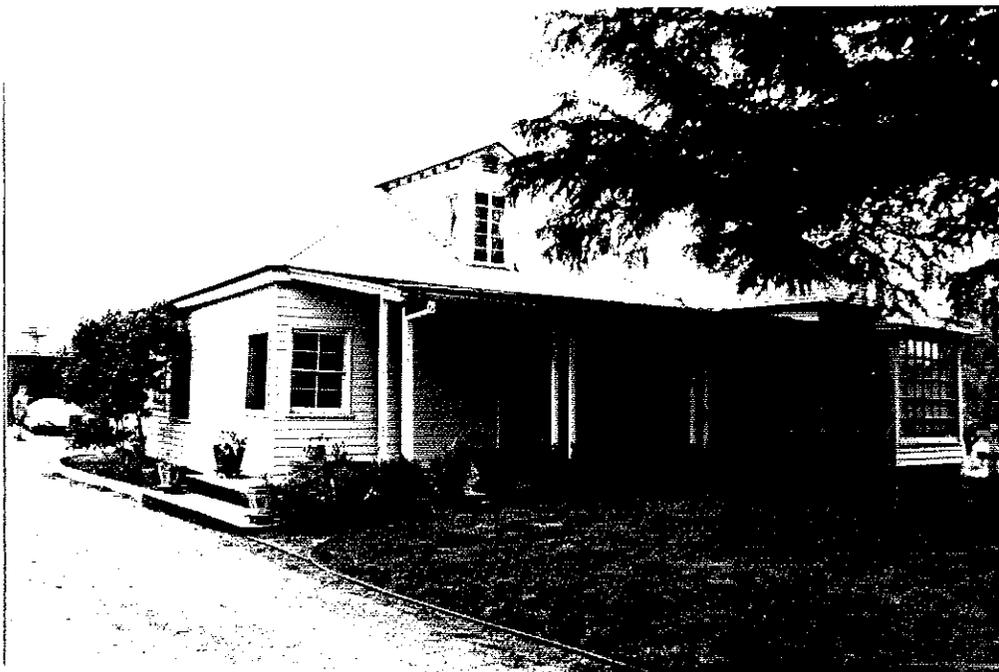
This 1 1/2 story house has a medium hip roof with a gabled dormer window. The house is a modified L-shape with an offset hip extension on the front with hipped rectangular bay window. Windows have been changed from the original. They are multi-paned double hung and casement with wood frames and raised wood mouldings. The front porch is attached with a shed roof supported by pairs of square columns. A pair of french doors open onto the porch. The house rests on a stone and concrete foundation and is covered with wide clapboard siding.

13. Condition: Excellent ___ Good Fair ___ Deteriorated ___ No longer in existence ___
14. Alterations: remodeled in 1944 - windows
15. Surroundings: (Check more than one if necessary) Open land ___ Scattered buildings Densely built-up ___
 Residential Industrial ___ Commercial ___ Other agricultural
16. Threats to site: None known Private development ___ Zoning ___ Vandalism ___
 Public Works project ___ Other: _____
17. Is the structure: On its original site? Moved? ___ Unknown? ___
18. Related features: mature Deodar cedar; three-car garage; swimming pool, shed

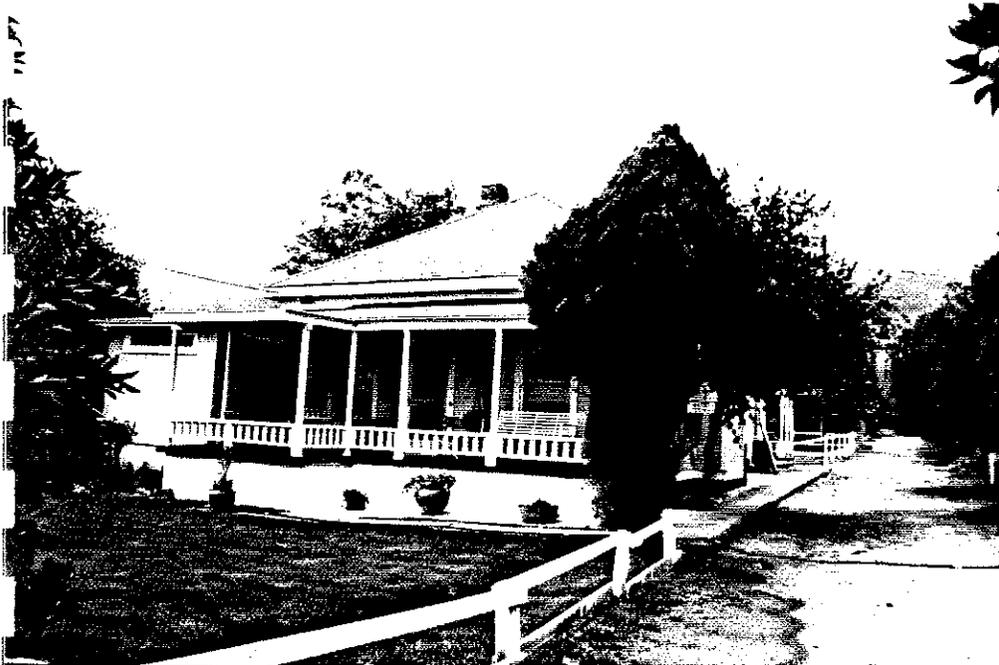
This single story residence has a medium pitched hip roof and is square in shape. The porch is attached with a hip roof with shed roof extension. Wood square columns, wider at the base, support the porch roof and are connected by a connecting low wood railing. Windows are wood frame and both double hung and casement with wood mouldings. The house rests on a stone and concrete foundation and is covered with medium clapboard siding. A corbelled brick chimney punctuates the roofline. An addition is attached to the front and south side of the house and is covered with vertical board siding.

13. Condition: Excellent Good ___ Fair ___ Deteriorated ___ No longer in existence ___
14. Alterations: addition on south side
15. Surroundings: (Check more than one if necessary) Open land ___ Scattered buildings Densely built-up ___
Residential Industrial ___ Commercial ___ Other agricultural
16. Threats to site: None known Private development ___ Zoning ___ Vandalism ___
Public Works project ___ Other: _____
17. Is the structure: On its original site? Moved? ___ Unknown? ___
18. Related features: shed, garage

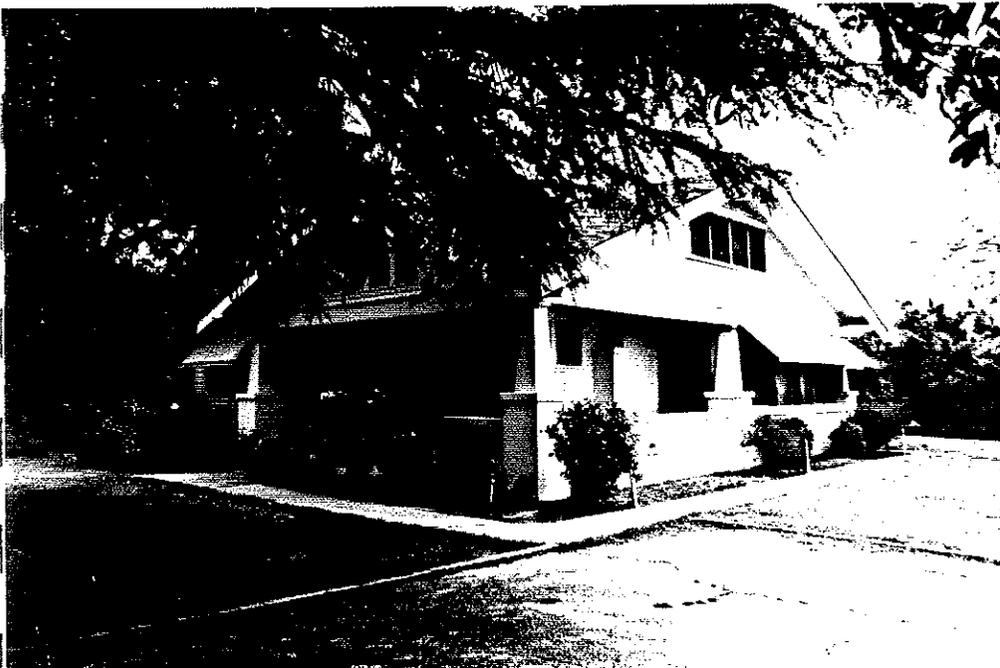
This large 1 1/2 story residence is rectangular in shape with a side facing gable roof and intersecting front gable. The porch is L-shaped and contained under the main gable. A concrete capped railing and tapered concrete and wood columns support the porch. The rear half of the side porch has been enclosed with windows. Some of the windows are fixed and double hung with wood frames and mouldings. Some of the windows, mainly on the south side, have been replaced with aluminum frame windows. The house rests on a concrete foundation and is covered with medium wide clapboard siding.

13. Condition: Excellent ___ Good Fair ___ Deteriorated ___ No longer in existence ___
14. Alterations: none apparent
15. Surroundings: (Check more than one if necessary) Open land ___ Scattered buildings Densely built-up ___
 Residential Industrial ___ Commercial ___ Other agricultural
16. Threats to site: None known Private development ___ Zoning ___ Vandalism ___
 Public Works project ___ Other: _____
17. Is the structure: On its original site? Moved? ___ Unknown? ___
18. Related features: horse barn, detached garage, mature trees

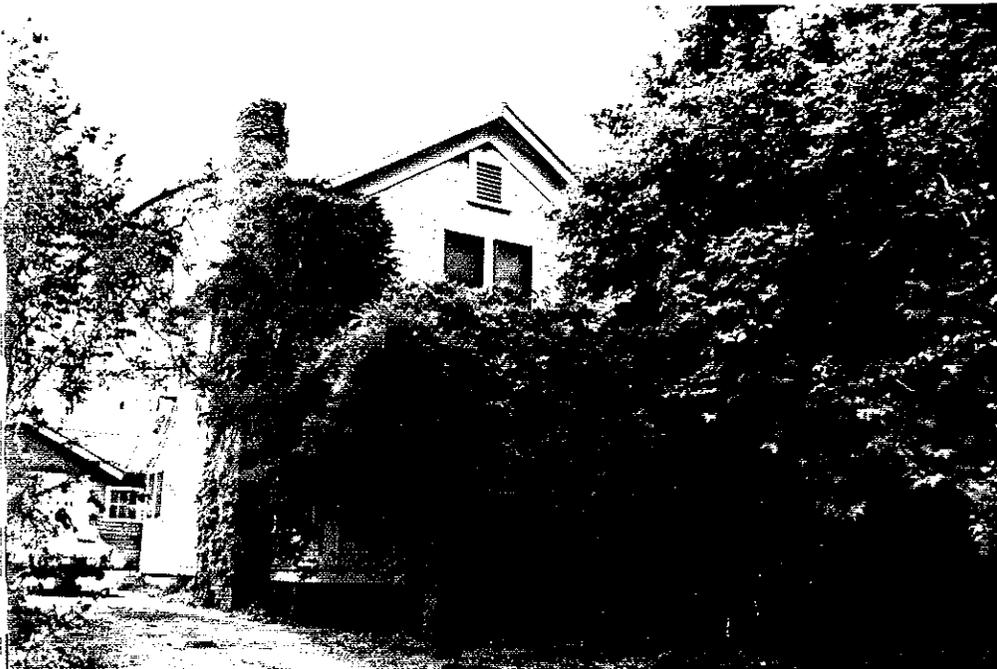
This combination two and 1 1/2 story residence is rectangular in shape with a high sidefacing gable roof with offset front gable. The eaves are boxed. A tall exterior brick chimney runs along the west side of the house. There is also a second brick chimney. The porch is adjacent to the front gable and covered by a wood pergola supported by square double wood capped columns. The porch railing is of stucco or concrete. Windows are double hung with wood frames and flat mouldings. The house rests on a concrete foundation and is covered with narrow clapboards. In the rear is a single story shed roof portion.

In the rear a gabled roof clapboard residence has been converted to a garage.

13. Condition: Excellent ___ Good Fair ___ Deteriorated ___ No longer in existence ___
14. Alterations: none apparent
15. Surroundings: (Check more than one if necessary) Open land ___ Scattered buildings Densely built-up ___
 Residential Industrial ___ Commercial ___ Other agricultural
16. Threats to site: None known Private development ___ Zoning ___ Vandalism ___
 Public Works project ___ Other: _____
17. Is the structure: On its original site? Moved? ___ Unknown? ___
18. Related features: detached garage; small bungalow; mature trees

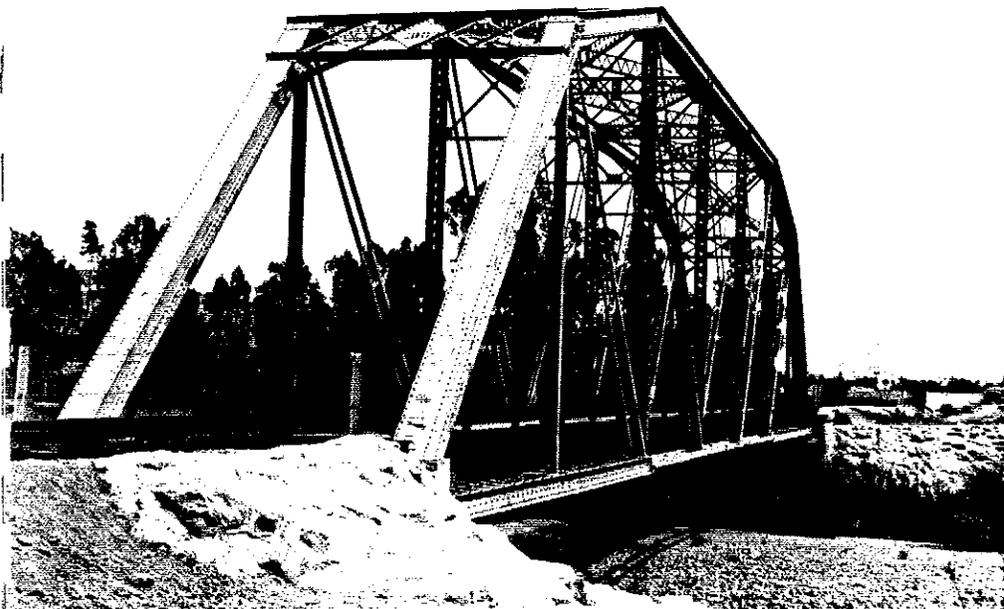
This bridge is quite similar to the Piru Train Bridge. That bridge is described as a typical steel through-truss bridge of turn-of-the-century construction type. The date on the bridge is 1902. The bridge may have been two span originally, with only one span remaining. The original abutments have been changed. They were originally constructed of Sespe Brownstone.

13. Condition: Excellent ___ Good Fair ___ Deteriorated ___ No longer in existence ___
14. Alterations: none apparent
15. Surroundings: (Check more than one if necessary) Open land Scattered buildings ___ Densely built-up ___
 Residential ___ Industrial ___ Commercial ___ Other Sespe Creek
16. Threats to site: None known Private development ___ Zoning ___ Vandalism ___
 Public Works project ___ Other: _____
17. Is the structure: On its original site? Moved? ___ Unknown? ___
18. Related features: N/A

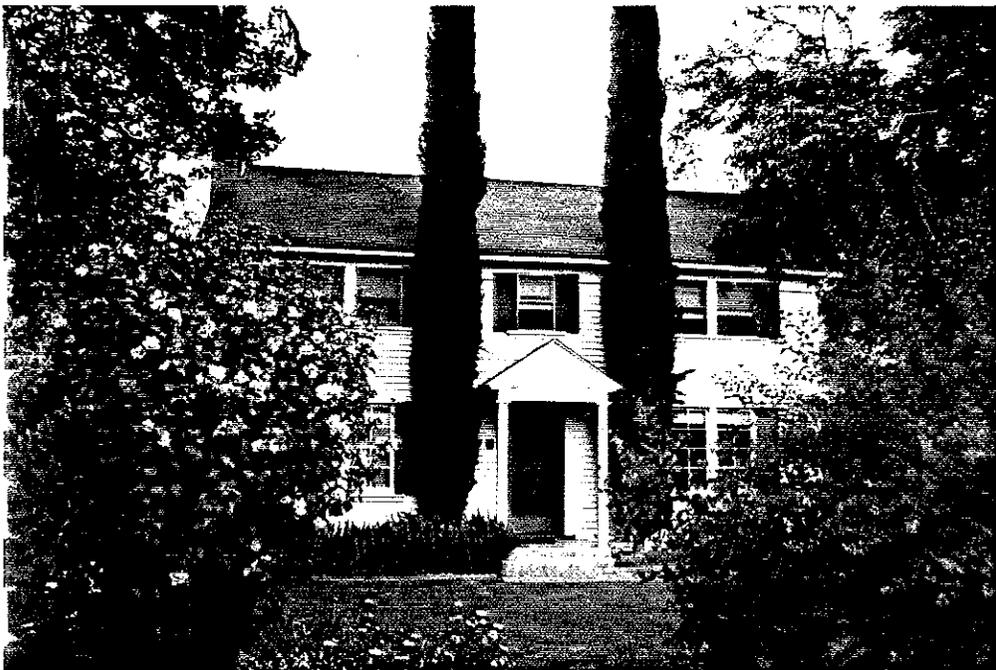
This two-story rectangular shaped house has a medium gable roof with boxed eaves. The house is symmetrical in its placement of windows and entry. The front porch has a small gabled roof with boxed and returned eaves supported by simple square columns capped at the top. On either side of the entry are pairs of double hung multi-paned windows with louvered shutters on each side. The second floor has smaller pairs of double hung windows with shutters spaced to line up with the windows on the first floor. There is an exterior brick chimney on the north side of the house. The house rests on a concrete foundation and is covered with clapboard siding.

13. Condition: Excellent Good ___ Fair ___ Deteriorated ___ No longer in existence ___
14. Alterations: none apparent
15. Surroundings: (Check more than one if necessary) Open land ___ Scattered buildings Densely built-up ___
 Residential Industrial ___ Commercial ___ Other agricultural
16. Threats to site: None known Private development ___ Zoning ___ Vandalism ___
 Public Works project ___ Other: _____
17. Is the structure: On its original site? ___ Moved? Unknown? ___
18. Related features: detached garage, pump house, mature trees

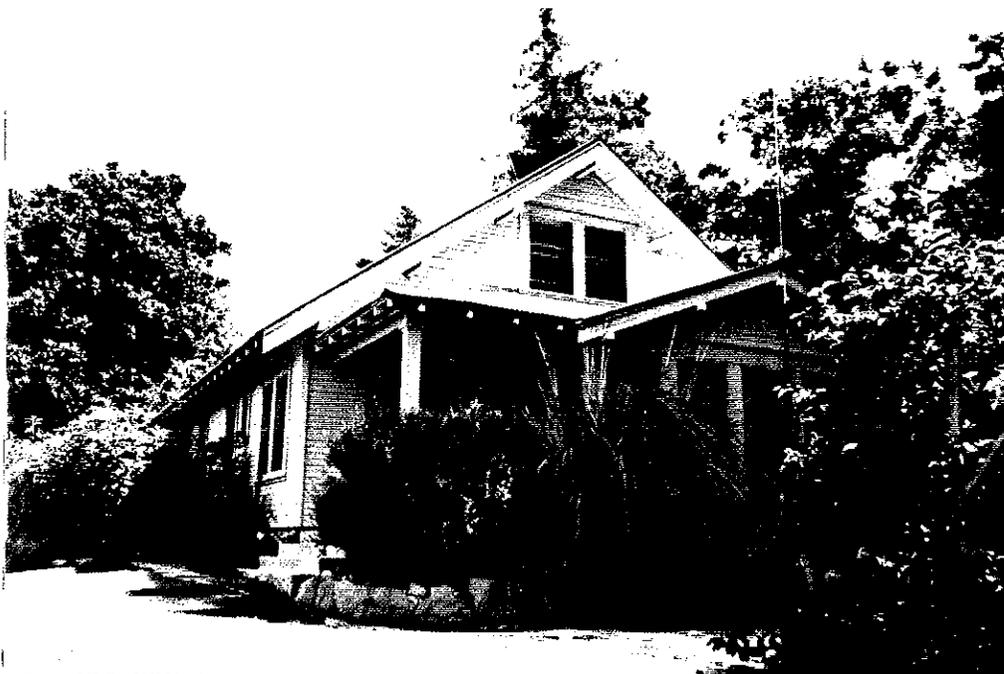
This 1 1/2 story rectangular shaped residence has a high pitched gable roof with exposed rafters and beams under the broad eaves. There is an offset gable next to the front porch. The front gable may have been the original porch and is now enclosed with windows. Above the porch is a hip roof supported by a square column capped at the top. Windows are double hung with wood frames and mouldings and angled at the top corners. The house rests on a concrete foundation and is covered with narrow wood siding. In the rear is an open patio with a shed roof cover.

13. Condition: Excellent Good ___ Fair ___ Deteriorated ___ No longer in existence ___
14. Alterations: none apparent
15. Surroundings: (Check more than one if necessary) Open land ___ Scattered buildings Densely built-up ___
 Residential Industrial ___ Commercial ___ Other agricultural
16. Threats to site: None known Private development ___ Zoning ___ Vandalism ___
 Public Works project ___ Other: _____
17. Is the structure: On its original site? Moved? ___ Unknown? ___
18. Related features: barn, sheds, stone patio, mature ornamental trees -- cork oak

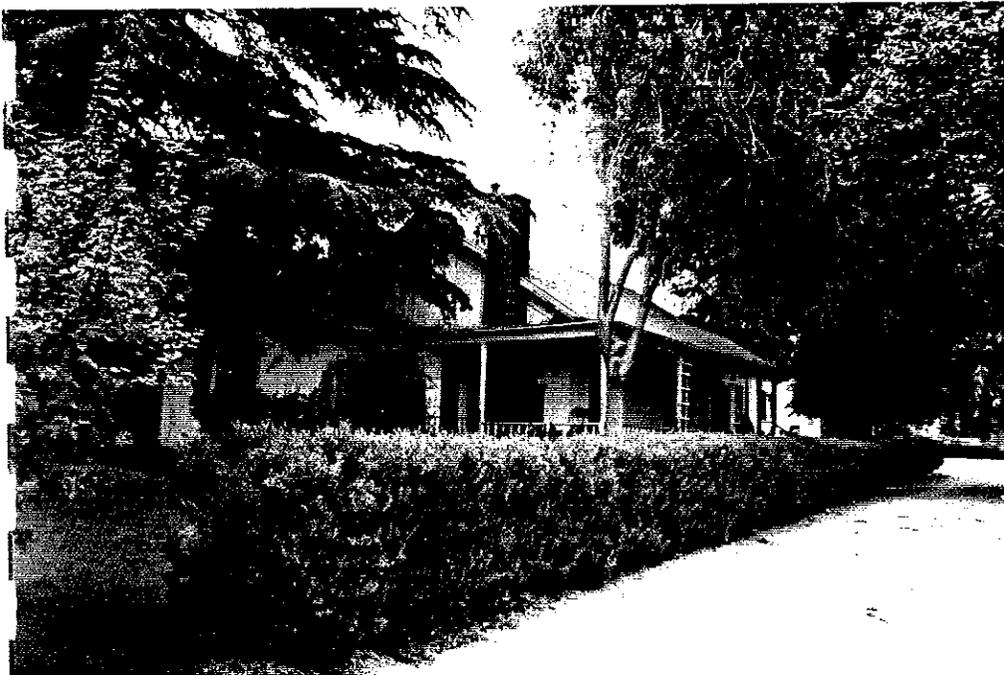
This rectangular single story residence has a medium gable roof with a small offset gable on the south side. Eaves are boxed on the main gable. The porch extends across the front of the house and around the south side. The shed type roof over the porch is supported by chamfered wood columns and a wood railing with narrow wood balusters. An exterior brick chimney is located on the south side of the house. The house has single wall construction with board and bat siding. Windows are double hung with wood frames and mouldings. There are french doors on the front porch. The house rests on a raised wood foundation.

13. Condition: Excellent Good Fair Deteriorated No longer in existence
14. Alterations: none apparent
15. Surroundings: (Check more than one if necessary) Open land Scattered buildings Densely built-up
Residential Industrial Commercial Other agricultural
16. Threats to site: None known Private development Zoning Vandalism
Public Works project Other: _____
17. Is the structure: On its original site? Moved? Unknown?
18. Related features: mature trees

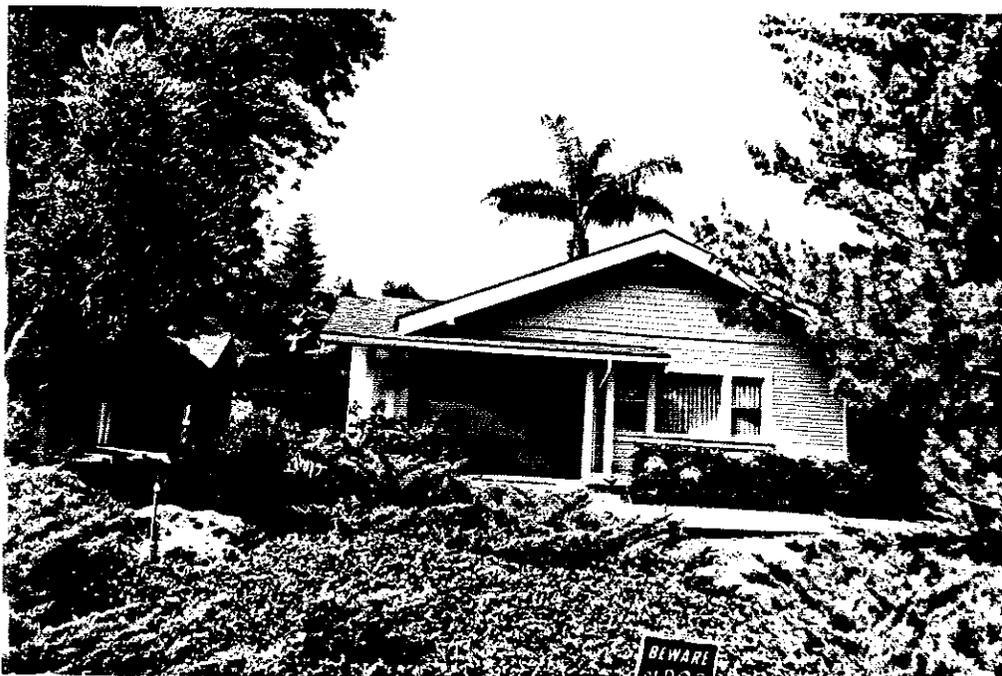
This single story bungalow is basically rectangular in shape with wings on the west and east sides. The front porch is recessed under the main side facing gable roof and supported by double square wood columns. Under the broad eaves are exposed beams and a lattice vent at the top of the main front gable. The windows are both fixed and double hung with wood frames and mouldings. The addition on the east side has sliding aluminum windows. The house rests on a concrete block foundation and is covered with shingles under the gable and clapboards on the remaining portion. The addition is covered with board and bat siding.

13. Condition: Excellent Good ___ Fair ___ Deteriorated ___ No longer in existence ___
14. Alterations: addition on east side - 1958
15. Surroundings: (Check more than one if necessary) Open land ___ Scattered buildings Densely built-up ___
Residential Industrial ___ Commercial ___ Other agricultural
16. Threats to site: None known Private development ___ Zoning ___ Vandalism ___
Public Works project ___ Other: _____
17. Is the structure: On its original site? Moved? ___ Unknown? ___
18. Related features: barn, detached garage, mature trees

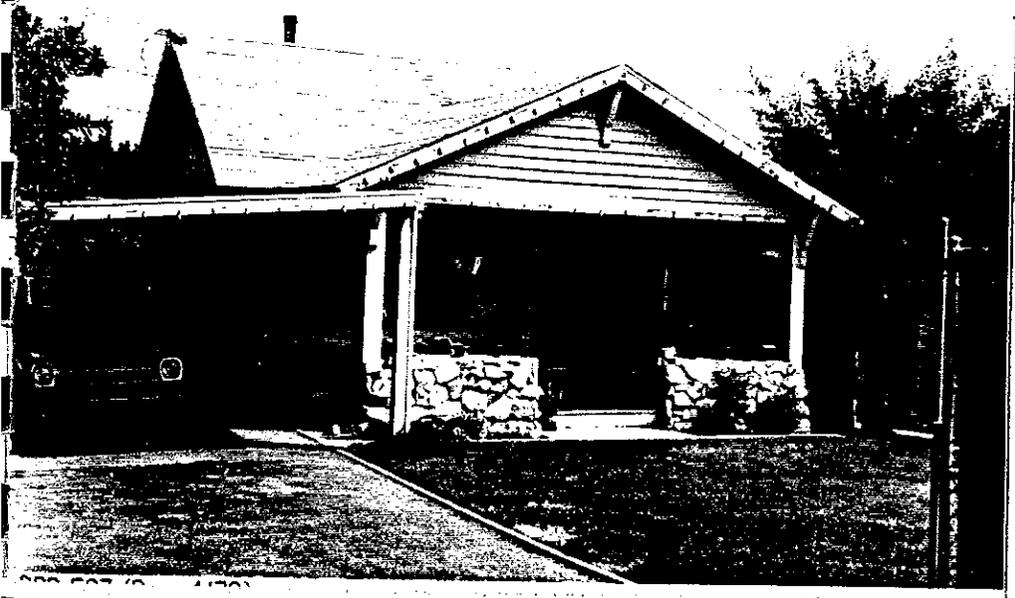
This single story residence has a medium sidfacing gable roof with a centered gable over the front porch. The porch is supported by square wood columns and solid wood railing faced in front with native stone. Under the front gable are knee brackets. Windows are wood frame double hung with flat wood mouldings pointed at the corners. The house rests on a concrete and rock foundation and is covered with medium clapboard siding. A carport is attached to the front east side of the house. The house was originally covered with board and bat siding. The porch was probably a later addition when the house was moved about 1916.

13. Condition: Excellent Good Fair Deteriorated No longer in existence
14. Alterations: siding
15. Surroundings: (Check more than one if necessary) Open land Scattered buildings Densely built-up
 Residential Industrial Commercial Other agricultural
16. Threats to site: None known Private development Zoning Vandalism
 Public Works project Other: _____
17. Is the structure: On its original site? Moved? Unknown?
18. Related features: carport

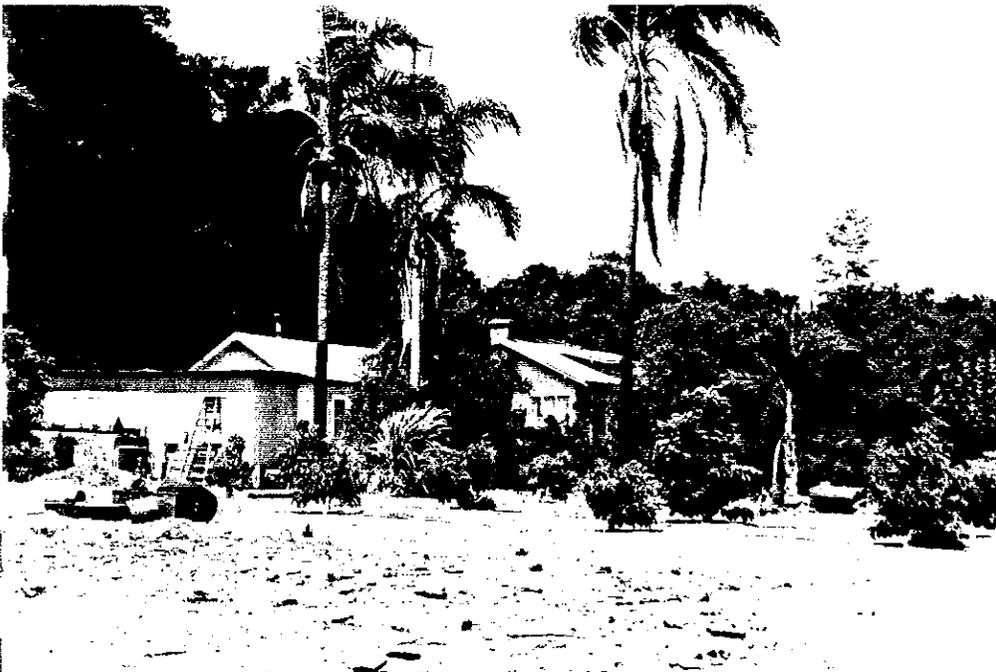
This single story bungalow is primarily rectangular in shape with an L-shaped wing on the rear west side. The roof is a medium pitched sidefacing gable with a shed roof dormer window. Rafters and beams are exposed under the broad eaves. On the west side of the house is a tall exterior brick chimney. Windows are both casement and double hung with raised wood mouldings. The house rests on a raised foundation with a horizontal wood skirt and is covered with shingle siding.

13. Condition: Excellent ___ Good ___ Fair Deteriorated ___ No longer in existence ___
14. Alterations: uncertain
15. Surroundings: (Check more than one if necessary) Open land ___ Scattered buildings Densely built-up ___
Residential Industrial ___ Commercial ___ Other park/agricultural
16. Threats to site: None known Private development ___ Zoning ___ Vandalism ___
Public Works project ___ Other: _____
17. Is the structure: On its original site? Moved? ___ Unknown? ___
18. Related features: shed, mature trees, small bungalow

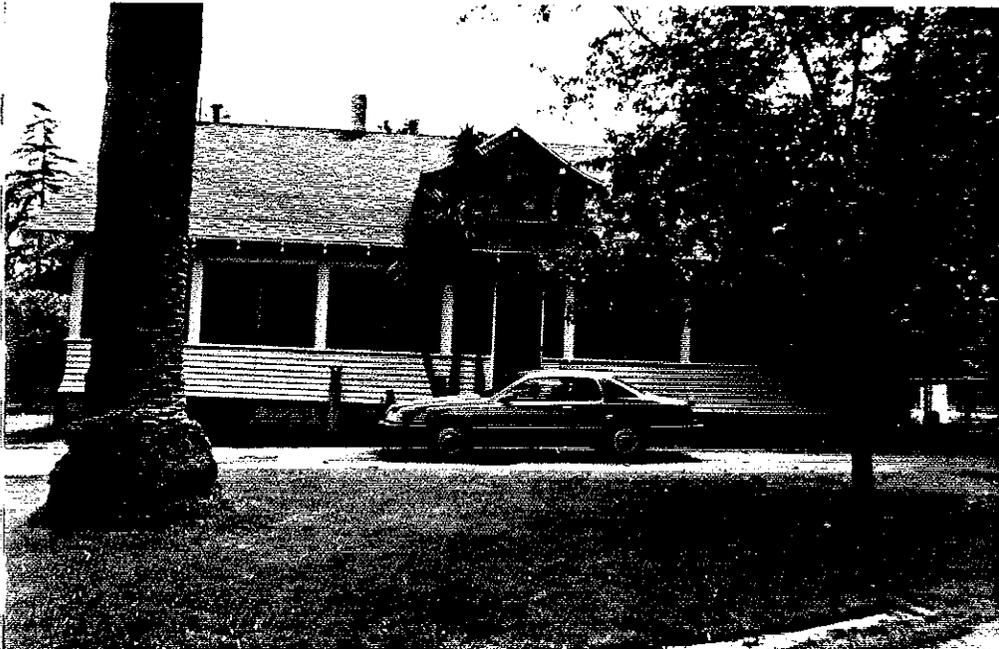
This one story rectangular shaped residence has a medium gable roof with gabled dormer window. The dormer gable curves slightly at the ends and has decorative brackets. Under the broad eaves are notched rafters. The porch is located on three sides of the house under the roofline. The front of the house on the west side has had the porch enclosed. The remainder of the porch has been screened in. The porch is supported by square wood columns and curved brackets at the corners. The lower half of the porch is covered with horizontal clapboard siding as is the rest of the house. Windows are wood frame double hung with wood mouldings. The windows were originally narrower and widened at a later date. The house rests on a raised concrete foundation. A brick chimney punctuates the roofline.

13. Condition: Excellent Good ___ Fair ___ Deteriorated ___ No longer in existence ___
14. Alterations: porch screened in; windows widened; porch enclosed on west side
15. Surroundings: (Check more than one if necessary) Open land ___ Scattered buildings Densely built-up ___
 Residential Industrial ___ Commercial ___ Other park/agricultural
16. Threats to site: None known Private development ___ Zoning ___ Vandalism ___
 Public Works project ___ Other: _____
17. Is the structure: On its original site? Moved? ___ Unknown? ___
18. Related features: mature trees, garage, swimming pool

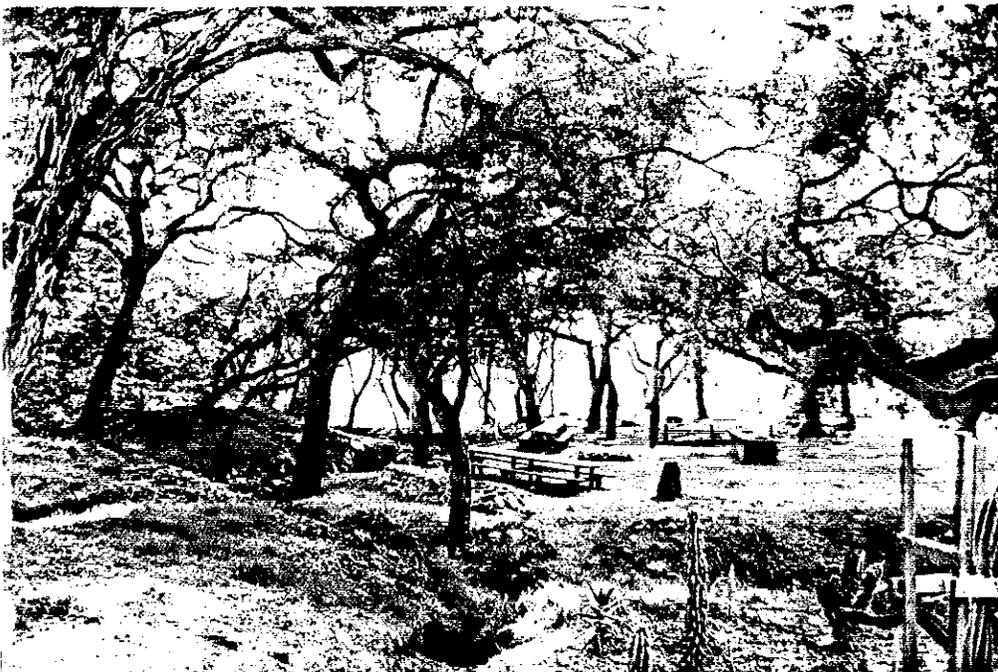
This 15 acre park is located on a gently sloping agricultural area west of Fillmore below San Cayetano Mountain. The park contains many native oak trees and a natural creek, which is dry most of the time.

Improvements to the park, over the years, include a grassy playing field, restrooms, parking area, camping area, picnic and barbeque facilities, and an amphitheatre. Other trees have been introduced to the park including pines and a Eucalyptus grove.

13. Condition: Excellent ___ Good Fair ___ Deteriorated ___ No longer in existence ___
14. Alterations: amphitheatre, new trees, play area
15. Surroundings: (Check more than one if necessary) Open land Scattered buildings ___ Densely built-up ___
Residential Industrial ___ Commercial ___ Other park
16. Threats to site: None known Private development ___ Zoning ___ Vandalism ___
Public Works project ___ Other: _____
17. Is the structure: On its original site? Moved? ___ Unknown? ___
18. Related features: amphitheatre, many native oak trees

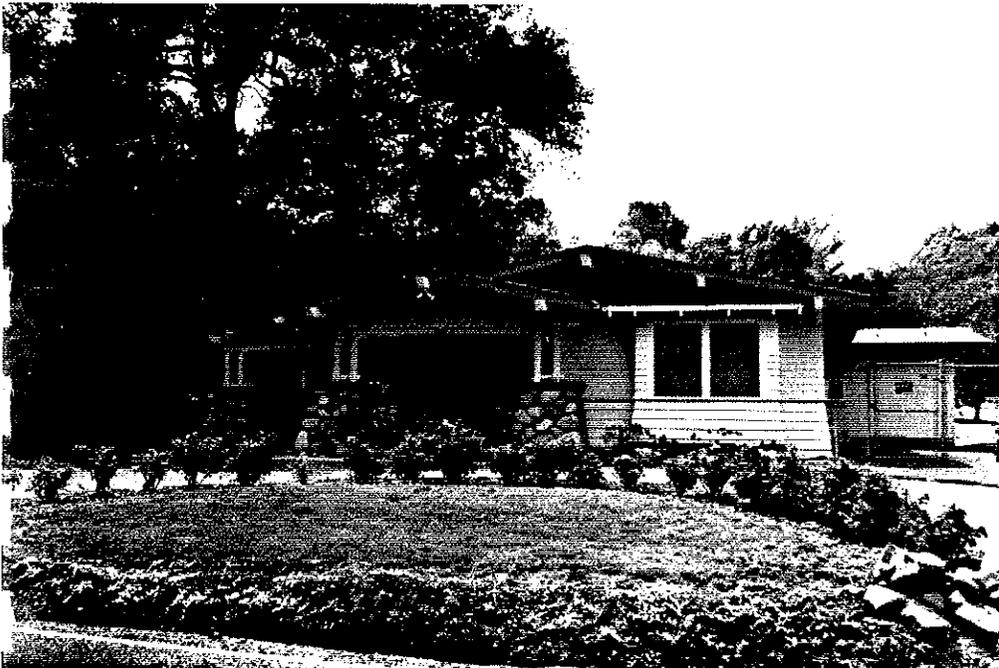
This single story Craftsman Bungalow has a series of intersecting low pitched gable roofs. The front porch is partly recessed under the main portion of the house with a low gable roof supported by large tapered native stone columns. The upper portion of the columns are square double wood columns. Under the broad eaves are projecting beams. The stone columns are repeated on the port cochere on the west side of the house. A square bay is located next to the front porch and is covered with a shed roof. The house rests on a raised concrete foundation and has a flared wide horizontal wood skirt on the lower third with shingles covering the rest of the house. A lattice vent is located under the main gable. Windows are double hung with wood frames and multi-panes and flat wood mouldings.

13. Condition: Excellent Good ___ Fair ___ Deteriorated ___ No longer in existence ___
14. Alterations: addition on east side in 1962
15. Surroundings: (Check more than one if necessary) Open land ___ Scattered buildings Densely built-up ___
 Residential Industrial ___ Commercial ___ Other park/agricultural
16. Threats to site: None known Private development ___ Zoning ___ Vandalism ___
 Public Works project ___ Other: _____
17. Is the structure: On its original site? Moved? ___ Unknown? ___
18. Related features: mature oaks

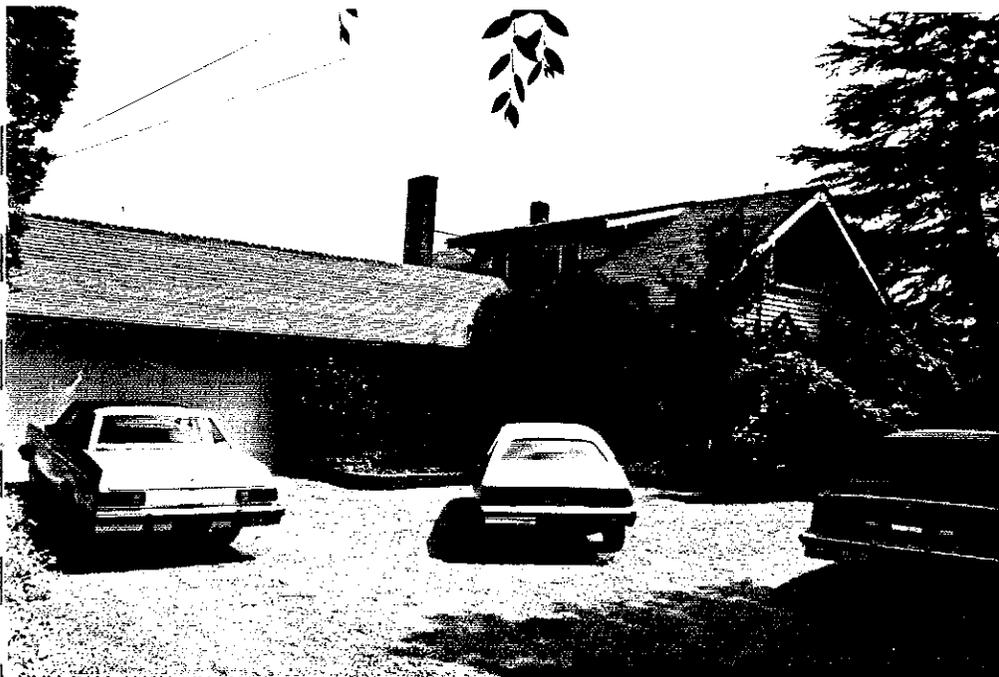
This large rectangular shaped residence is 1- 1/2 stories tall with a high pitched gable roof. A shed roof dormer window is located on the east side and a gabled dormer window on the west side. The screened-in porch is located under the sloping gable on the west side of the house. There are two tall brick chimneys, one on the west side and one on the east side. Under the broad rafters are exposed beams. Windows are both double hung and casement with wood frames and mouldings. The house rests on a concrete foundation and is covered with clapboard siding. On the west side the single story garage is connected to the house with an additional wing.

13. Condition: Excellent ___ Good Fair ___ Deteriorated ___ No longer in existence ___
14. Alterations: addition on east side
15. Surroundings: (Check more than one if necessary) Open land ___ Scattered buildings Densely built-up ___
Residential Industrial ___ Commercial ___ Other agricultural
16. Threats to site: None known Private development ___ Zoning ___ Vandalism ___
Public Works project ___ Other: _____
17. Is the structure: On its original site? Moved? ___ Unknown? ___
18. Related features: mature trees, shed, swimming pool, bath house

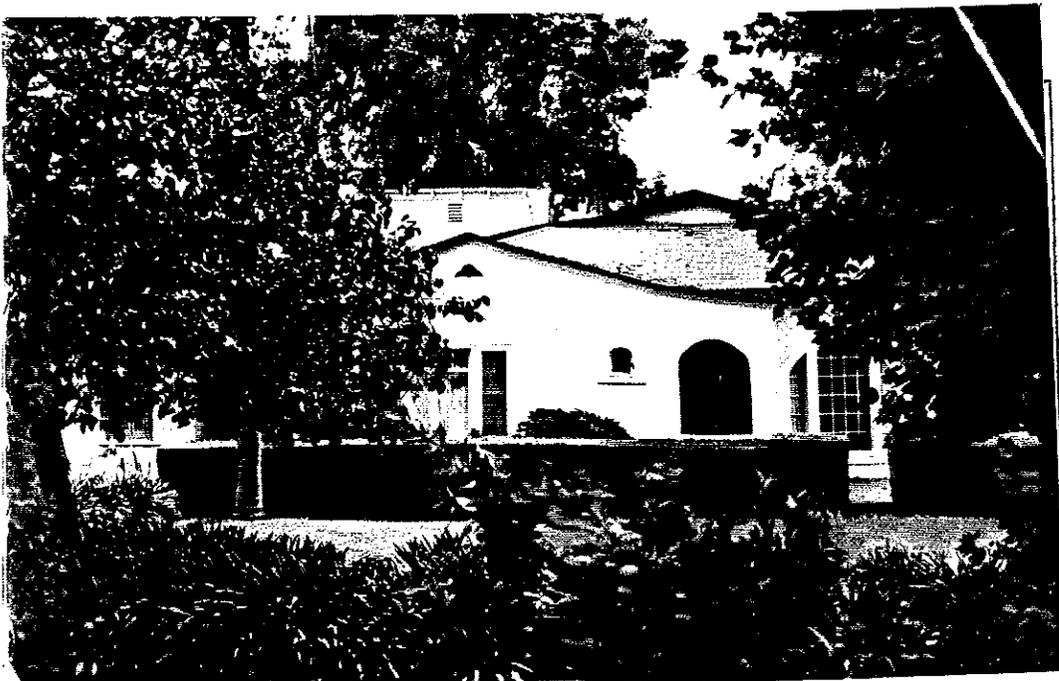
This house has a combination gable and flat roof and has both one and two story sections. The entrance is arched with the offset gable tapering into a shed roof over the porch. A major feature is the large arched multi-paned front window. Next to the recessed entrance is a small round arched opening. Windows are fixed and double hung with wood frames with raised wood mouldings. The house rests on a concrete foundation and is covered with stucco except for the second floor addition which is covered with wood siding. The small bungalow in the rear has a gable roof and wood siding.

13. Condition: Excellent ___ Good Fair ___ Deteriorated ___ No longer in existence ___
14. Alterations: addition - 1974
15. Surroundings: (Check more than one if necessary) Open land ___ Scattered buildings Densely built-up ___
 Residential Industrial ___ Commercial ___ Other agricultural
16. Threats to site: None known Private development ___ Zoning ___ Vandalism ___
 Public Works project ___ Other: ___
17. Is the structure: On its original site? Moved? ___ Unknown? ___
18. Related features: small bungalow in rear

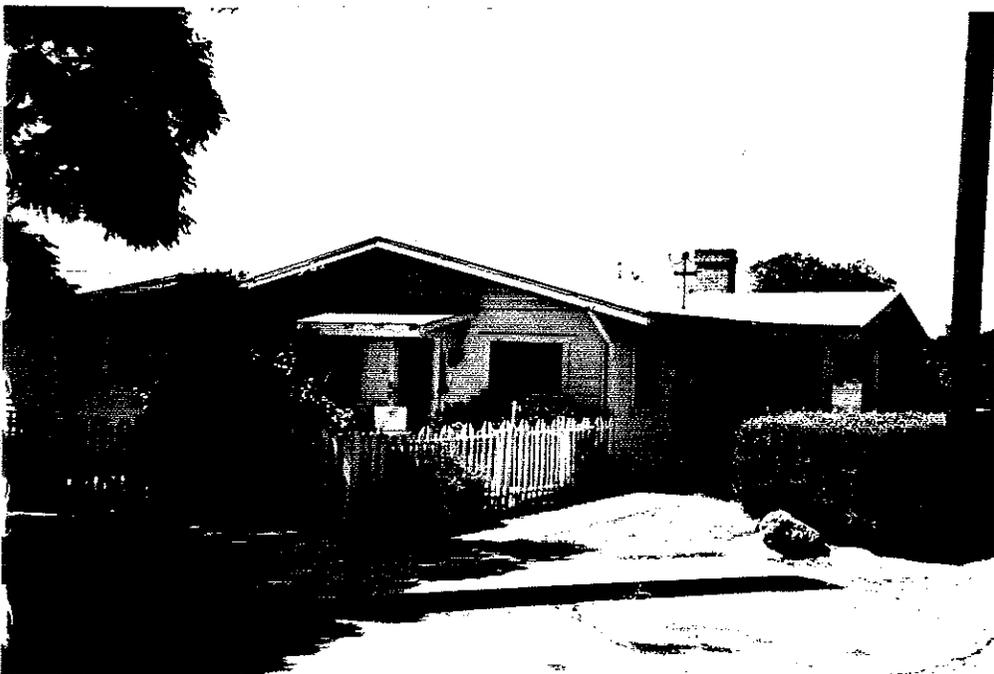
The residence (1686) has a low pitched gable roof with a gabled car port extending on one side supported by wood columns. Under the closed eaves are knee brackets and vertical board decorative vent. A shed roof addition has been added on the opposite side of the carport. Over the front porch is a shed roof supported by metal pillars. The house has a brick chimney. Windows are both double hung and fixed with wood frames and mouldings. To the east of the house are the milk room, barns, office and milk stalls.

13. Condition: Excellent ___ Good ___ Fair X Deteriorated ___ No longer in existence ___
14. Alterations: additions
15. Surroundings: (Check more than one if necessary) Open land ___ Scattered buildings X Densely built-up ___
 Residential X Industrial ___ Commercial X Other agricultural
16. Threats to site: None known X Private development ___ Zoning ___ Vandalism ___
 Public Works project ___ Other: _____
17. Is the structure: On its original site? X Moved? ___ Unknown? ___
18. Related features: residence, dairy buildings, barns, office

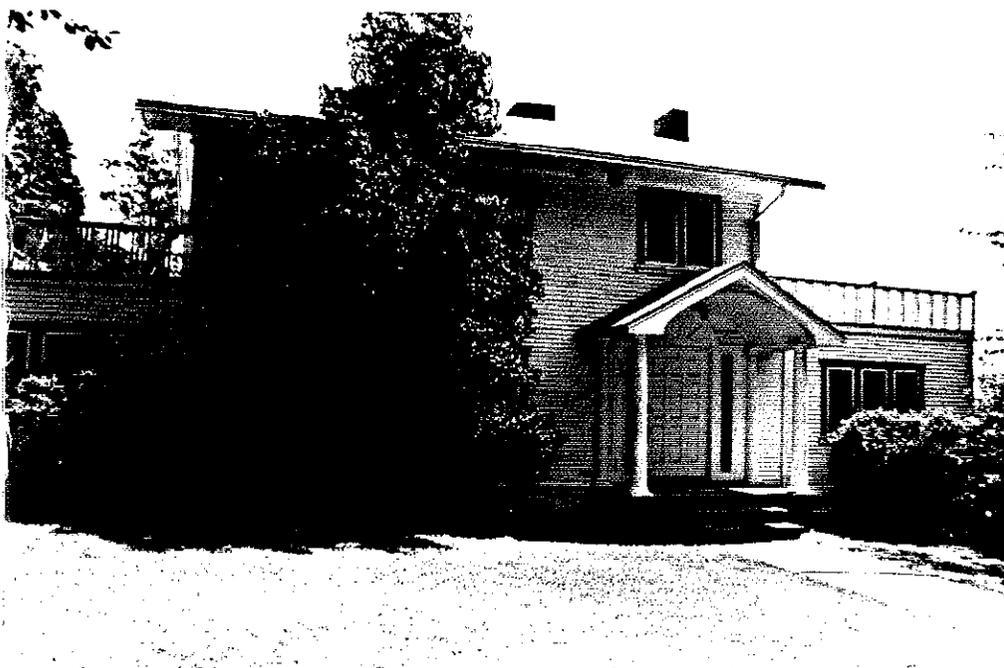
This ranch headquarters presently encompasses several residences, farm buildings and several hundred acres of citrus. The main ranch house, the foreman's residence, is located on a hillside setting surrounded by large trees. The house is a combination of a large rectangular two-story portion flanked by two one story wings. The two-story portion has a medium pitched gable roof with boxed eaves. The front entry is attached with a gable roof supported by two circular doric columns. Next to the main entrance are two Doric pilasters, one on each side of the long narrow sidelights. The front door has recessed panels with an arched wood panel above the door. The eaves under the porch roof are slightly curved. Windows are double hung with wood frames and mouldings and multi-panes in the upper half. The house rests on a concrete foundation and is covered with narrow clapboard siding. The wings on each side have flat roofs with wood balconies. The railing has narrow bands of wood alternating in threes. There is a brick chimney on the west side of the house. The house is built into the gently sloping hillside and is surrounded by mature trees.

13. Condition: Excellent ___ Good X Fair ___ Deteriorated ___ No longer in existence ___
14. Alterations: main house has additions
15. Surroundings: (Check more than one if necessary) Open land ___ Scattered buildings X Densely built-up ___
Residential X Industrial ___ Commercial ___ Other agricultural
16. Threats to site: None known X Private development ___ Zoning ___ Vandalism ___
Public Works project ___ Other: _____
17. Is the structure: On its original site? X Moved? X Unknown? ___
18. Related features: mature trees, worker's houses, farm buildings

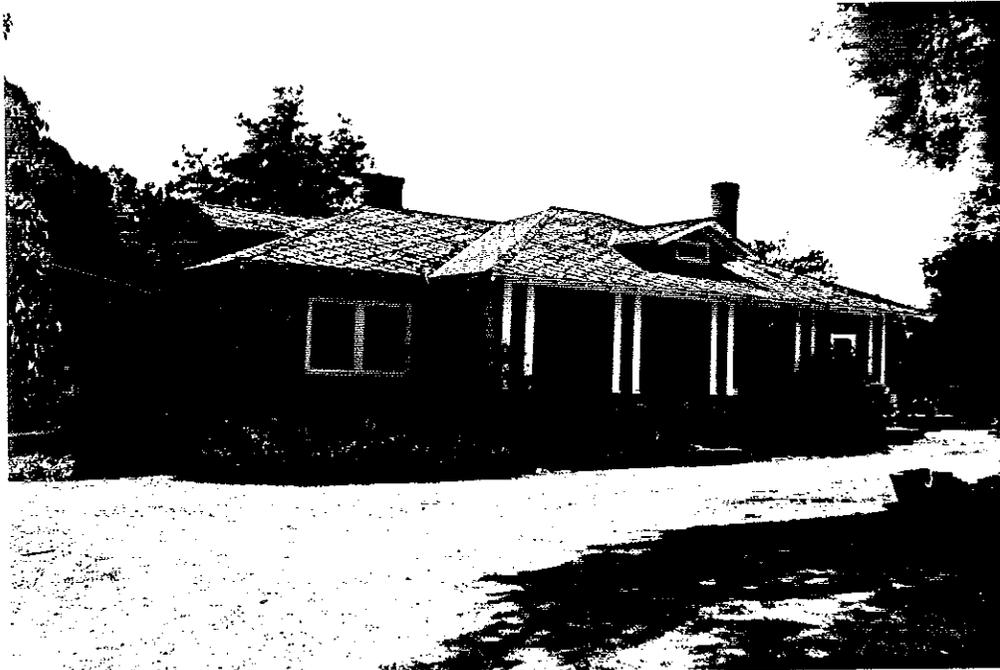
Cook house/dining hall/general headquarters

This house was built about 1911 as the cook house/dining hall. The bell to call the ranch employees for meals once stood outside this building. The ranch was called La Campana (The Bell Ranch). The building is of unusual construction built of hollow clay tile. The long rectangular shape has a hip roof with an offset hip over the porch. The porch is supported by double square wood columns, and rafters are exposed under the eaves. Gabled dormer windows break up the roof line. There are two brick chimneys. Windows are double hung with wood frames and mouldings.

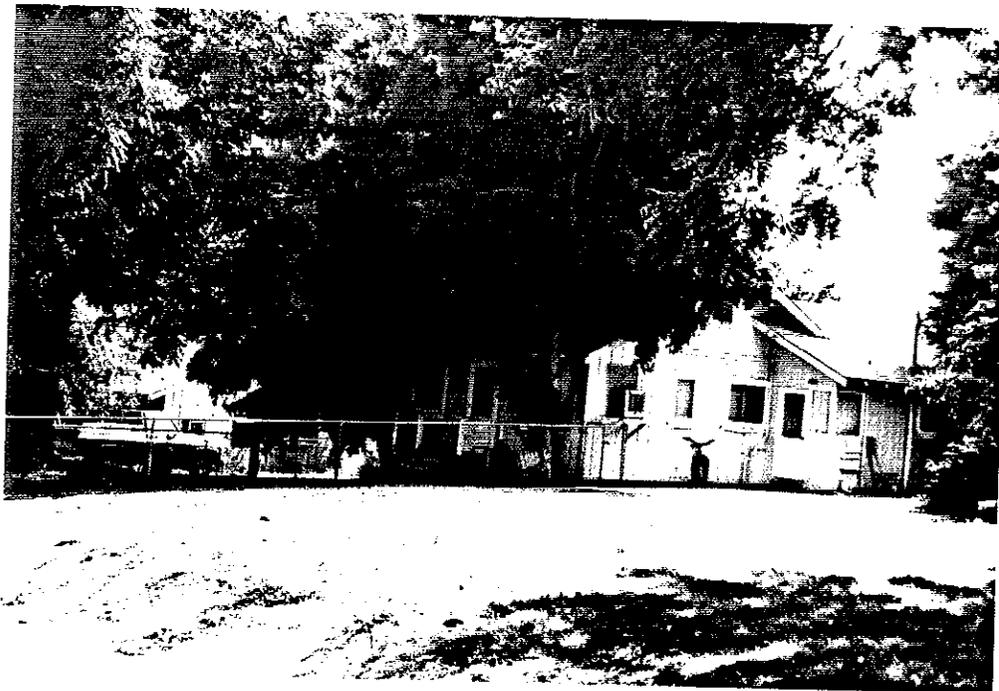
Worker's residence

This is one of four worker's houses built around 1918. This one story house has a gable roof with a shed roof portion on the east side. Windows are double hung and casement with wood frames and mouldings. Siding is board and batten. The remaining houses (not pictured) are similar in style and age. Some have clapboard siding instead of board and batten siding.
