CULTURAL HERITAGE SURVEY PHASE IV SANTA CLARA VALLEY

**COUNTY OF VENTURA
CULTURAL HERITAGE SURVEY
PHASE IV - SANTA CLARA VALLEY**

**Prepared by Judy Triem
San Buenaventura Research Associates**

January 1988

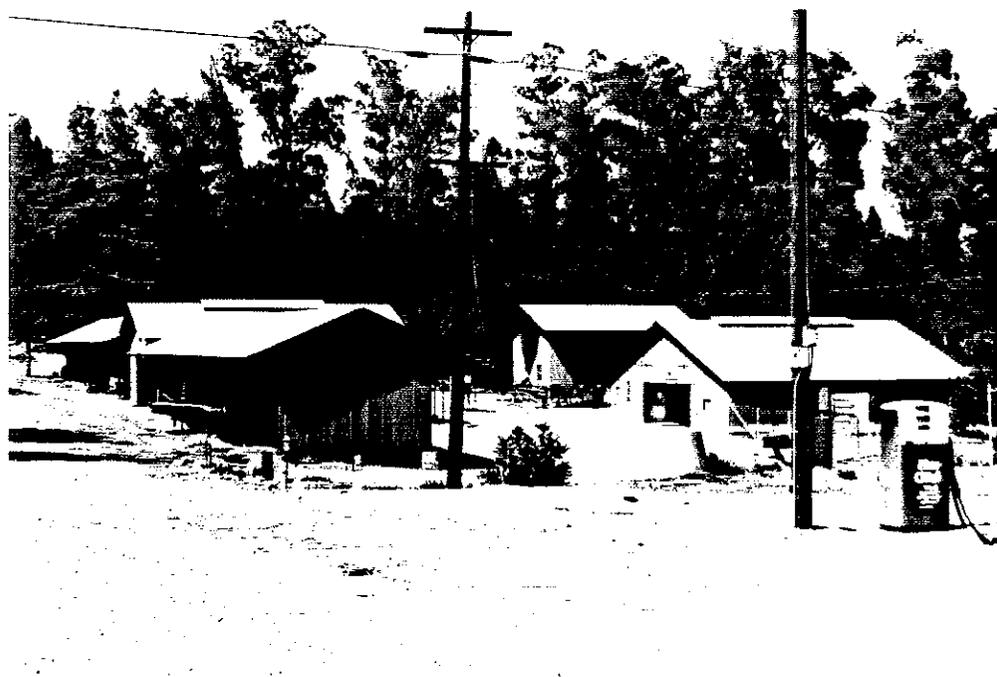
Barns, outbuildings

The barns and sheds have gable roofs and are constructed of corrugated metal siding. Some have windows with wood frames. These buildings were constructed about 1937.

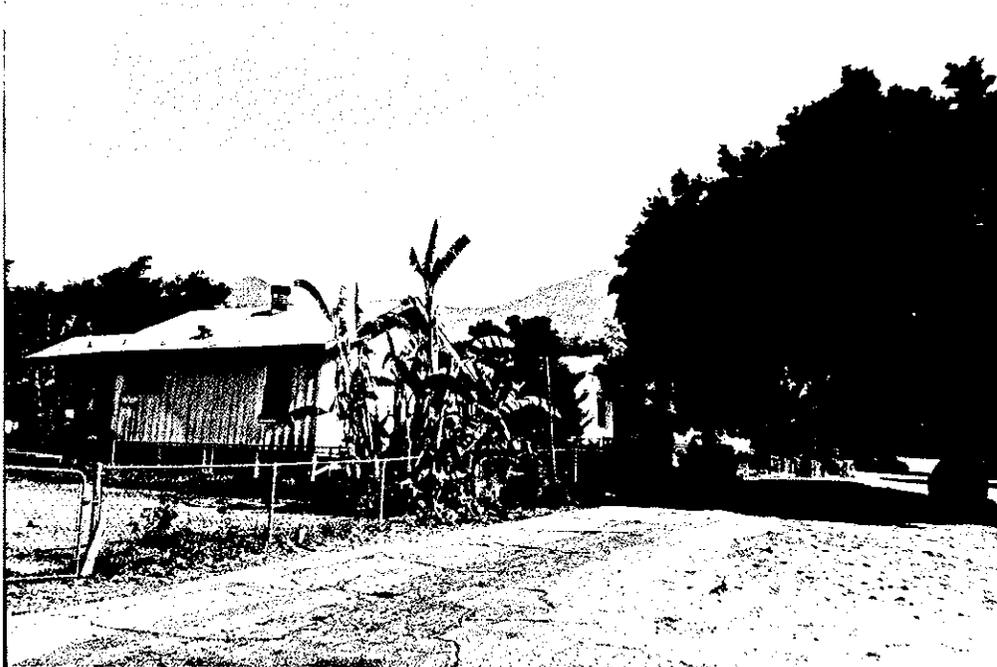
317-337 Sycamore Rd
Parcel #: 041-160-245 & 295
Owner: Samuel Edwards & Assoc.

These worker's cottages used to be located in the center of the Hardison Ranch but were moved to their present location on Sycamore Rd. west of the ranch in the mid-1940s. There were originally 37 cottages. It is uncertain how many remain today. Most are single story board and batten residences with gable roofs, exposed rafters, multi-paned double hung windows and a small front stoop covered by a shed roof. Some have brick chimneys. Dirt roads separate the rows of cottages. There are also many mature trees including native oak trees.

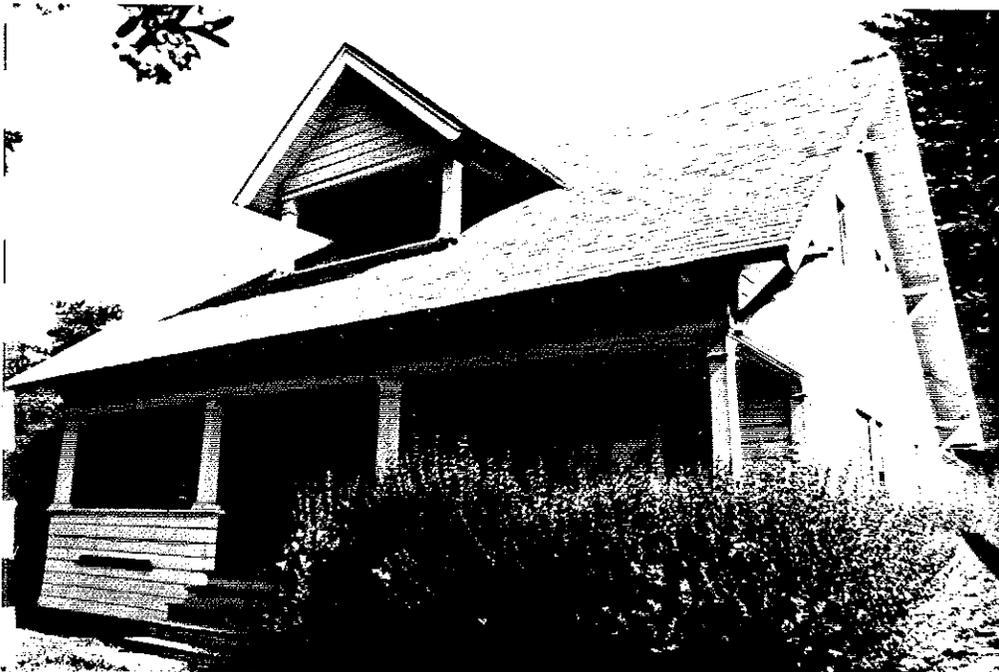
This large 1 1/2 story residence has a high sidefacing gable roof with a gabled dormer window with recessed balcony. The dormer is supported by square wood columns capped at the top. Under the broad eaves are curved knee brackets and exposed rafters. The recessed front porch is supported by four square capped columns on the upper portion and an enclosed railing on the lower portion. Windows are fixed and double hung with flat wood trim. The house is on a raised concrete foundation and is covered with wide board siding. The rear portion of the house gives the residence a T-shape. It is one story with a medium gable roof and bands of windows along the side. A brick chimney punctuates the roofline. In the rear is a Sespe stone building with a gabled roof and paneled door with stone lintel above.

13. Condition: Excellent ___ Good ___ Fair X Deteriorated ___ No longer in existence ___
14. Alterations: rear portion may be first house
15. Surroundings: (Check more than one if necessary) Open land ___ Scattered buildings X Densely built-up ___
Residential X Industrial ___ Commercial ___ Other agricultural
16. Threats to site: None known X Private development ___ Zoning ___ Vandalism ___
Public Works project ___ Other: _____
17. Is the structure: On its original site? X Moved? ___ Unknown? ___
18. Related features: _____

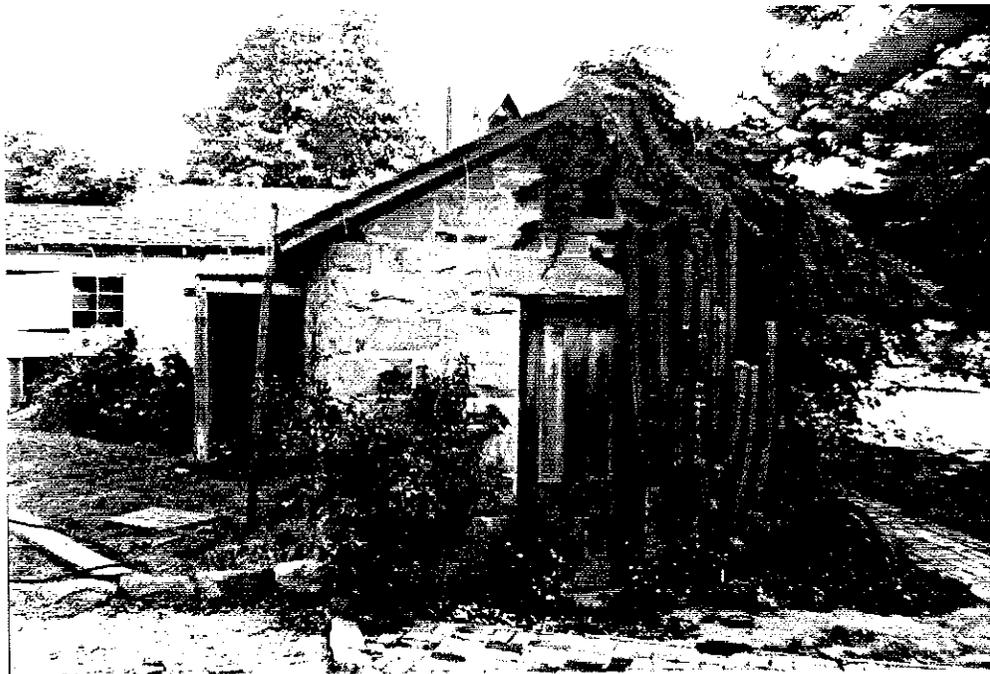
Milk House

This small rectangular shaped building was probably constructed in the 1890s as a milk house. It has a gable roof and is built of Sespe stone. The windows have stone lintels and wood frames. The entrance has a large stone lintel with a wood frame, and the door is made of wood with four recessed panels. It is located behind the main house.
