To: Colin Nemeroff  
Stantec  
Project/File: 2042614000

From: Jun Wang, PE  
Zachary Elliott, PE  
Stantec  
Date: March 15, 2023

**Reference: Meier Canyon Creek Floodplain Study****Introduction**

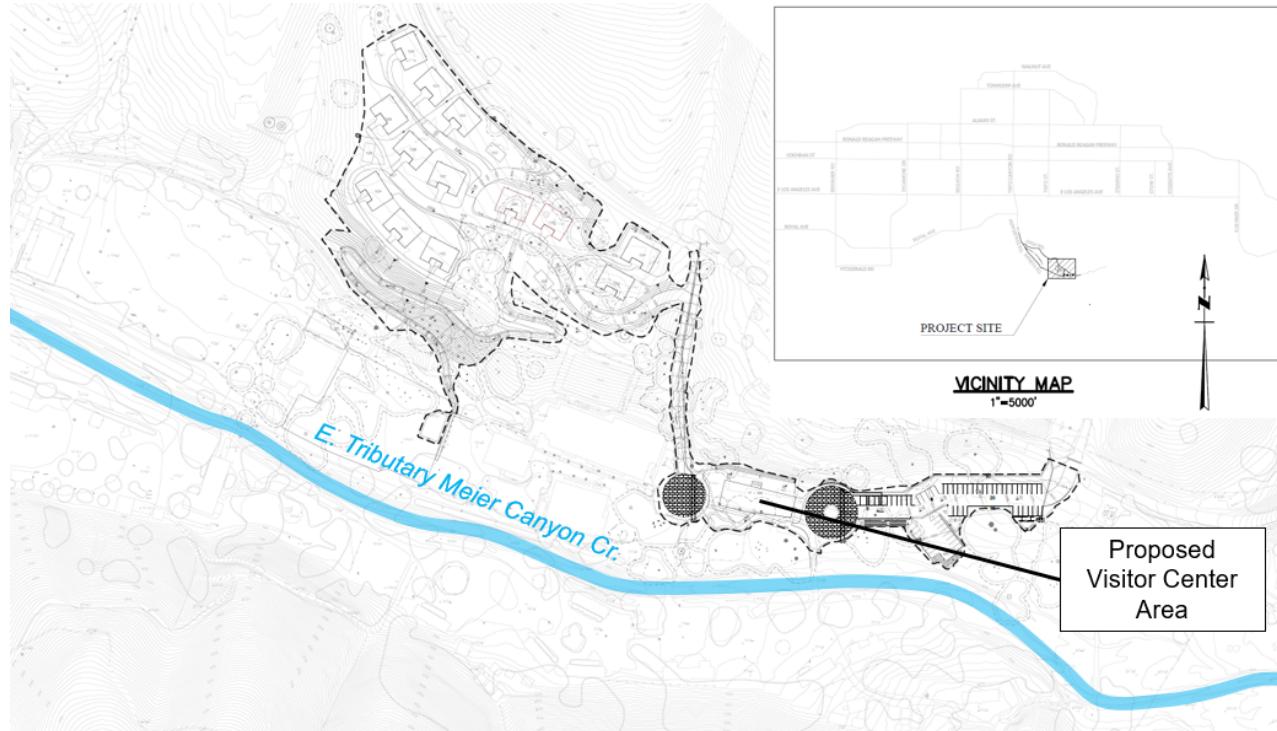
**Figure 1** shows an overview of the study reach and proposed project facilities.

**Figure 1. Meier Canyon Creek and Camp Alonim facilities study area**

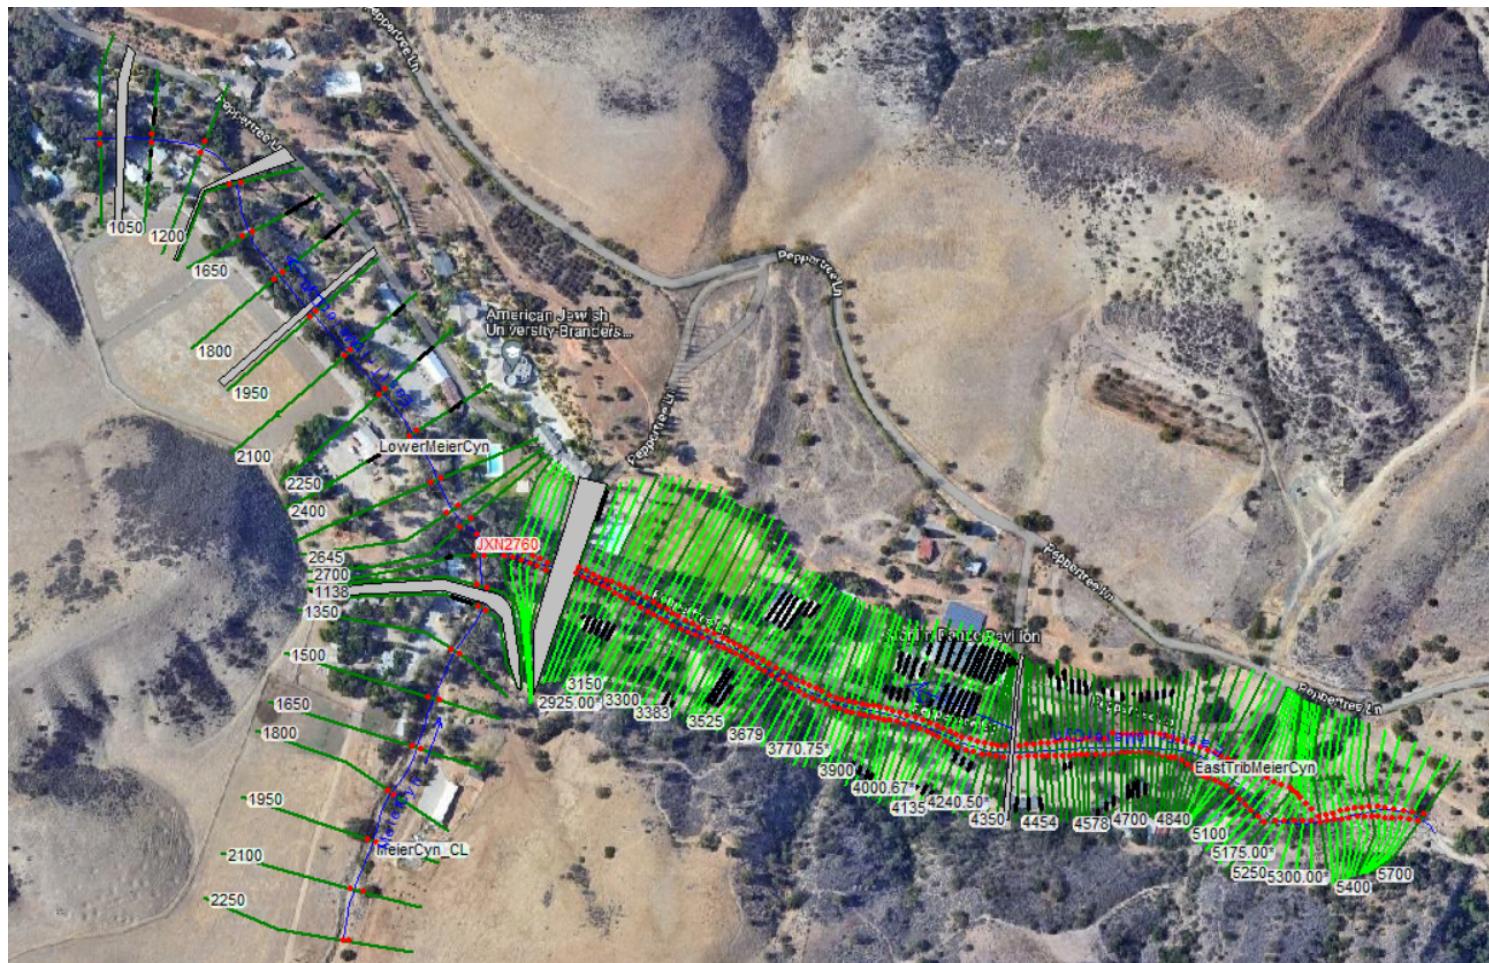
An existing condition hydraulic model for the Study Reach in the vicinity of the Camp project area was developed based upon the 2018 one-foot contour aerial photometric data (Cooper Aerial Surveys Co.). The model is a one-dimensional (1D), steady-state HEC-RAS model that includes an approximately 2,900-foot reach of Meier Canyon Creek from south of the Camp to the western edge of the Camp as well as an approximately 2,900-foot reach of the East Tributary Meier Canyon Creek (reach adjacent to the proposed new visitor center structure). A schematic of the existing condition 1D HEC-RAS model geometry of the Study Reach, including cross-section locations, is shown on **Figure 2**.

Figure 2. Schematic of 1D HEC-RAS hydraulic model geometry for Meier Canyon Creek Study Reach, existing condition

Manning's n surface roughness coefficients of the study reach were estimated using the values described in *Open-Channel Hydraulics* (Chow, 1959) based upon Google Earth aerial imagery and available field photo observations. The estimated Manning's n values range from 0.04 within the main channel to 0.06 in the overbank areas considering channel bed materials, vegetation, and other obstructions. A 'mixed flow' regime model simulation was run to allow for computation of supercritical flow and/or hydraulic jumps and assuming normal depths at the upstream and downstream boundaries.

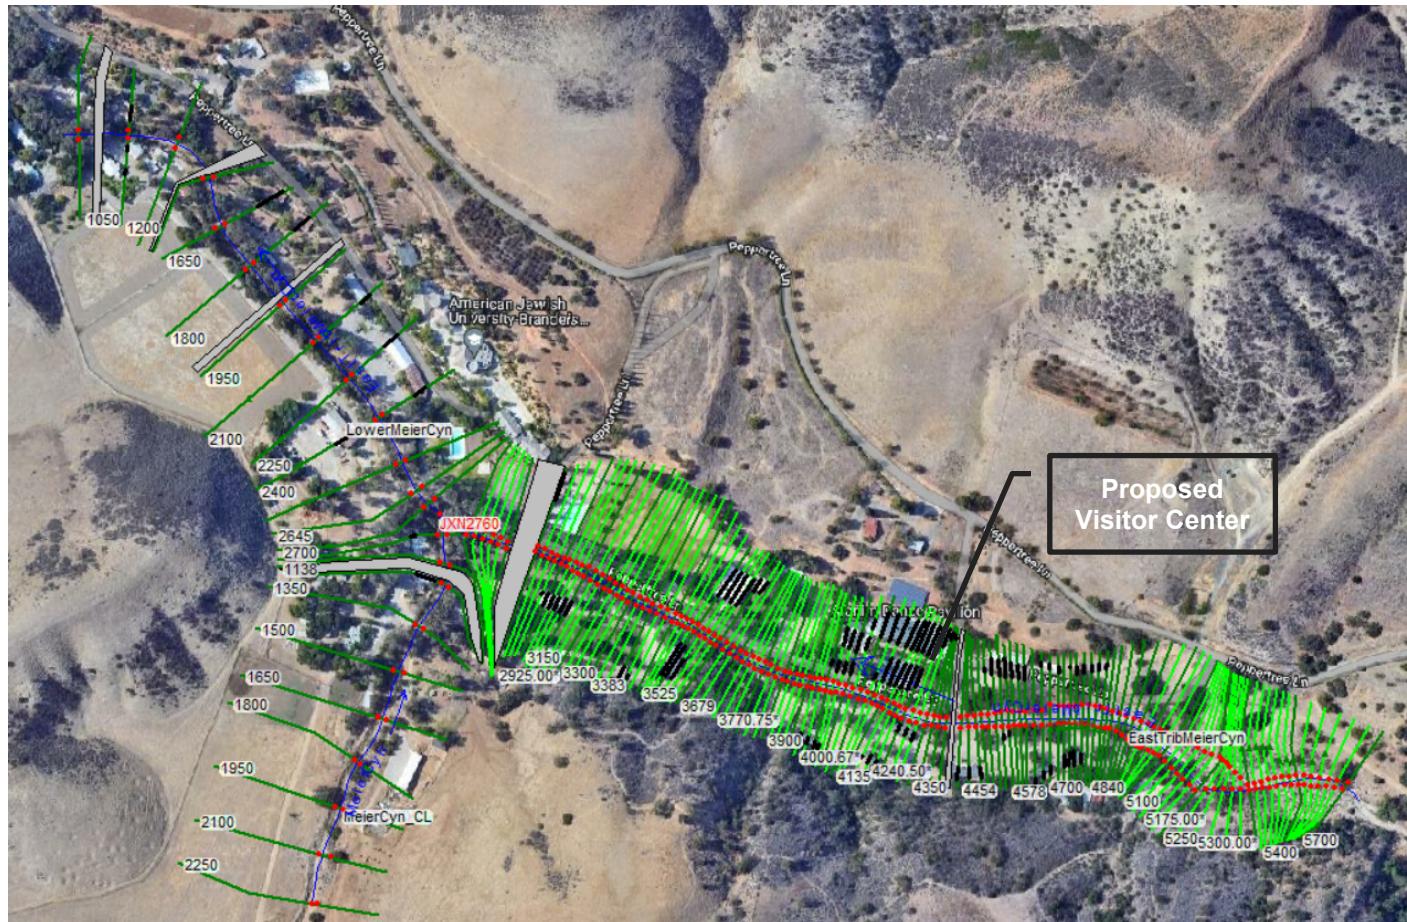
To evaluate the potential changes in the Meier Canyon Creek hydraulic characteristics, Stantec updated the HEC-RAS model to include the proposed structures and topography for the new visitor center and adjacent infrastructure at 17 model cross-sections between stations 5032 and 4350. **Figure 3** shows the updated model geometry, including the additional interpolated cross-sections added along the East Tributary Meier Canyon Creek reach (light green lines with a minimum spacing of 25 feet) and the updated terrain for the proposed visitor center structure and adjacent infrastructure.

Figure 3. Schematic of 1D HEC-RAS hydraulic model geometry for Meier Canyon Creek Study Reach, proposed condition

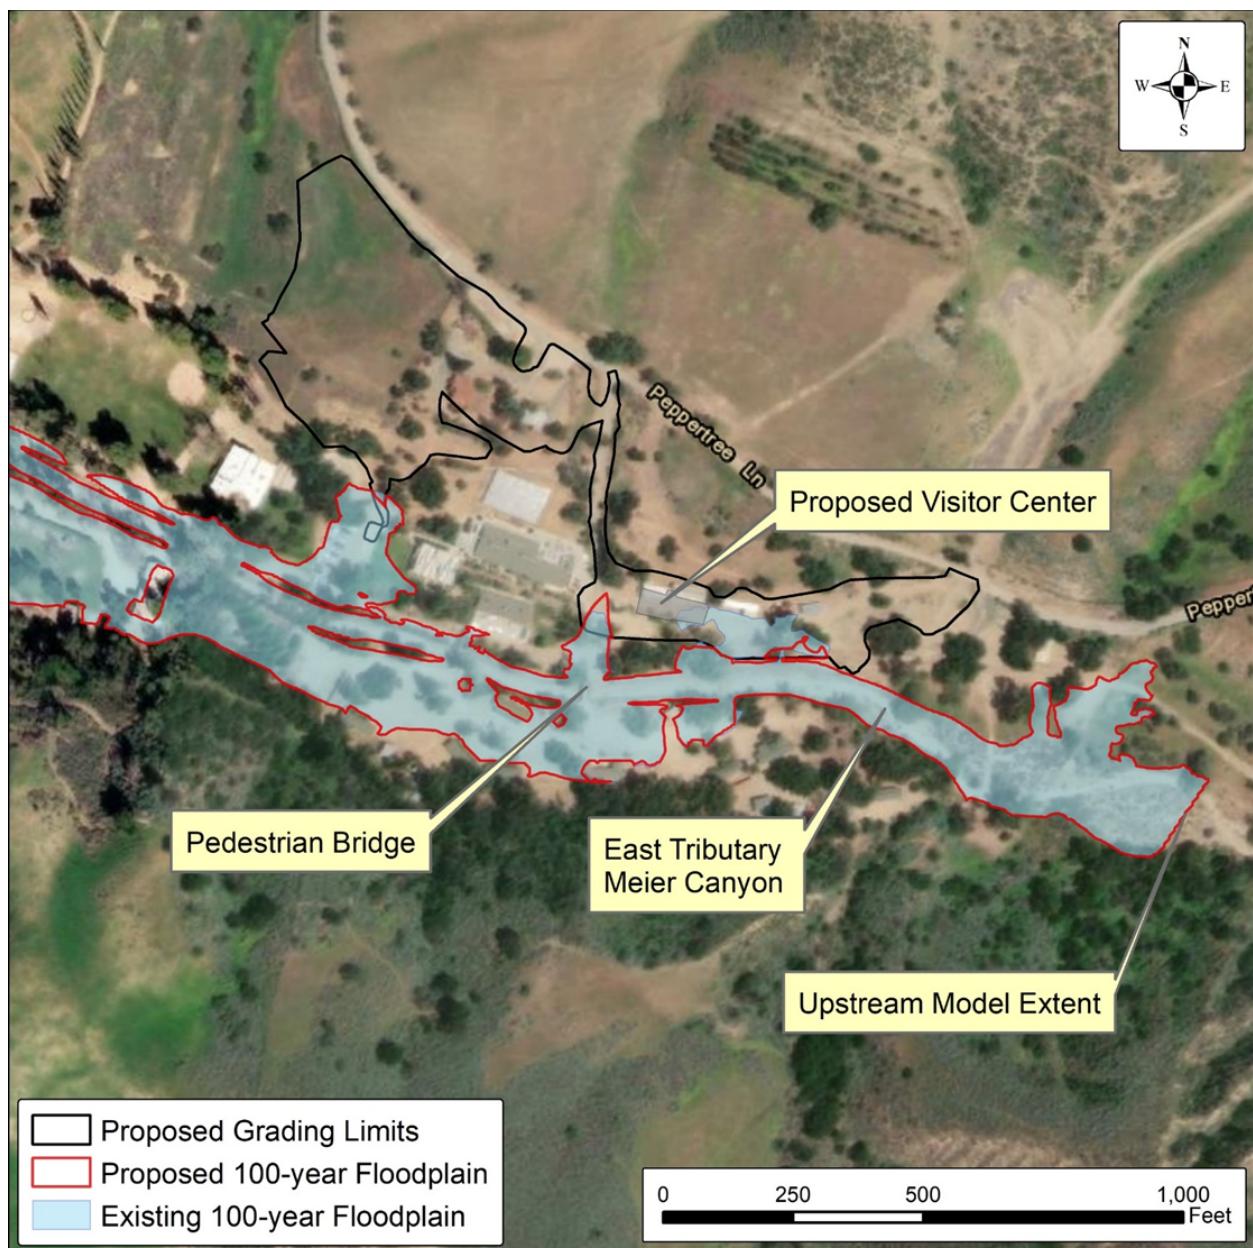
Based on the 1D hydraulic models described in the previous sections of this memo, the floodplain limits for the existing vs. proposed conditions were delineated and are shown on **Figure 4**. **Figure 5** shows a closer view of the estimated floodplain limits for the existing vs. proposed conditions with the proposed visitor center footprint and surface contour details.

Figure 4. Comparison of existing vs. proposed conditions for 100-year flood along East Tributary of Meier Canyon Creek

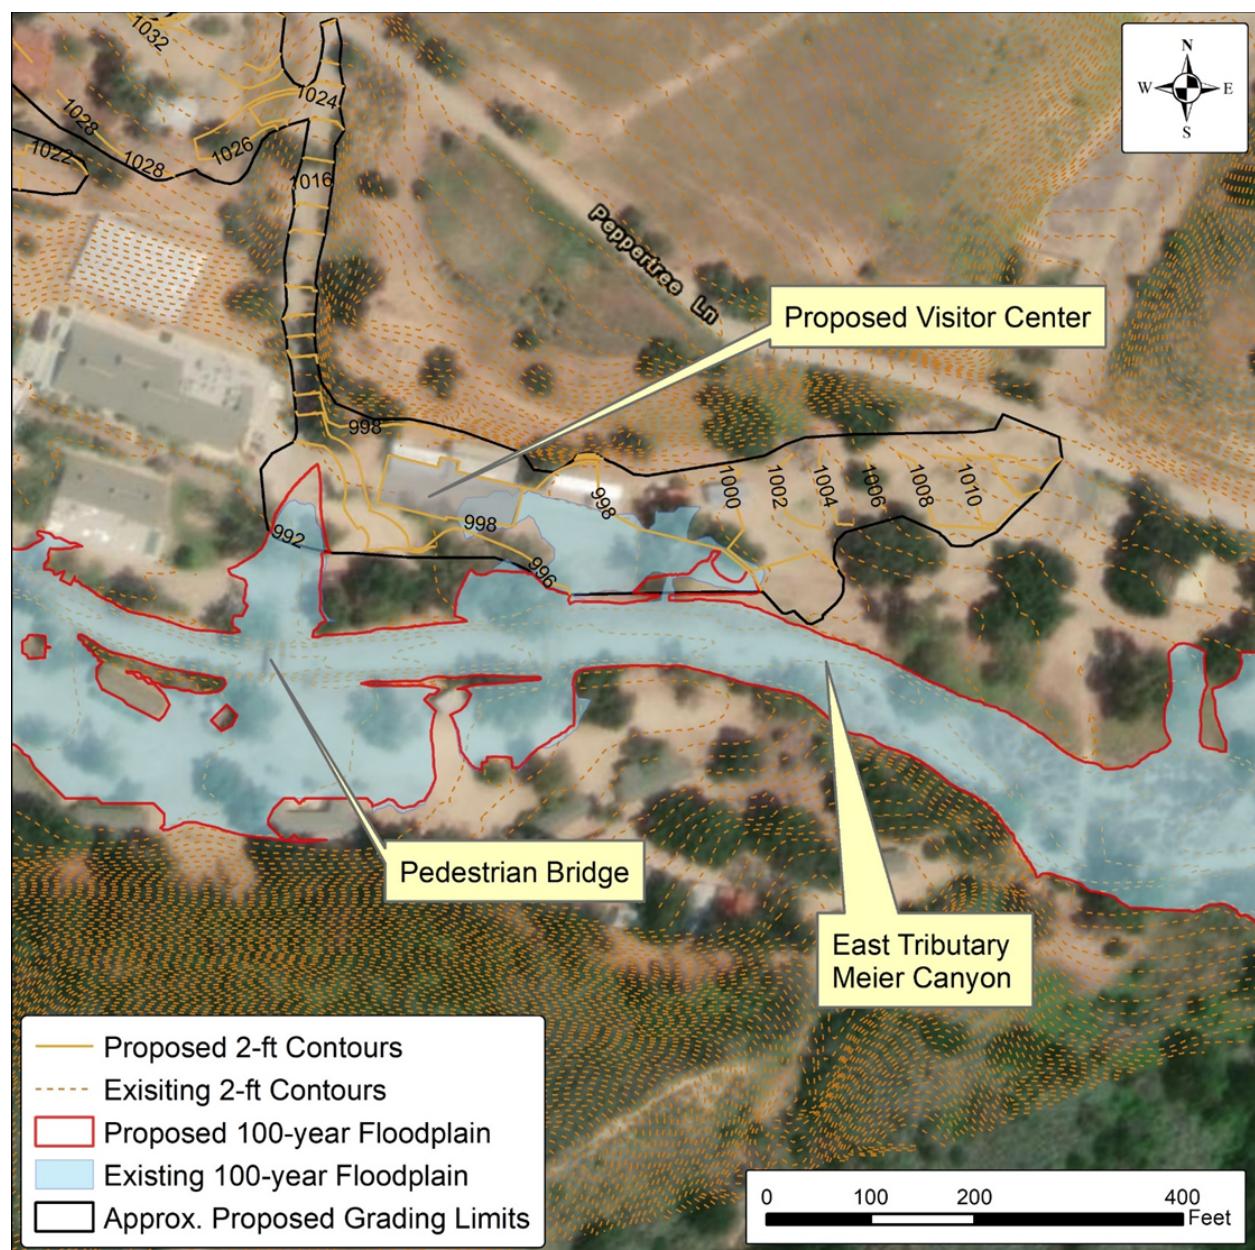
**Figure 5. Comparison of existing vs. proposed conditions for 100-year flood along East Tributary of Meier Canyon Creek, closer view of visitor center footprint and surface contours**

The maximum 100-year flood water surface elevation at the location of the proposed visitor center building is estimated to be approximately 995.0 feet (at the upstream, southeast corner of the building footprint). The maximum 100-year flood water surface elevation at the downstream, southwest corner of the building footprint is estimated to be about 992.7 feet. These estimates can be used to select the finished floor elevation for the proposed visitor center structure.

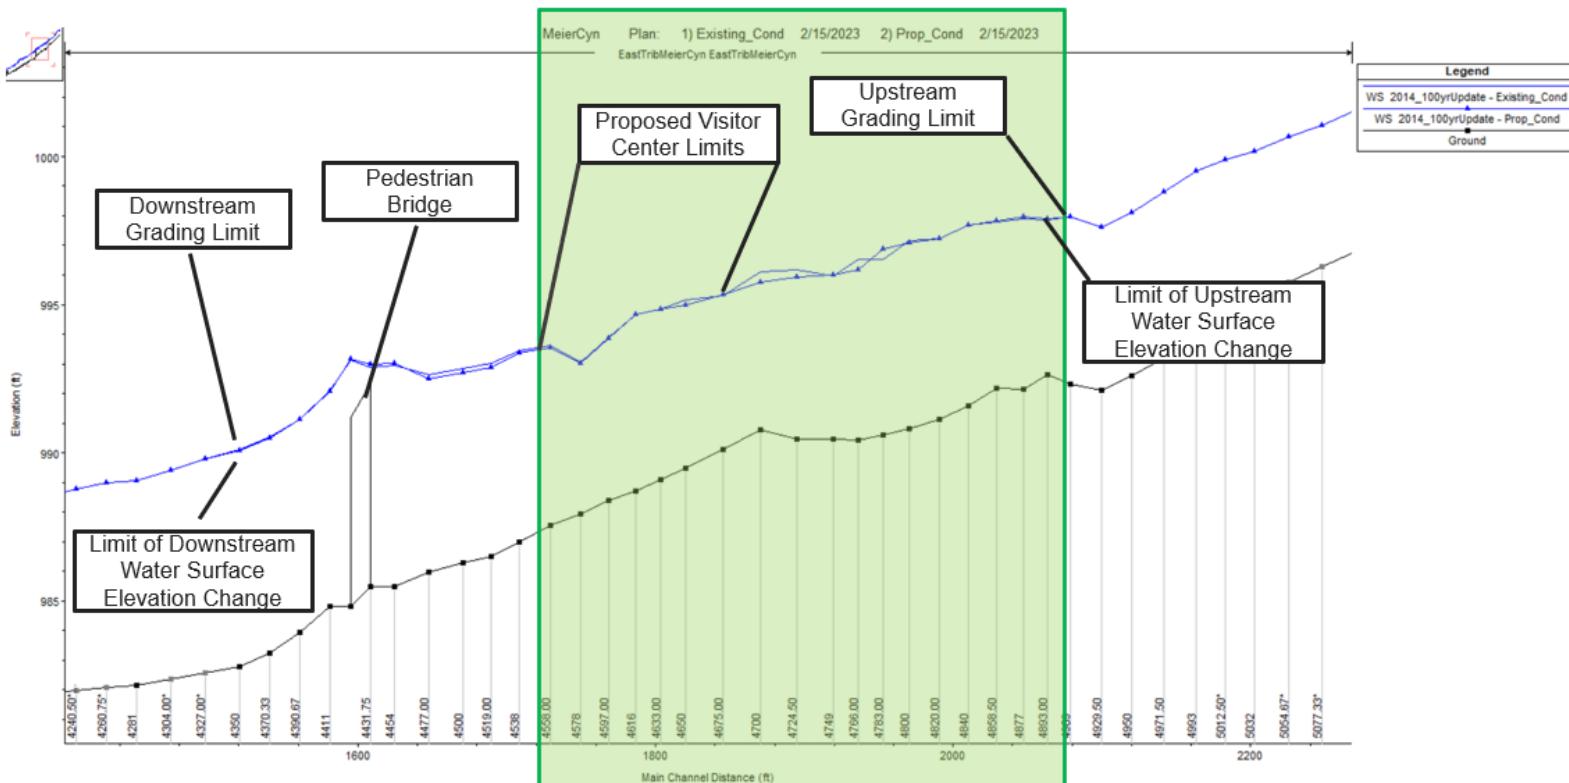
A profile of the channel thalweg for the East Tributary of Meier Canyon Creek and maximum water surface elevation for the existing and proposed conditions is shown on **Figure 6**. **Figure 7 – Figure 11** show cross-section results at selected cross-sections upstream, adjacent to, and downstream of the proposed visitor center development area. Note, the blue and red vertical lines on **Figure 8 – Figure 10** show the approximate lateral limits of the floodplain boundary for the existing vs. proposed conditions, respectively.

Figure 6. Profile of East Tributary of Meier Canyon Creek HEC-RAS model water surface profiles for existing vs. proposed conditions

Based on the 1D hydraulic model results developed for this analysis, minimal changes in water surface elevation and mean flow velocity for the 100-year flood are expected to occur within the AJU Camp property limits (see **Figure 6**). The estimated changes in flow depth and average velocity are between a distance of approximately 250 upstream of the proposed visitor center to about 300 feet downstream of the visitor center along the East Tributary of Meier Canyon Creek.

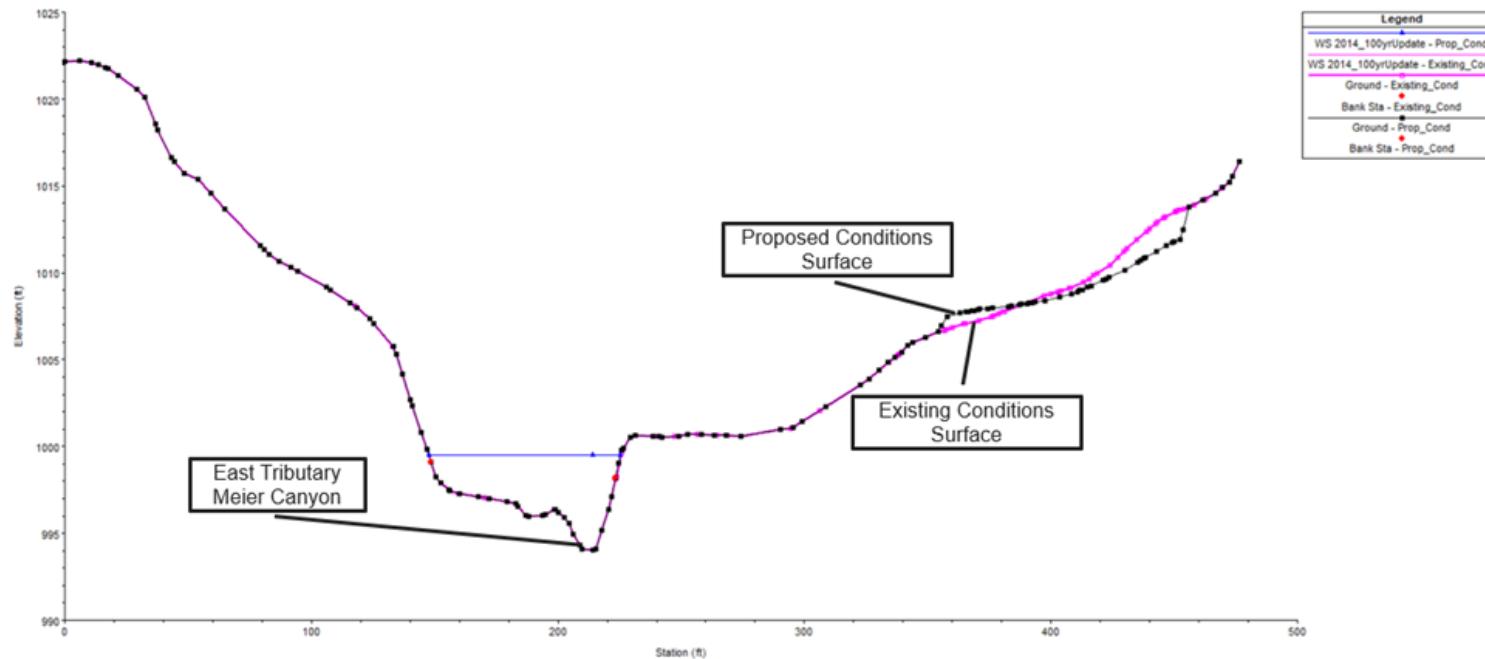
Figure 7. Cross-section 4993 – approximately 400 feet upstream of proposed visitor center

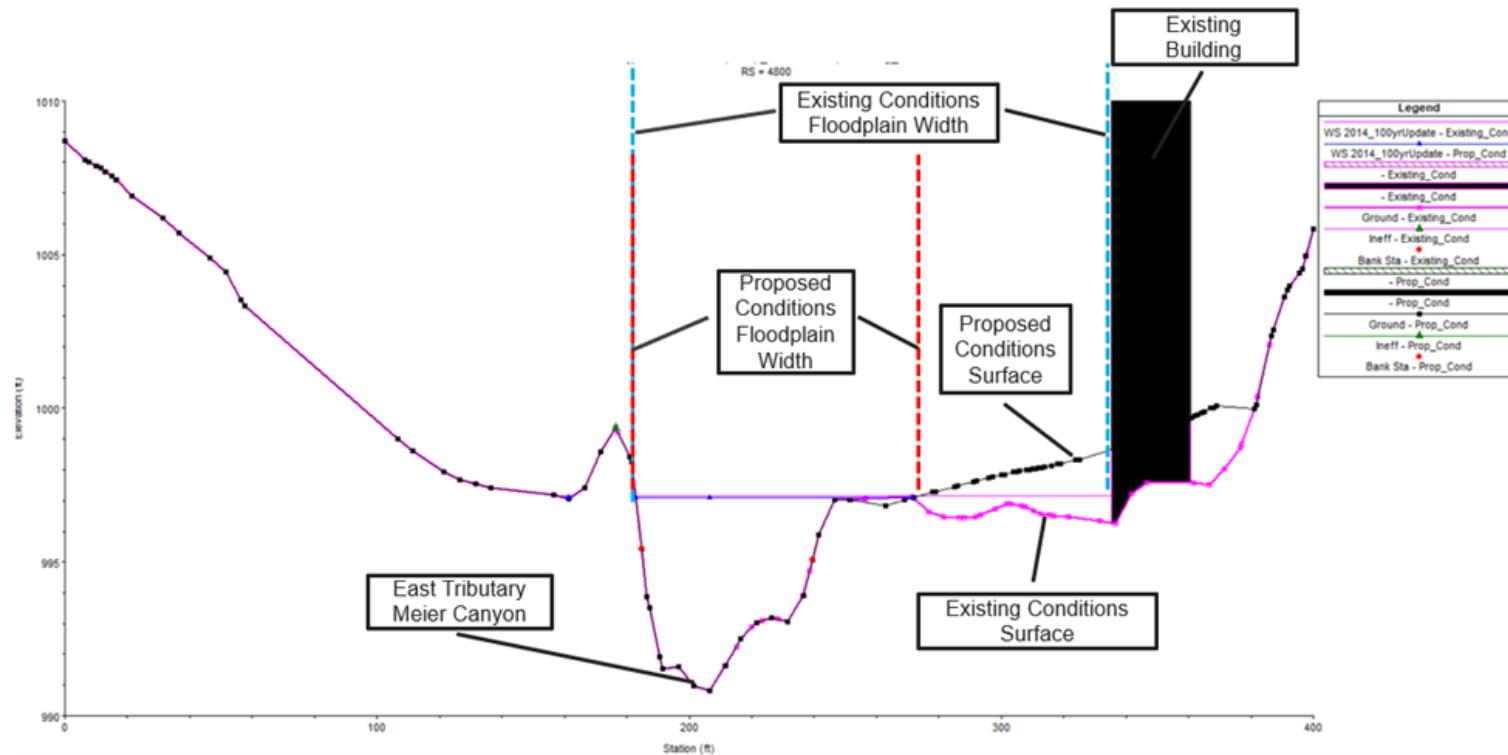
Figure 8. Cross-section 4800 – approximately 150 feet upstream of proposed visitor center

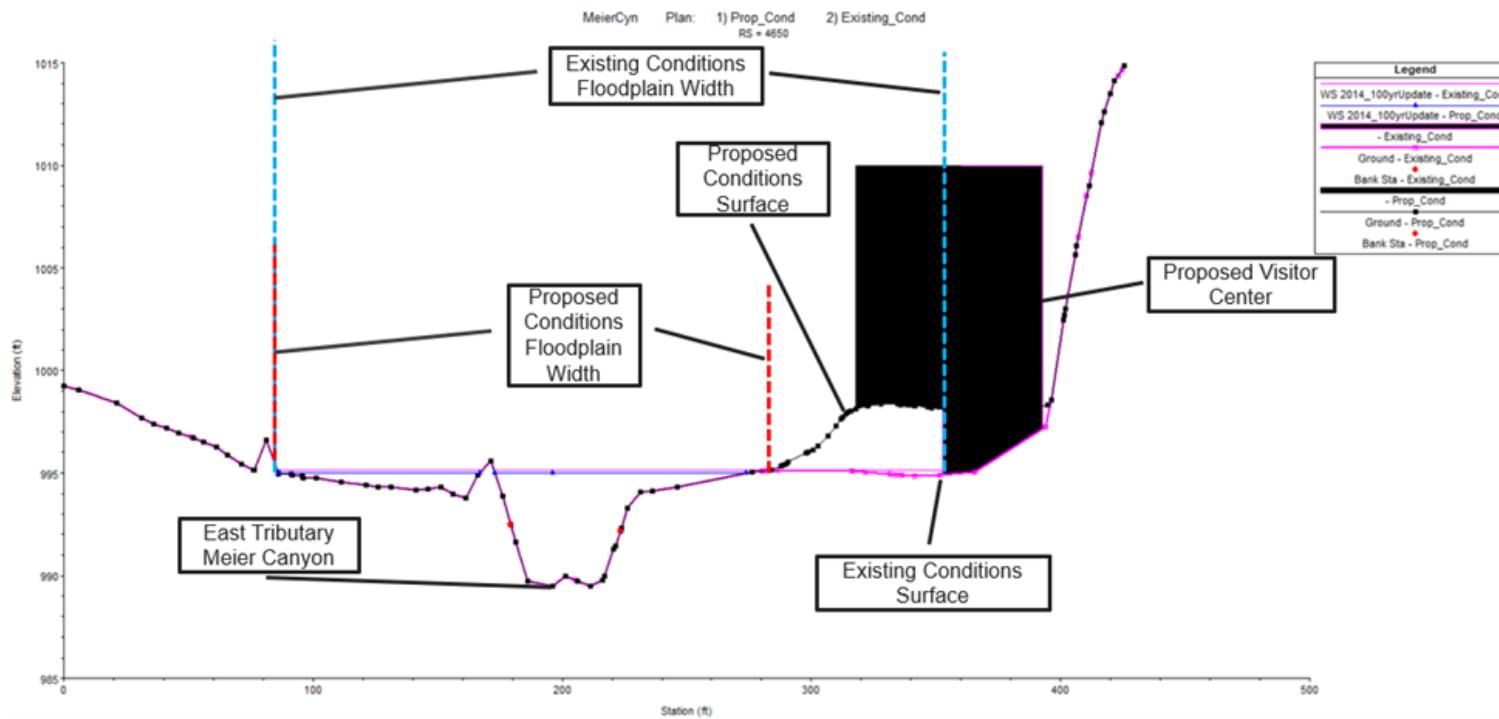
Figure 9. Cross-section 4650 – approximately 230-ft upstream of pedestrian bridge

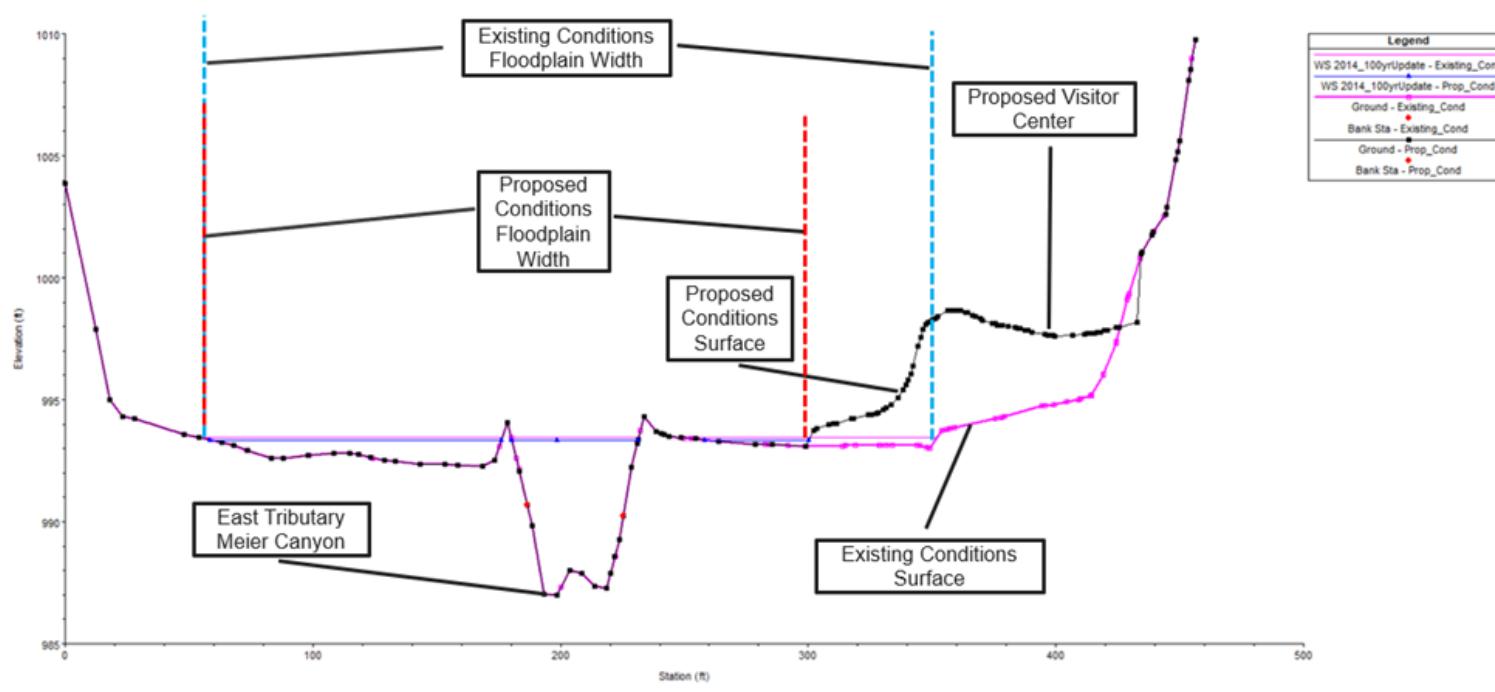
Figure 10. Cross-section 4538 – downstream end of proposed visitor center

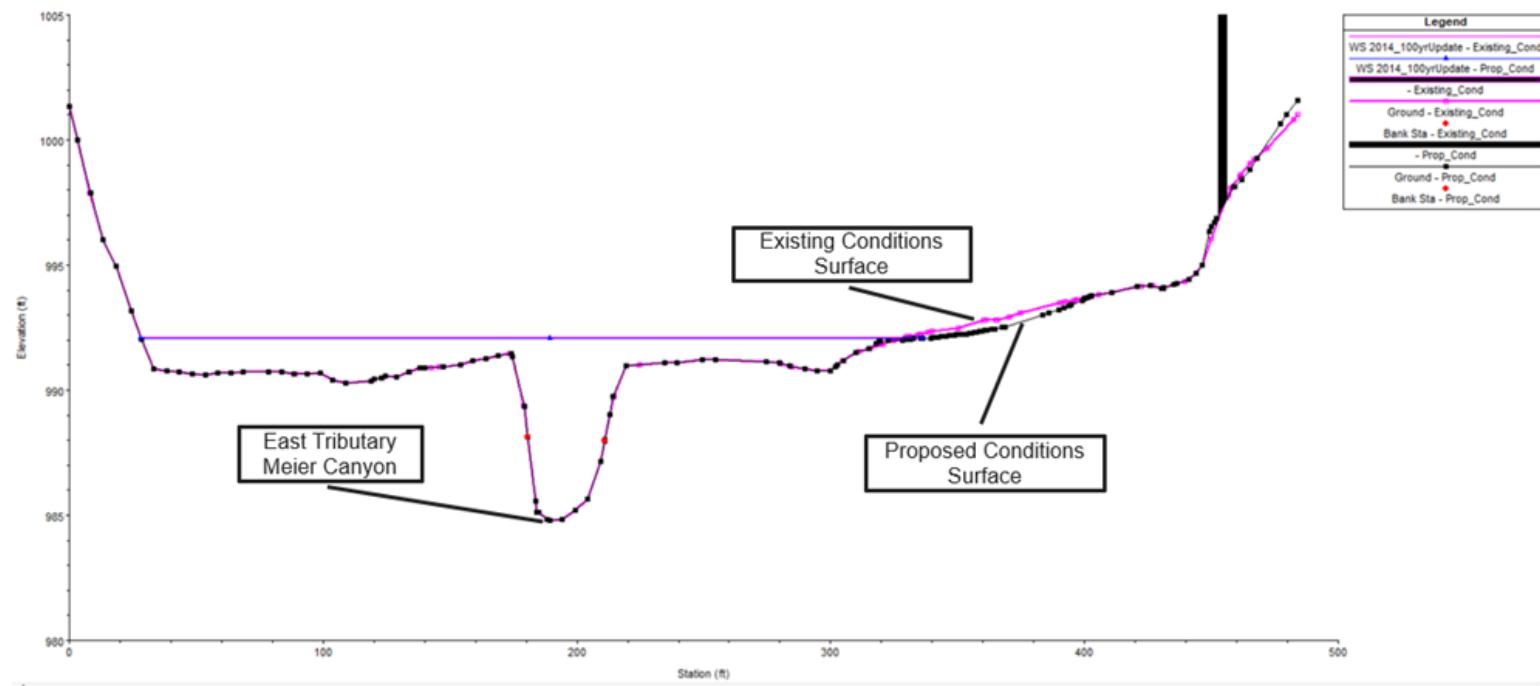
Figure 11. Cross-section 4411 – approximately 30-ft downstream of bridge, downstream end of proposed development area
