# GEOMORPHIC CONDITIONS UPDATE AND BASIS OF DESIGN FOR LITTLE SYCAMORE CREEK, CAMP HESS KRAMER

Prepared for  
Wilshire Boulevard Temple Camps and  
Stantec

April 2021

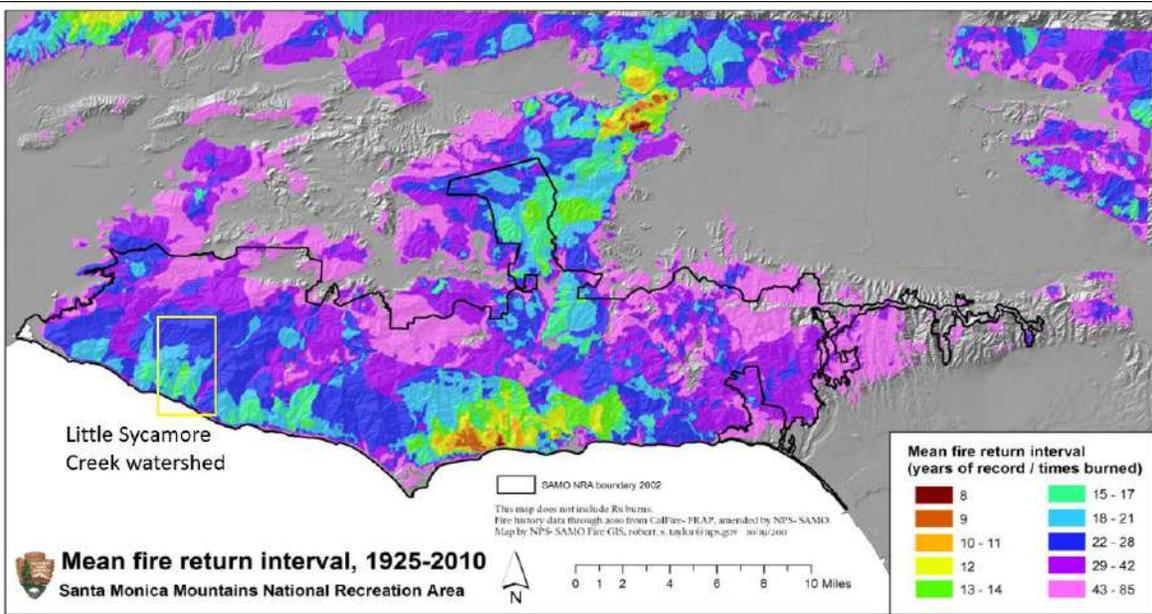
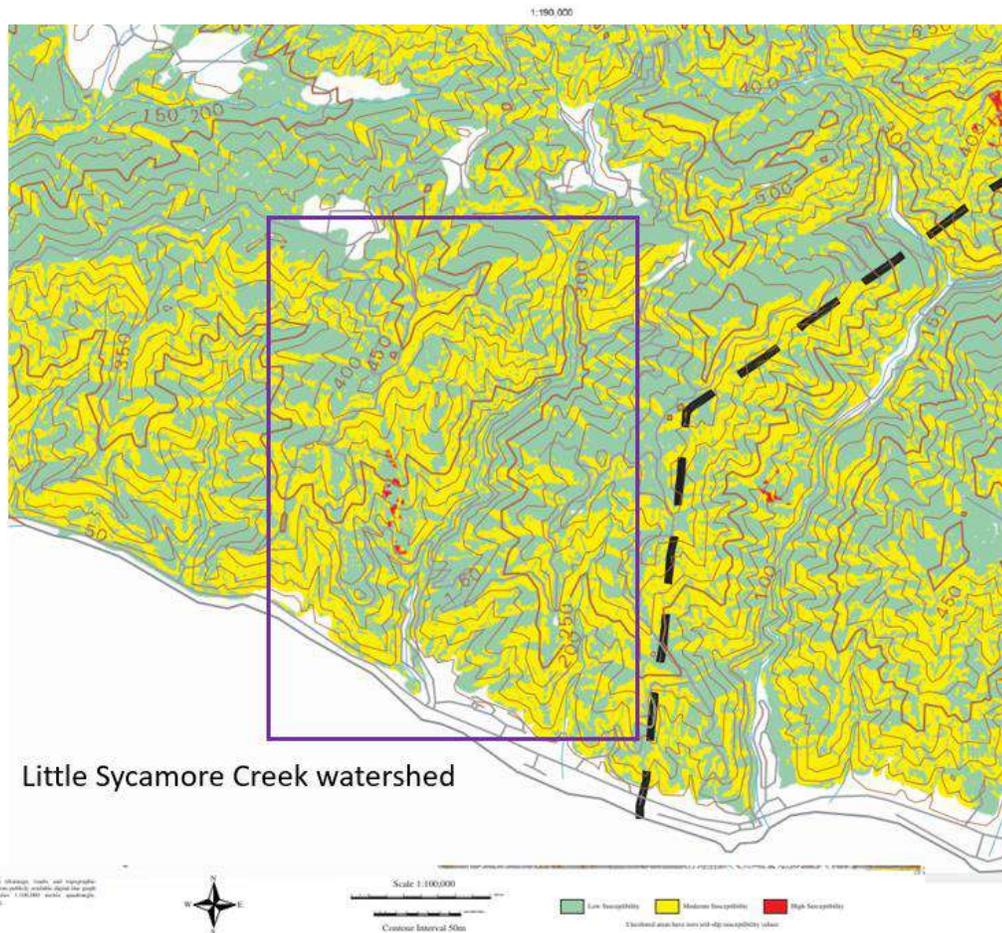
Little Sycamore Canyon Geomorphic Conditions & Basis of Design  
**Figure 2**  
 Fire frequency (upper) and landslide susceptibility  
 (lower) for Little Sycamore Canyon

Plate 2. Soil-Slip Susceptibility Map for part of the Los Angeles 30' x 60' Quadrangle, Southern California  
 Preliminary Soil-Slip Susceptibility Maps, Southwestern California

The watershed has a long history of fire: between 1925 and 2010 it experienced fires on average every 13-28 years (Figure 2; National Parks Service, 2020). Owing to its steepness, the underlying geology, and the fire frequency, the watershed is highly susceptible to debris flow and landslides. The United States Geological Service (USGS, 2003) maps most of the west side of Little Sycamore Canyon as having medium soil slip susceptibility with some areas of high susceptibility (Figure 2). The eastern side of the canyon is mostly classified as low susceptibility with some medium areas.

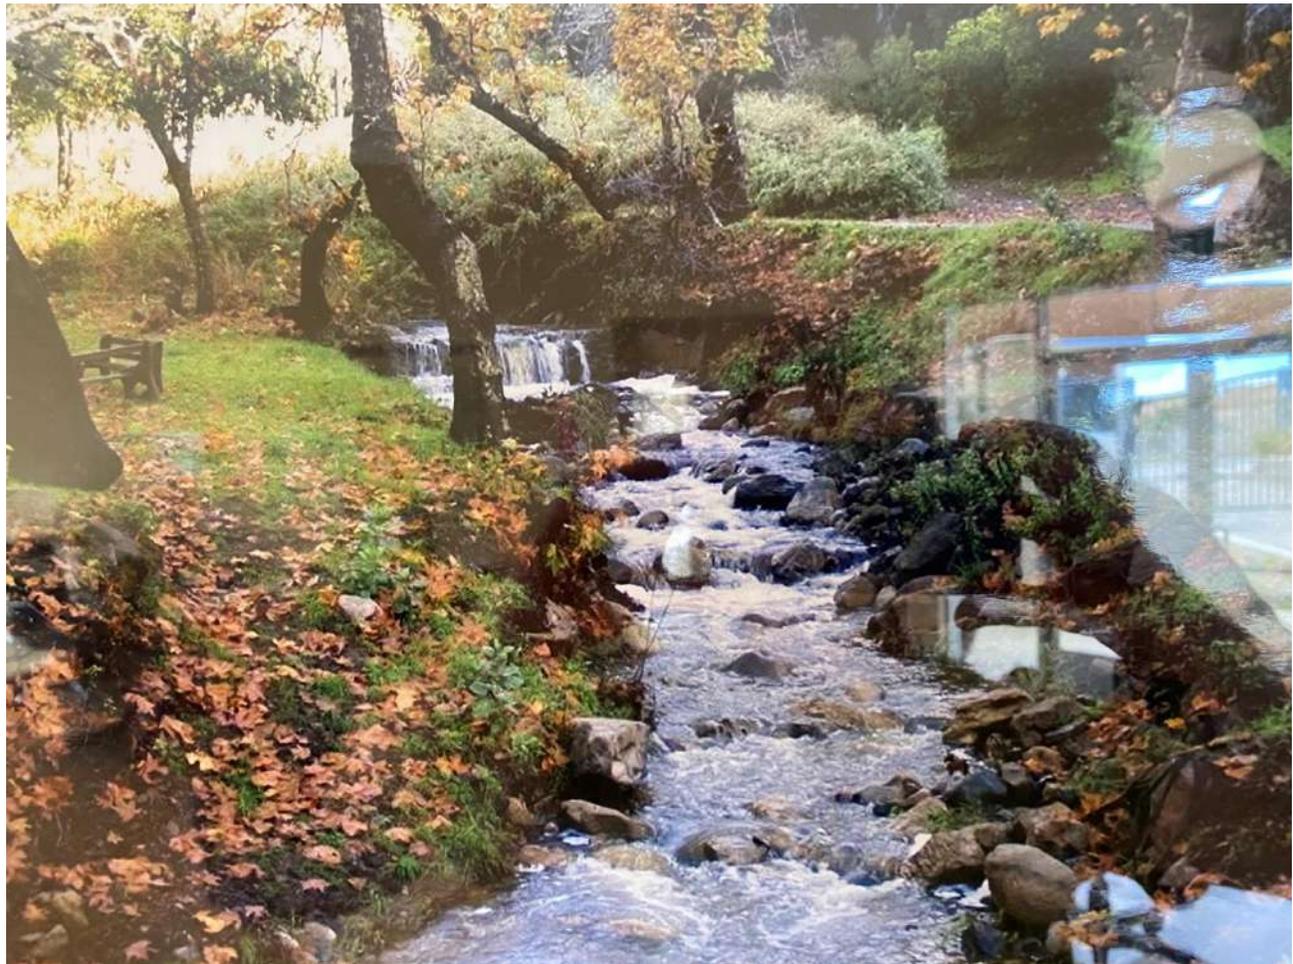
Step pool conditions in Little Sycamore Canyon  
prior to 2019 (date unknown)

2. The channel had a much coarser bed than the post fire condition: most reaches had a cobble or boulder bed as illustrated in Figure 3. Similar conditions are visible in historic photos of the creek on the walls of Camp Hess Kramer (Figure 4).

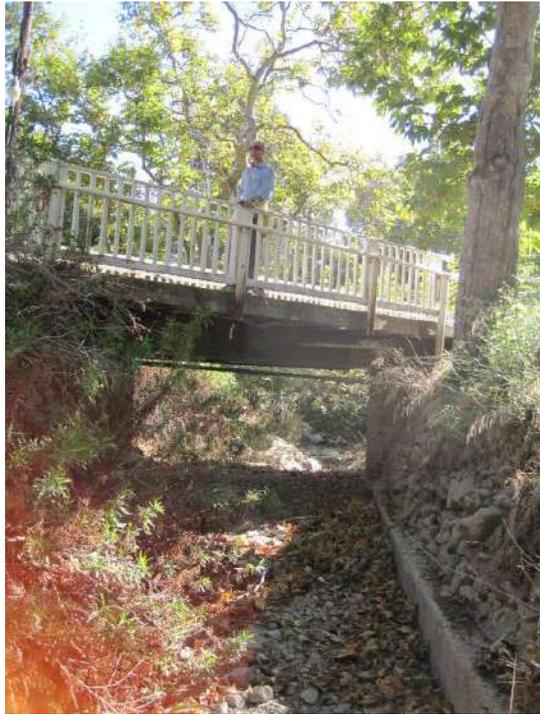
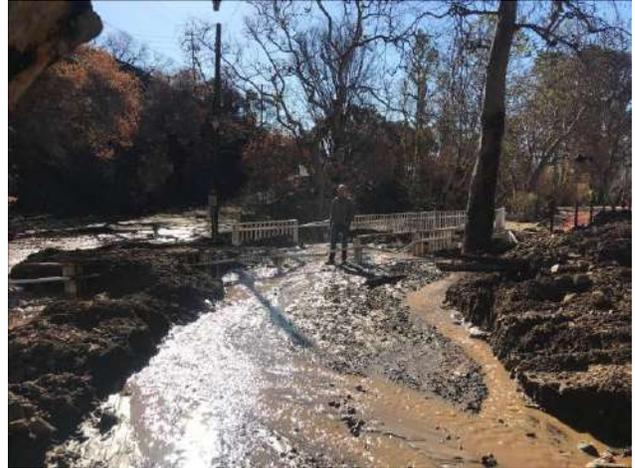
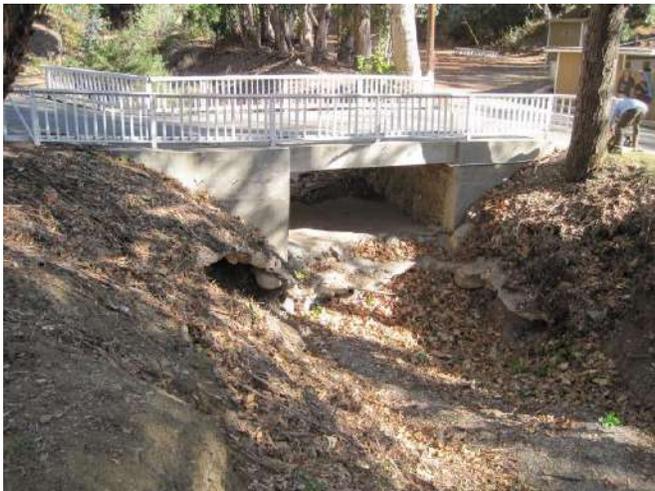
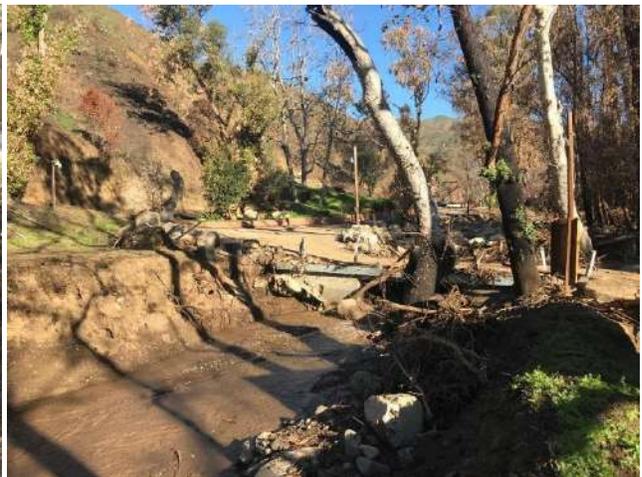
**Figure 5**

2011 Pre debris flow

2019 Post debris flow

Pre and post debris flow conditions

Following the 2018 Woolsey Fire and 2019 flood ESA revisited the creek to evaluate post-damage conditions and support WBT in developing emergency response plans to remove and relocate some of the deposited sediment from the creek, to increase conveyance and reduce the risk of flooding while the Camp recovery and long-term planning process took place. During this visit we observed that much of the channel was completely filled by boulders and coarse sediment originating from a landslide from Yerba Buena Road at Station (Sta.) 30+00 (approximately) that blocked the undersized bridges at Sta. 23+00 (Bridge 6-V) and Sta. 18+00 (Bridge 4-V). Paired before and after photos of these bridges are shown in Figure 5. Blockages had caused the creek to avulse<sup>3</sup> around the bridges and force a path near the old arts and crafts building, parking lot and lawn.

Downstream of Bridge 4-V, the pattern switched from channel deposition to primarily bank erosion, with a thinner layer of bed sediment in places. The banks of the creek adjacent to the parking lot were eroded where historic fill and organic matter had been placed, exposing unconsolidated and ad-hoc fill in vertical banks. Bridges 1-P and 2-V were destroyed. The transition from deposition to erosion was likely caused by the fact that two vehicular bridges (4-V and 6-V) blocked with debris and created backwater areas that induced sedimentation, while the downstream bridges failed and allowed the remaining sediment to pass through them, scouring the banks. Stantec produced a pair of creek profiles (Figure 6) using LiDAR topography from 2014 (pre flood) and 2020. The profiles show 2-3 feet of bed sedimentation in most areas of the creek, with 5-7 feet in reach between Bridge 6-V and the location where the Yerba Buena Road landslide entered the channel. Additional sedimentation of several feet occurred on floodplain areas as well as within the camp.

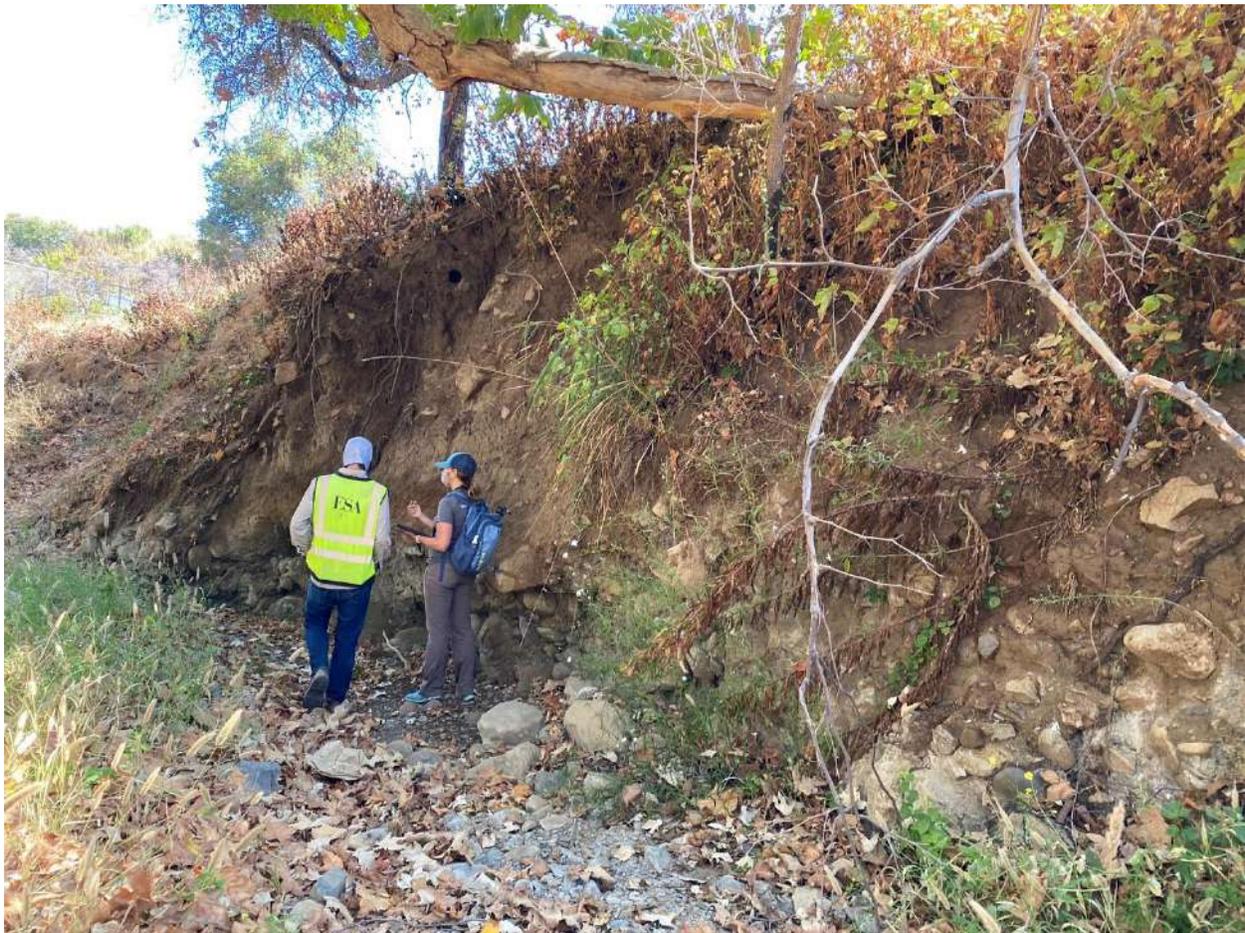
**Figure 11**

Example of bank erosion site where stabilization is proposed

**Bank erosion and bank stability.** Many of the banks where organic and other landscape debris as well as other unconsolidated fill materials had accumulated were scoured bare by the 2019 flooding, especially around the lower camp area and at the middle camp where the proposed road realignment is proposed. Several areas of bank (see examples in Figure 11) remain in oversteepened condition and are prone to future erosion.

*Channel Design Recommendations:* We recommend utilizing a combination of actions and measures to stabilize oversteepened and eroding banks. The measures include grading to lay back oversteepened banks back to a shallower and more stable profile to support native revegetation

and biotechnical stabilization measures, and in several select areas where infrastructure (roadway, bridges, etc) is directly adjacent to the channel, we recommend installation of rock toe protection to prevent bank retreat that could pose a risk to the camp infrastructure and programs. Biotechnical stabilization includes vegetated soil lifts (VSL), brush mat and live pole planting. More structural measures include vegetated rock slope protection and rock slope protection (transitions to, from and under bridges). Rock structures should be designed to account for up to seven feet of bed scour depending on location as flood-deposited gravels are washed out, in addition to the standard scour estimates below the pre-flood channel bed (3'-4'). For the bank stabilization areas shown in Figure 15 and summarized in Table 2 the profile was set to be as shallow as feasible. Bank stabilization measures were designated to steeper design gradients where either infrastructure impeded or cut slopes would have been excessively long before conforming to the valley side slopes or were in conflict with other project elements. These bank stabilization measures, based on natural analogs observed within the corridor utilize living plant materials to supplement structural elements and provide long term and resilient stability as the trees and plants establish. The bank stabilization structures shall be designed to account for specific geomorphic and hydraulic conditions in Little Sycamore Creek in order to protect and enhance creek functions within the creek corridor. Once established, biotechnical stabilization structures will also augment the overall revegetation plan to improve habitat complexity and linkages. The proposed actions and measures for bank stabilization are shown on sheets R1-R8 of the Creek Restoration Grading Plans and Sections and R9-R14 of the Creek Restoration Typical Details and are consistent with Ventura County's policies COS-1.1, COS-1-3, COS-1.4, COS-1.7 and Sec. 8178-2.4 – Specific Standards as discussed in the accompanying Wilshire Boulevard Temple Camps – Camp Hess Kramer and Gindling Hilltop Woolsey Fire Rebuild Policy Consistency Analysis.

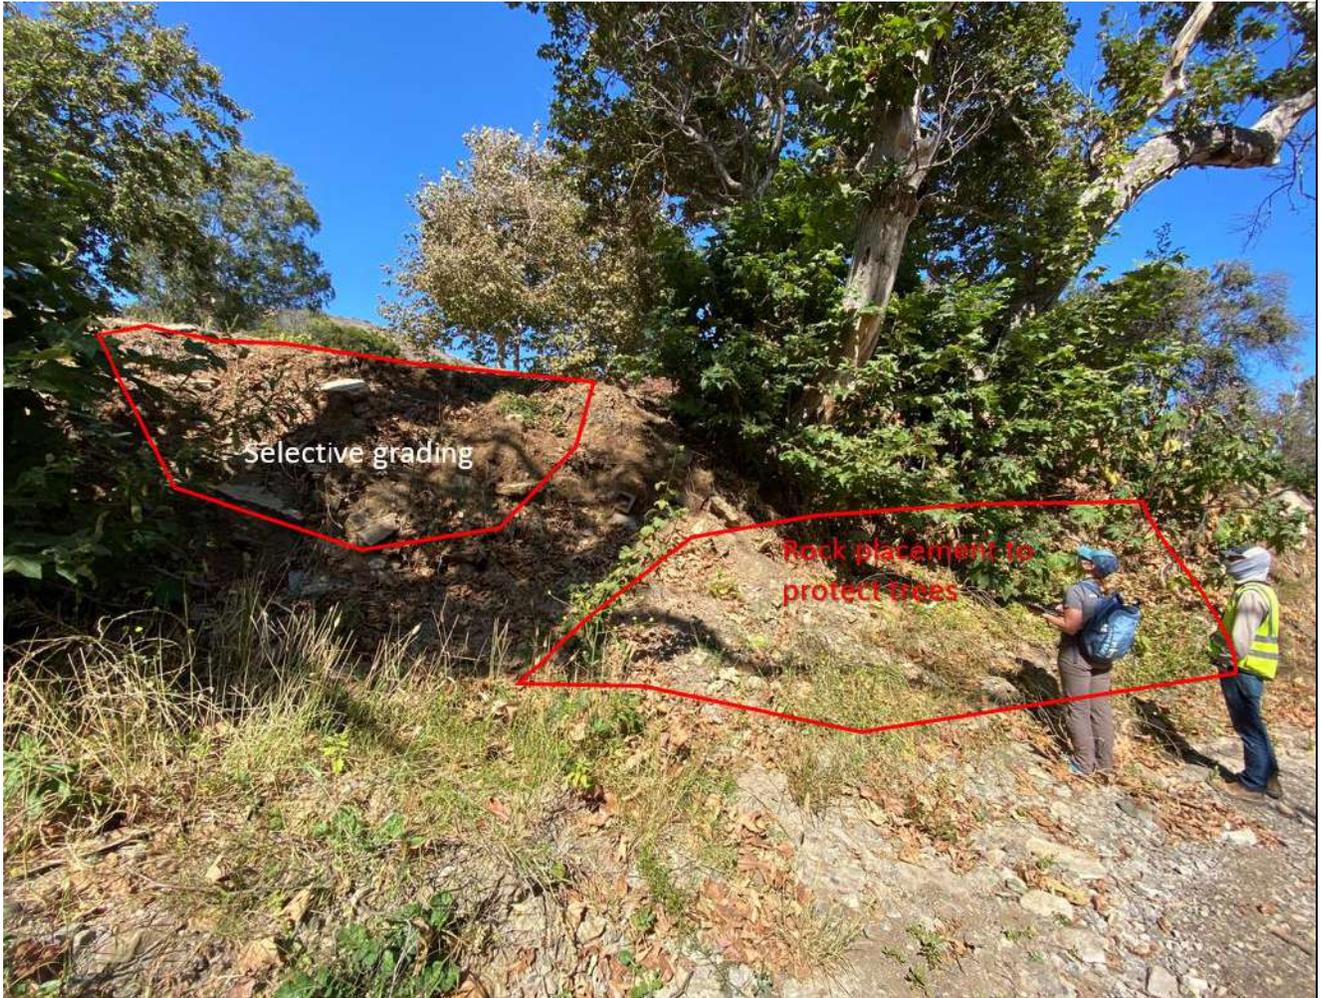
**Figure 12**

Example of a site where selective grading to remove fill plus placement of rock protection around tree roots is proposed

*Channel Design Recommendations:* Where high value trees or other constraints prevent comprehensive bank regrading we recommend selective grading around tree crowns to remove stockpiled debris and overburden bank soils while preserving the root structure. The conform grading at select trees within the bank stabilization and channel widening areas will establish 'tree islands' to preserve the trees to incorporate and maintain existing riparian structure and to support complexity within the riparian corridor. In some areas such as the parking lot we recommend reconstructing severely eroded banks around high value trees utilizing a combination of vegetated rock slope protection and vegetated soil lifts (VSL) to reestablish stable and resilient banks. These actions protect and enhance creek functions by developing detailed grading plans and bank stabilization measures that prioritize the preservation of the limited number of mature trees within the creek corridor. In most locations tree preservation will be augmented with specific complimentary plantings of other native tree and understory species which will enhance habitat complexity and linkages. The proposed grading and tree protection measures are shown on sheets R1-R8 of the Creek Restoration Grading Plans and Sections and R9-R14 of the Creek Restoration Typical Details and are consistent with Ventura County's policies COS-1.1, COS-1-3, COS-1.4, COS-1.7.

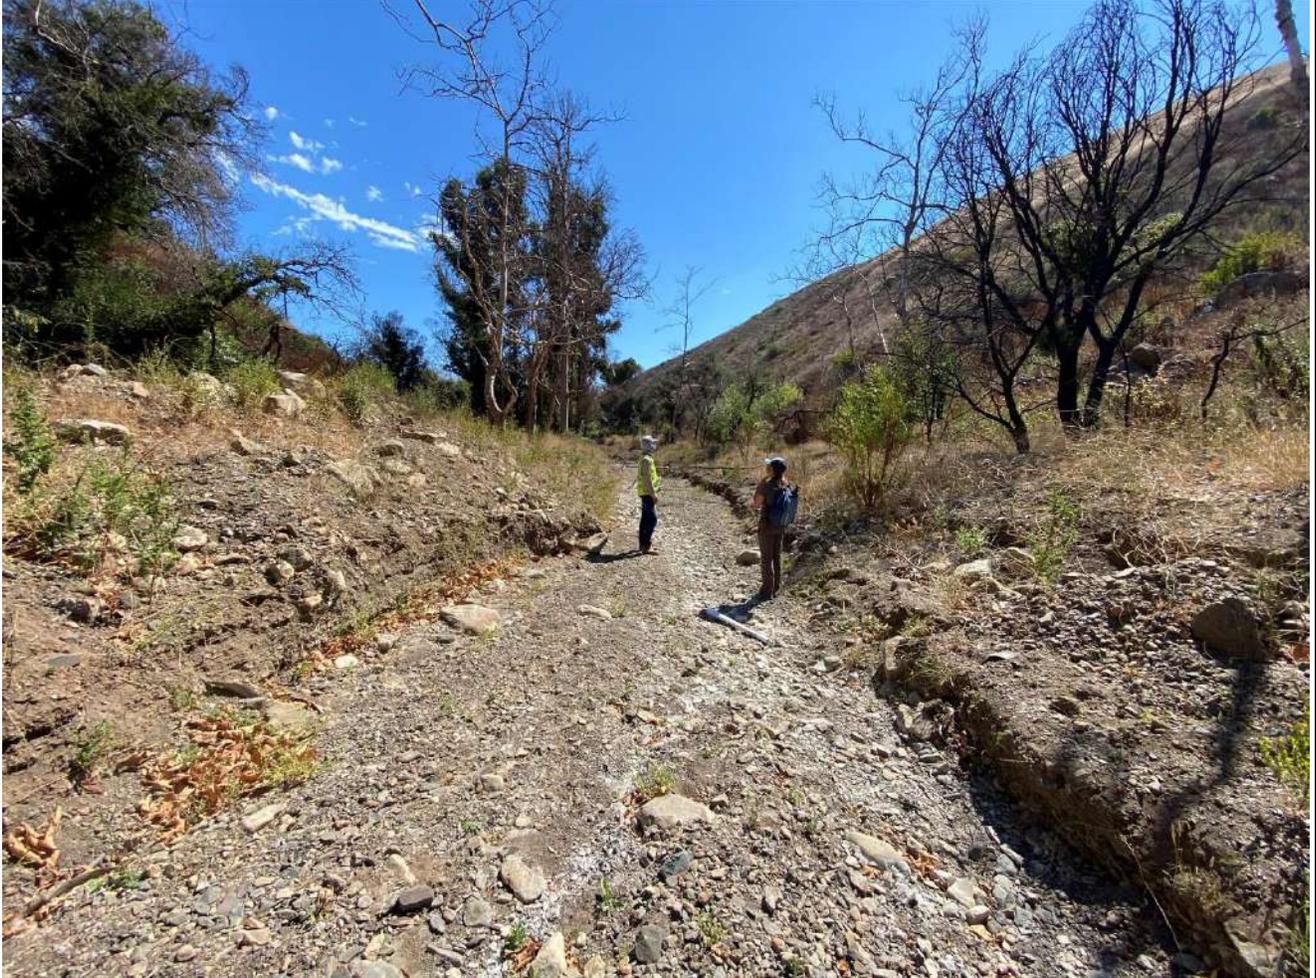
Camp Hess Kramer Geomorphic Conditions & Basis of Design  
**Figure 13**  
Proposed area for floodplain lowering to reduce  
confinement (left bank)

*Channel Design Recommendations:* Where feasible, ESA recommends that confined and/or buried channel reaches are widened and low floodplain areas actively graded out to at least the pre-flood level or deeper, to provide areas where the channel can migrate, expend excess energy and deposit sediment in the future at low risk to camp infrastructure and operations. Floodplain and channel widening elevations should be set based on the pre-flood channel profile since we expect the channel to incise into recent gravel deposits over the next 5-10 years, becoming less connected to the floodplain than under existing post-flood conditions. We recommend setting the floodplain elevations 1-2 feet (approximately) above the pre-flood channel invert where space allows, to compensate for expected future channel incision through the recent sediment deposits. These actions protect and enhance creek functions by actively removing flood-deposited sediments to reset and enhance channel capacity, reducing shear stress and improving conditions for natural regimes of deposition and erosion within the channel. In addition, channel grading and widening and bank set backs will support overall resilience and sustainability within the corridor in terms of future flood conveyance and debris flows leading to reduced maintenance requirements over time. The proposed actions are shown on sheets R1-R8 of the Creek Restoration Grading Plans and Sections and R9-R14 of the Creek Restoration Typical Details and are consistent with

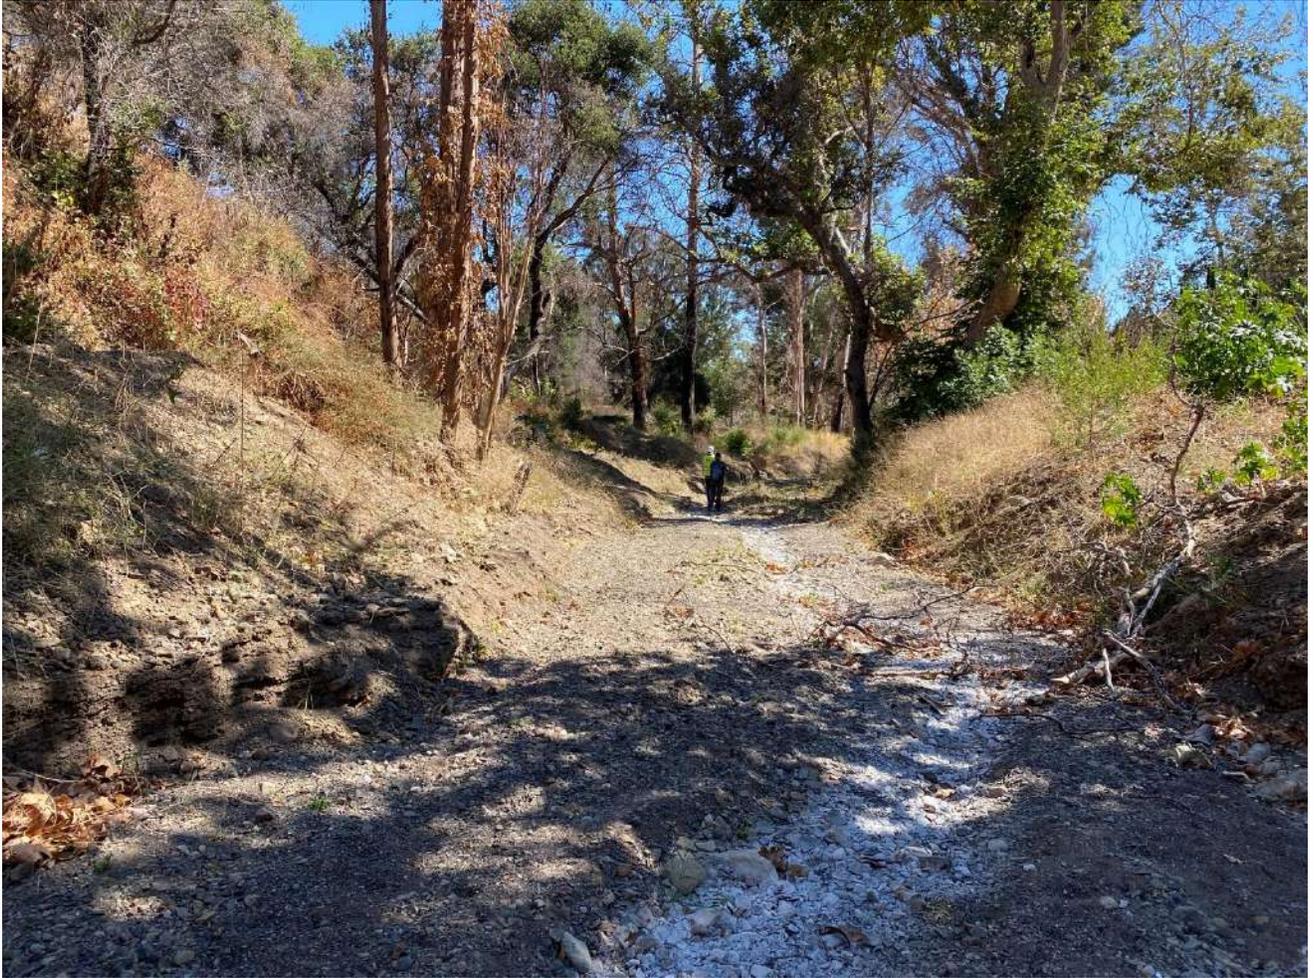
**Figure 14**

Area of proposed sediment and debris removal

*Channel Design Recommendations:* We recommend removal of excess sediment and overburden materials from the areas adjacent the channel including floodplain and transitional bank zones to 1) expand the creek corridor where appropriate, 2) to restore connected floodplain habitat and function where possible, and 3) to reduce the risk of sediment remobilizing and re-depositing downstream. Paired with channel and floodplain restoration actions, the sediment removal will protect and enhance creek functions by reducing shear stress and improving conditions for natural regimes of deposition and erosion within the channel. Debris removal will reestablish and expand areas for revegetation with native trees and plants. In addition, the sediment removal directly integrates and supports channel widening and bank set back actions to support overall resilience and sustainability within the corridor in terms of future flood conveyance and debris flows leading to reduced maintenance requirements over time. The proposed measures are shown on sheets R1-R8 of the Creek Restoration Grading Plans and Sections and R9-R14 of the Creek Restoration Typical Details and are consistent with Ventura County’s policies *COS-1.1, COS-1-3, COS-1.4, COS-1.07, COS-1.8* and *Sec. 8178-2.4 – Specific Standards as discussed in the accompanying Wilshire Boulevard Temple Camps – Camp Hess Kramer and Gindling Hilltop Woolsey Fire Rebuild Policy Consistency Analysis.*

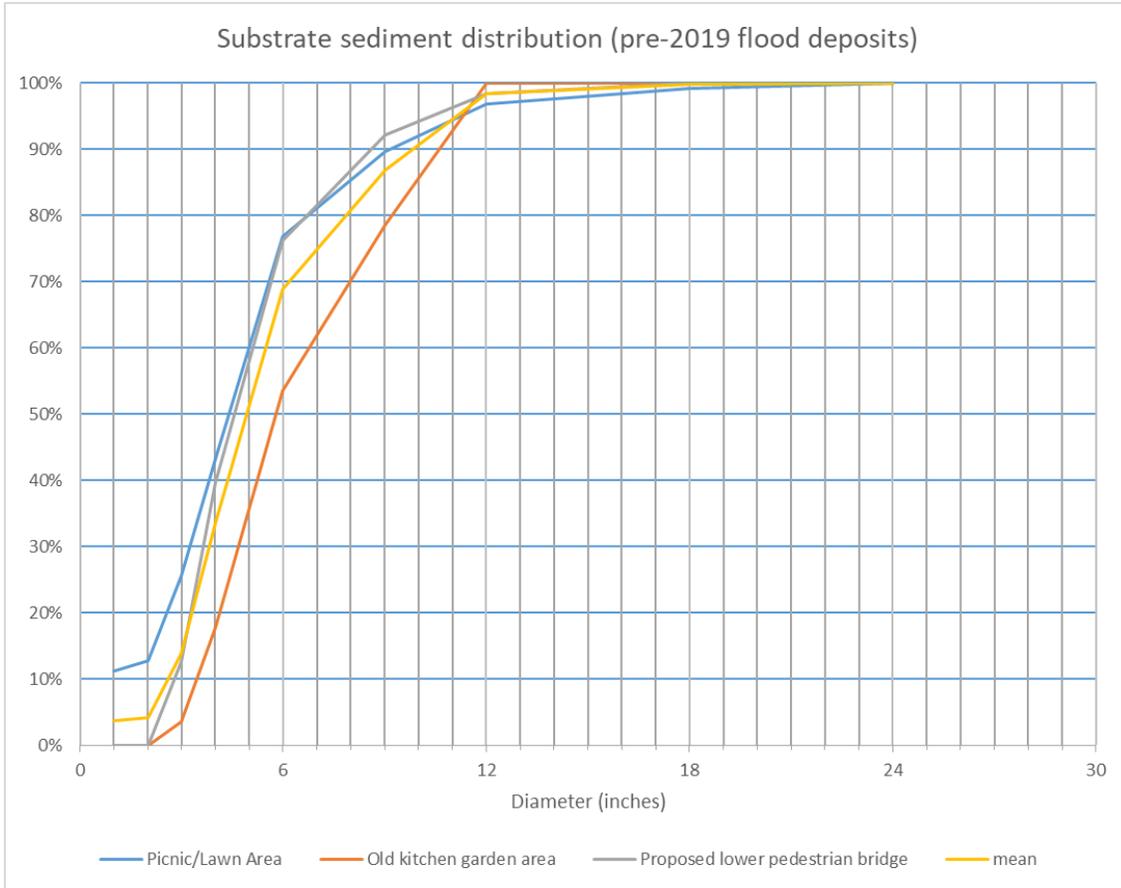
**Figure A-1**  
Particle size distribution for coarse (pre-flood) channel bed

Based on the observed median particle size of around 0.5 inches for the overlying 2019 flood deposits the critical shear stress is about 0.2 lb/sq ft. For the underlying pre-2019 flood cobble-boulder bed the median diameter is 5 inches with a corresponding critical shear stress of 1.9 lb/sq ft. For the  $d_{84}$  (sometimes used to assess transport of poorly sorted beds where large particles shield the median sized particles from erosion) the respective values are 0.23 lb/sq ft for the 2019 flood deposits and 3.46 lb/sq ft for the underlying cobble-boulder bed.
