# **HISTORIC RESOURCES REPORT**

**8442 Santa Ana Road**  
**(APN 060-0-220-150)**

Ventura County, California

August 14, 2020

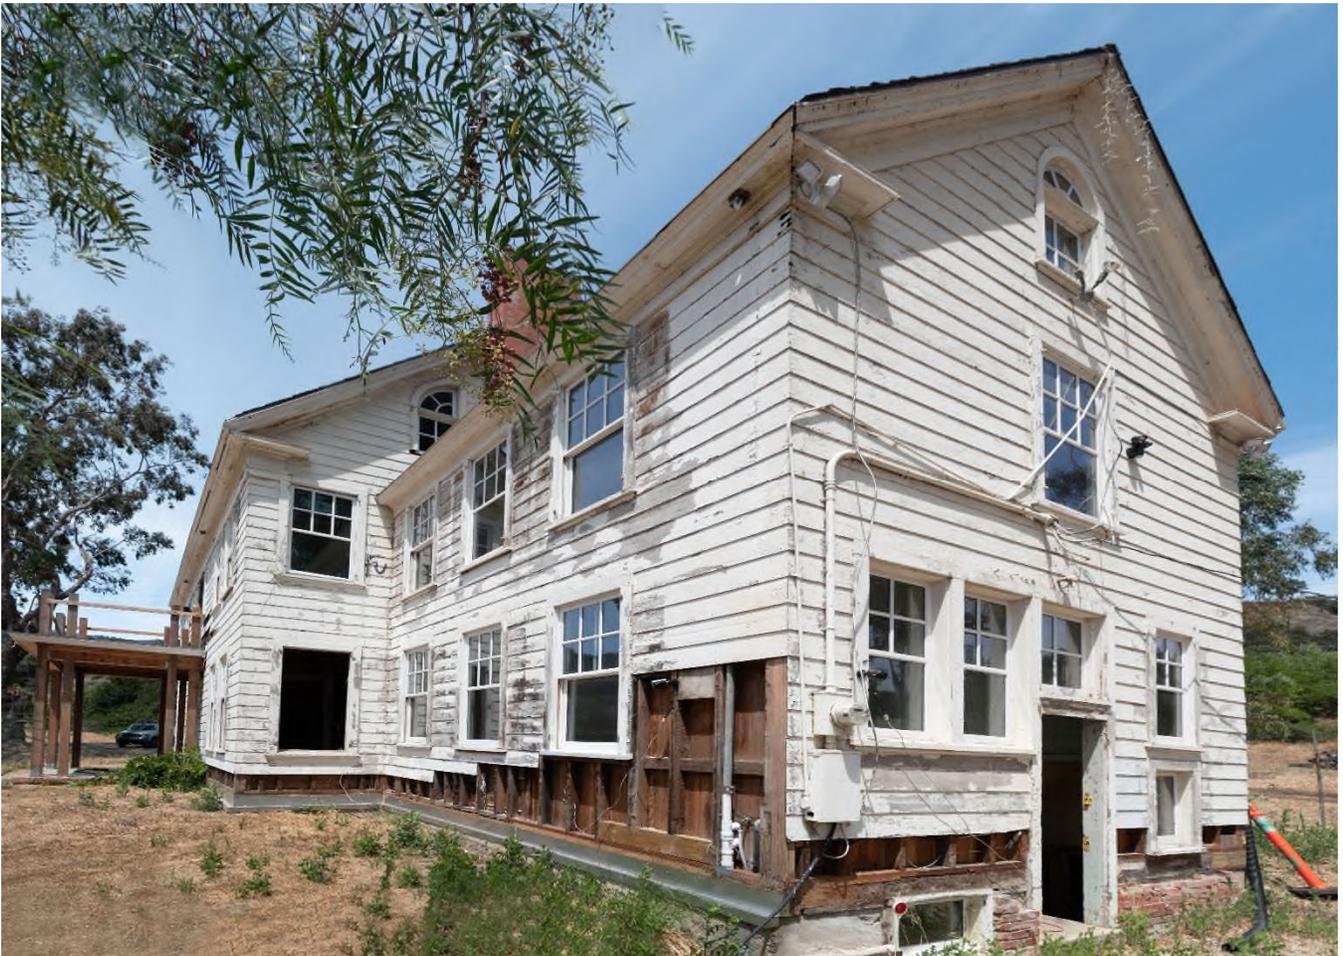
**Figure 10, South Elevation, detail of the east end of the elevation, existing conditions**

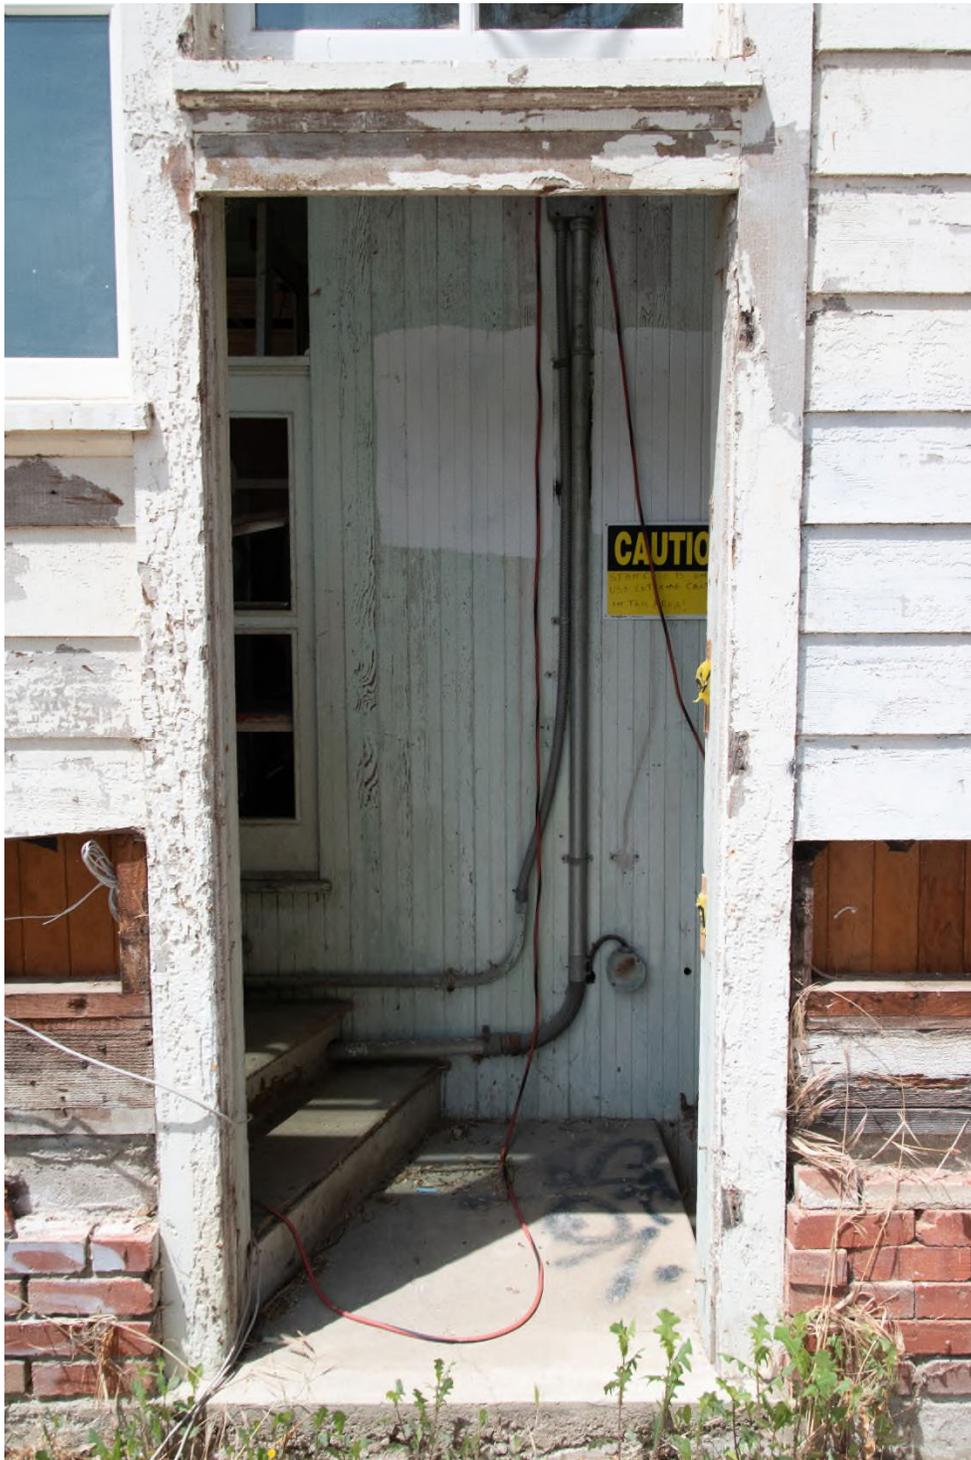
**Figure 16, East Elevation, detail of door opening into service wing**

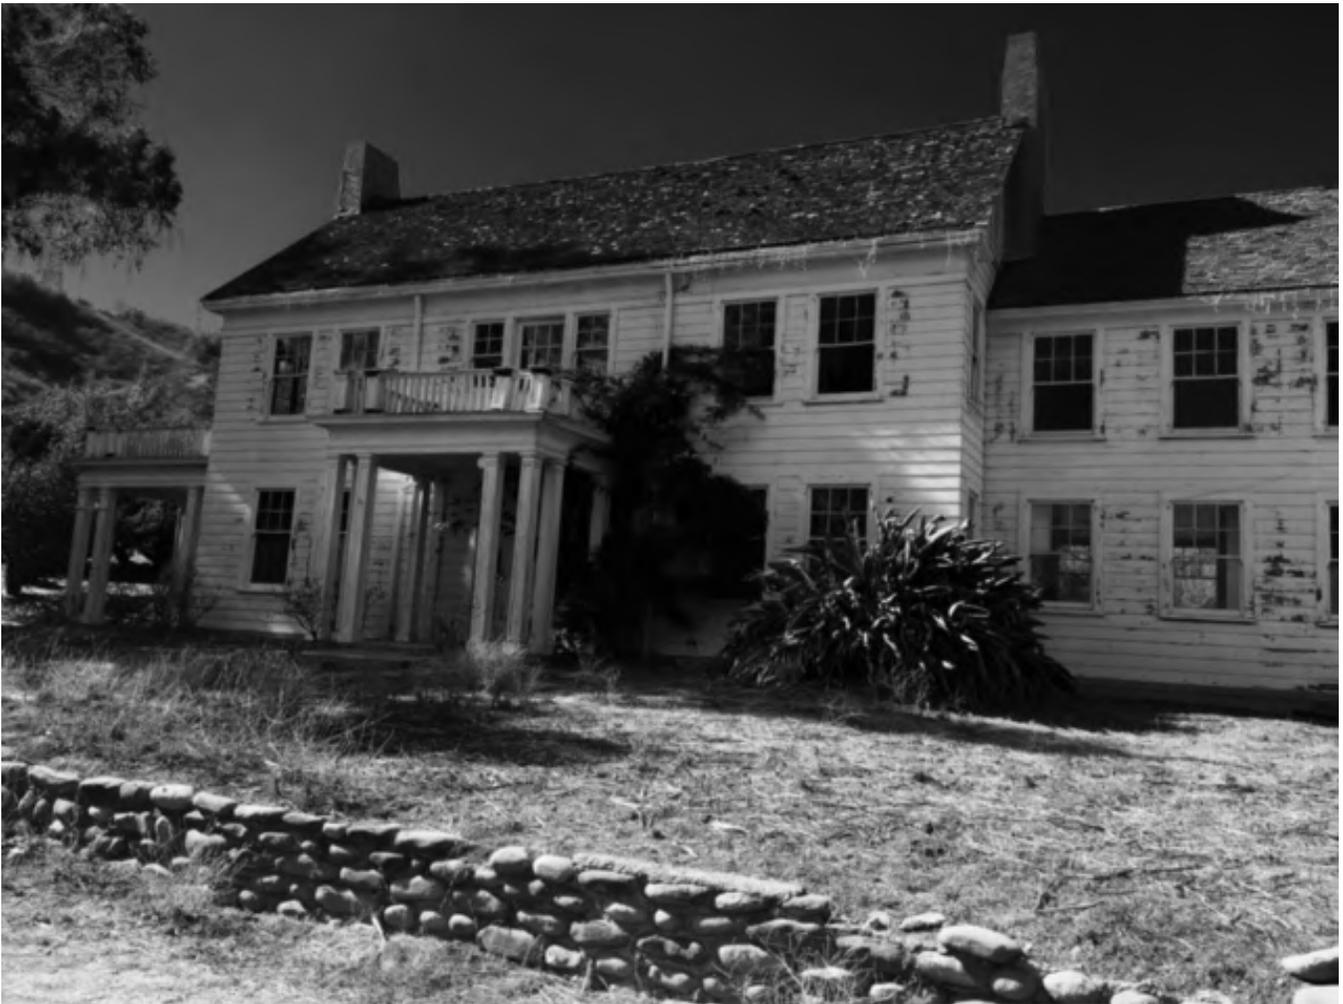
**Figure 21, South Elevation before removal of porch and veranda and replacement of fenestration (photograph appears to date to the early to mid-2000s)**

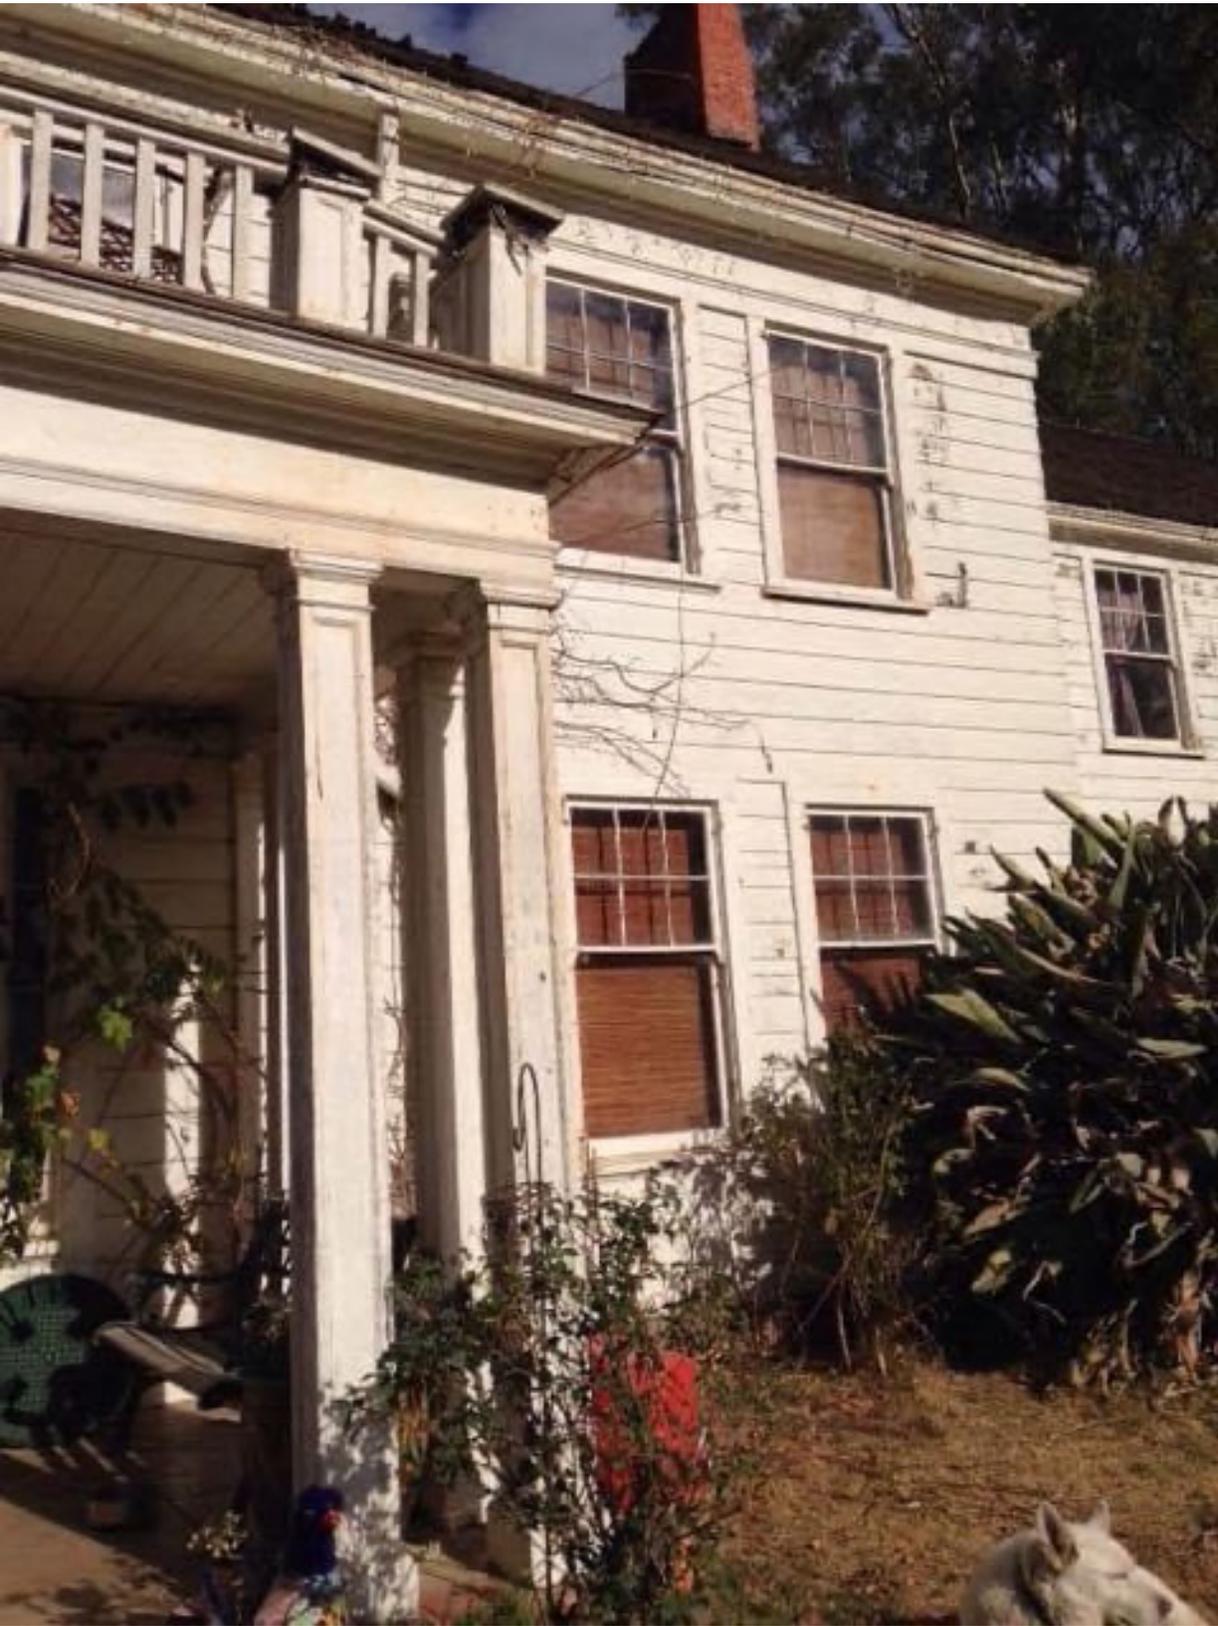
**Figure 22, South Elevation before removal of porch and veranda and replacement of fenestration (photograph appears to date to the late 1990s or early 2000s)**

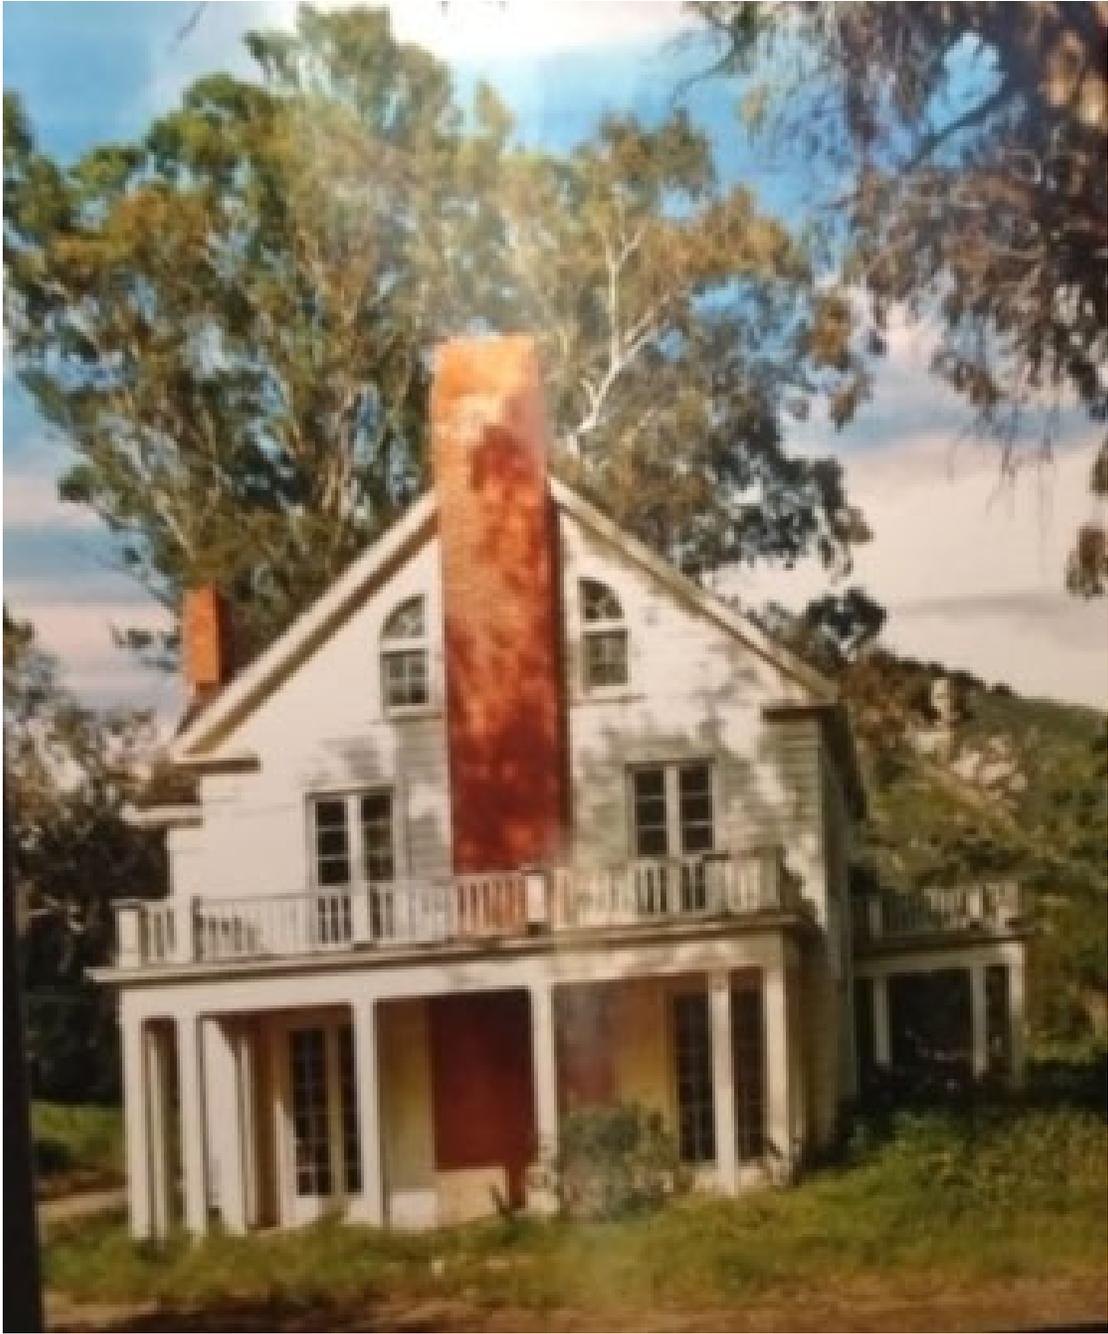
**Figure 23, West Elevation before removal of porch and veranda and replacement of fenestration (taken sometime in the 2000s)**

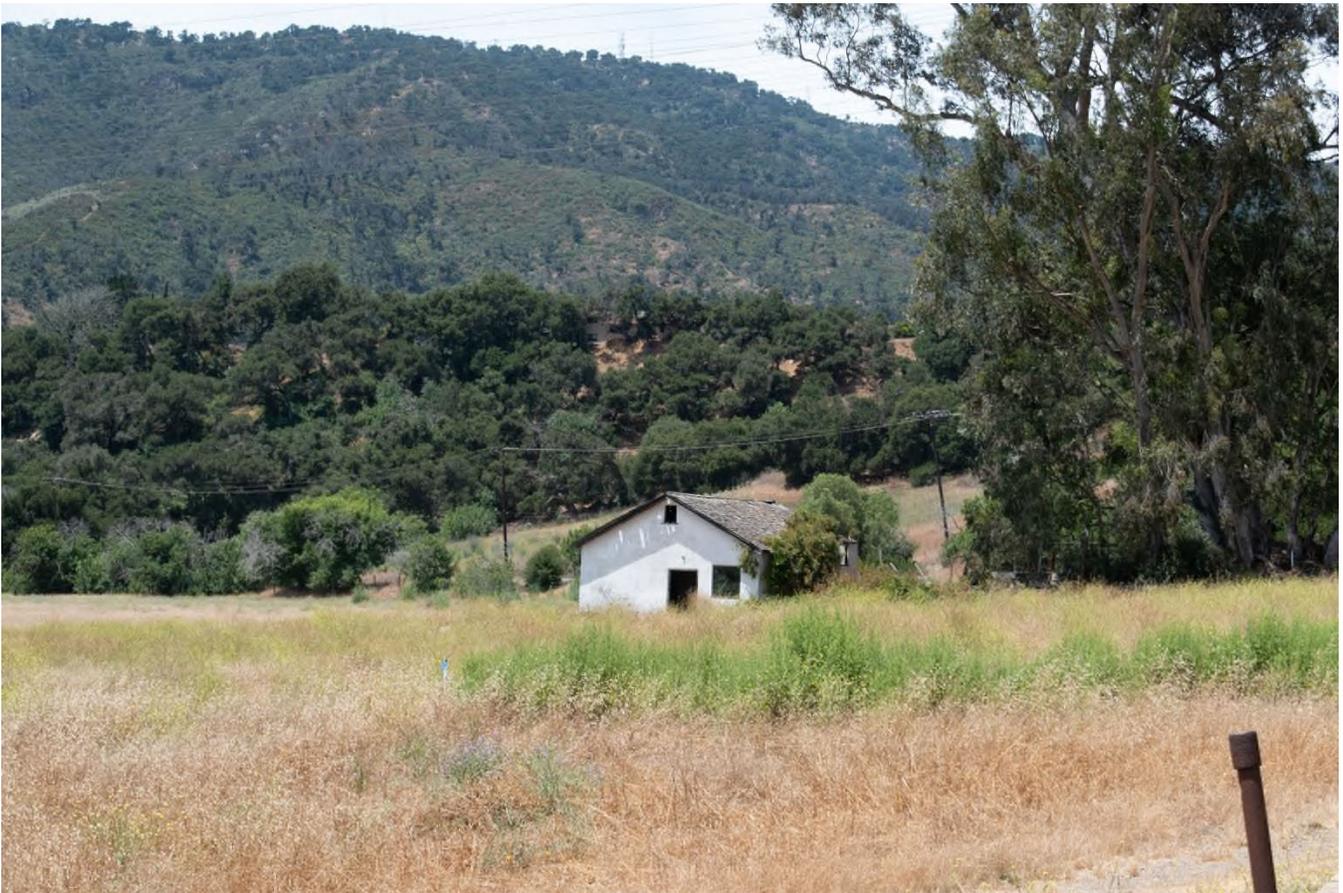
This is a stucco-clad wood frame building located north of the house (Figures 29 - 31). The building is capped by a complex cross-gable wood shingle roof with shallow eaves. The building's doors and windows have been removed or extensively damaged. A partially enclosed area surrounded by low concrete walls, located off the north end of the building, may have been associated with the possible use of the building as a dairy.

**Figure 30, "Dairy," West Elevation, existing conditions**

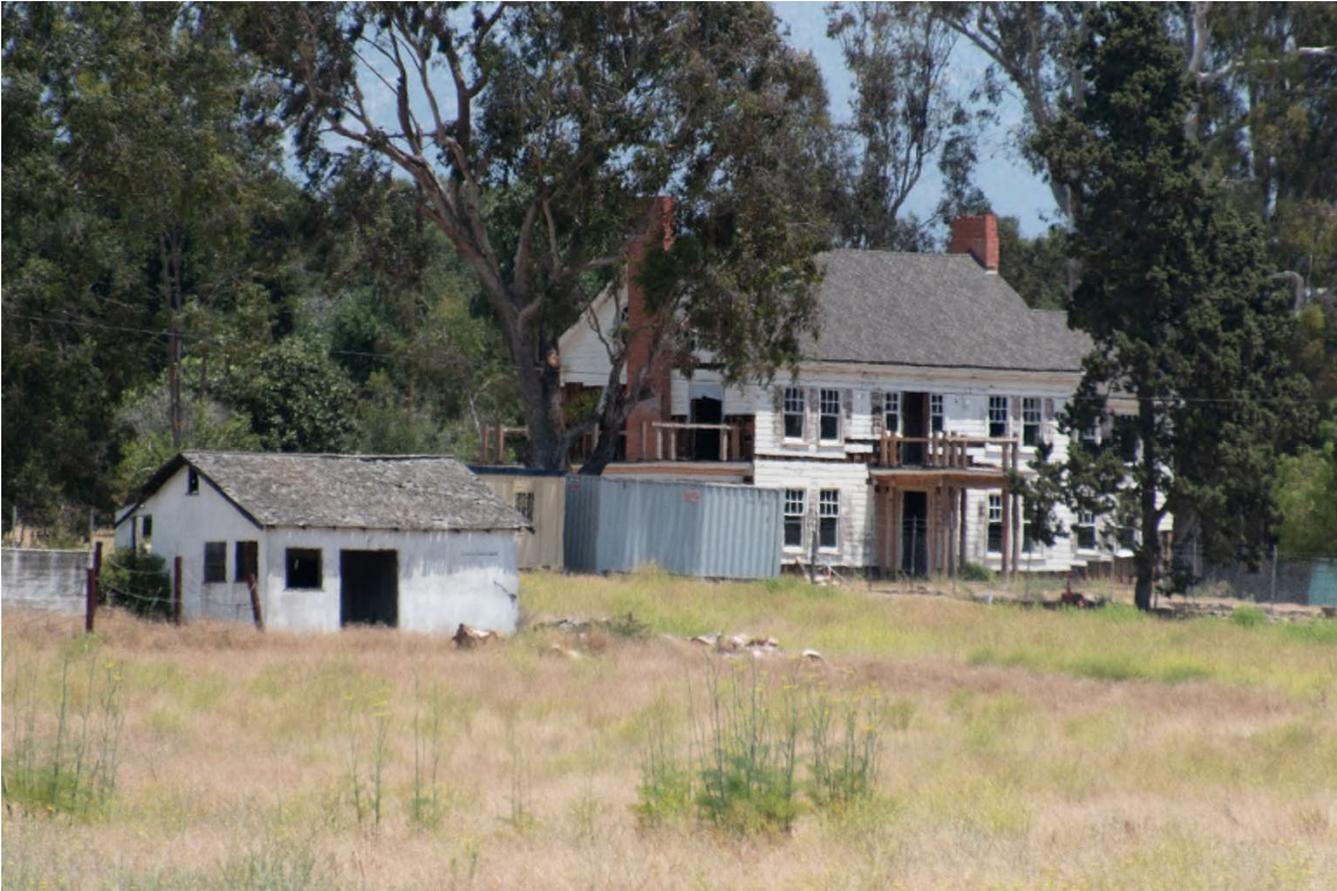
**Figure 31, "Dairy," South and West Elevations with house in background, existing conditions**

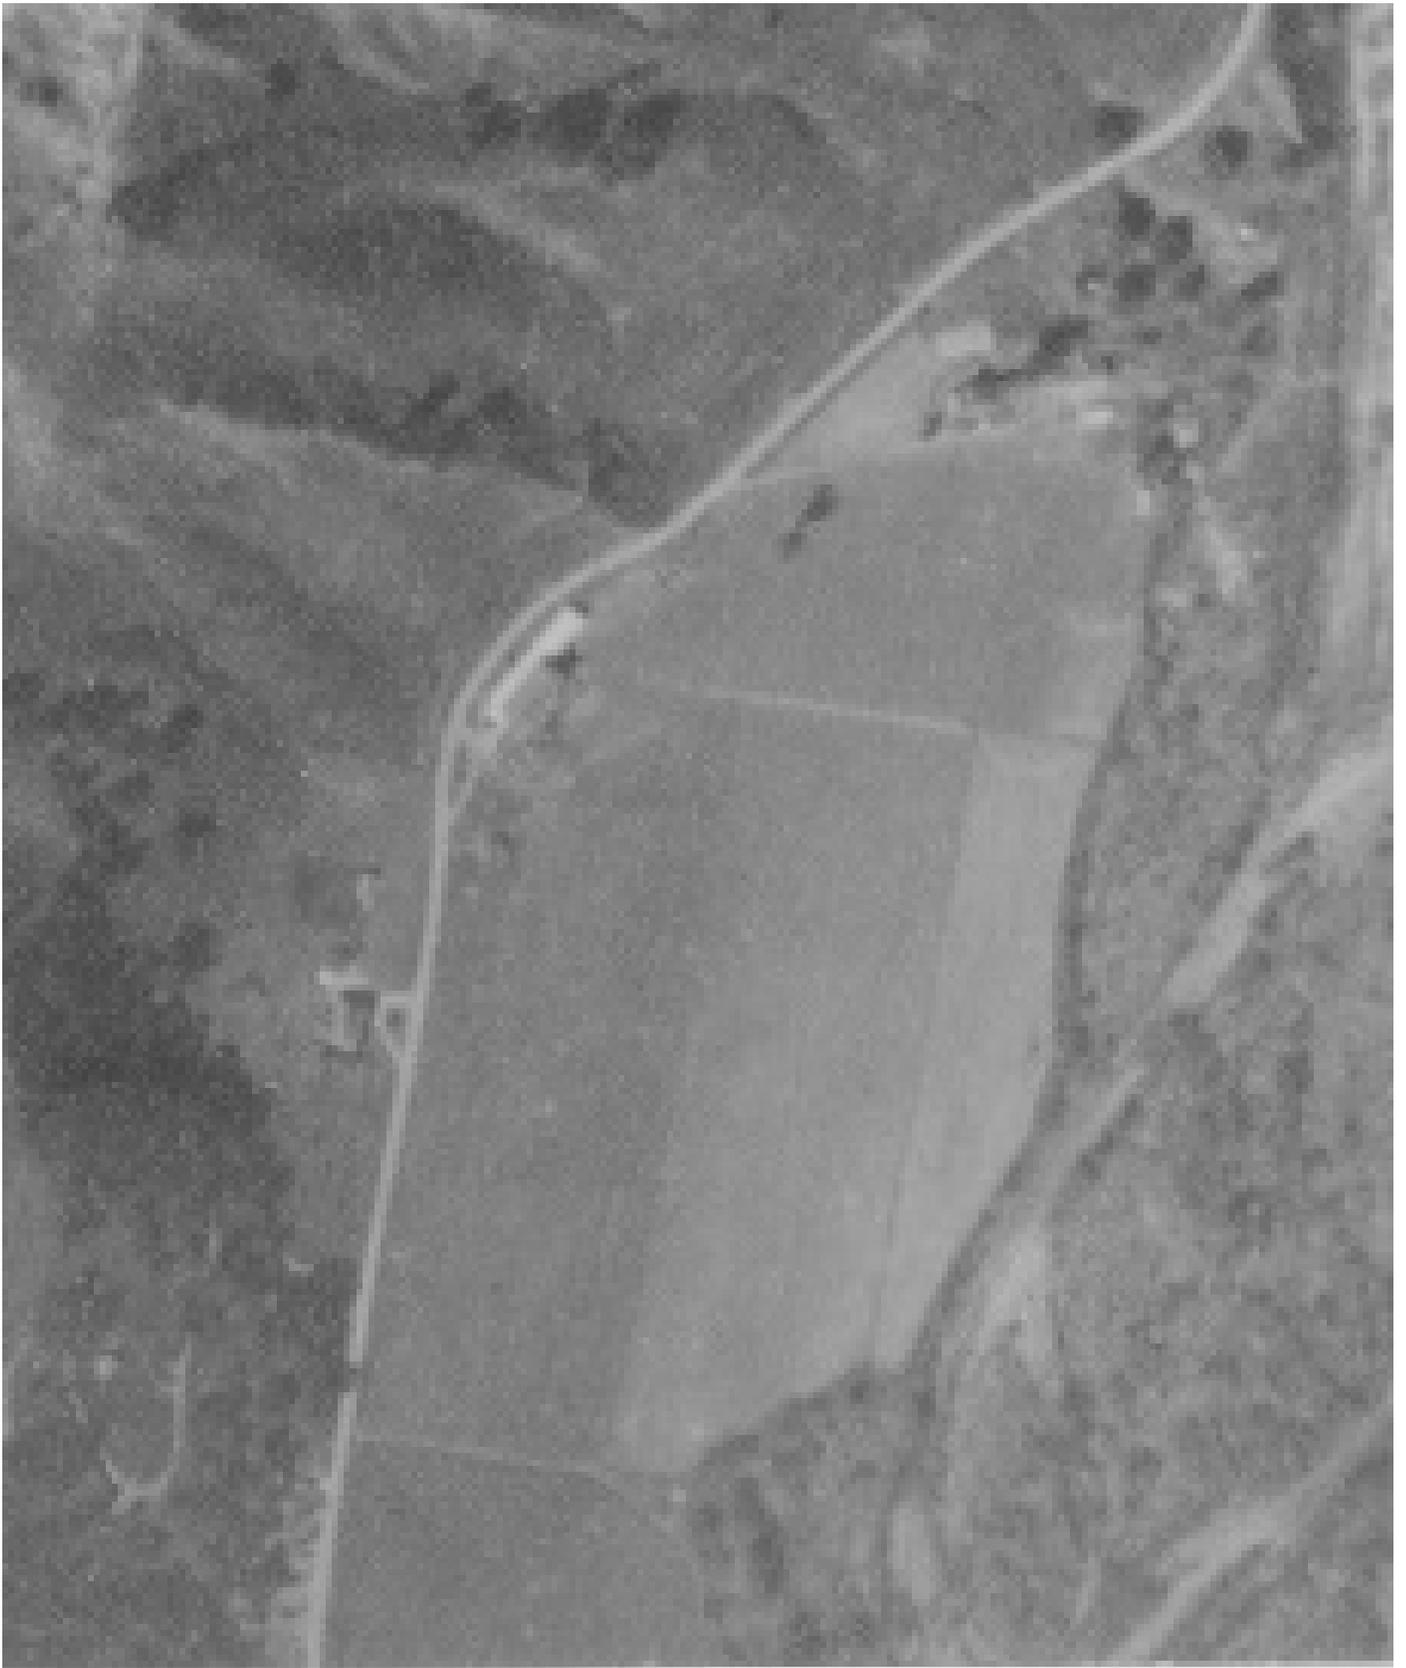
- A 1929 aerial photograph depicts the house and terraces as well as a driveway leading from Santa Ana Road to the house. This photograph also depicts a building (now demolished) adjacent to the Santa Ana Road frontage that was likely associated with the ranch's agricultural operations. Fields extends from the house to the western end of the property (Figure 43);

**Figure 43, Project Property in 1929 (Flight C-431\_a-17, Feb. 1, 1929, Map and Imagery Collection, University of California, Santa Barbara)**

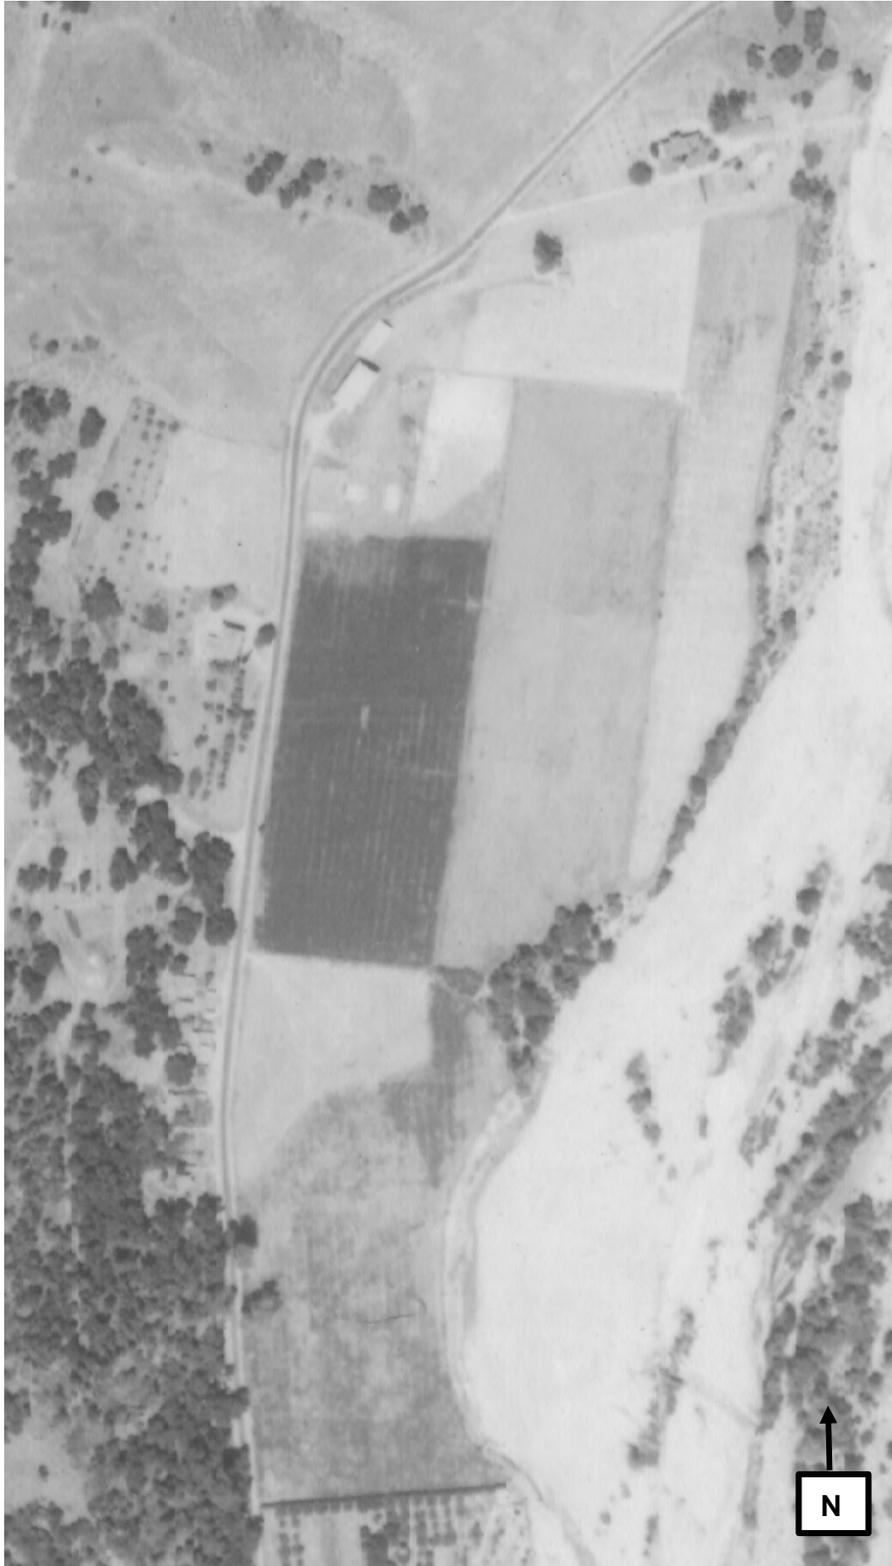
- A 1938 aerial photograph depicts the "dairy" building and cultivated fields extending west of the house. With the exception of the terraces and ornamental planting in the vicinity of house, landscaping appears to minimal in nature (Figure 44);

Figure 44, Project Property in 1938 (Flight ax-1938\_63-11, May 9, 1938, Map and Imagery Collection, University of California, Santa Barbara)

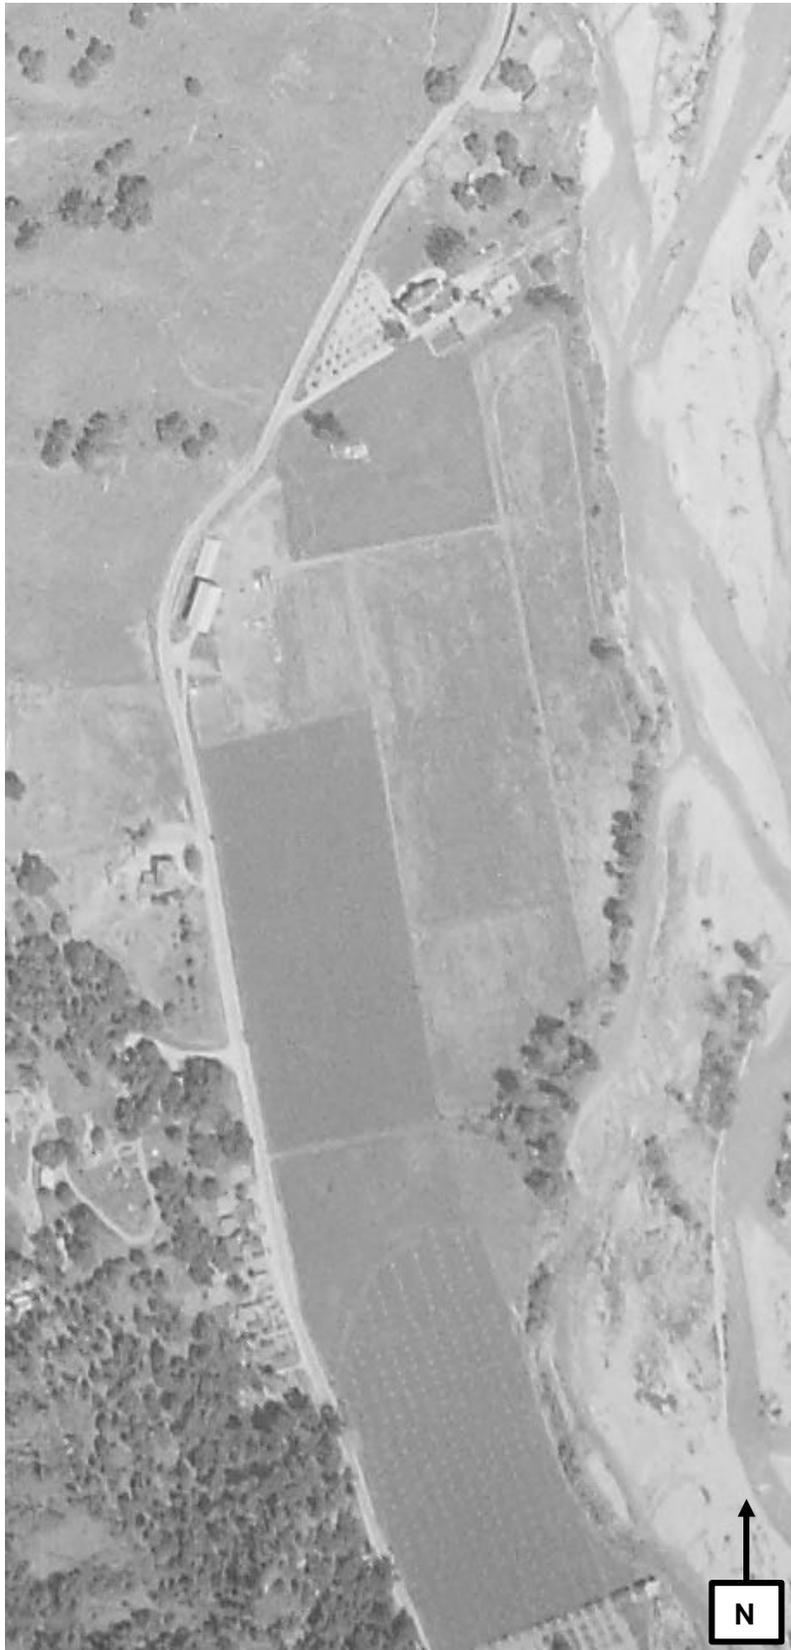
- A 1941 aerial photograph depicts several changes to the property including the planting of an orchard at the north end of the driveway at its entrance onto Santa Ana Road and more extensive plantings around the house. It appears several small structures were located off the south end of the terraces. The construction date for these buildings is unknown; this is the first year they are clearly depicted on available aerial photographs (Figure 45);

Figure 45, Project Property in 1941 (Flight C-7046\_110, April 3, 1941, Map and Imagery Collection, University of California, Santa Barbara)

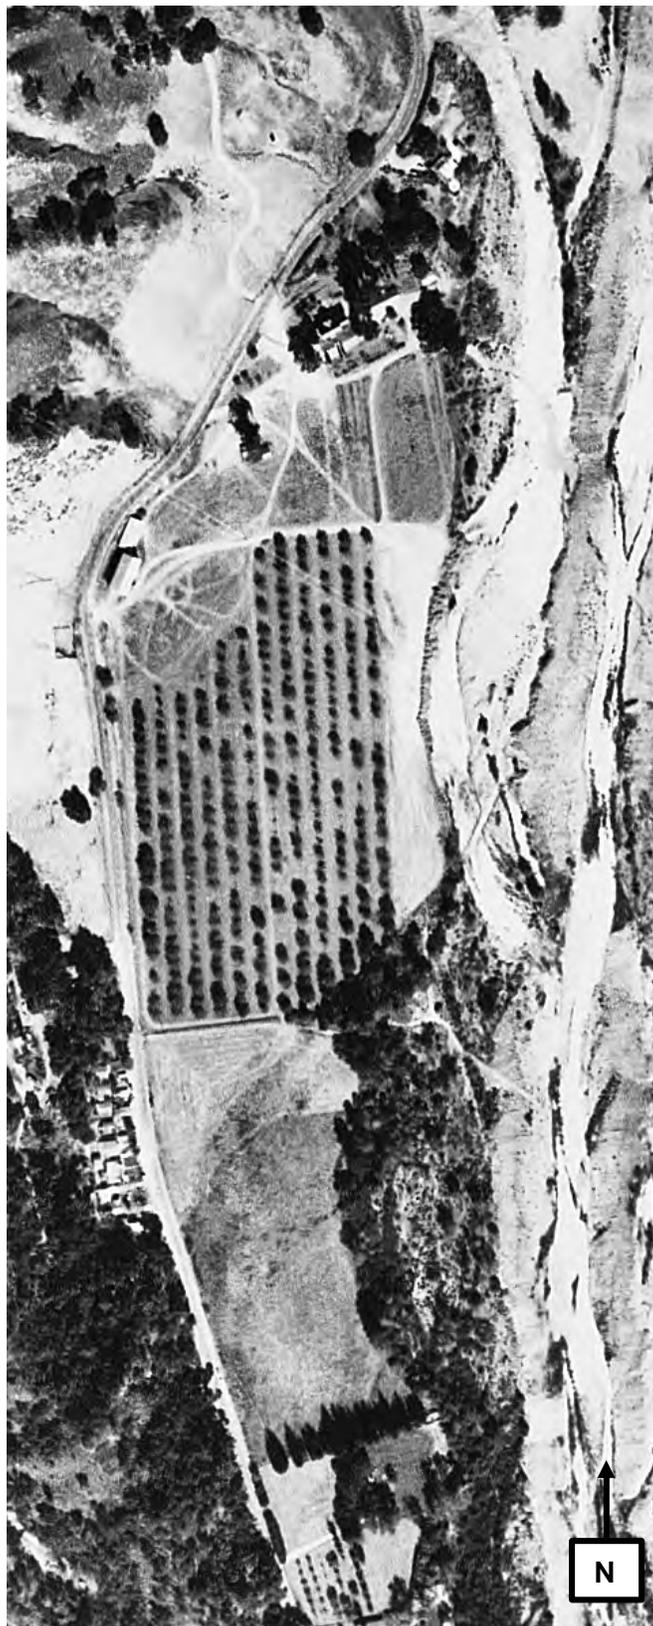
- A 1959 aerial photograph depicts a larger orchard had been planted west of the "dairy" building and the orchard at the north end of the entrance drive had been removed (Figure 46);

**Figure 46, Project Property in 1959 (Flight axi\_1959-20w-62, August 3, 1959, Map and Imagery Collection, University of California, Santa Barbara)**

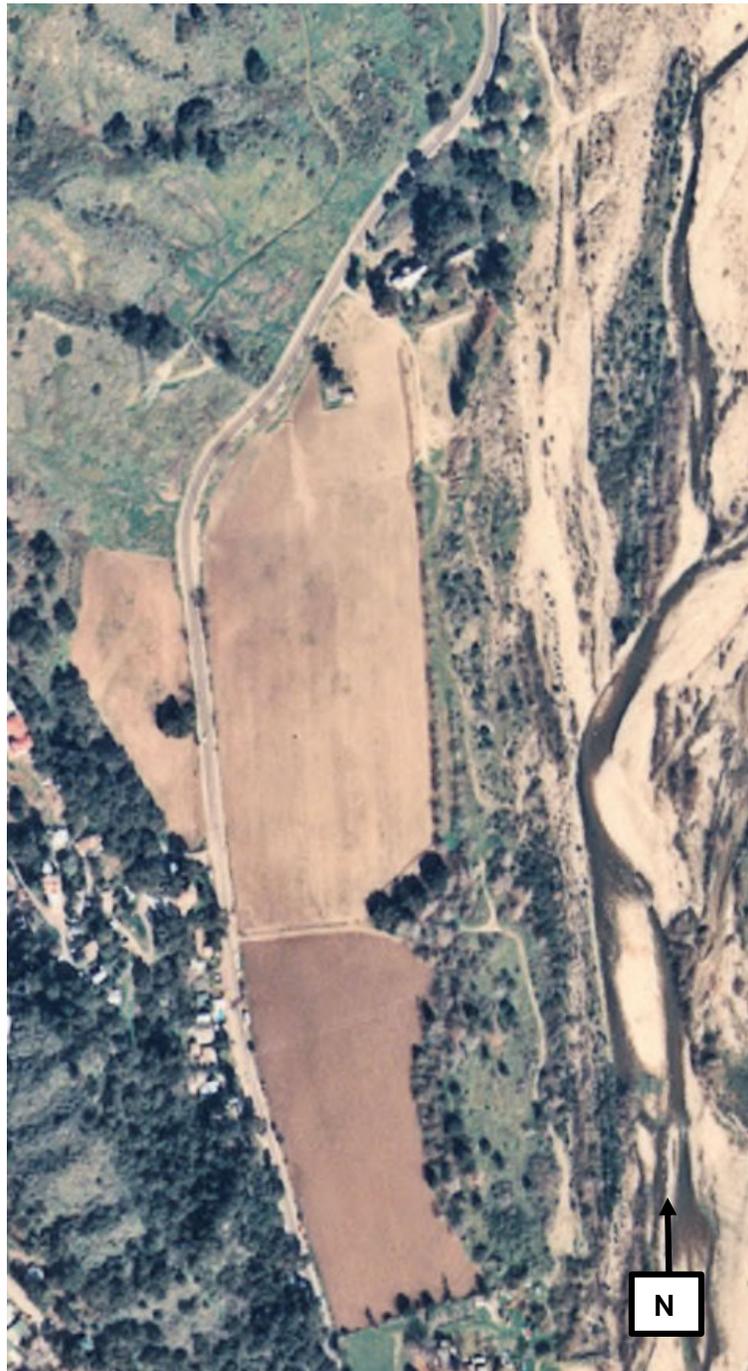
- A 1984 aerial photograph reveals the orchard was removed sometime between 1979 and 1984 (Figure 47).

**Figure 47, Project Property in 1984 (Flight pw-ven-4\_178, 1984, Map and Imagery Collection, University of California, Santa Barbara)**
