Staff Report and Recommendations Agenda of December 8, 2025, Item 5a

A request for a Certificate of Review for the replacement of all wood-clad windows with aluminum-clad windows at the Santa Clara Elementary School, located at 324 S E Street, Oxnard, CA 93030. The scope of work also includes restriping of the existing teacher parking lot, the installation of a new ADA compliant ramp at the existing teacher parking lot, and the re-painting of the exterior of the existing building. (Case No. CH25-0051).

324 S E Street, Oxnard, CA 93030
Assessor's Parcel Number (APN): 202-0-084-040
Historic Designation: undesignated, but potentially eligible historic resource
Common/Historic Name: Santa Clara Elementary School

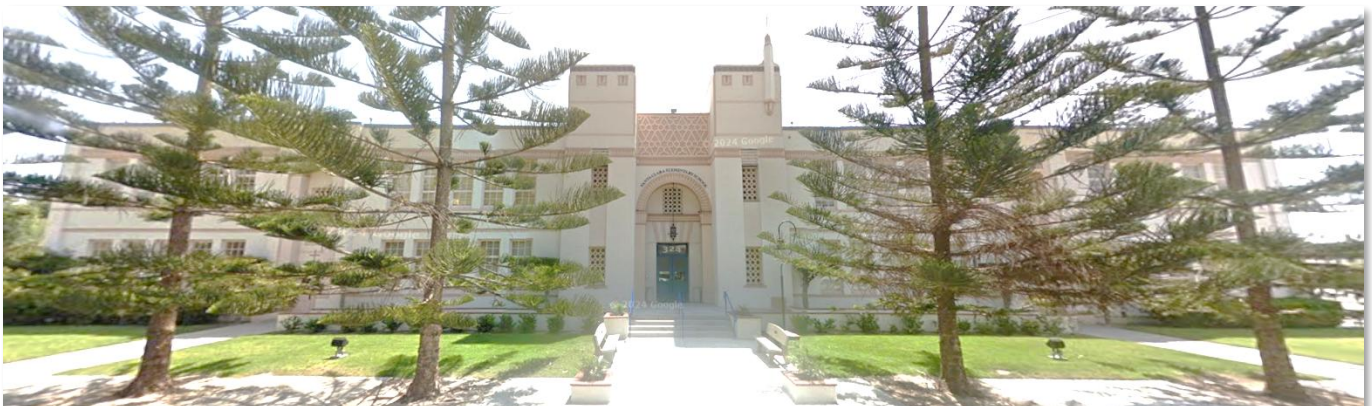
Figure 1 – Santa Clara Elementary School (looking east), 2016

The subject property was documented in the *1981 Oxnard - Santa Paula Historic Resources Survey (Phase I Part II)* ("historic survey") prepared by Ms. Judith P. Triem. The school building is shown in Figure 1 with its original windows (since removed). The historic survey describes the development of the neighborhood and subject property as follows:
