**PRELIMINARY GEOLOGIC AND GEOTECHNICAL ENGINEERING
INVESTIGATION, PROPOSED CABINS AND WELCOME CENTER,
BRANDEIS-BARDIN CAMPUS,
Simi Valley, California**

W.O. 7588

**Subject: Preliminary Geologic and Geotechnical Engineering
Investigation, Proposed Cabins and Welcome Center,
Brandeis-Bardin Campus, Simi Valley, California**

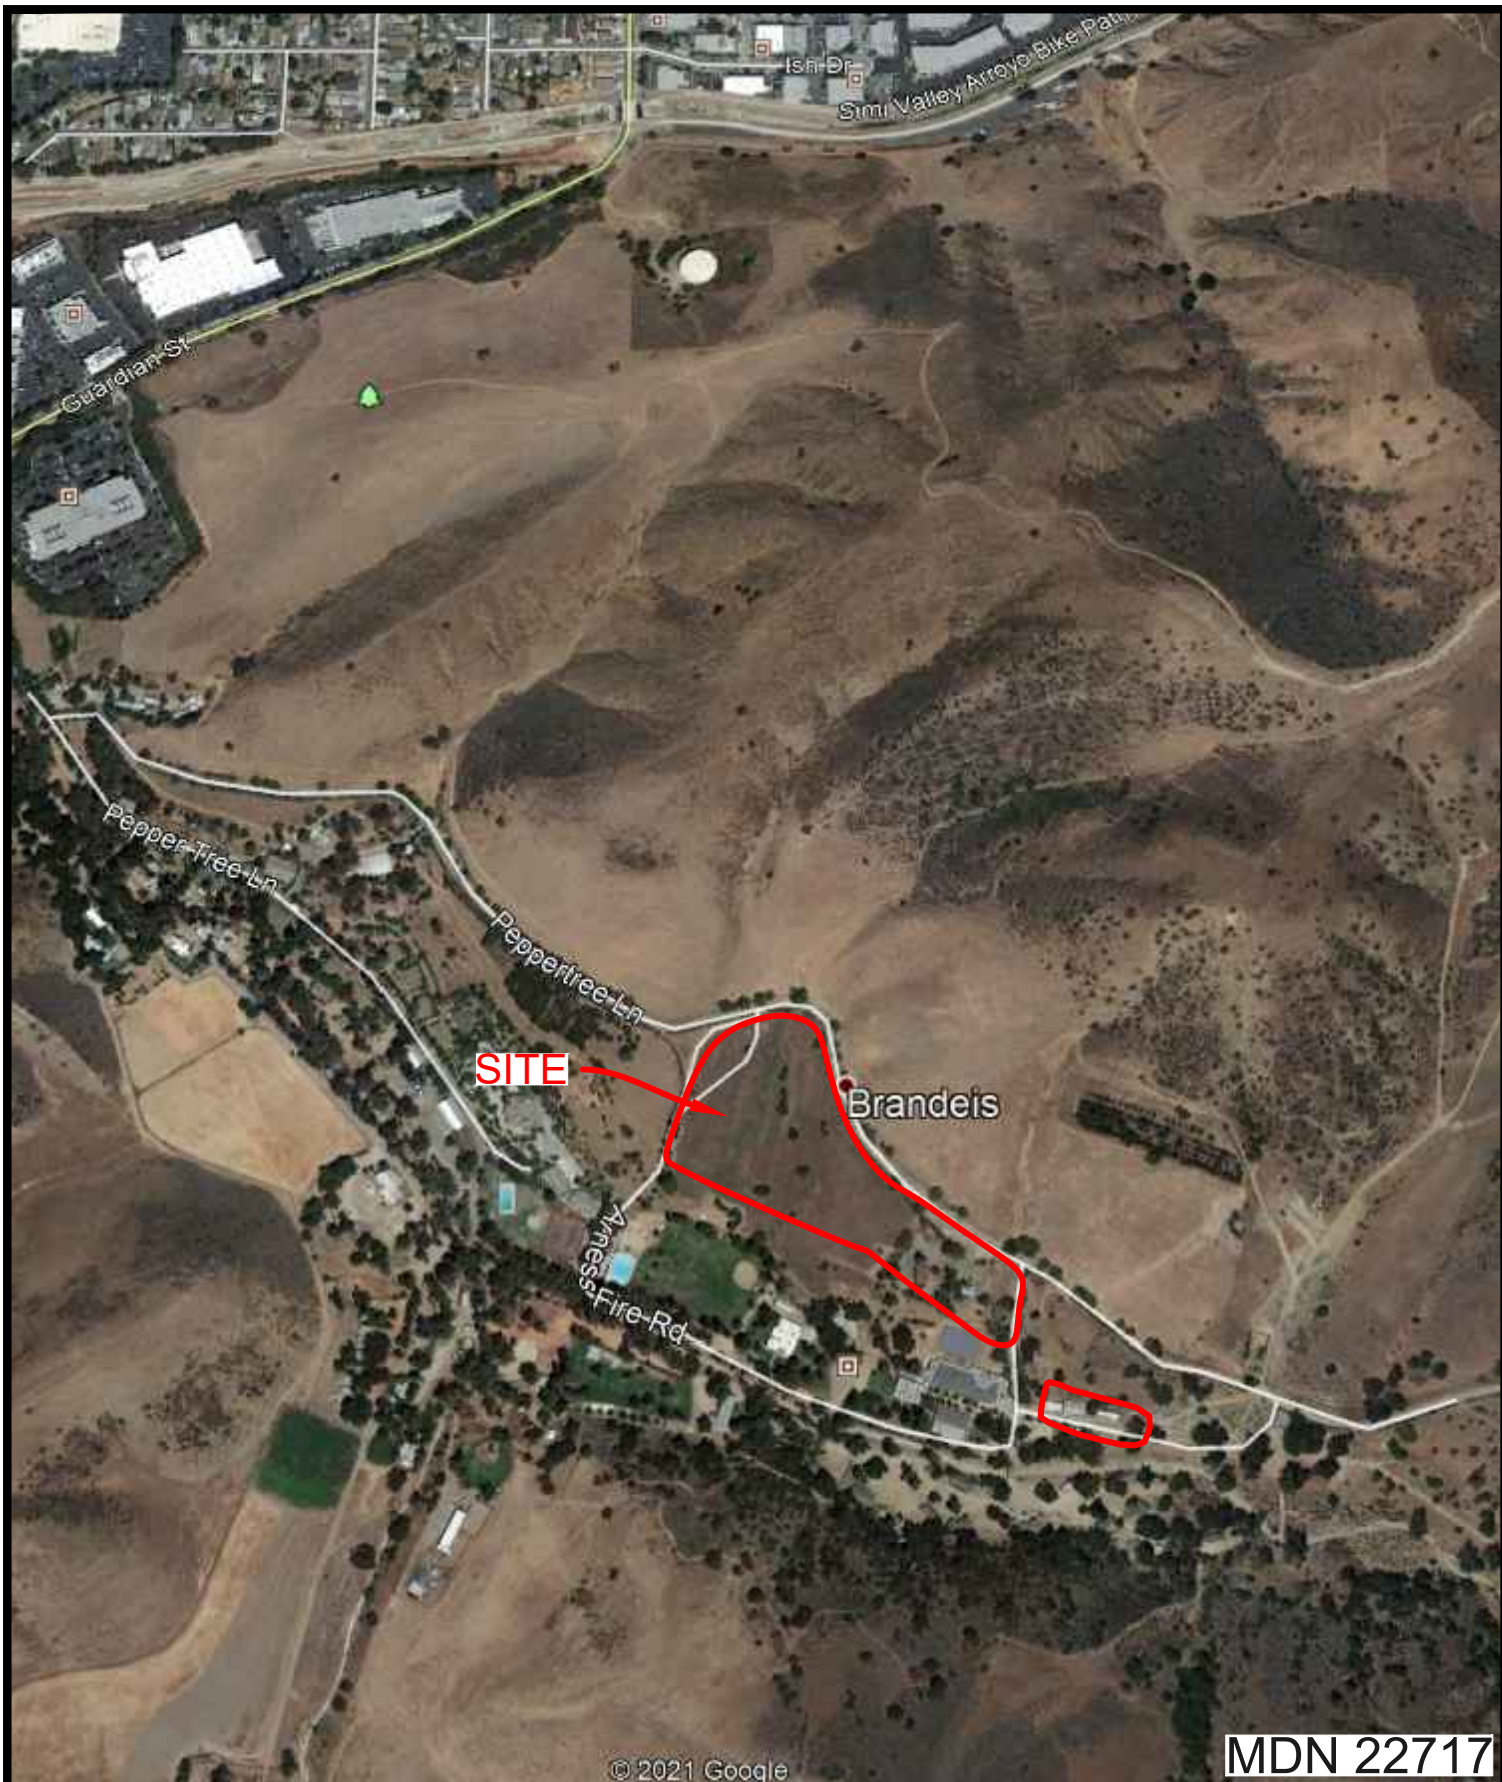
The subject site is located within the southeastern part of Simi Valley on the eastern flanks of Meier Canyon (Figure 1). Meier Canyon is a tributary to the Arroyo Simi drainage channel located north of the subject property. A topographic map of the site is included as Plate 1, Geologic Map. The area addressed in this report consists of the west sloping surface between Peppertree Lane and the main canyon bottom, as shown on Plate 1. This area consists of a broad surface elevated above the main canyon bottom to the west. Two tributary canyons pass through the site before entering Meier Canyon. One of the tributaries is located along the northern part of the subject site and one passes through the central part of the site. The two tributary canyons continue to ascend to the east and above the subject property. The slope gradients range from flatter than 10:1 on the elevated surfaces to 2:1 along the sides of the central tributary channel.

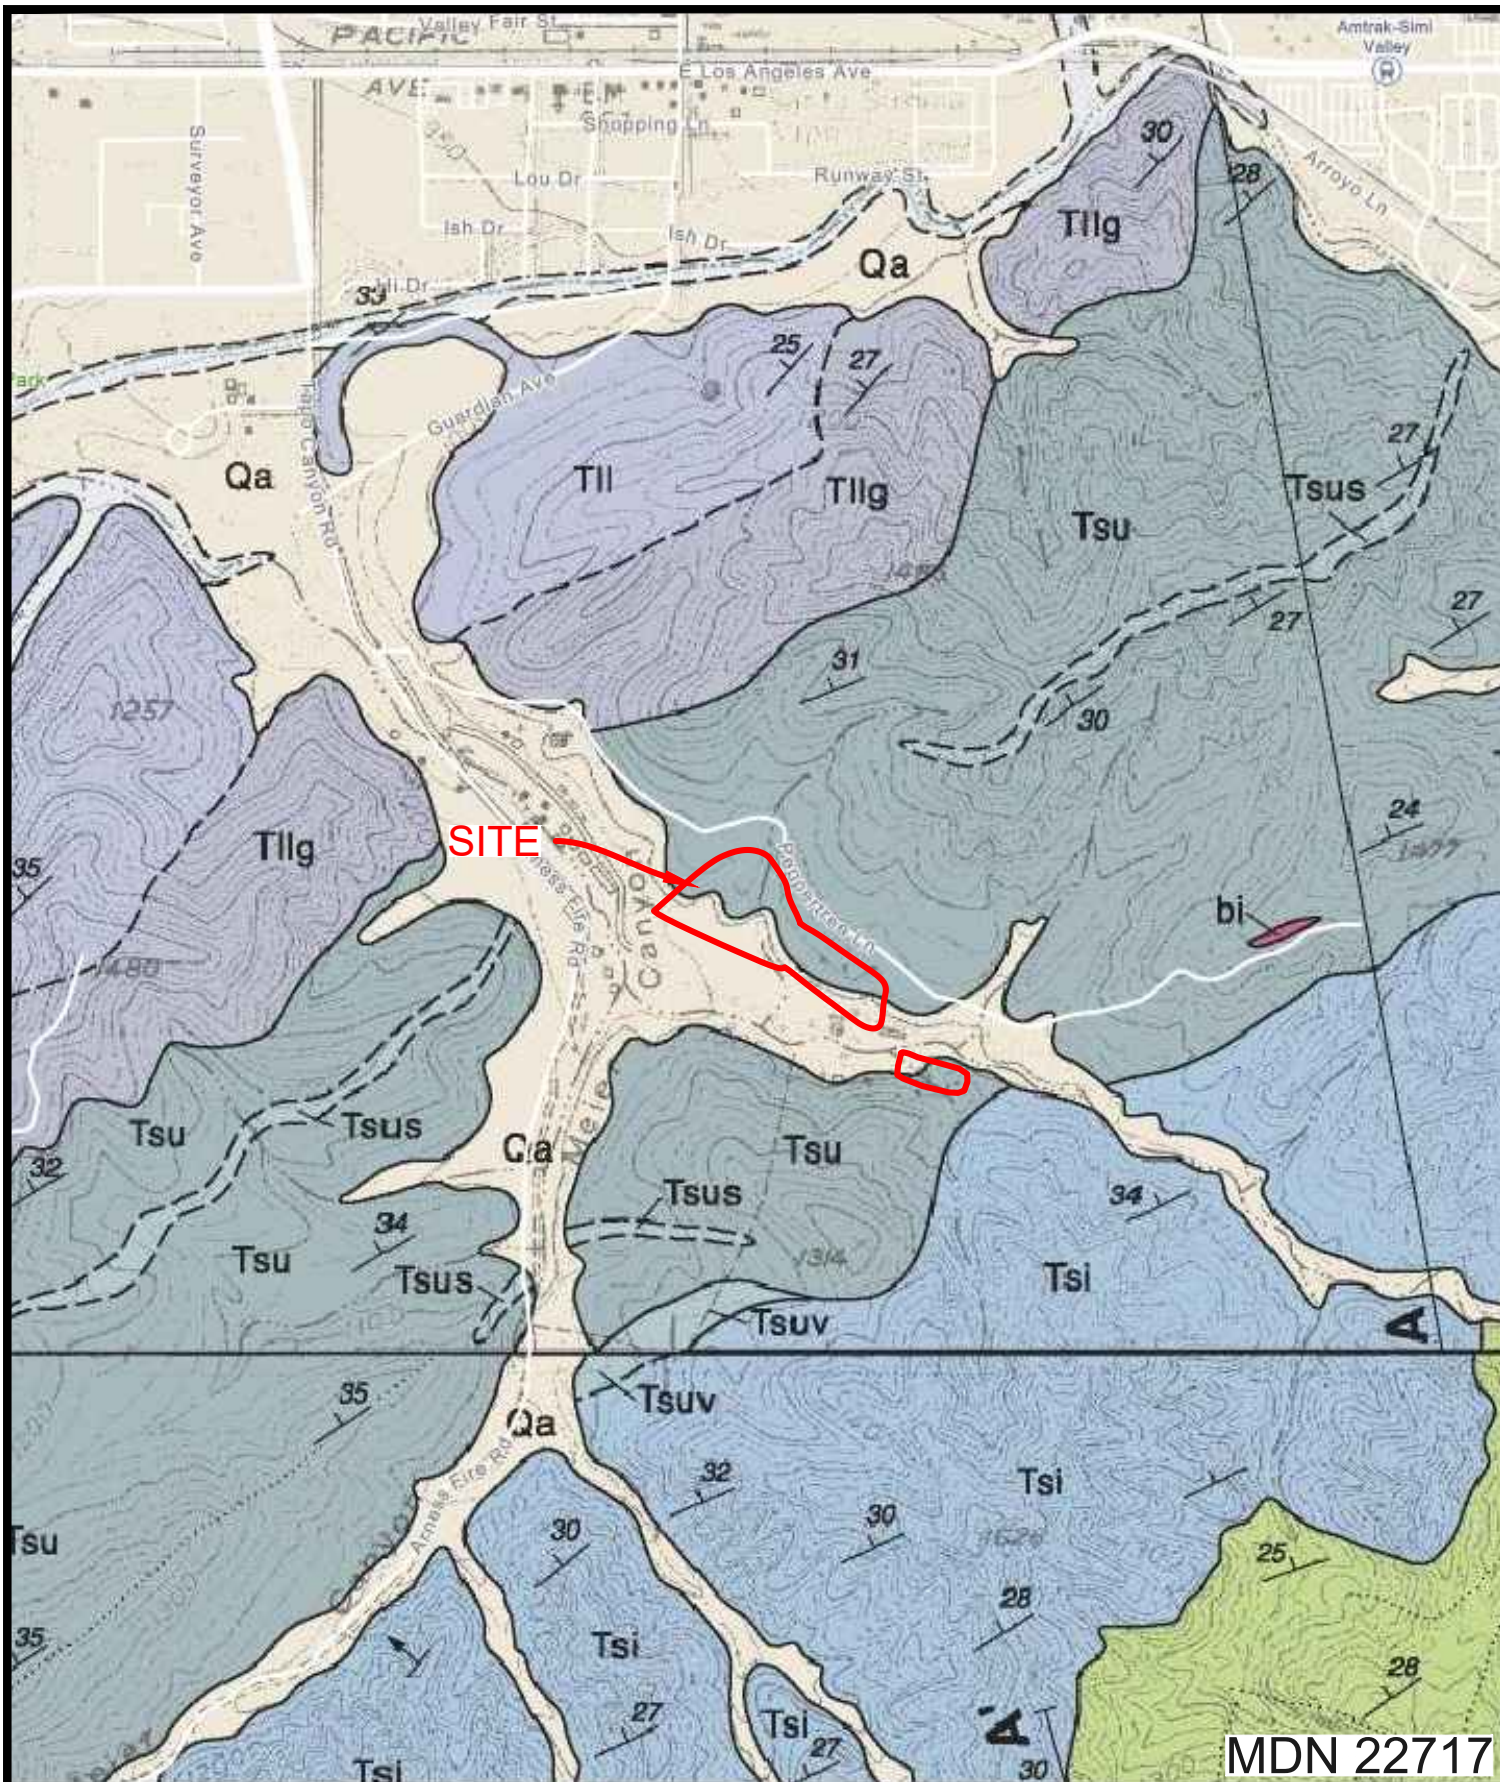
FIGURE 2

The Transverse Ranges are characterized by a very thick, nearly continuous sequence of Upper Cretaceous through Quaternary sedimentary rocks that has been deformed into a series of east-west trending folds associated with thrust and reverse faults. This deformation has created intrabasin highlands and intervening lowlands. The closest active fault to the site is the Simi Fault, located approximately 2.9 miles north of the area of proposed development. A Regional Geologic Map is included as Figure 2.

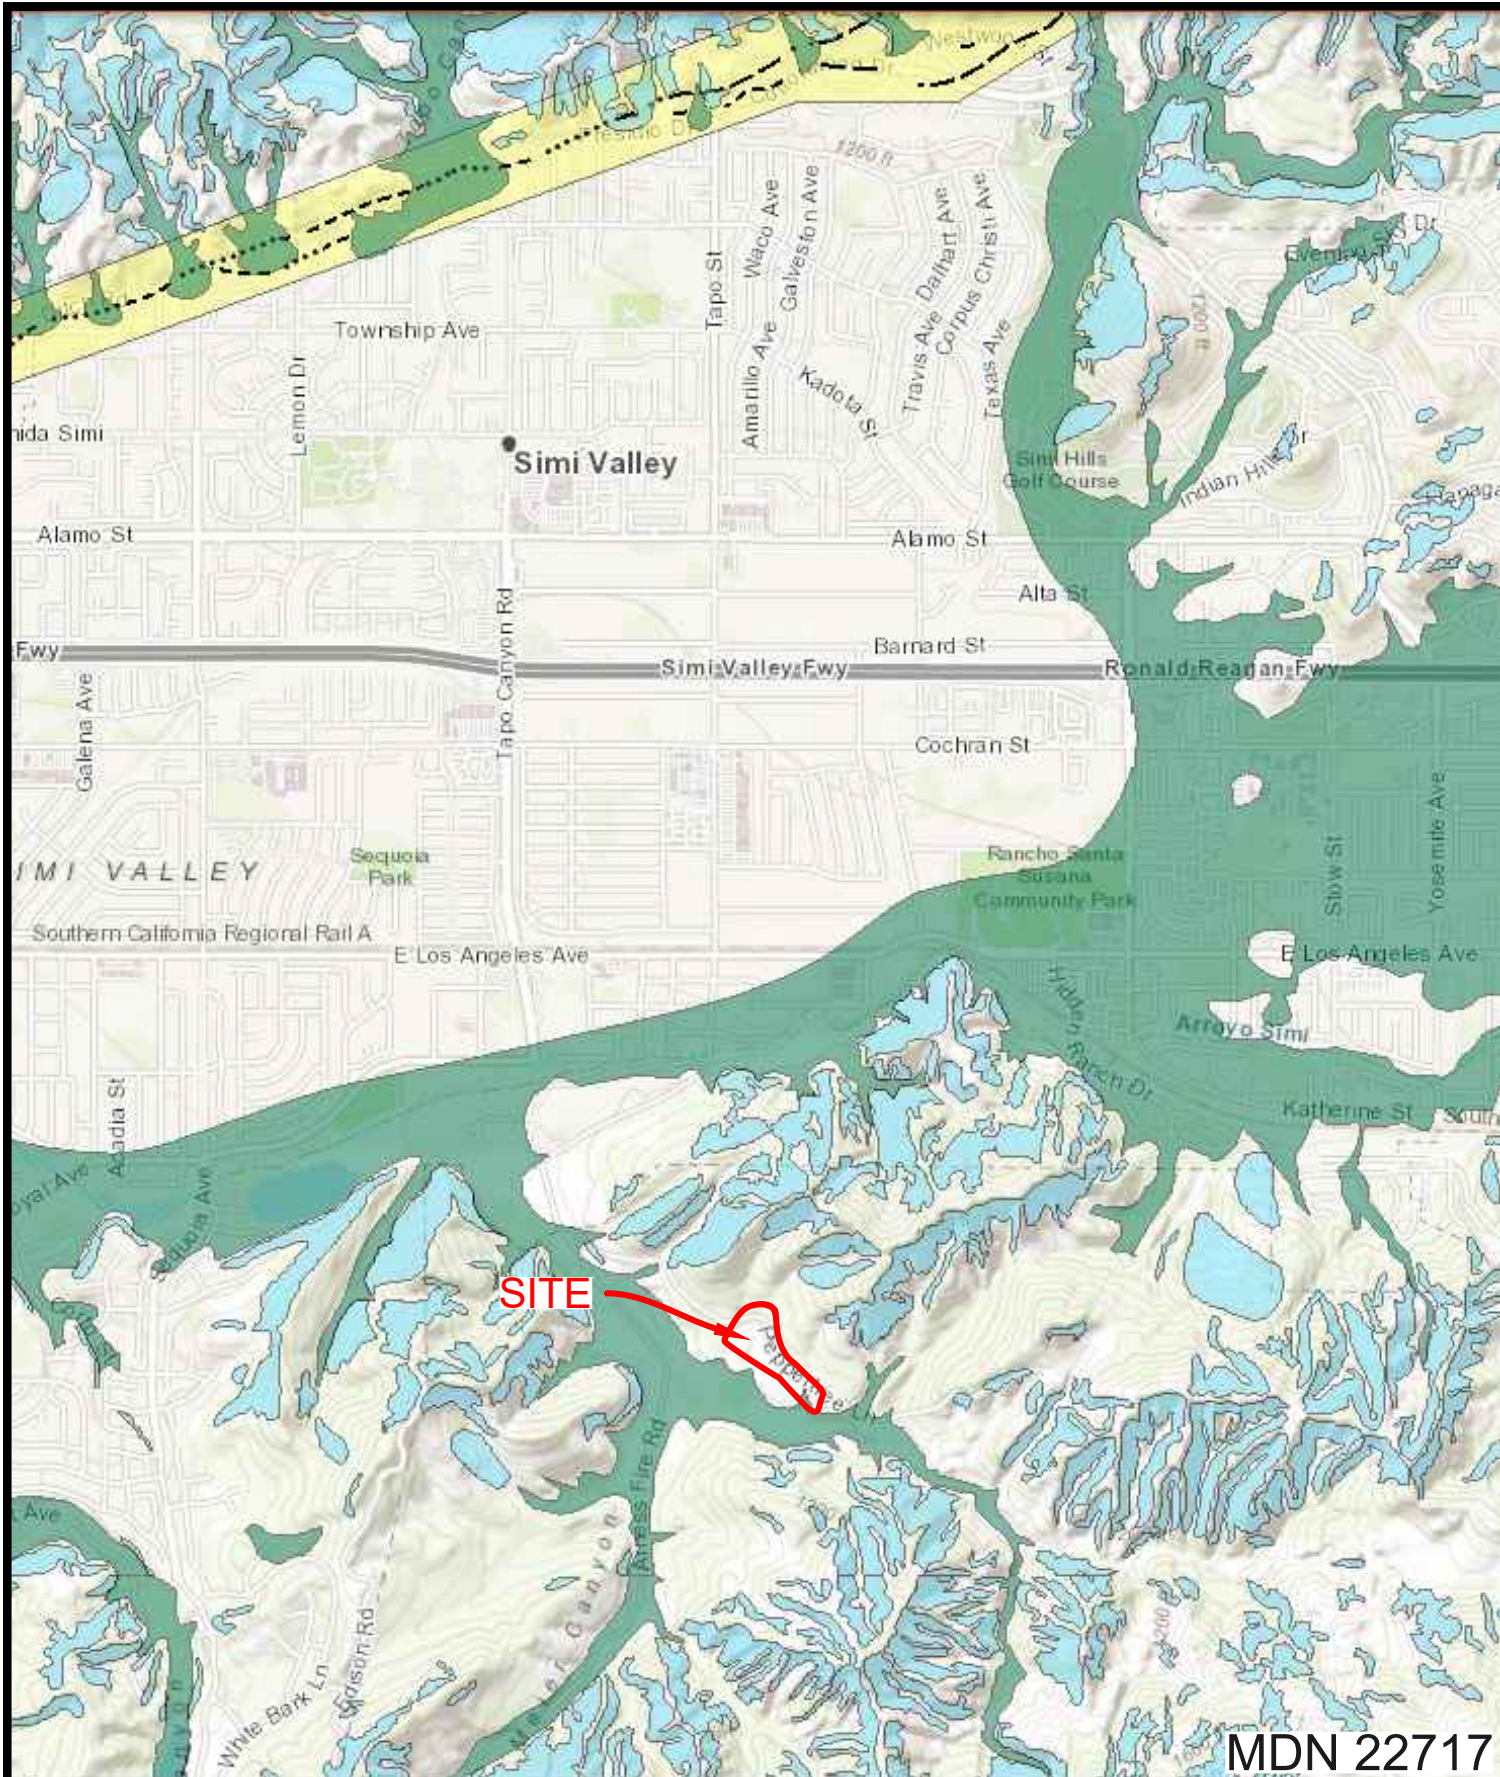
FIGURE 3

The proposed site is not within an Alquist-Priolo Earthquake Fault Zone and is not located within a Seismic Hazard Zone (Figure 3). There are faults in close enough proximity to the site to cause moderate to intense ground shaking during the lifetime of the proposed development.

SEISMIC HAZARD ZONE MAP AMERICAN JEWISH UNIVERSITY

The site is not located within an established Earthquake Fault Zone (Figure 3). The Simi Fault is mapped approximately 2.9 miles to the north of the site. The Simi Fault is a left-oblique reverse fault within the Simi-Santa Rosa fault zone, a series of north-dipping faults

The proposed cabins are located outside the limits of the designated area of liquefaction potential presented on the State of California Seismic Hazard Zone map (Figure 3) and are underlain by terrace deposits. Therefore, liquefaction is not considered a potential hazard for the cabins. The proposed welcome center is located within a zone of potential liquefaction. Previous studies to the north of the proposed welcome center encountered dense older alluvium that was not subject to liquefaction. Similar conditions are anticipated around the welcome center and additional exploration will be performed when access becomes available.

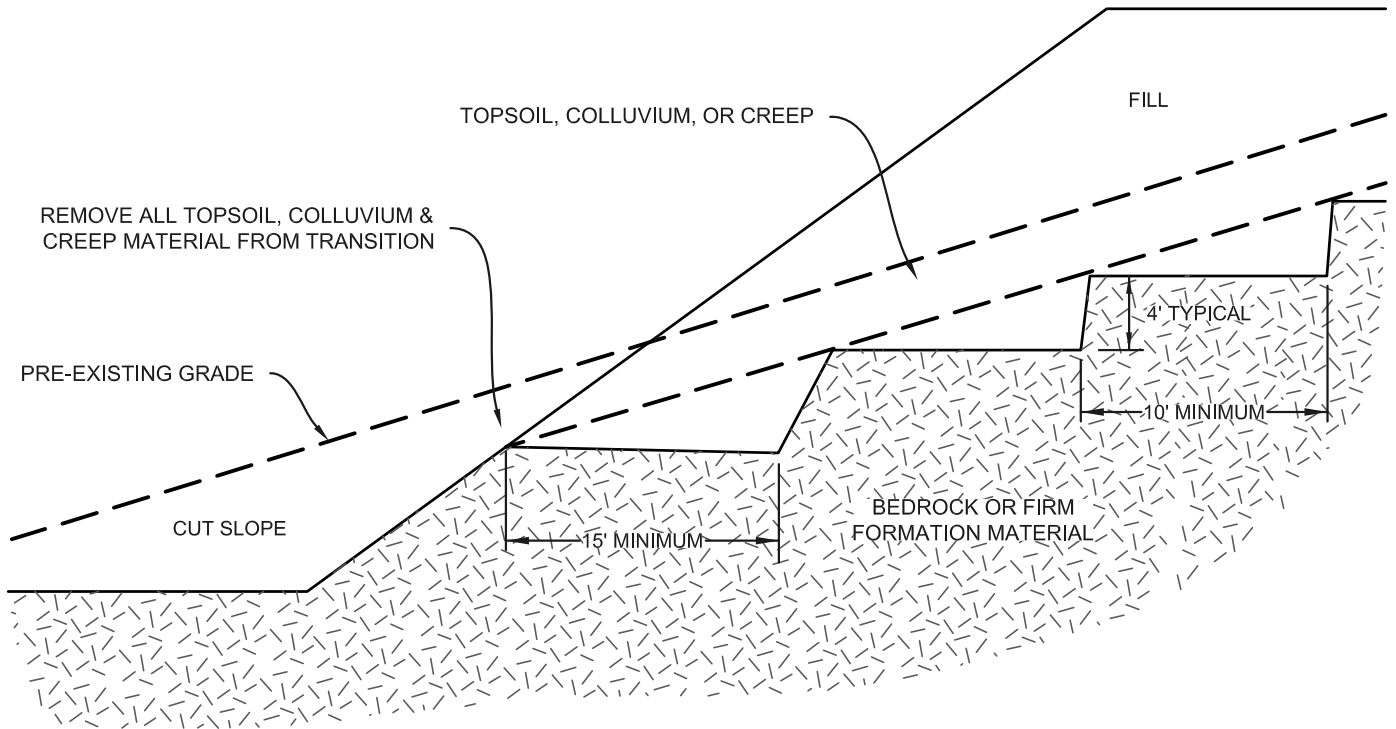
Figure 4

TYPICAL FILL OVER CUT SLOPE DESIGN

Fill over cut slopes should be constructed in accordance with the *Typical Fill Over Cut Slope Design* detail (Figure 4) and fill over natural slopes should be in accordance with the *Typical Fill Over Natural Slope Design* detail (Figure 5). Subdrains may be required at fill over cut or fill over natural conditions and will be evaluated during grading.

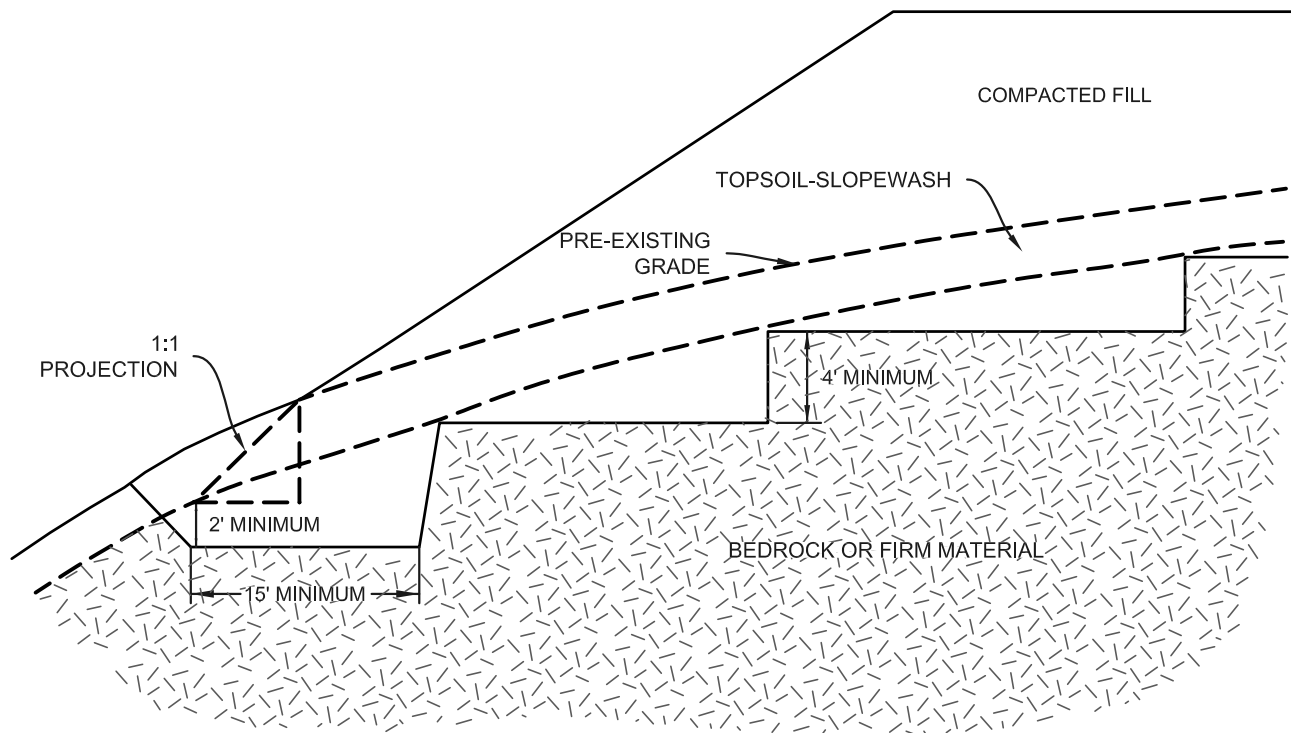
Figure 5

TYPICAL FILL OVER NATURAL SLOPE DESIGN

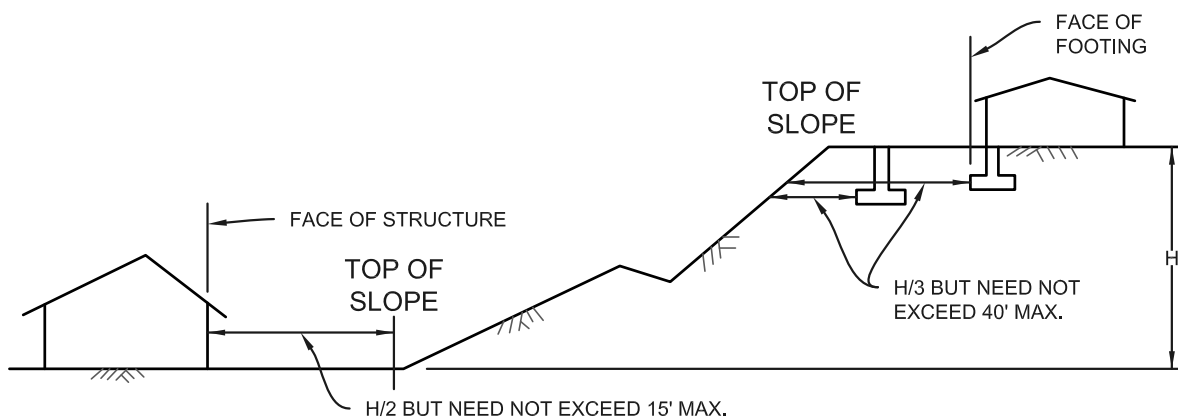
REQUIRED SLOPE SETBACK DESIGN

7. Building or structure footings shall be set back a horizontal distance, x , from the face of adjacent descending slope. The horizontal distance is calculated as $x=H/3$, where H is the height of slope. The distance x should not be less than 5 feet nor more than 40 feet. The distance x may be provided by deepening the footings (Figure 8).

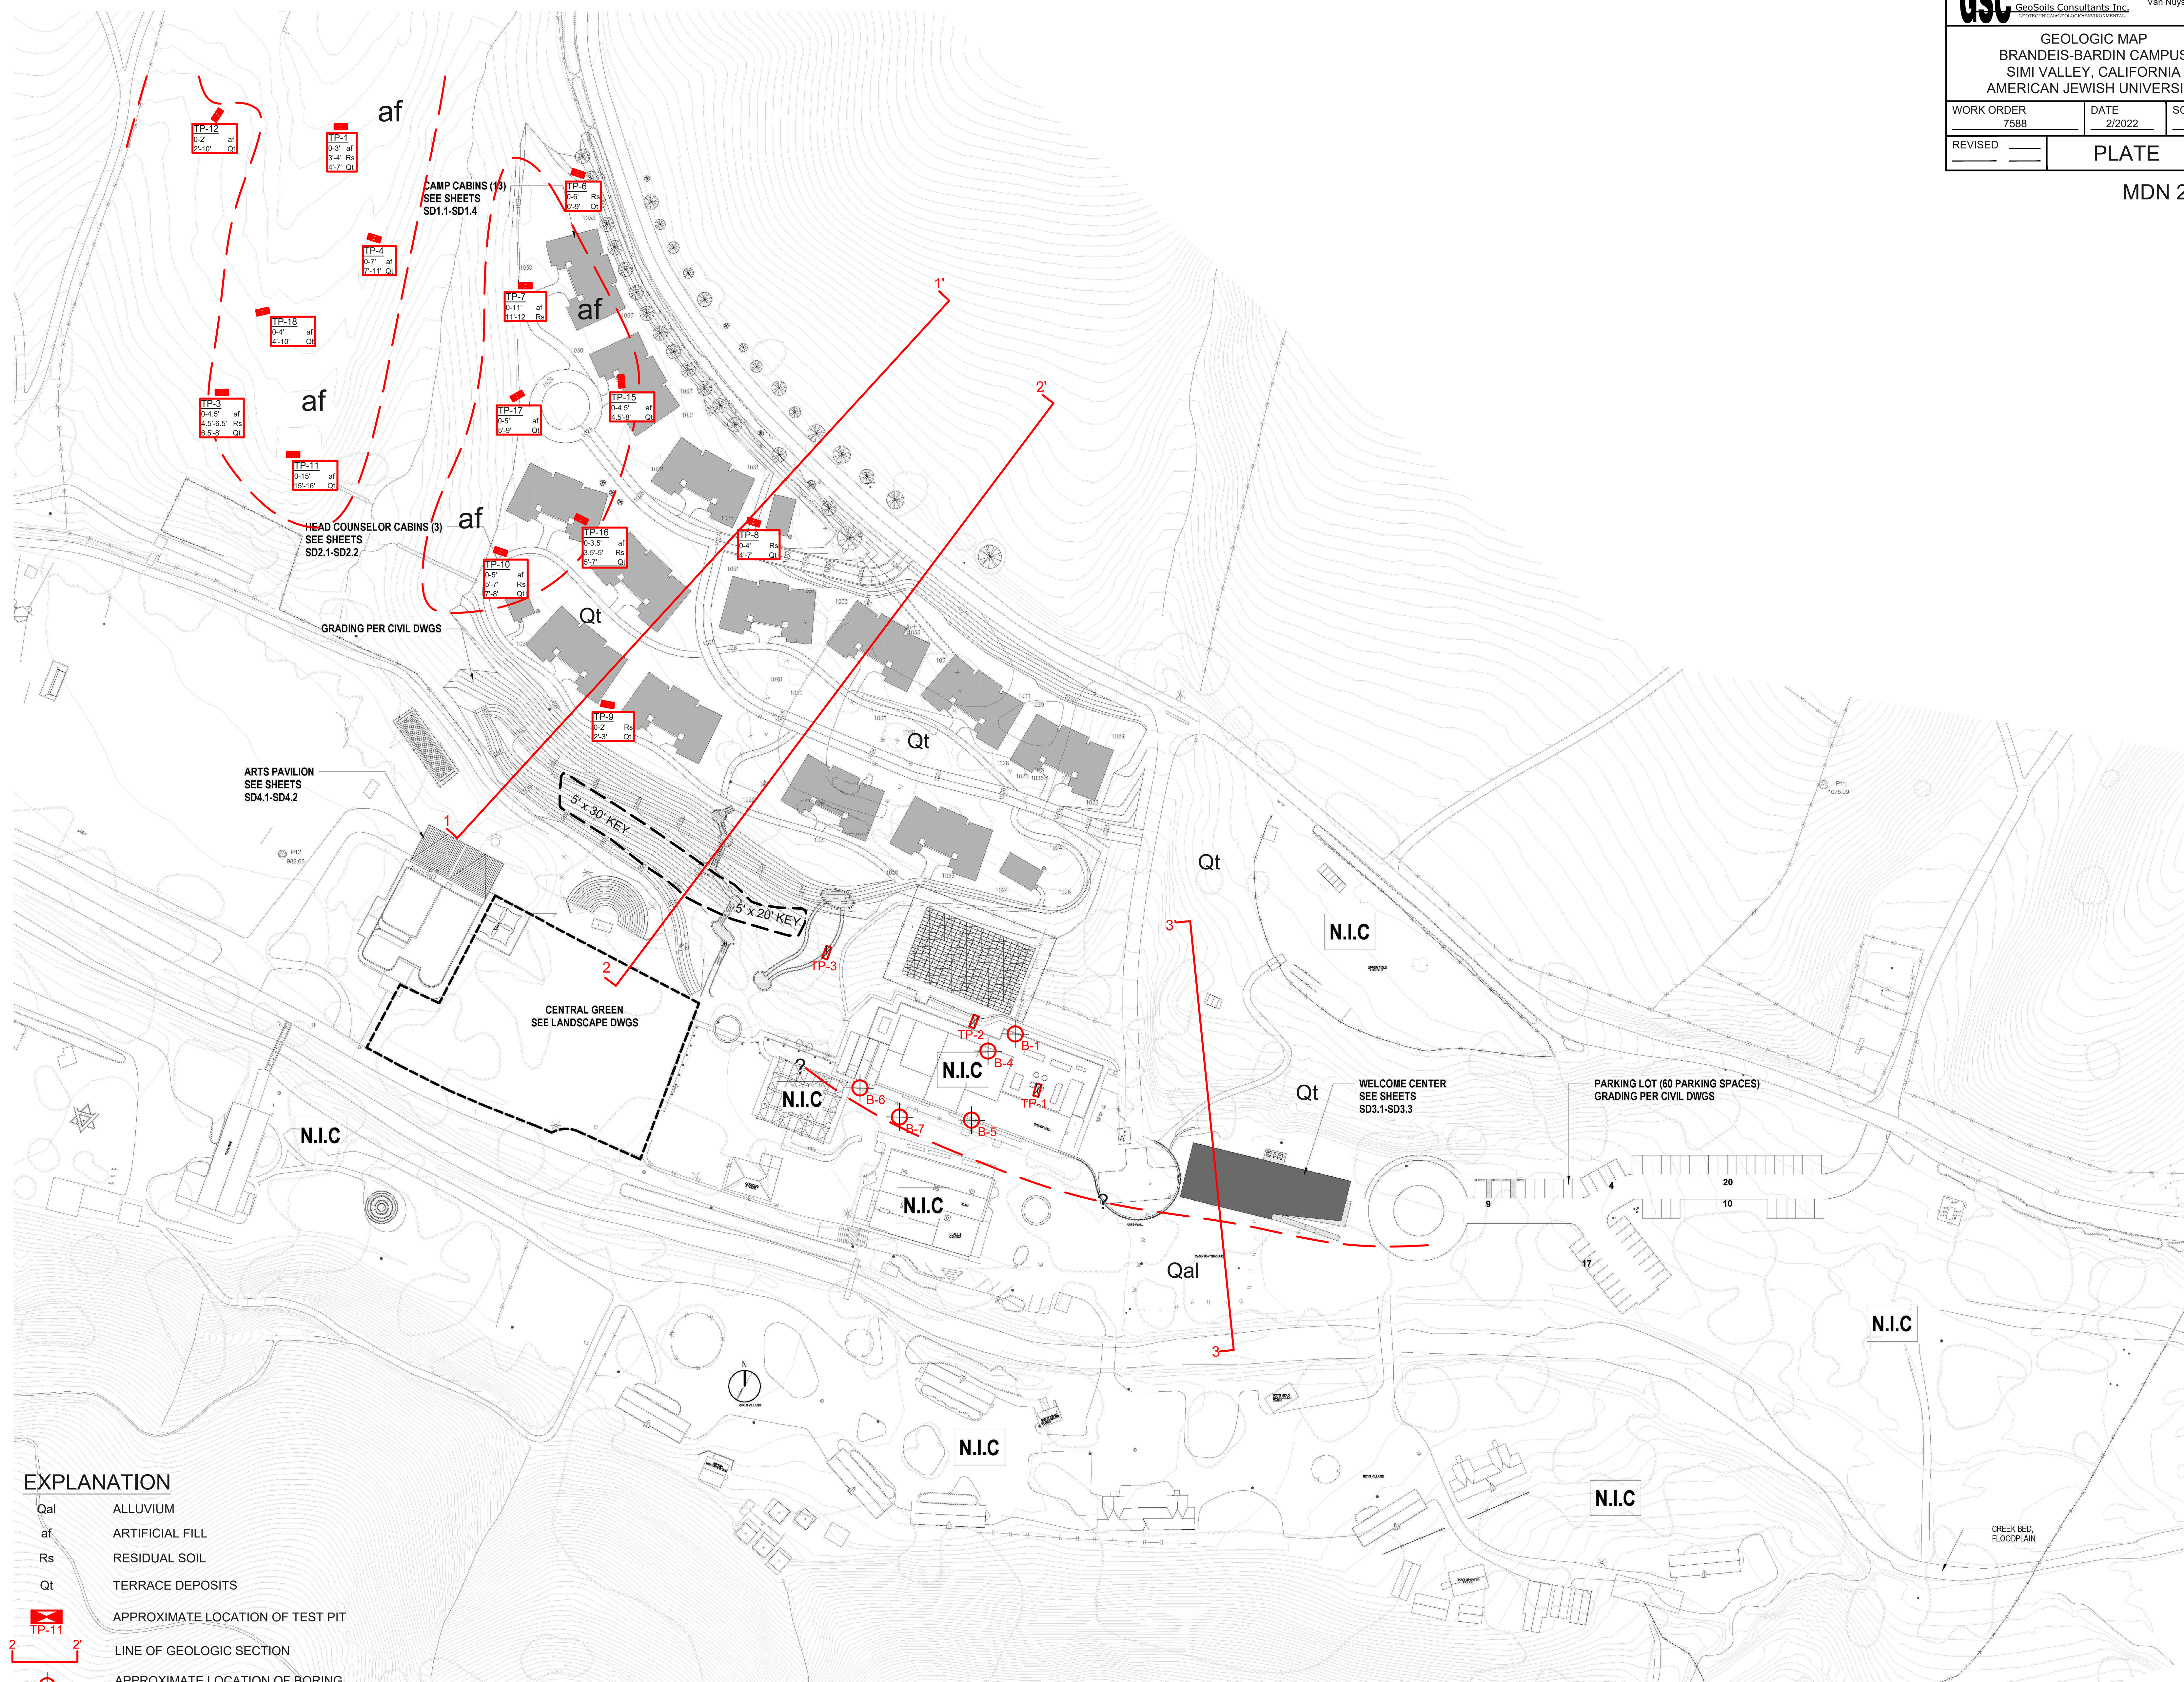
EXPLANATION

Qal	ALLUVIUM
af	ARTIFICIAL FILL
Rs	RESIDUAL SOIL
Qt	TERRACE DEPOSITS

Previous grading was performed on the site and fill was placed on the elevated surfaces at the approximate locations shown on Plate 1. In addition, it appears that the steeper slopes along the western part of the site were cut to create a wider valley floor. The gradient of these slopes is locally steeper than 2:1. The area of the proposed welcome center appears to be located in an area cut out of the original hillside.

1. Site reconnaissance and field mapping.
2. Review of regional geologic maps, seismic hazard zone maps, and previous consultant reports.
3. Excavating, logging, and sampling of 18 backhoe test pits. The approximate locations of the test pits are shown on Plate 1, Geologic Map, and test pit logs are included in Appendix A. Exploration was not performed for the proposed welcome center at this time and will be performed in the future. Please note Test Pits 2, 5, 13, and 14 were located outside the area of planned development and are not shown on Plate 1.
4. Laboratory testing on samples retrieved from the test pits. The results of the testing are presented in Appendix B.
5. Preparation of a Geologic Map, Plate 1, and Cross-Sections, Plate 2.
6. Preparation of this report.

Artificial Fill (af): The artificial fill consisted of yellowish brown, silty, fine to coarse sand with gravel and some cobbles. The fill is loose to medium dense and dry to slightly moist. The fill is up to 11 feet thick in the central part of the site (Plate 1). The artificial fill is uncertified and unsuitable for structural support; therefore, it should be removed and recompacted in areas of proposed grading.

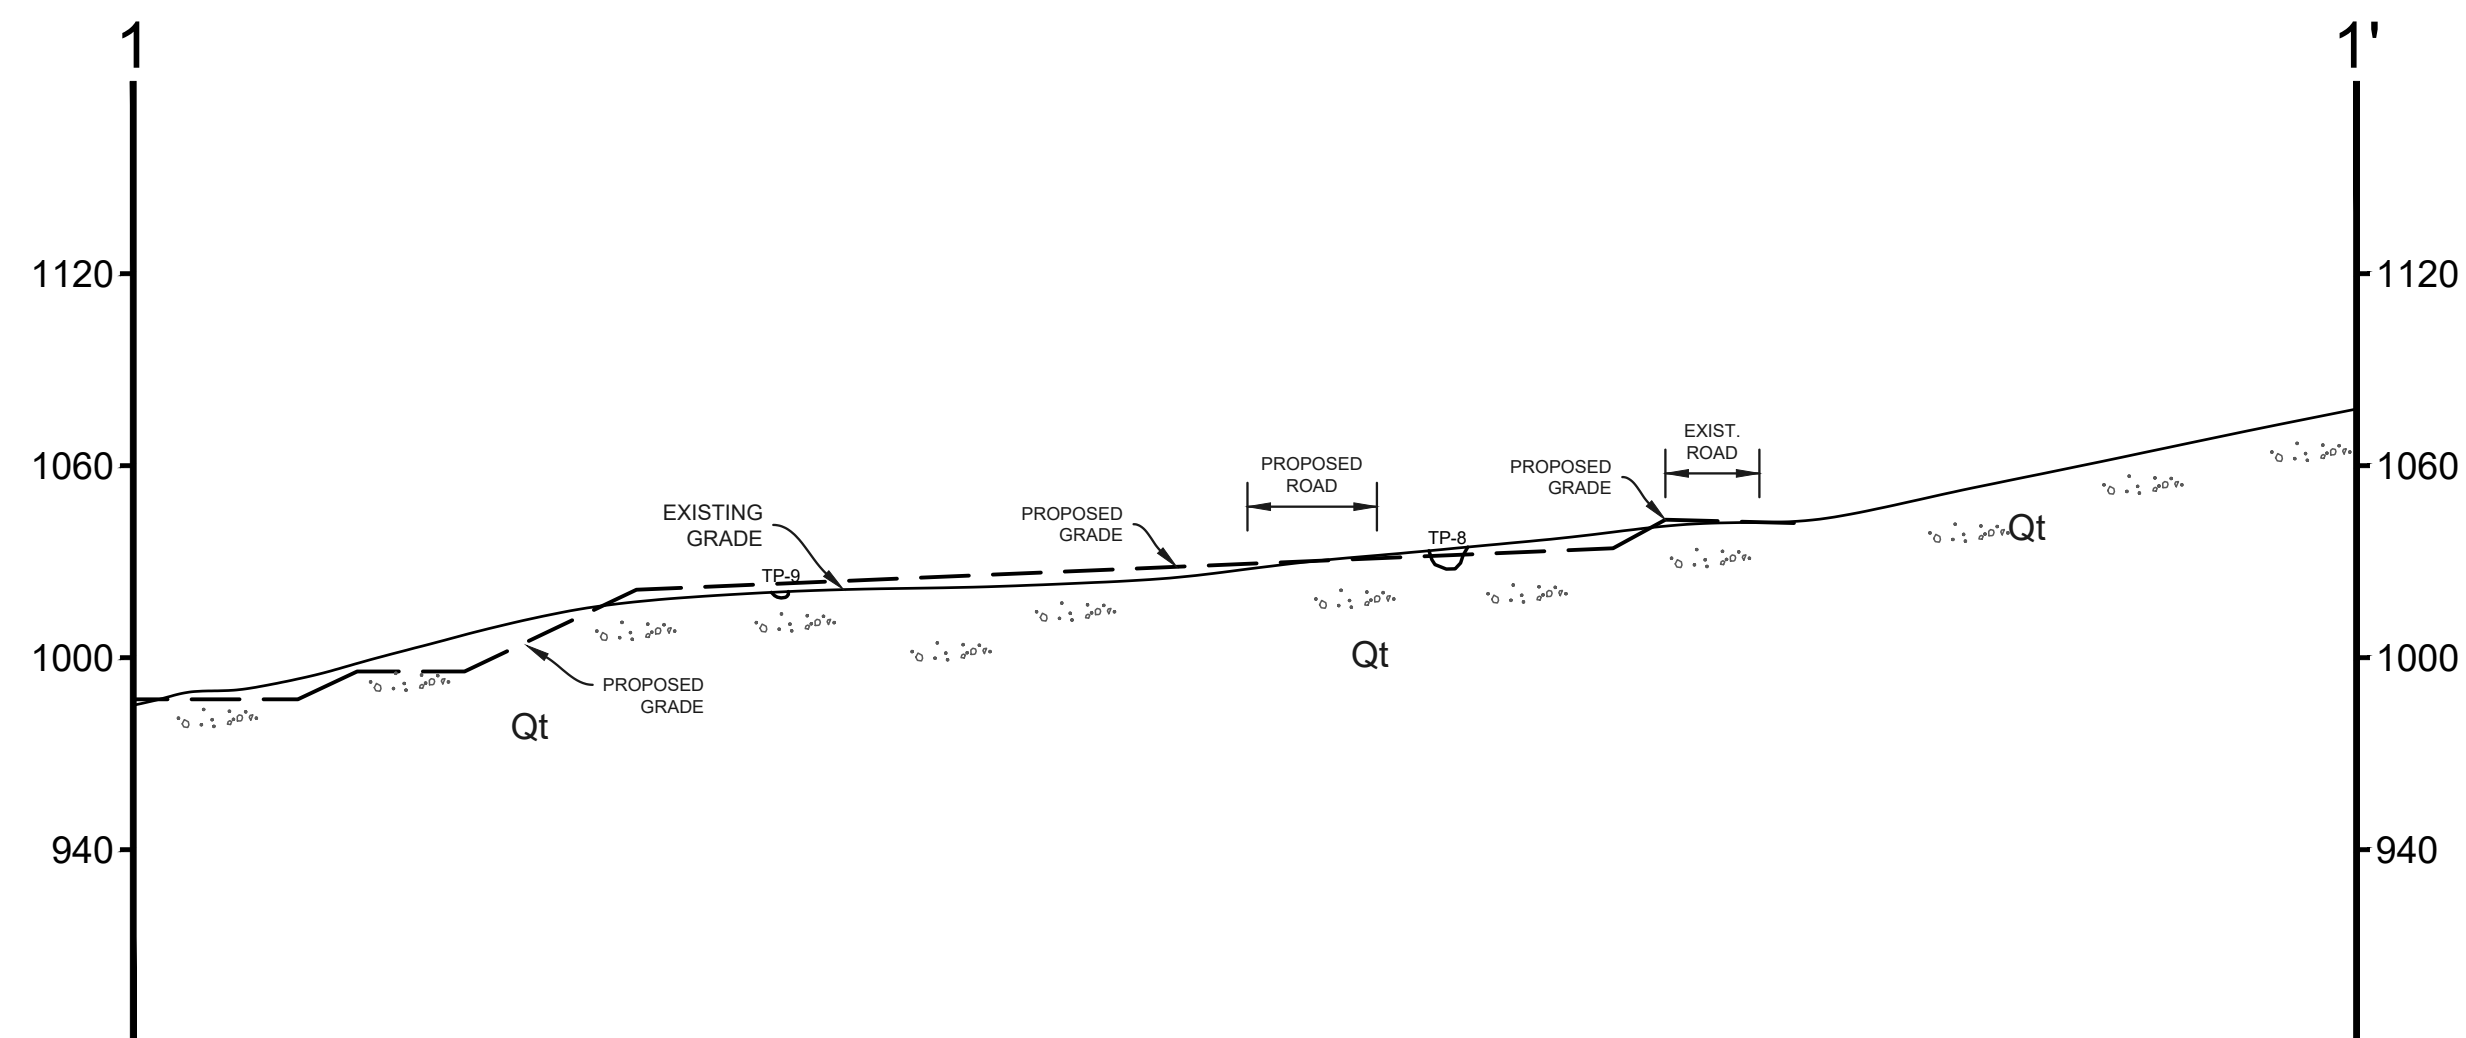
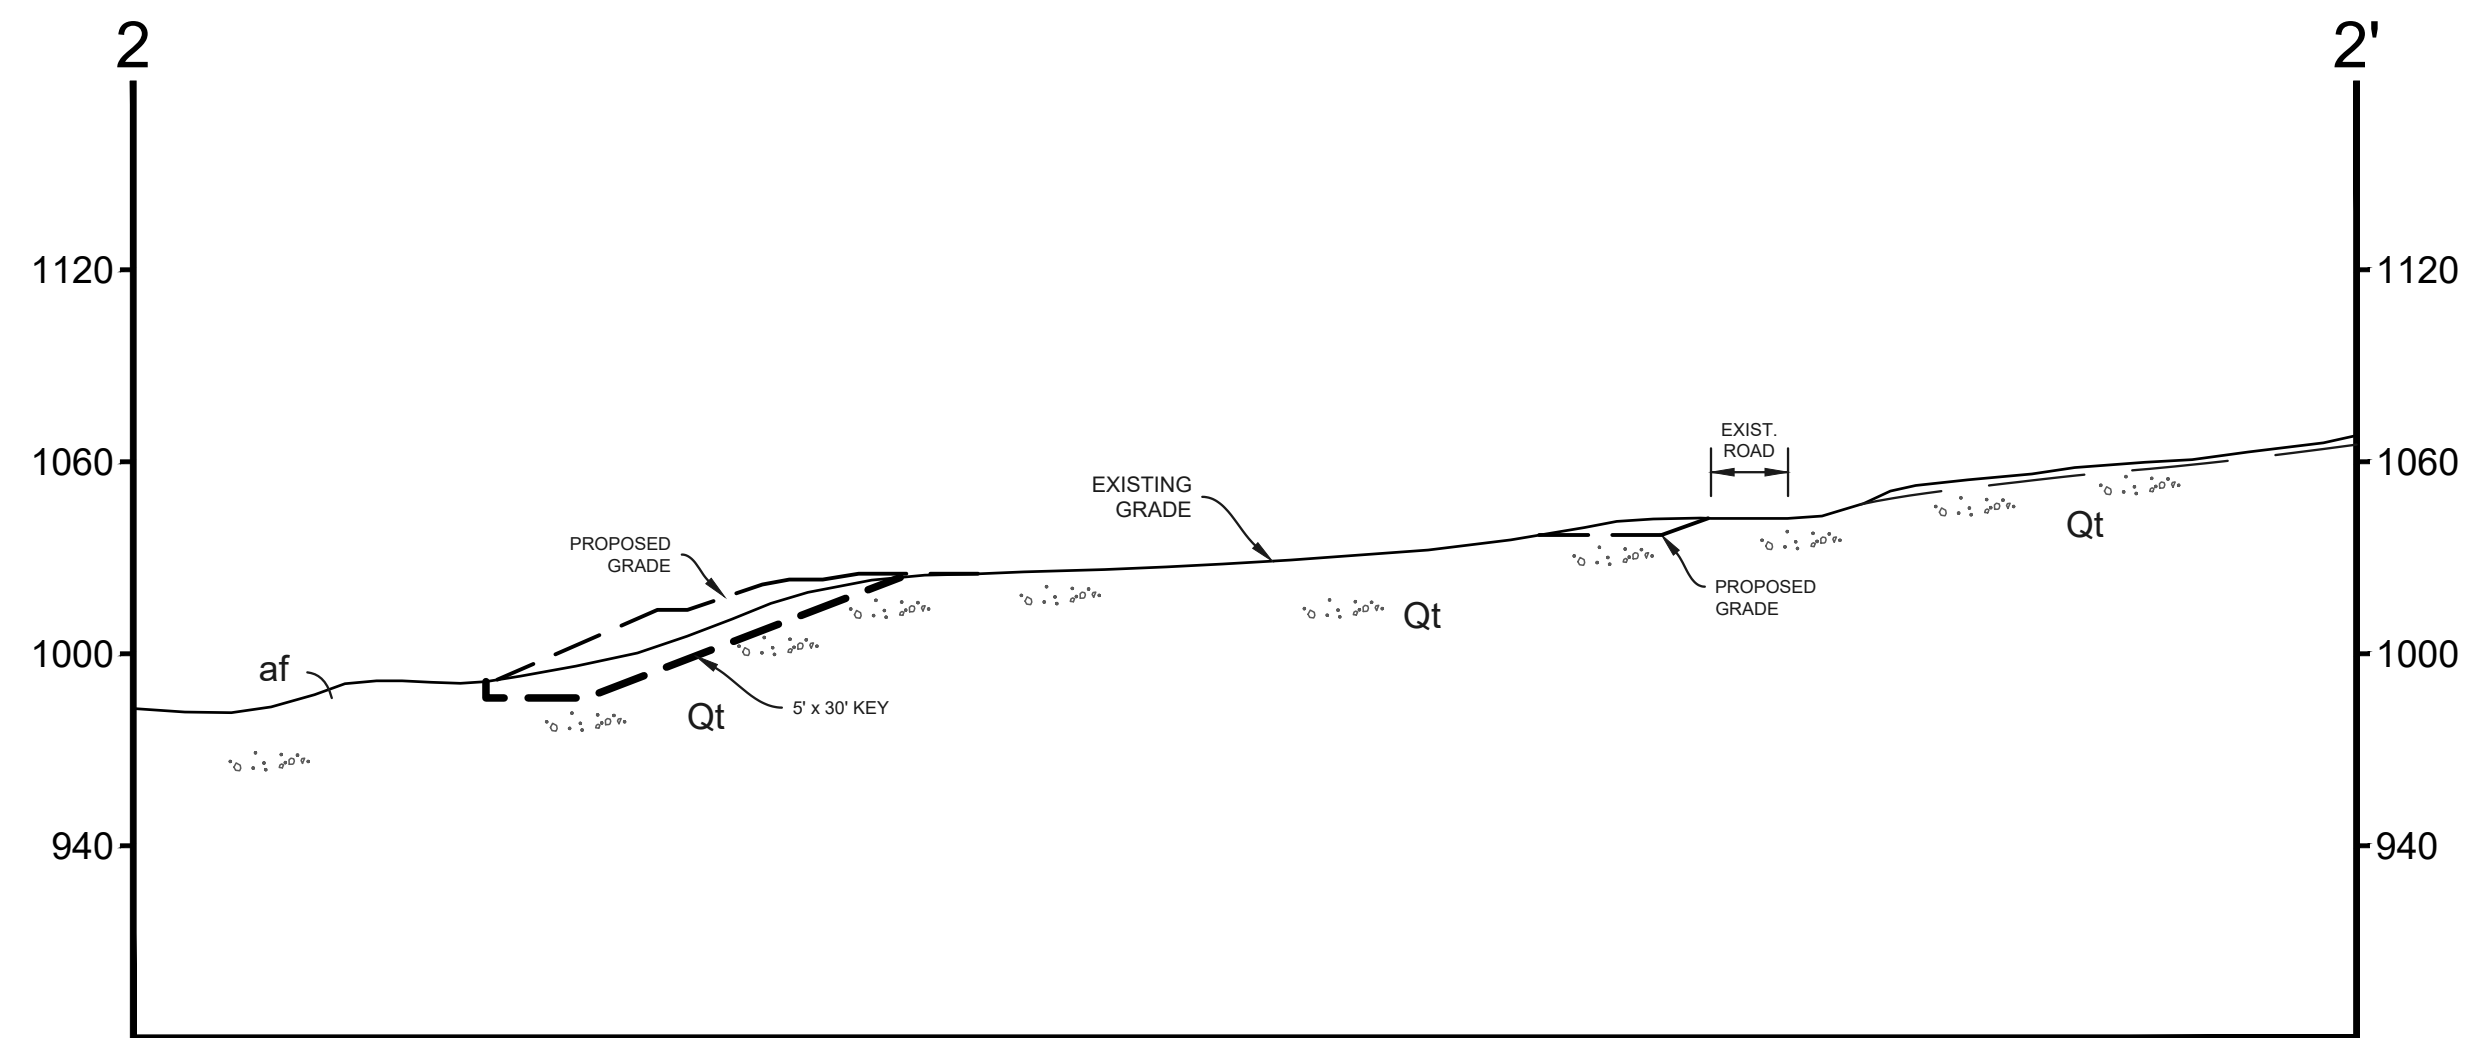
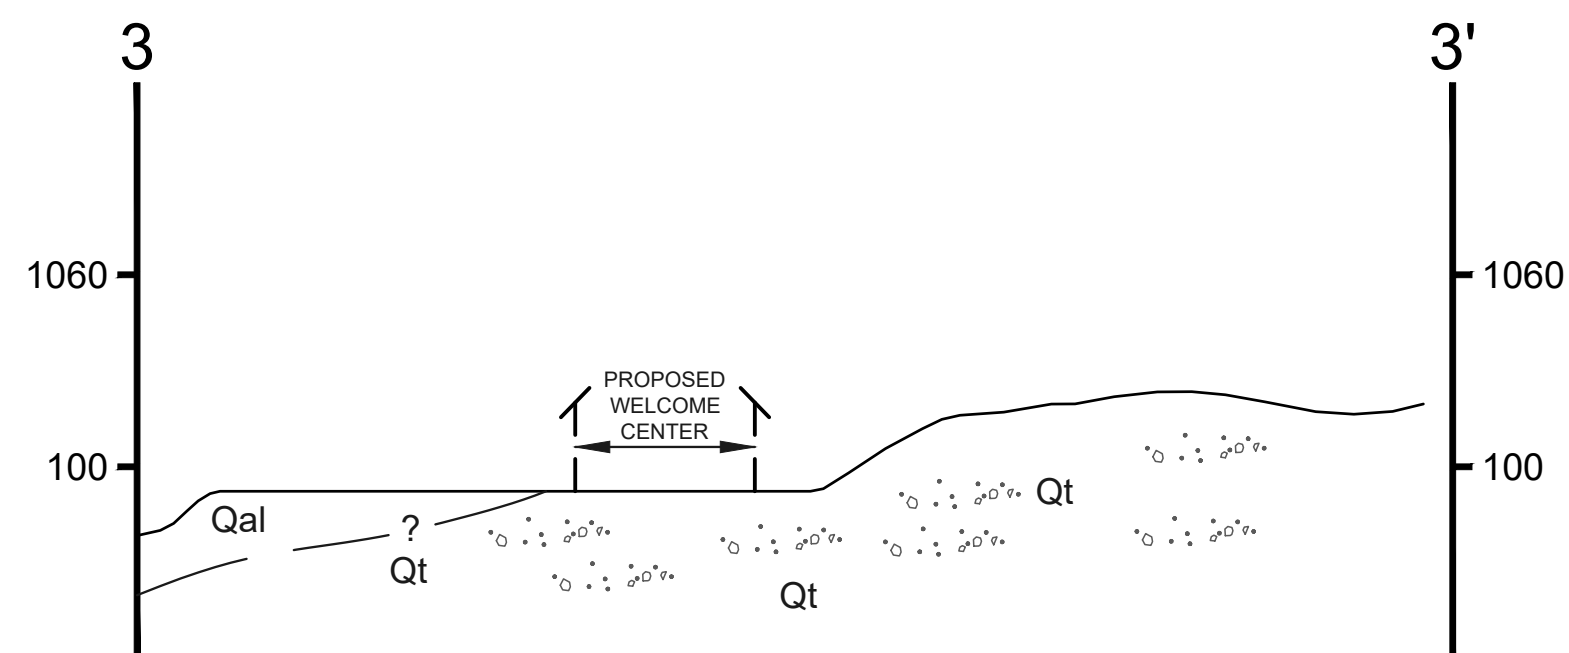
MDN 22717		
GSC GeoSoils Consultants Inc. <small>GEOTECHNICAL • GEOLOGIC • ENVIRONMENTAL</small>		
6634 Valjean Avenue Van Nuys, CA 91406		
GEOLOGIC CROSS-SECTIONS BRANDEIS-BARDIN CAMPUS SIMI VALLEY, CALIFORNIA AMERICAN JEWISH UNIVERSITY		
WORK ORDER 7588	DATE 2/2022	SCALE 1" = 60'
REVISED _____	PLATE 2

The proposed slope below the cabins consists of a combination cut and fill slope, as well as fill or cut slope. To avoid sliver fills on the slope, the eastern part of the slope shall be graded as a stabilization fill slope with a key at the toe as shown on the Geologic Map and Cross-Sections (Plates 1 and 2). The key should be founded in firm terrace deposits. To avoid a fill over cut situation, the entire slope may be replaced as a fill slope.

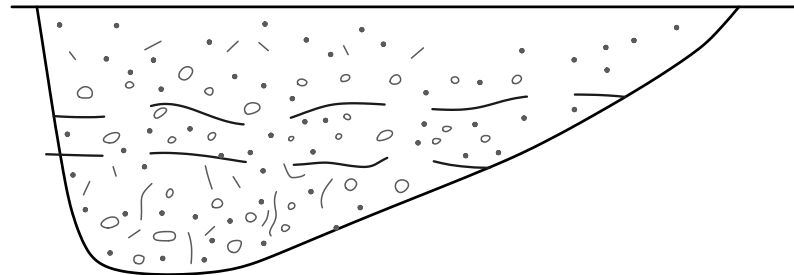
TEST PIT LOG 2

DEPTH	MATERIAL	DESCRIPTION	COMMENTS
0-3'	Artificial Fill (af)	Yellow brown, gravelly, sandy silt, moderately dense to dense, slightly moist, abundant cobble	
3-4'	Residual Soil (Rs)	Brown, gravelly, silty sand, slightly porous, slightly moist, moderately dense	
4-7'	Older Alluvium (Qf)	Yellow brown, gravelly, sandy clay, dense, dry to slightly moist, well indurated, abundant caliche, abundant rounded cobble, slightly porous

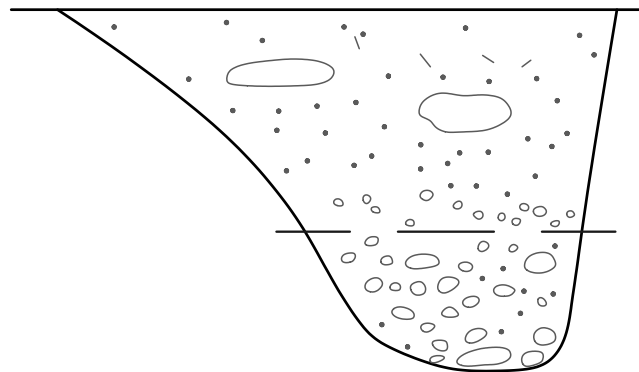
TEST PIT LOG 3

DEPTH	MATERIAL	DESCRIPTION	COMMENTS
0-6'	Artificial Fill (af)	Yellow brown, gravelly, sandy silt to gravelly, silty sand, loose, slightly moist, abundant cobble and trash consisting of debris and large concrete and metal	Logged from the surface due to caving hazard
6-9.5'	Older Alluvium (Qf)	Yellow brown, gravelly, sandy clay, dense, dry to slightly moist, well indurated, abundant caliche, abundant rounded cobble, slightly porous

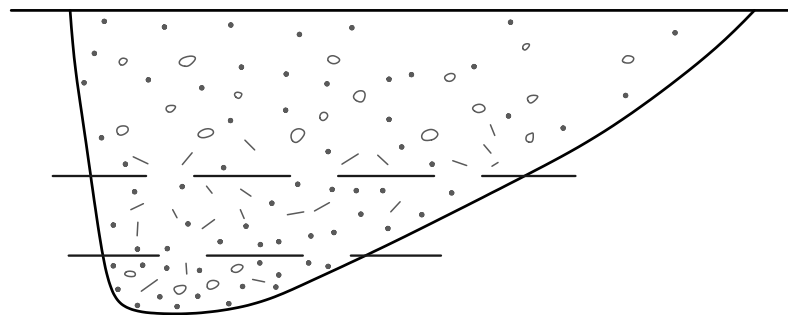
TEST PIT LOG 4

DEPTH	MATERIAL	DESCRIPTION	COMMENTS
0-4.5'	Artificial Fill (af)	Yellow brown, gravelly, sandy silt, moderately dense to dense, slightly moist, abundant cobble	
4.5-6.5'	Residual Soils (Rs)	Reddish brown, sandy clay, slightly moist, very stiff, dense	
6.5-8.0'	Older Alluvium (Qf)	Yellow brown, gravelly, sandy clay, dense, dry to slightly moist, well indurated, abundant caliche, abundant rounded cobble, slightly porous
