**PRELIMINARY GEOLOGIC AND GEOTECHNICAL ENGINEERING
INVESTIGATION, PROPOSED CABINS AND WELCOME CENTER,
BRANDEIS-BARDIN CAMPUS,
Simi Valley, California**

W.O. 7588

**Subject: Preliminary Geologic and Geotechnical Engineering
Investigation, Proposed Cabins and Welcome Center,
Brandeis-Bardin Campus, Simi Valley, California**

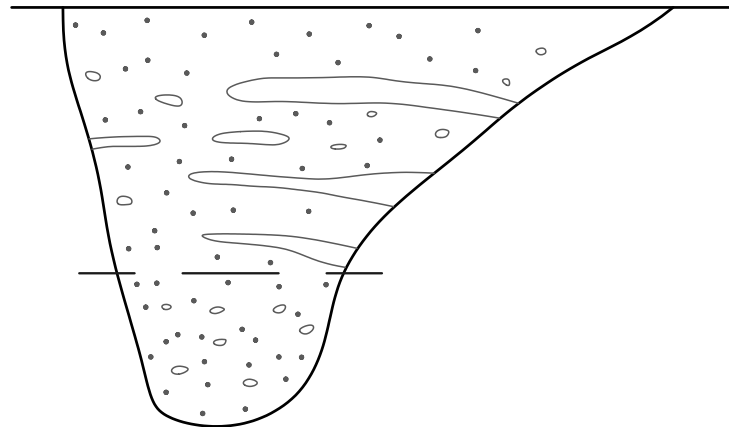
TEST PIT LOG 5

DEPTH	MATERIAL	DESCRIPTION	COMMENTS
0-7'	Artificial Fill (af)	Yellow brown, gravelly, sandy silt, moderately dense to dense, slightly moist, abundant cobble	
7-11'	Older Alluvium (Qt)	Yellow brown, gravelly, sandy clay, dense, dry to slightly moist, well indurated, abundant caliche, abundant rounded cobble, slightly porous

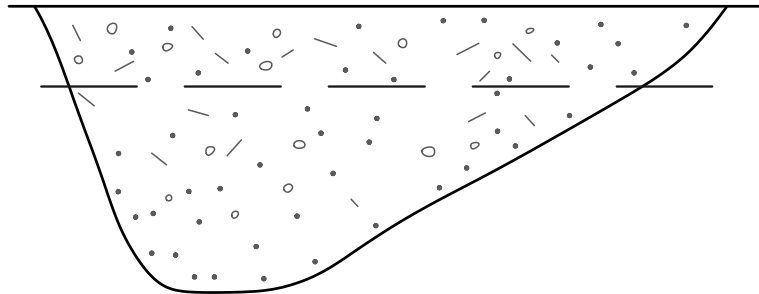
TEST PIT LOG 6

DEPTH	MATERIAL	DESCRIPTION	COMMENTS
0-2'	Artificial Fill (af)	Yellow brown, gravelly, sandy silt, moderately dense to dense, slightly moist, abundant cobble	
2-7.5'	Older Alluvium (Qt)	Yellow brown, gravelly, sandy clay, dense, dry to slightly moist, well indurated, abundant caliche, abundant rounded cobble, slightly porous

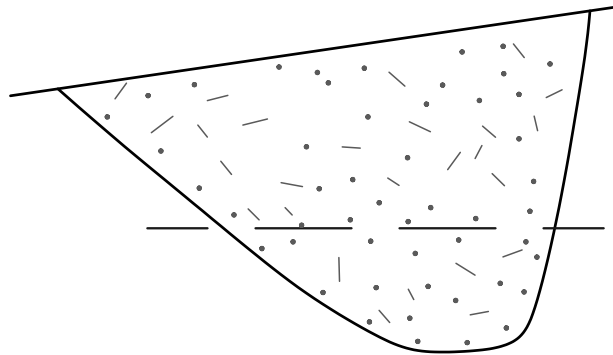
TEST PIT LOG 7

DEPTH	MATERIAL	DESCRIPTION	COMMENTS
0-6'	Residual Soil (Rs)	Brown, sandy clay, dense, very stiff, slightly moist, some caliche present	
6-9'	Older Alluvium (Qt)	Yellowish dark brown, sandy clay, dense, very stiff, slightly moist, caliche stringers present	Color changes in soil from brown to greenish brown at 6'

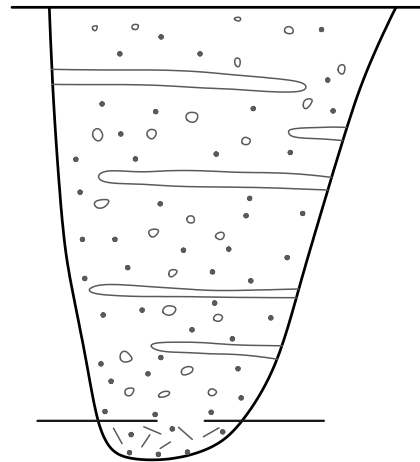
TEST PIT LOG 8

DEPTH	MATERIAL	DESCRIPTION	COMMENTS
0-11'	Artificial Fill (af)	Yellow brown, gravelly, sandy silt, moderately dense to dense, slightly moist, abundant cobble	
11-12'	Residual Soil (Rs)	Brown, sandy clay, dense, very stiff, slightly moist, some caliche present

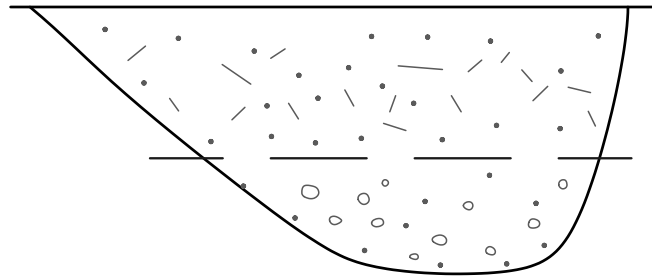
TEST PIT LOG 9

DEPTH	MATERIAL	DESCRIPTION	COMMENTS
0-4'	Residual Soil (Rs)	Brown, sandy clay, dense, very stiff, slightly moist, some caliche present	
4-7'	Older Alluvium (Qt)	Yellow brown, gravelly, sandy clay, dense, dry to slightly moist, well indurated, abundant caliche, abundant rounded cobble, slightly porous

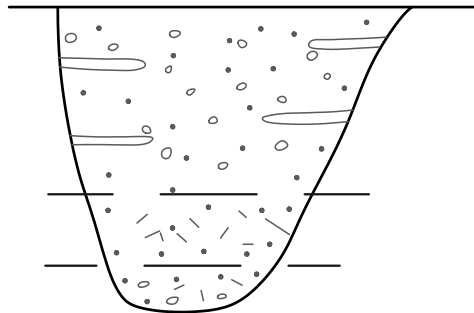
TEST PIT LOG 11

DEPTH	MATERIAL	DESCRIPTION	COMMENTS
0-5'	Artificial Fill (af)	Yellow brown, gravelly, sandy silt, moderately dense to dense, slightly moist, abundant cobble	
5-7'	Residual Soils (Rs)	Brown, sandy clay, dense, very stiff, slightly moist, some caliche present	
7-8'	Older Alluvium (Qf)	Yellow brown, gravelly, sandy clay, dense, dry to slightly moist, well indurated, abundant caliche, abundant rounded cobble, slightly porous

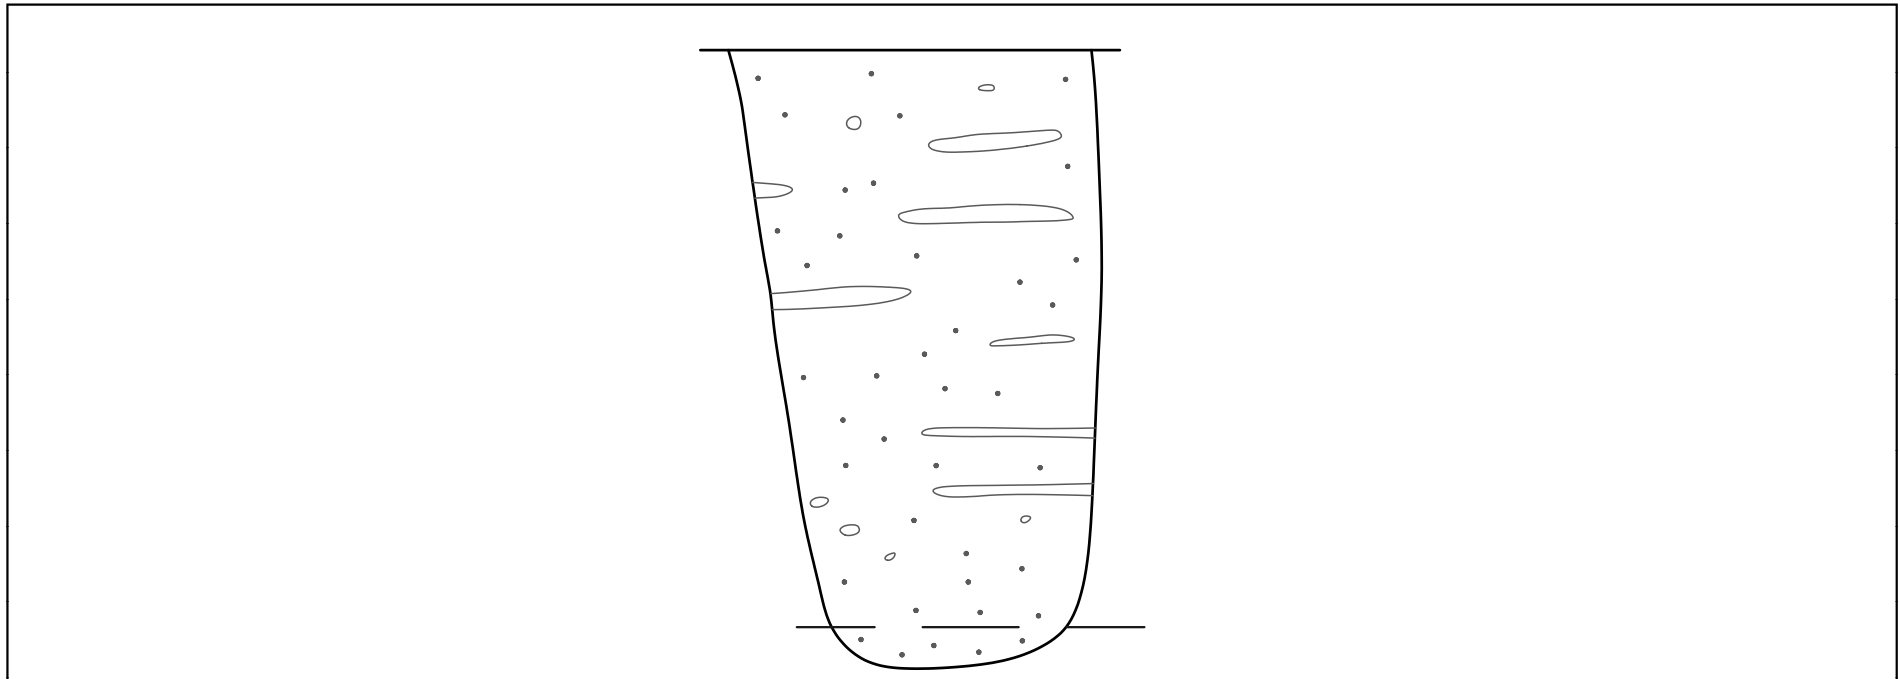
TEST PIT LOG 1

DEPTH	MATERIAL	DESCRIPTION	COMMENTS
0-15'	Artificial Fill (af)	Yellow brown, gravelly, sandy silt, moderately dense to dense, slightly moist, abundant cobble	
15-16'	Older Alluvium (Qt)	Yellow brown, gravelly, sandy clay, dense, dry to slightly moist, well indurated, abundant caliche, abundant rounded cobble, slightly porous

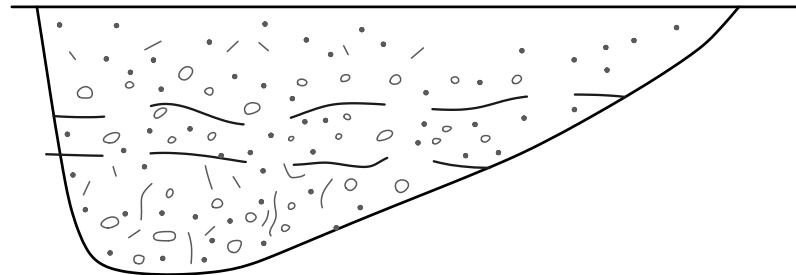
TEST PIT LOG 2

DEPTH	MATERIAL	DESCRIPTION	COMMENTS
0-3'	Artificial Fill (af)	Yellow brown, gravelly, sandy silt, moderately dense to dense, slightly moist, abundant cobble	
3-4'	Residual Soil (Rs)	Brown, gravelly, silty sand, slightly porous, slightly moist, moderately dense	
4-7'	Older Alluvium (Qf)	Yellow brown, gravelly, sandy clay, dense, dry to slightly moist, well indurated, abundant caliche, abundant rounded cobble, slightly porous

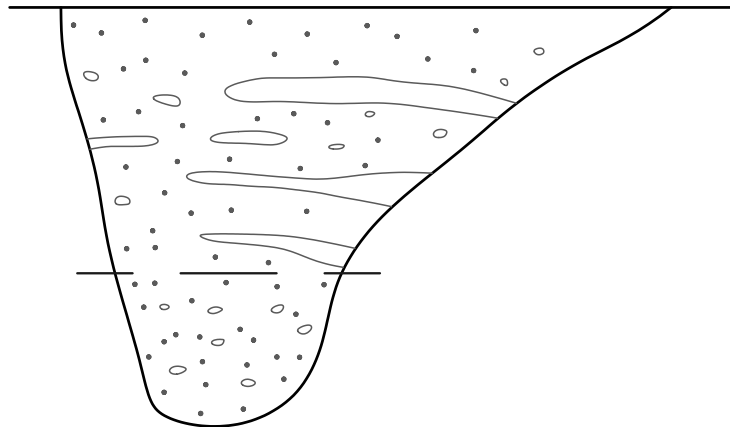
TEST PIT LOG 5

DEPTH	MATERIAL	DESCRIPTION	COMMENTS
0-7'	Artificial Fill (af)	Yellow brown, gravelly, sandy silt, moderately dense to dense, slightly moist, abundant cobble	
7-11'	Older Alluvium (Qt)	Yellow brown, gravelly, sandy clay, dense, dry to slightly moist, well indurated, abundant caliche, abundant rounded cobble, slightly porous

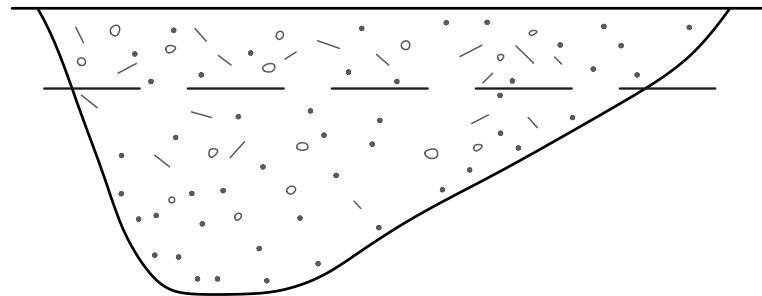
TEST PIT LOG 6

DEPTH	MATERIAL	DESCRIPTION	COMMENTS
0-2'	Artificial Fill (af)	Yellow brown, gravelly, sandy silt, moderately dense to dense, slightly moist, abundant cobble	
2-7.5'	Older Alluvium (Qt)	Yellow brown, gravelly, sandy clay, dense, dry to slightly moist, well indurated, abundant caliche, abundant rounded cobble, slightly porous

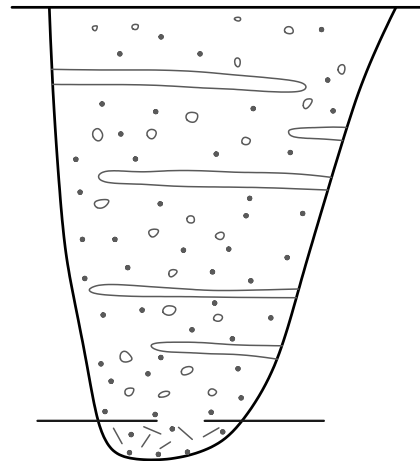
TEST PIT LOG 8

DEPTH	MATERIAL	DESCRIPTION	COMMENTS
0-11'	Artificial Fill (af)	Yellow brown, gravelly, sandy silt, moderately dense to dense, slightly moist, abundant cobble	
11-12'	Residual Soil (Rs)	Brown, sandy clay, dense, very stiff, slightly moist, some caliche present

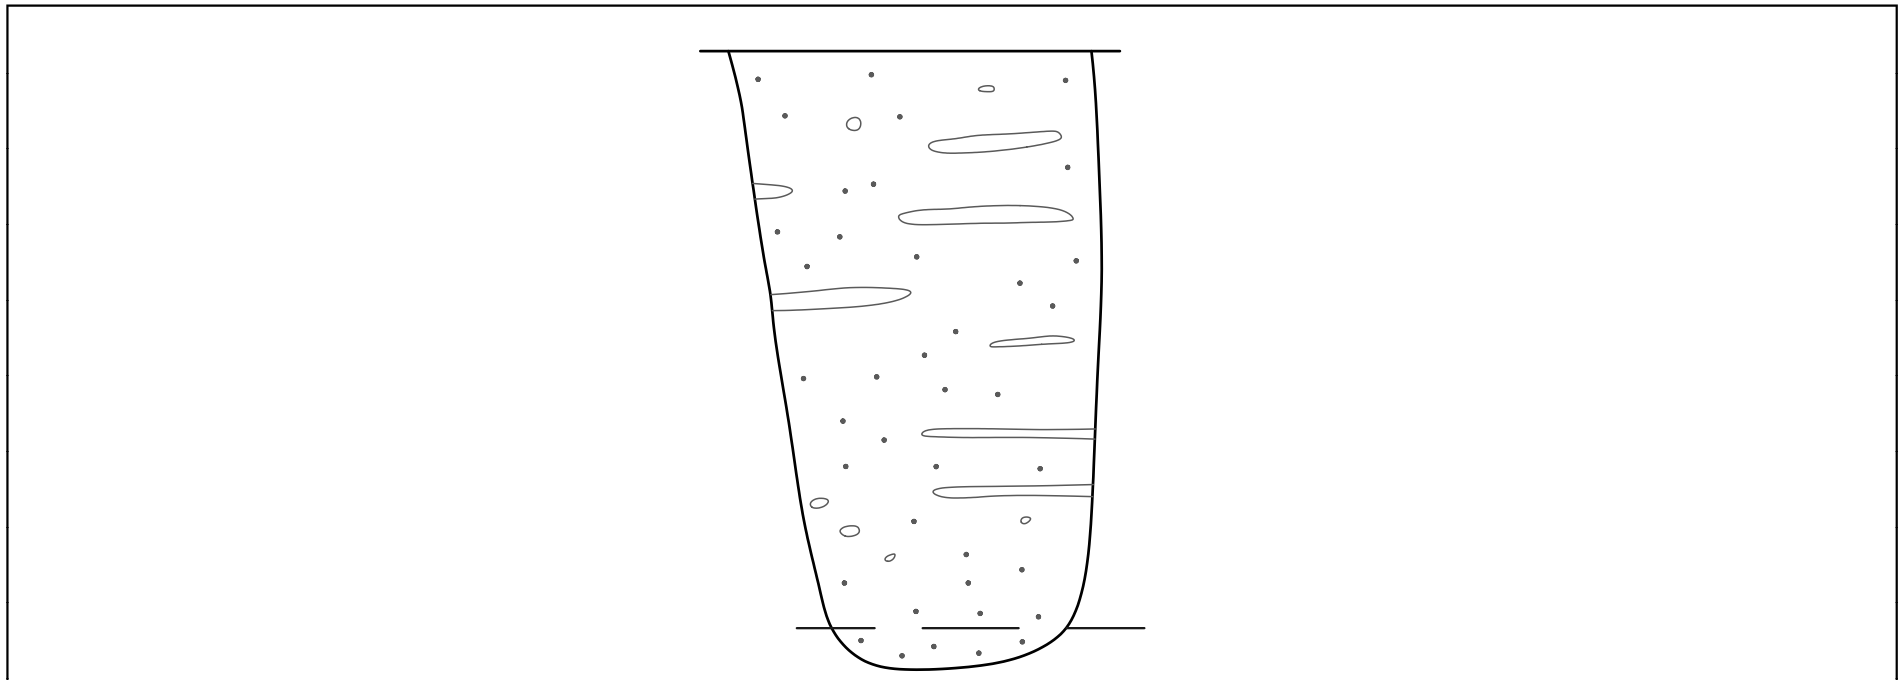
TEST PIT LOG 12

DEPTH	MATERIAL	DESCRIPTION	COMMENTS
0-15'	Artificial Fill (af)	Yellow brown, gravelly, sandy silt, moderately dense to dense, slightly moist, abundant cobble	
15-16'	Older Alluvium (Qt)	Yellow brown, gravelly, sandy clay, dense, dry to slightly moist, well indurated, abundant caliche, abundant rounded cobble, slightly porous

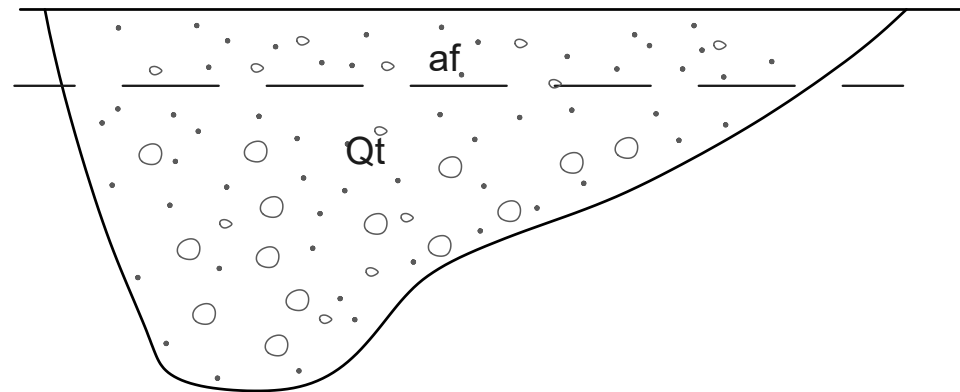
TEST PIT LOG 13

DEPTH	MATERIAL	DESCRIPTION	COMMENTS
0-2'	Artificial Fill (af)	Yellow brown, gravelly, sandy silt, moderately dense to dense, slightly moist, abundant cobble	
2-10'	Older Alluvium (Qt)	Yellow brown, gravelly, sandy clay, dense, dry to slightly moist, well indurated, abundant caliche, abundant rounded cobble, slightly porous

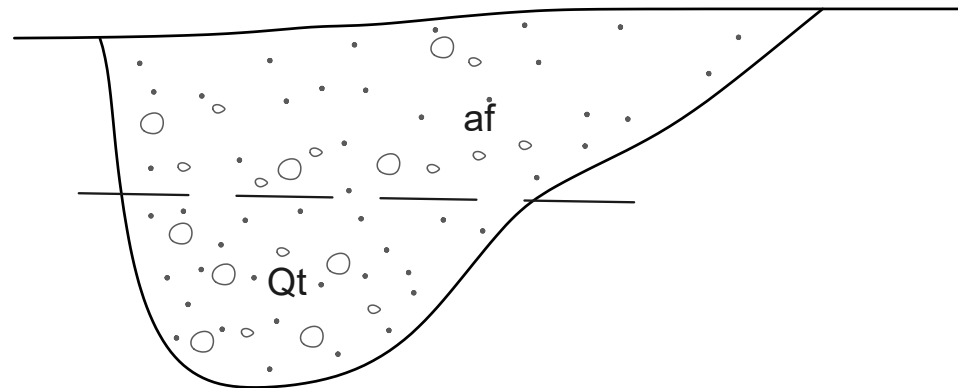
TEST PIT LOG 14

DEPTH	MATERIAL	DESCRIPTION	COMMENTS
0-4'	Artificial Fill (af)	Yellow brown, gravelly, sandy silt, moderately dense to dense, slightly moist, abundant cobble	
4-9'	Older Alluvium (Qt)	Yellow brown, gravelly, sandy clay, dense, dry to slightly moist, well indurated, abundant caliche, abundant rounded cobble, slightly porous

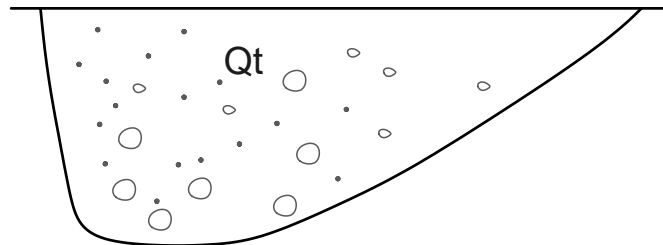
TEST PIT LOG 15

DEPTH	MATERIAL	DESCRIPTION	COMMENTS
0-6'	Older Alluvium (Qt)	Yellow brown, gravelly, sandy clay, dense, dry to slightly moist, well indurated, abundant caliche, abundant rounded cobble, slightly porous

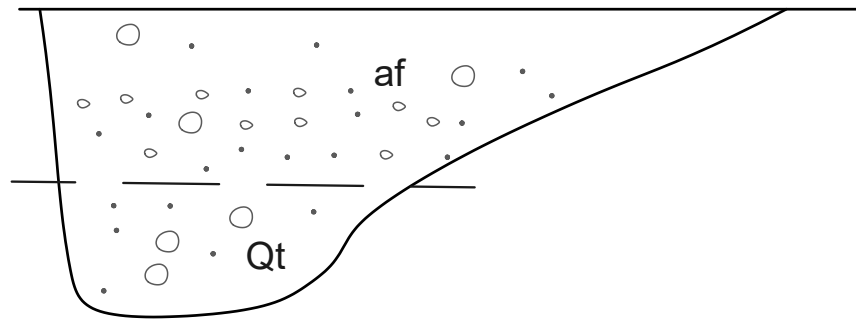
TEST PIT LOG 16

DEPTH	MATERIAL	DESCRIPTION	COMMENTS
0-4.5'	Artificial Fill (af)	Yellow brown, gravelly, sandy silt, moderately dense to dense, slightly moist, abundant cobble	
4.5-8'	Older Alluvium (Qt)	Yellow brown, gravelly, sandy clay, dense, dry to slightly moist, well indurated, abundant caliche, abundant rounded cobble, slightly porous

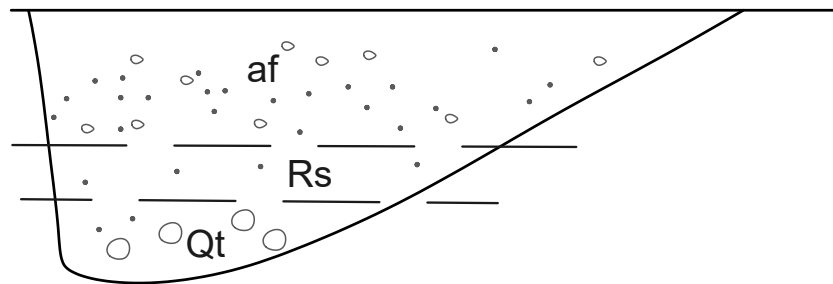
TEST PIT LOG 17

DEPTH	MATERIAL	DESCRIPTION	COMMENTS
0-3.5'	Artificial Fill (af)	Yellow brown, gravelly, sandy silt, moderately dense to dense, slightly moist, abundant cobble	
3.5-5'	Residual Soil (Rs)	Brown, sandy clay, dense, very stiff, slightly moist, some caliche present	
5-7'	Older Alluvium (Qt)	Yellow brown, gravelly, sandy clay, dense, dry to slightly moist, well indurated, abundant caliche, abundant rounded cobble, slightly porous

SCALE H: V: **PIT ORIENT:** **NATURAL SLOPE ANGLE** **TD** 7'

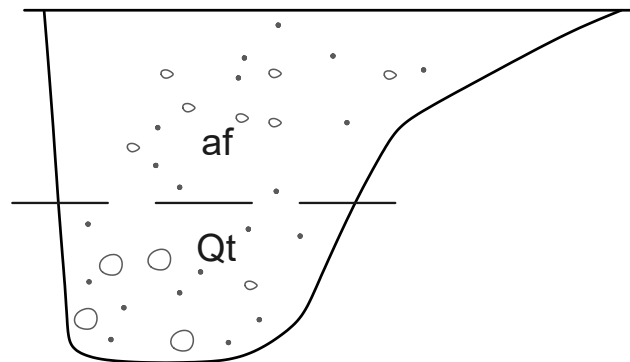
TEST PIT LOG 18

DEPTH	MATERIAL	DESCRIPTION	COMMENTS
0-5'	Artificial Fill (af)	Yellow brown, gravelly, sandy silt, moderately dense to dense, slightly moist, abundant cobble	
5-9'	Older Alluvium (Qt)	Yellow brown, gravelly, sandy clay, dense, dry to slightly moist, well indurated, abundant caliche, abundant rounded cobble, slightly porous

SCALE H: V: **PIT ORIENT:** **NATURAL SLOPE ANGLE** **TD** 9'

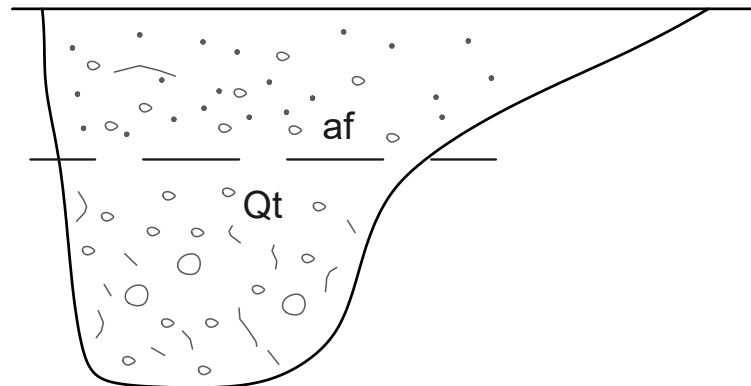
DEPTH	MATERIAL	DESCRIPTION	COMMENTS
0-4'	Artificial Fill (af)	Yellow brown, gravelly, sandy silt, moderately dense to dense, slightly moist, abundant cobble	
4-10'	Older Alluvium (Qt)	Yellow brown, gravelly, sandy clay, dense, dry to slightly moist, well indurated, abundant caliche, abundant rounded cobble, slightly porous

SCALE H: V: **PIT ORIENT:** **NATURAL SLOPE ANGLE** **TD** 10'

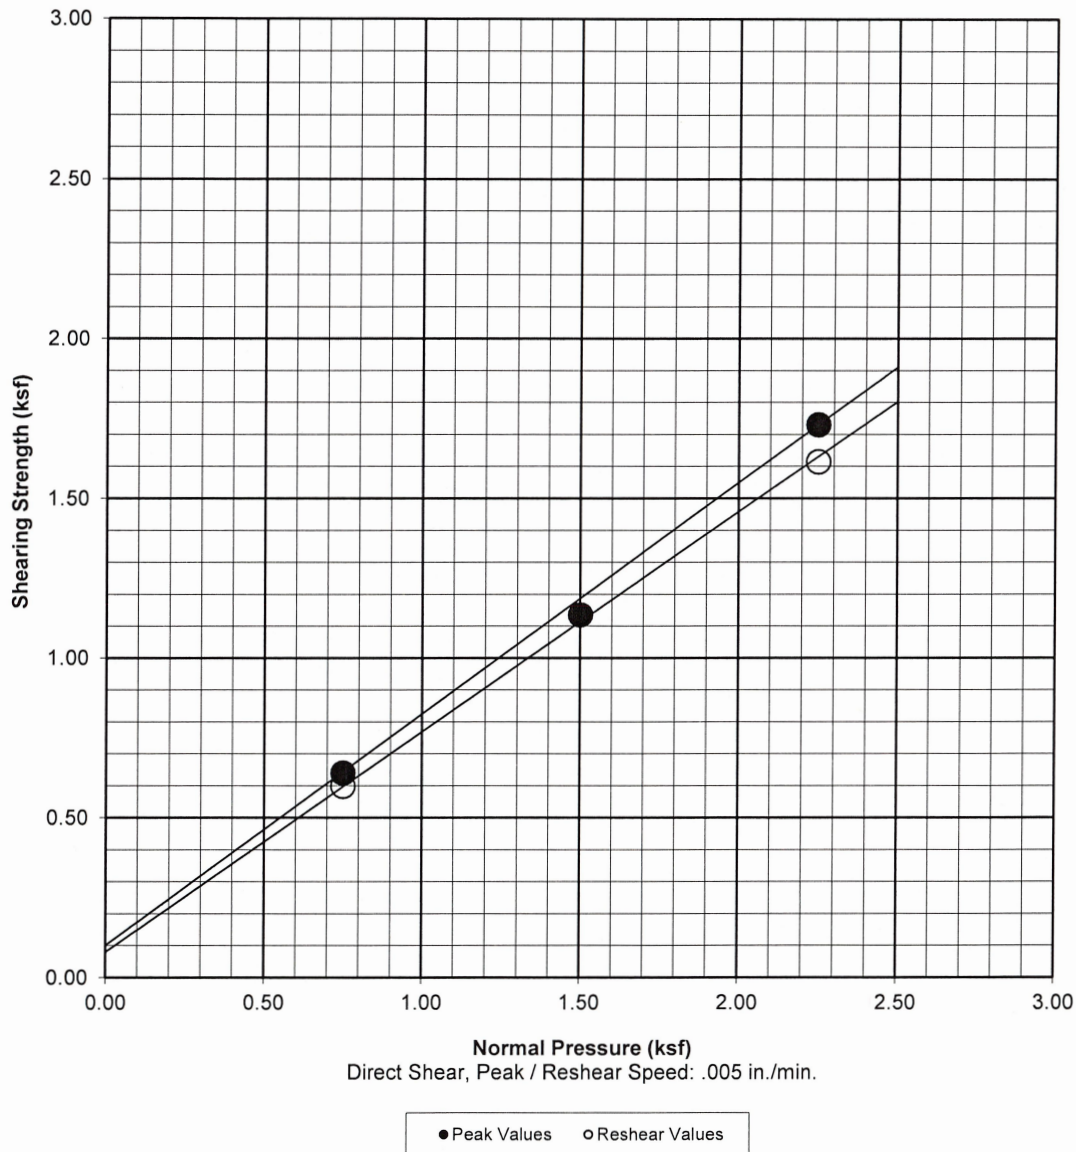
Reshear

C(psf): 80 Phi (degrees): 34.5

Sample **Remolded** to 90% Relative Density, saturated.
Remolded Dry Density = 113.4 PCF

Brown slightly clayey silty vf-c SAND.

One shear test was performed in a strain-control type Direct Shear Machine. The samples were sheared under varying continued loads in order to determine the Coulomb shear strength parameters: Cohesion and angle of internal friction. All samples were tested in an artificially-saturated condition. The results are plotted on the shear test diagrams included with this report as Plate SH-1.

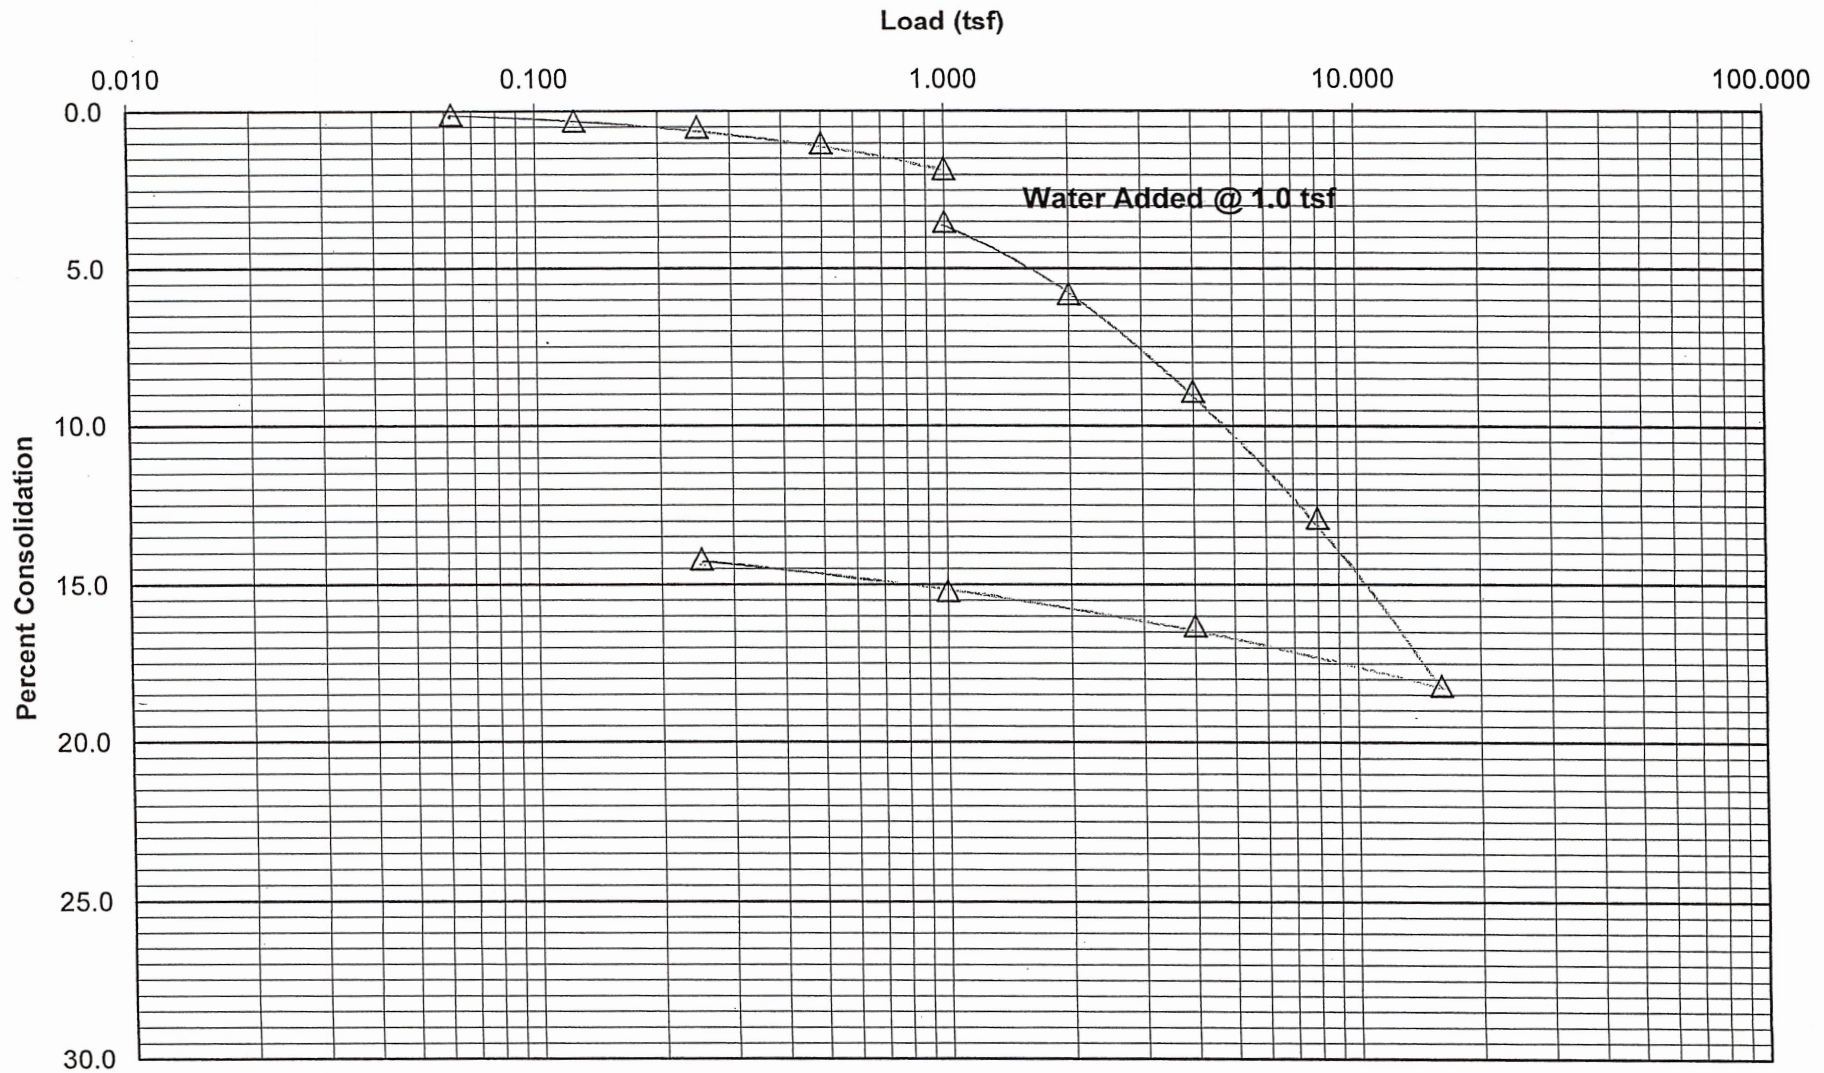
Consolidation Diagram

Moisture(%)
Before: 13.9 After: 23.0

Sample(in.)
Height: 1.00 Diameter: 2.36

TP-5 @ 5.0'
Light brown silty CLAY.

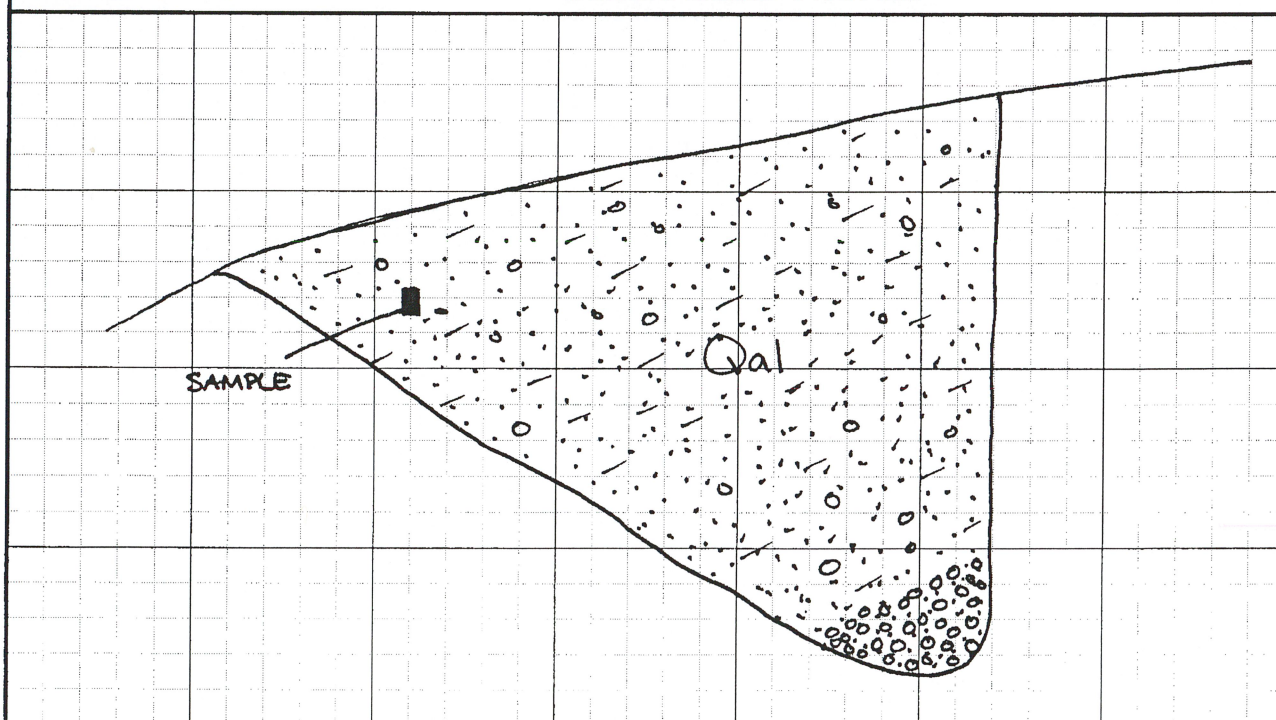
EXPLORATION: TP 2

ATTITUDE	DESCRIPTION
<p>f - fault s - shear j - joint b - bedding</p>	<p>0.0 - 16.0' QUATERNARY ALLUVIUM; Qal, silty sand, reddish brown, slightly moist, firm, subrounded clasts up to 5" in diameter, few larger up to 1' in diameter, upper 2.0' contains roots and rootlets.</p> <p>@12.0' boulder clasts in sandy matrix, yellowish brown, slightly moist, very firm.</p> <p>TOO HARD TO SAMPLE.</p> <p style="text-align: center;">

SCALE 1" = 5'

GENERALIZED PROFILE

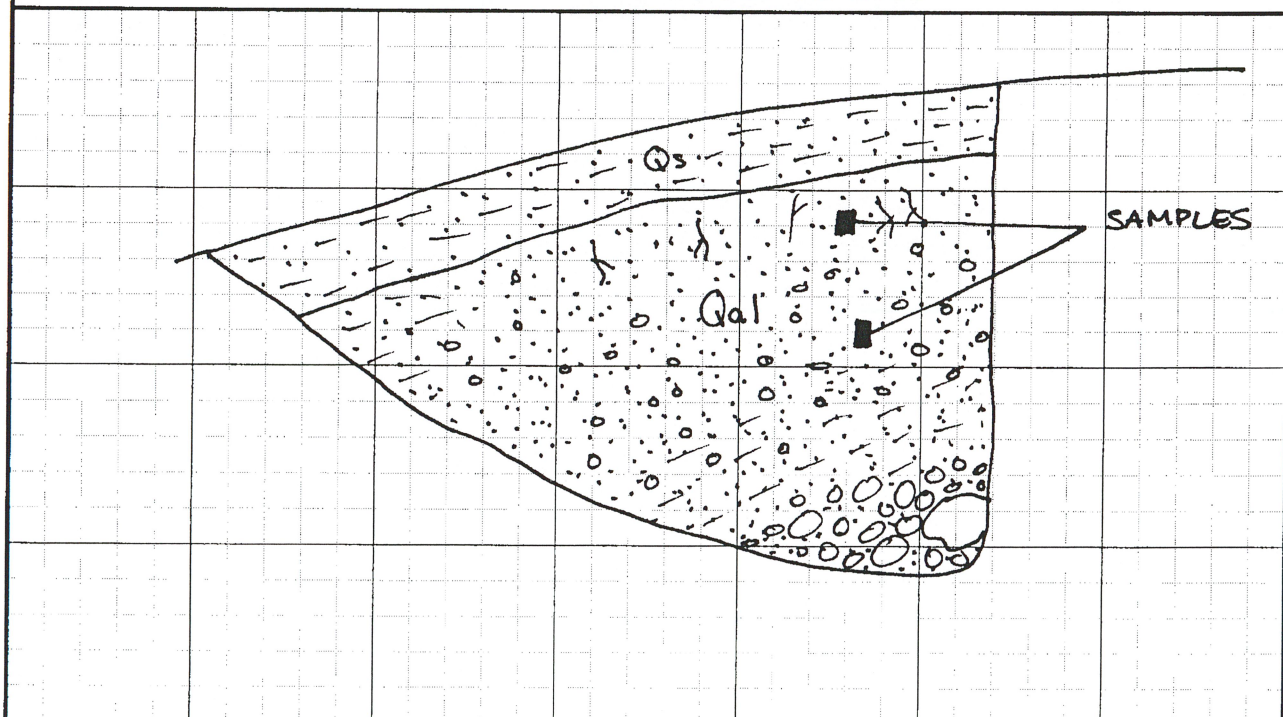
EXPLORATION: TP 3

ATTITUDE	DESCRIPTION
<p>f - fault s - shear j - joint b - bedding</p>	<p>0.0 - 2.0' SOIL; Qs, sandy silt, dark brown, moist, moderately firm, roots.</p> <p>2.0 - 14.0' QUATERNARY ALLUVIUM; Qal, clayey silt and sandy silt, reddish brown, moist, firm, abundant subrounded clasts up to 6" in length, a few large up to 1.0', roots in upper 2.0', a few rootlets throughout, increasing in density and decreasing in moisture.</p> <p>@10.5' abundant pebbles to boulder size clasts up to 2' in diameter in a sandy matrix, minor ravelling, rounded clasts.</p> <p>UNABLE TO DEEPEN DUE TO ABUNDANT CLASTS.</p> <p style="text-align: center;">

SCALE 1" = 5'

GENERALIZED PROFILE

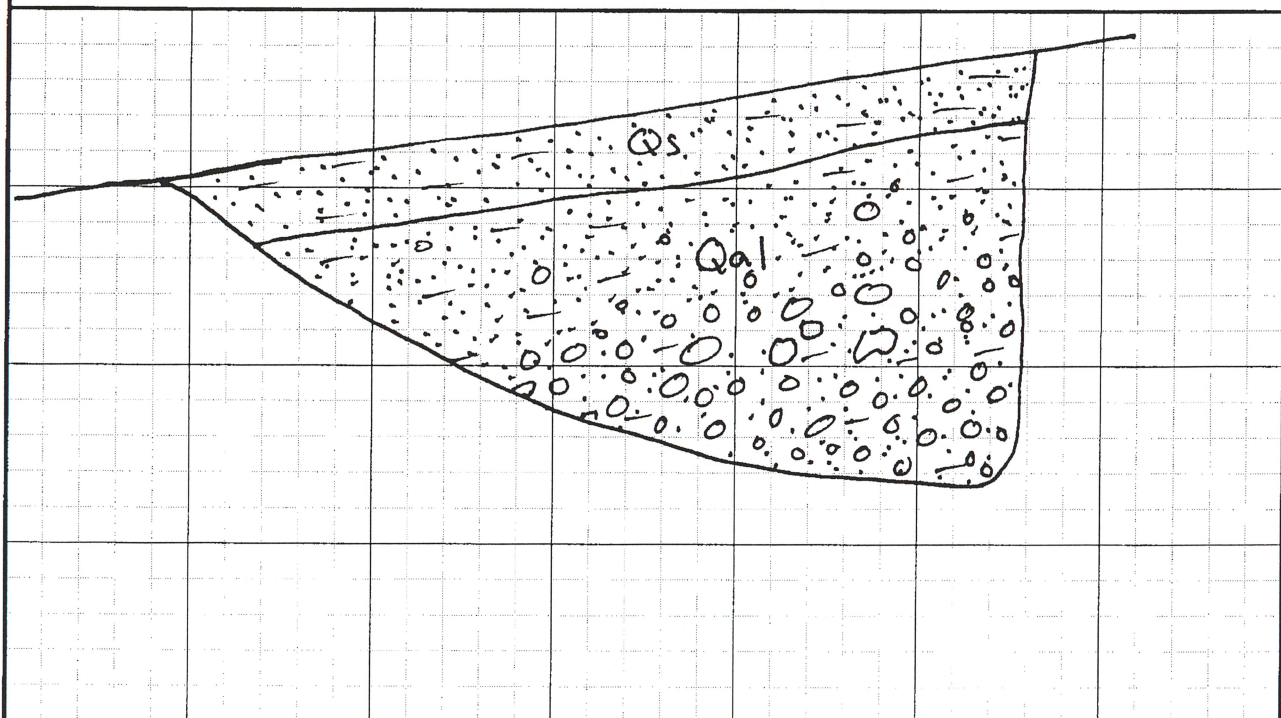
ATTITUDE	DESCRIPTION
f - fault s - shear j - joint b - bedding	<p>0.0 - 2.0' SOIL; Qs, clayey sand, dark brown, moist, moderately firm, roots.</p> <p>2.0 - 12.0' QUATERNARY ALLUVIUM; Qal, silty sand to sandy silt, reddish brown, slightly moist, firm, abundant pebble to cobble size clasts.</p> <p>@6.0' abundant clasts, very dense.</p> <p>@9.0' pebble to boulder clasts in a coarse grained sandy matrix, reddish brown, slightly moist, very dense.</p> <p style="text-align: center;">

SCALE 1" = 5'

GENERALIZED PROFILE
