Re: 534-42 S. F Street Determination of Eligibility for Designation as a City of Oxnard Historic Landmark

534-42 S. F Street

Determination of Eligibility for Designation as a City of Oxnard Historic Landmark

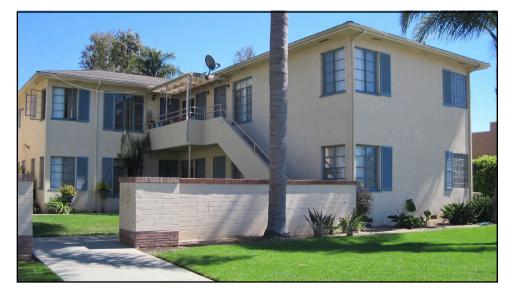
Description of Photo: (View, date, accession #)
Southern building, northern and western elevations. (9/16/2013)

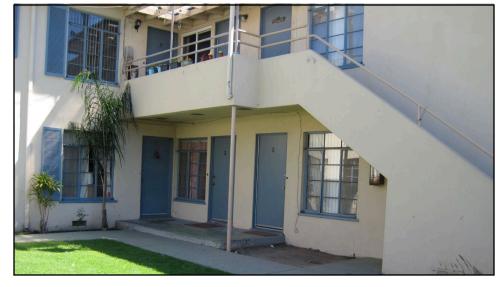
Detail of entries, balcony and stairway.
(9/16/2013)

are accessed via common balconies covered by open wood frame pergolas supported by pipe columns. The stainways feature stucco balustrades topped with steel pipe handrails. A low brick wall topped with a single-course cornice connects the top of the Ls and completes the enclosure of the courtyard. [continued] P3b. Resource Attributes (List attributes and codes)	, -			•	
balustrades topped with steel pipe handrails. A low brick wall topped with a single-course comice connects the top of the Ls and completes the enclosure of the courtyard. [continued] P3b. Resource Attributes (List attributes and codes) HP3-Multiple Family Property P4. Resources Present Building Structure Object Site District Other (isolates, etc.) P5a. Photograph or Drawing (Photograph required for buildings, structures, and objects) P5b. Description of Photo: (View, date, accession #) Western elevation, 9/16/2013 P6. Date Constructed/Age and Sources: Prehistoric Both 1950-F P7. Owner and Address Armando J. and Catherine Berriz 1781 Brooksfall Court Westlake Village, CA 91361 P8. Recorded by: (Name, affiliation and address) Mitch Stone, San Buenaventura Research Associates 1328 Woodland Drive Santa Paula, CA 93060 P9. Date Recorded: 10/2/2013 P10. Survey Type: (Describe) Landmark application P11. Report Citation: (Cite survey report and other sources, or enter "none") Attachments NONE Continuation Sheet District Record Rock Art Record Other (List)					· ·

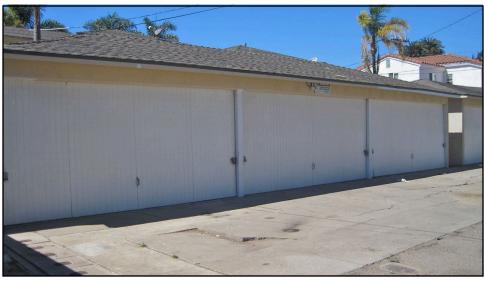
Garages, eastern elevation. (9/13/2013)

The wall is broken for a centered entry and concrete sidewalk originally framed by low brick planters, now replaced with brick pilasters. Two, single-story 3-bay garages are oriented towards the alley to the rear (east side) of the property. The garages are hip-roofed and accessed via vertical wood paneled awning doors. Landscape materials are confined mainly to low foundation plantings and shrubs both within and outside of the courtyard, and several mature palm trees located between the divider wall and the street.

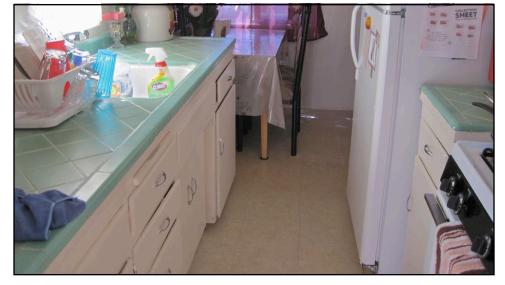
Kitchen interior, typical. (9/13/2013)

The property has retained substantial integrity. The property is still in its original location. Its design in the Modern style has remained essentially intact. An aluminum slider inserted within one original opening is the only apparent alteration to the fabric of the buildings. An open wood framed two-story screen joining the apartment buildings at the rear of the courtyard has been removed, along with a freestanding pergola originally located at the entry sidewalk. The property's integrity of materials and workmanship are also largely intact. The property is in good condition. In addition, the property retains a number of key interior architectural features, including original cabinets, and counter tiling in the kitchens and bathrooms.

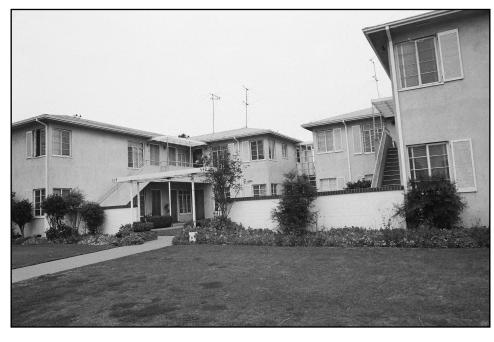
Description of Photo: (View, date, accession #)
Western elevation, showing original wall configuration, pergola and screen. (1981)

- replacement of one steel sash window on the second story of the southern building with aluminum sliders.
- covering of two small brick planters at the street entry with brick pilasters
- removal of a freestanding pergola over the street entry
- removal of a frame screen connecting the buildings at the rear of the building Ls.
